INTERSTATE COMMERCE COMMISSION

REPORT OF THE DIRECTOR OF THE BUREAU OF SAFETY IN RE INVESTIGATION OF AN ACCIDENT WHICH OCCURRED ON THE SOUTHERN RAILWAY SYSTEM, LINES WEST, NEAR SHANNON, GA., ON JULY 18, 1928.

April 23, 1929.

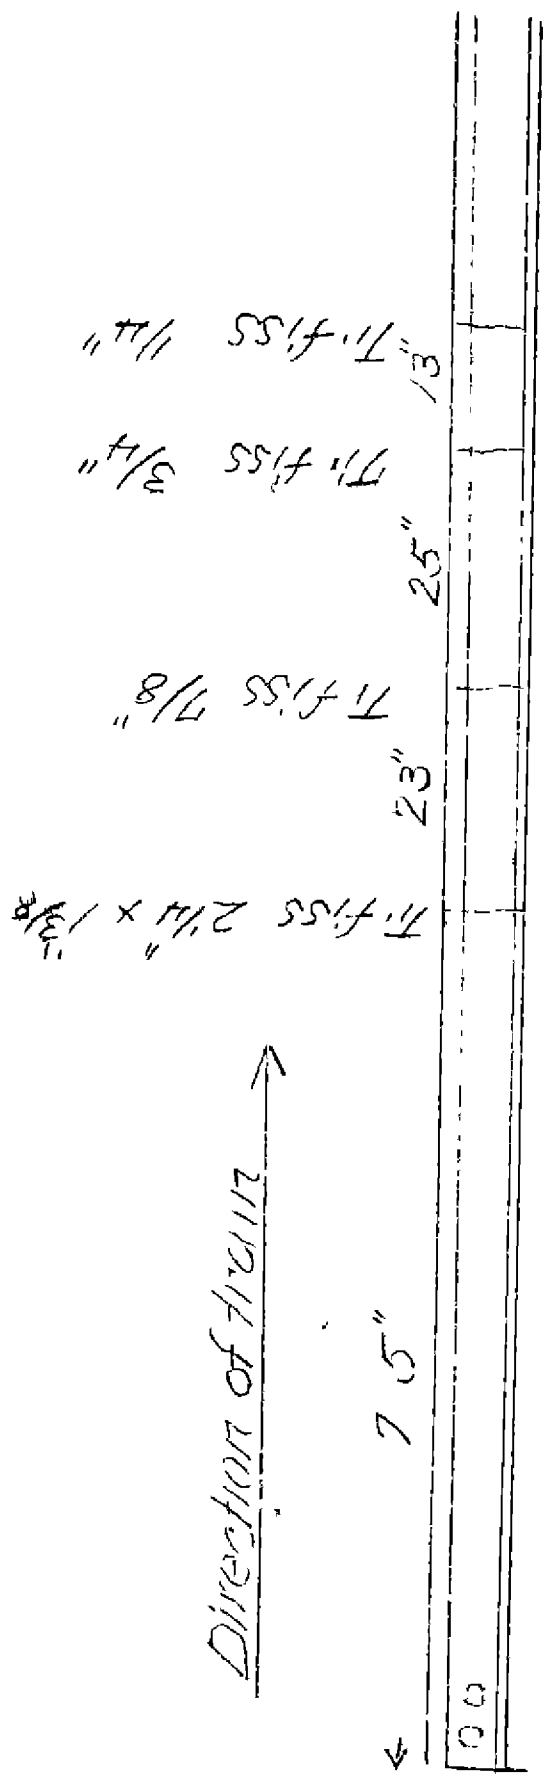
Broken rail 85 lbs T&I & RR Co. Nov 1926 Hecht 544378
 Accident on the Southern Ry near Shannon, Ga

It is clearly evident that the cause of the derailment was a broken rail, due to the presence of a number of transverse fissures. Four fissures were displayed at the time of the accident. At the first break in the rail, 7 feet 5 inches from the receiving end, the largest transverse fissure was shown. It covered the greater part of the area of the head and had a darkened surface. This fissure had reached the peripheral surface, admitted air and caused the discoloration of the faces of the fissure. The other three transverse fissures were smaller in diameter and presented faces of a silvery lustre common to fissures in their development previous to the time they are exposed to the air. These fissures were progressively smaller in diameter, according to their distance from the principal one. No special importance, however, attaches to this progressive diminution in size. Examples are frequently met where large fissures are located between smaller ones. The rate of growth depends upon track conditions, but every part of the length of the head is exposed to conditions which tend toward the formation of transverse fissures. Maximum stresses and local minor variations in strains probably account for the position and size of individual fissures. It would seem more reasonable to infer that variations in the conditions of exposure of individual rails account for differences in the sizes of transverse fissures rather than that they are due to primitive variations in strength along different parts of the lengths of the rails. There is probably a relation between the ages of transverse fissures and their sizes in the same rail. No reason has yet been established why a transverse fissure should not originate in any part of the length of the rail. This feature is mentioned as a suggestion to those who will undertake the extension of knowledge concerning the inception of this type of fracture. If perchance a reason is found for the loci of transverse fissures in the same rail, the next step would be to establish why some heats are, or are alleged to be, more prone to display transverse fissures than others. Efforts should be made to obtain information upon tangible objects of inquiry, having to do with this menacing type of fracture.

The top of the head was planed off to the depth of the nuclei of the transverse fissure and then pickled in hot hydrochloric acid in quest of shrinkage cracks, or shattered zones, so-called. None were found. The cross section of the rail was in good shape, showing limited amounts of wear.
