# INTERSTATE COMMERCE COMMISSION

## REPORT OF THE CHIEF OF THE DIVISION OF SAFETY COVERING THE INVESTIGATION OF AN ACCIDENT ON THE SOUTHERN RAILWAY NEAR TUXEDO, N C, ON AUGUST 12, 1914

FEBRUARY 8, 1915

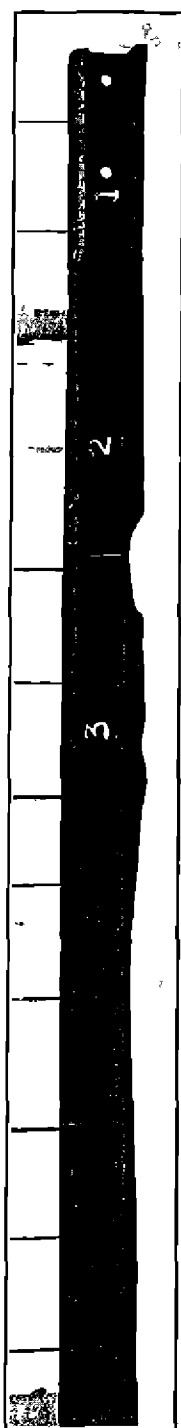
No 1—General view of the fractured portion of the rail from the gauge side. Direction traveled by the train, from left to right.

In the track it occupied a place on the outside of a 10° curve, with a prescribed superelevation of 4 inches. At the time of derailment it was broken in two places near its leaving end, the position of which fractures are shown on figure No 1. The lengths of the several fragments, beginning at the receiving end, were 29 feet 9½ inches, 1 foot 10½ inches, and 1 foot 4 inches, respectively.

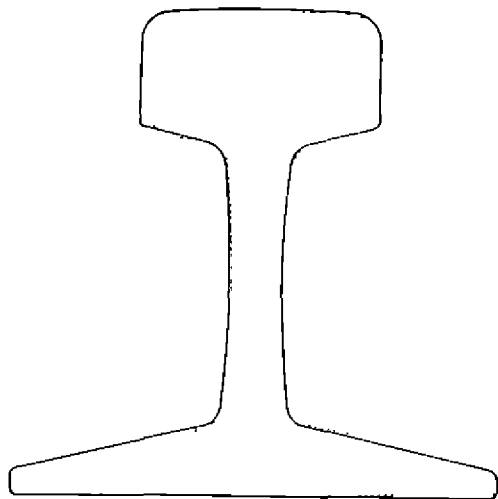
Amount of flange wear indicated by dotted lines

The fractured rail had experienced considerable flange wear, as shown by the accompanying sketch, where the full lines of the drawing represent the original cross section, according to the dimensions prescribed for the A S C E, 85-pound section, while the present worn shape is shown by dotted lines.

The metal which had been lost by abrasion and wear amounted to about 0.38 square inch, chiefly flange wear, and from the gauge side of the running surface of the head. This abrasive loss was due to the outward thrusts of the wheel flanges, incident to its position on the outside of a sharp curve.

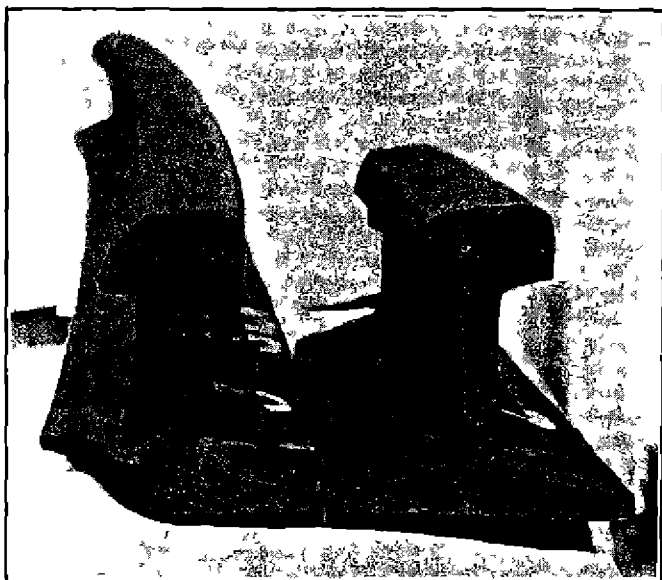
No. 4—Fractures at leaving ends of fragments 3 and 2 respectively taken from left to right. Initial line of rupture on fragment 3 secondary line of rupture on fragment 2.

Figure No 4 shows the fractures on the leaving ends of fragments 3 and 2, respectively, from left to right on the cut. The initial plane of rupture, the same as shown in figure No 2, appears in this cut on the end of fragment 3, while the secondary line of rupture of the rail appears on the end of fragment 2, the right hand figure of the cut.

These two lines of rupture traversed the rail in opposite directions. The primary rupture had its origin at the outside edge of the flange of the base, extending thence through the base, detaching a crescent-shaped piece from the compression side, passing up through the web and head, and completing the fracture of the rail.

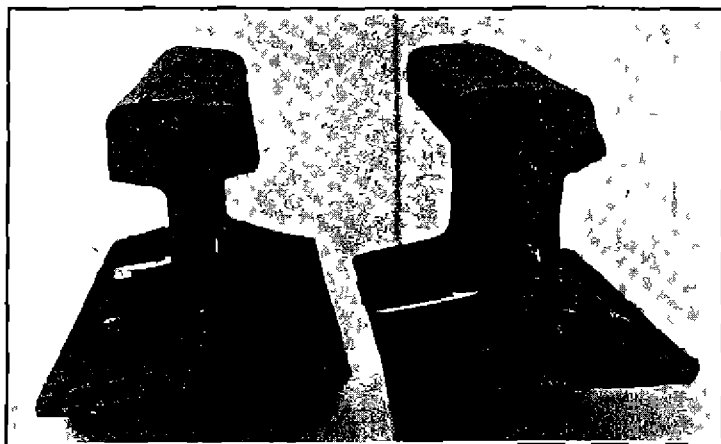
No 5.—Fractures at receiving ends of fragments 2 and 1 respectively taken from left to right

Initial line of rupture on fragment 2 secondary line on fragment 1 Battered edge of head on gauge side and wheel flange indentation on inside edge of web of fragment 1

Figure No 5 shows the receiving ends of fragments 2 and 1, respectively. The initial plane of rupture again appears in this cut on the end of fragment 2, the secondary plane on the end of fragment 1. The battered edge of the head of fragment 1 on the gauge side and a semicircular indentation on the inside of the web of this fragment will be noticed.

The receiving end of fragment 1 was battered on the gauge side of the head and also indented by a wheel flange on the inner edge of the web, further indicating that fragment 1 was on its side at this stage in the derailment, that is, turned outward with an angular movement of approximately  $90^\circ$ . The interval of time required for a wheel to travel the length of fragment 2, about one twentieth of a second at 25 miles per hour, would seem too brief in which to accomplish the turning of the rail from an upright position at its receiving end to a quarter of a turn at its leaving end. Hence the evidence presented by the fragments leads to the inference that the rail was at least partially overturned at the time of development of the initial line of rupture and subsequently completely overturned at its leaving end.

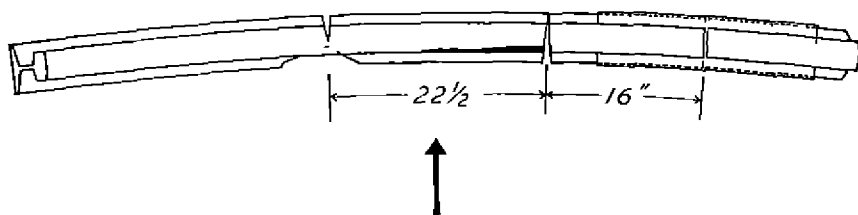
The progressive manner in which the rail broke, as indicated by the fragments, is illustrated on the accompanying sketch.

A force was evidently exerted in the direction of the arrow, putting the outside flange of the rail into a state of tension, and causing the initial line of rupture to have its point of inception at the edge of the outer flange. A crescent shaped piece was detached from the inner flange of the base on the compression side of the bend. The general direction of travel of this line of rupture was from outside toward the inside of the rail.

After the rail was broken in one place, it would then present a short overhanging end attached by the splice bars to the rail next beyond. The force continuing to act on this short end would next develop a fracture starting from the inside face of the rail, extending to the outside. This was the direction taken by the secondary line of rupture, as shown by the evidence on the fragments.

A partial shearing of the head of fragment 2 occurred on the gauge side, indicated by the heavy line on the sketch. One wheel

The arrow is placed on the sketch for the purpose of indicating the direction of the lateral force with respect to the rail, but will not be taken to signify that it was a horizontal force. The failure of the rail is not attributed to a direct horizontal thrust, but to its overturning by reason of that horizontal thrust, followed by the weight of the engine breaking the rail. The case would be an unusual one if the rail was fractured in an upright position, due to augmented tension of the outside flange from centrifugal forces. The evidence gathered does not lead to the latter explanation, but to the former one, that the rail first turned and was then fractured when partly or completely on its side. The transverse tests, which showed greatly diminished resistance when the rail was loaded on its side against the normal direction of loading, favor the probability of its rupture when on its side.
