INTERSTATE COMMERCE COMMISSION

REPORT OF THE DIRECTOR OF THE BUREAU OF SAFETY IN RE
INVESTIGATION OF AN ACCIDENT WHICH OCCURRED ON
THE ST. LOUIS, BROWNSVILLE & MEXICO RAILWAY, MISSOURI
PACIFIC SYSTEM, AT RICARDO, TEXAS, ON JANUARY 7,
1929.

March 6, 1929.

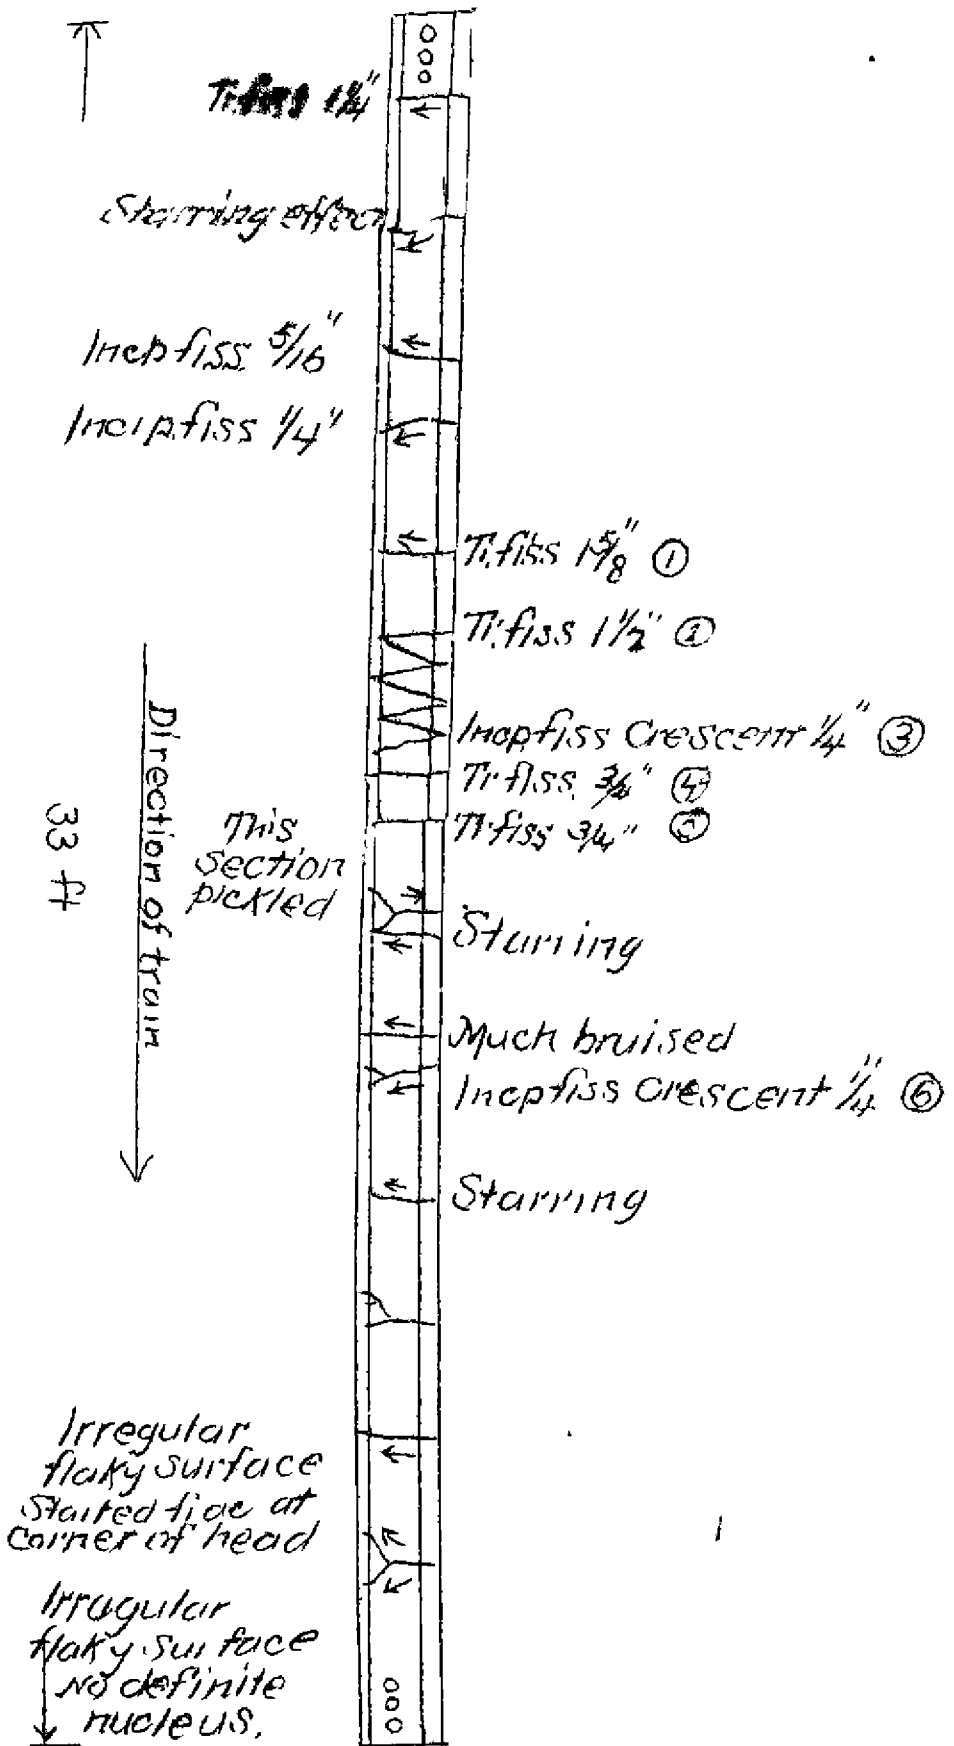
Broken rail 75 lbs A.S.C.E Maryland 1111111-06 Heat 34777
 Accident on the Gulf Coast Lines, near Ricardo, Texas
 January 7, 1929

The rail which broke causing this accident, displayed a number of transverse fissures; the presence of which led to its fracture. It was 33 feet long, weighing 75 pounds per yard, Bessemer steel, and rolled by the Maryland Steel Company, August, 1906, heat number 34777.

The initial point of fracture made in the track was at a transverse fissure located 10 feet 4 inches from the receiving end. This fissure had a diameter of $1 \frac{5}{8}$ inches. Five other transverse fissures were displayed in the fragmentation of the rail as it occurred at the time of the accident. They ranged in diameters from $1 \frac{1}{2}$ inches down to $\frac{1}{4}$ inch. The smallest fissure represented one in its early stage of development. Its nucleus was concentric with a small crescent shaped surface of silvery lustre.

On this occasion there were five additional fissures displayed as previously remarked. Subsequent examination revealed three more fissures in the 10-foot 4-inch piece of rail at the receiving end. In all this rail contained nine transverse fissures in different stages of development. All were located on the gauge side of the head with

nuclei $1\frac{1}{2}$ inch below the running surface. This is nearer the running surface than generally the case. Track conditions are such that $\frac{5}{8}$ inch or a little deeper is the more common depth below the top of the head at which transverse fissures have their loci. The influence of track conditions is shown by the fissures generally originating on the gauge side of the head.

A short fragment of this rail, each end of which displayed a transverse fissure, was examined by planing off the top of the head to the depth of the nuclei of the transverse fissures and pickling the exposed surface in hot hydrochloric acid. A zone of metal along the middle of the width of the head displayed a generally shattered state of the metal. This shattered zone had a width about four-tenths that of the head of the rail. It was defined at each boundary by a pronounced longitudinal seam. A zone so completely shattered as this is seldom seen in the interior core of the head of a rail.

In the present example attention centers on the decidedly shattered state of the metal in the central core of the head of the rail. The several transverse fissures had their nuclei at one edge, gauge side, of this shattered zone. It should be remarked in passing that the shattered zone or core of the head is believed to represent a condition which existed at the time of fabrication and remained during its entire period in service.
