INTERSTATE COMMERCE COMMISSION

REPORT OF THE CHIEF OF THE BUREAU OF SAFETY COVERING THE INVESTIGATION OF AN ACCIDENT WHICH OCCURRED ON THE ST LOUIS-SAN FRANCISCO RAILROAD AT KNOBVIEW, MO, ON DECEMBER 21, 1919

DECEMBER 10, 1920

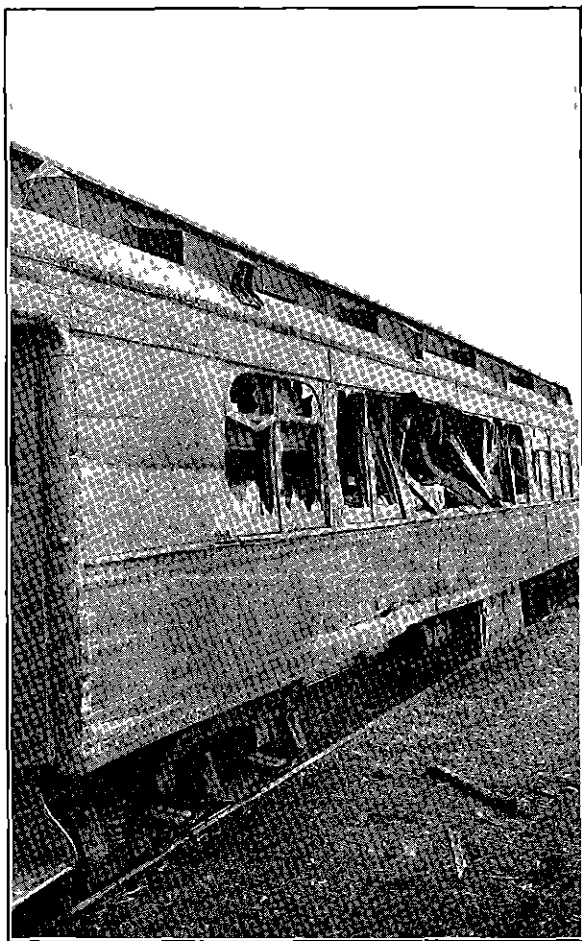
The engine and first 5 cars of train No 10 remained coupled together and came to a stop with the engine about 1,450 feet east of the switch points. Of this portion of the train, only the chair car was derailed, the rear truck of this car having been the first part of the train to derail. This car came to rest leaning against some of the freight cars on the siding, with its right side quite badly damaged, as seen in illustration No 1. The train parted between the fifth and sixth cars, the rear portion of the train coming to a stop with the last car, which was not derailed, just east of the switch points. The front end of the sixth car, which was the Pullman sleeper *Jolanda*, was demolished for about 20 feet by reason of its coming in contact with the front end of engine 26, of the freight train. Illustration No 2 shows this car, resting on its side after having been cleared from the track. The next four cars, although derailed, remained upright and were not seriously damaged, while the dining car, the last car in the train, was not derailed or damaged. The front end and side of engine 26 were badly damaged, as shown in illustration No 3.

Fig 1 —Side view of chair car No 753 after derailment Axle
under this car was broken

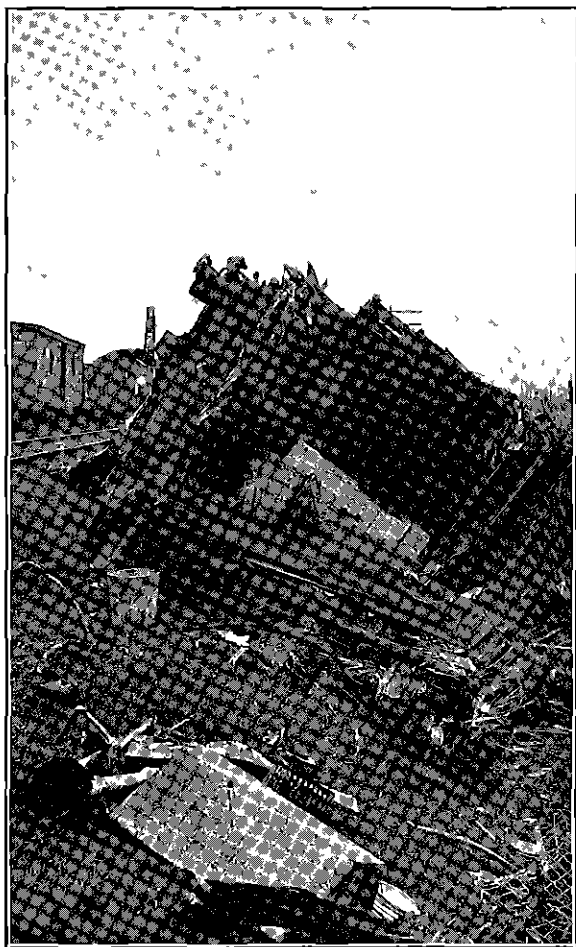
Fig 2 —View of Pullman sleeper Tolanda on its side after having been cleared from the track

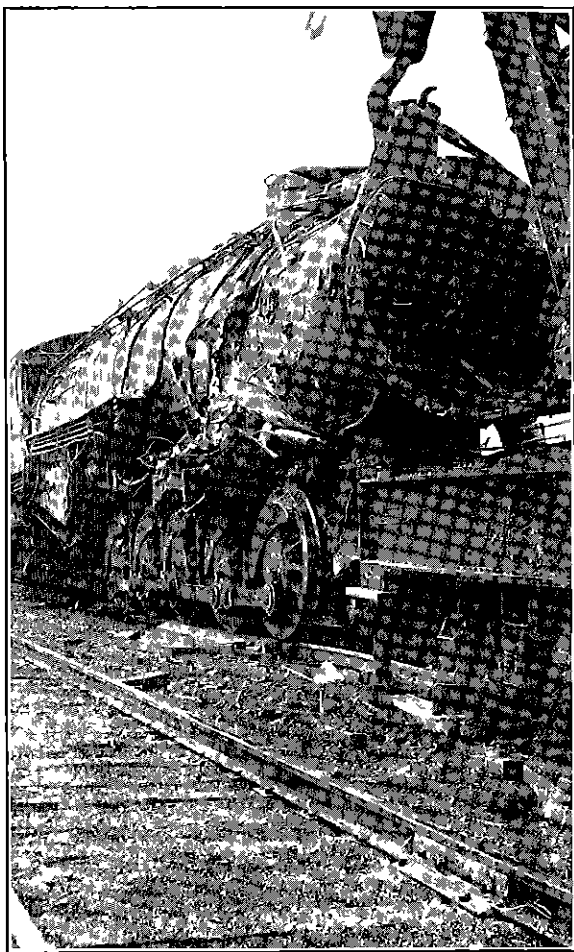
Fig 3 —View of freight engine 26 showing damaged front and side after side swipe of passenger train 2d No 10

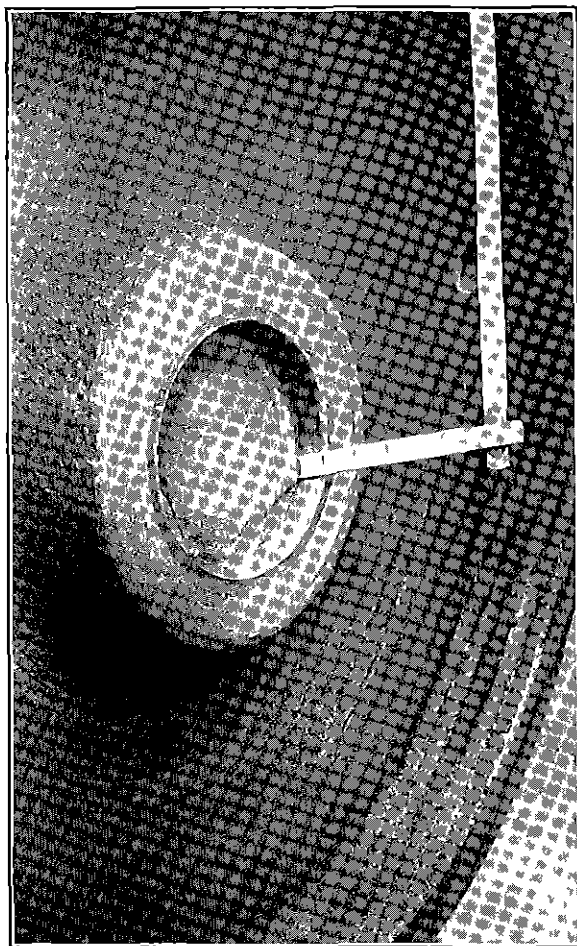
An inspection of the equipment of train 2d No 10 disclosed that the axle of the leading pair of wheels of the rear truck of the chair car, the fifth car in the train, had broken within the wheel-fit of the south wheel, the break being 1 to 1½ inches from the outside of the wheel. (See fig 4.) Apparently this axle broke when the train

The axle failed with a progressive fracture, the origin of which was at the periphery of the wheel seat, but located within the hub of the wheel. The surface of rupture was from 1 to 1½ inches below the outer face of the hub.

Fig 4 - View of broken axle of chair car No 753 Plane of rupture 1" to 1½" within the outer face of hub of wheel

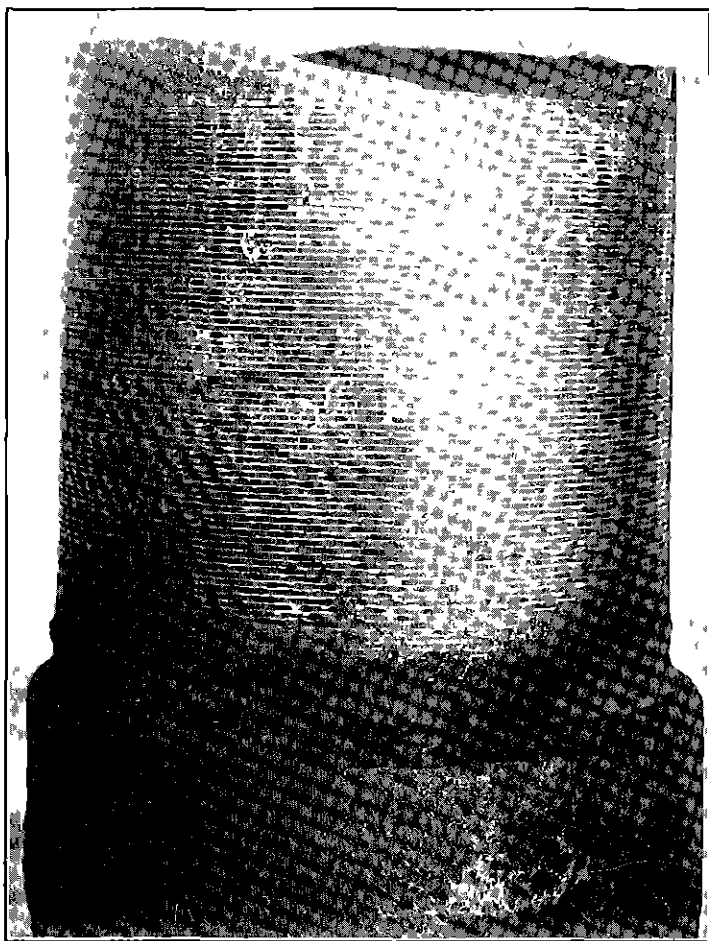
Chatter marks of the lathe tool appear on the turned surface of the wheel seat marks which are indicative of heavy cuts having been taken in turning forgings. At the broken end, the wheel seat was not concentric with the adjacent part of the forging. About one-eighth inch had been turned off one side of the forging, and one-half inch from the other side, in the formation of the wheel seat. The feed of the lathe tool was 15 per inch.

The chief cause which contributed to the failure of this axle is assigned to the rough cut taken in the lathe when the wheel seat was turned. No mechanical, physical, nor chemical tests were made on the fragments of this axle. None appeared necessary. The origin of the rupture was clearly shown, and the character of the turned surface furnished a reason for its occurrence.

Fig 6 —Side view of broken axle showing character of turned surface of wheel seat
Origin of fracture at tool mark on rough turned surface of wheel seat

Upon pressing off the wheel the character of the surface of the wheel seat was revealed. It showed that a rough cut had been taken in the lathe in turning the axle. The line of rupture had its incipient point at the circumference of the wheel seat, coinciding with a tool mark. Other incipient cracks on the same surface followed similar tool marks.

In brief, the character of the surface of the wheel seat was apparently responsible for the failure of the axle. From information at hand, on the results of repeated stresses on axles, the character of this surface is regarded as an adequate cause for its failure.

This is a matter which demands attention in the manufacture of axles. Slight economy in first cost results from taking a rough cut, in turning an axle, omitting a proper finishing cut, economy incomparable with the dangers involved and expense incurred in its failure in service.

Axles are vital members. Lavish expenditures on interior fittings of cars are out of place if necessary precautions are neglected in the manufacture of the axles. Current methods of inspection appear to have ignored or omitted consideration of the importance which attaches to the proper machining of axles. Specifications governing then tests and acceptance are singularly lacking in reference to this feature, the neglect of which leads to the destruction of the axles and becomes a menace to the safety of travel. It should be sufficient to call attention to these errors of omission to insure the introduction of corrective measures.

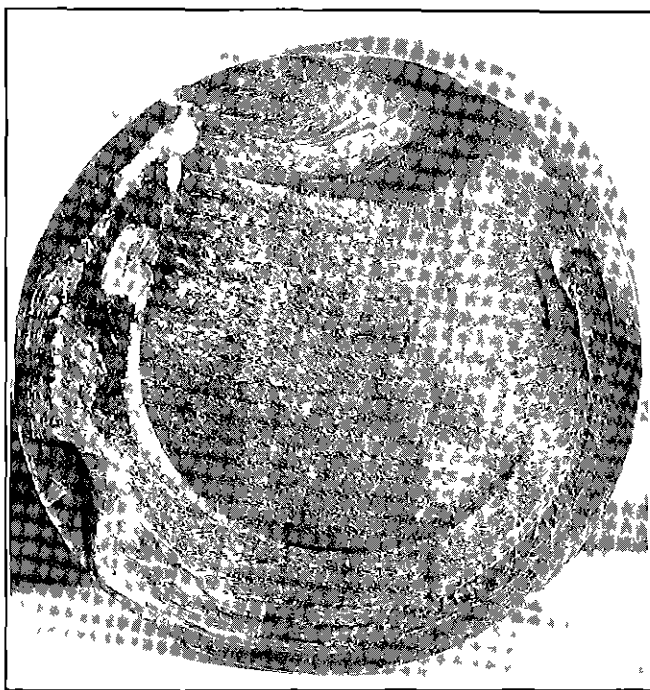
Figures Nos. 5 and 6 are end and side views, respectively, of the axle as it appeared after removing the wheel. It required a pressure of 250 tons to remove the wheel at the fractured end, and 260 tons pressure to remove the other wheel. The concentric curved line which shows on the end view, about 4¼ inches diameter, represents a depression on the fractured surface made by the follower of the wheel press in forcing the axle from the wheel.

Examination of the fractured surface showed the progressive character of the break. Its initial point was at the circumference of the axle. At the surface of the wheel seat the plane of rupture followed a tool mark made by the lathe tool in turning the axle. The primitive surface of rupture was deflected after following the tool mark a short distance, and then merged with a second plane of rupture. The latter also had its origin at the peripheral surface of the wheel seat, and likewise at a circumferential mark made by the lathe tool. There was an extension of the first plane of rupture shown by a fine crack on the circumference of the axle, also two other incipient cracks which were located quartering with the primitive point of rupture.

The surface of rupture progressively extended until three-quarters or more of the cross section was fractured, then final separation of the axle occurred, precipitating the derailment.

Fig 5—End view of broken axle after wheel was removed. Progressive fracture having its origin at circumference of axle $1\frac{1}{2}$ " within outer face of hub

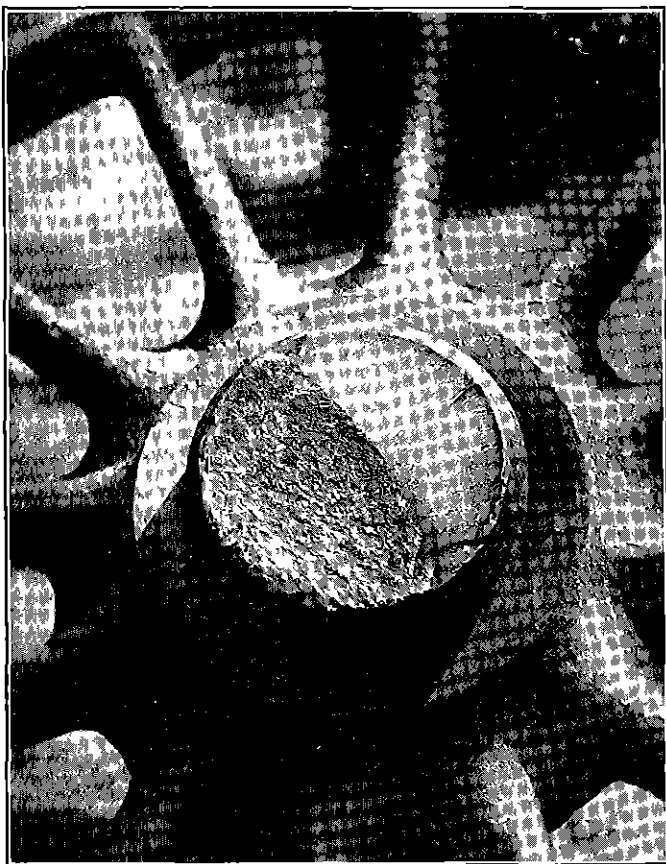
Fig 8 —Appearance of progressive fracture of trailer axle

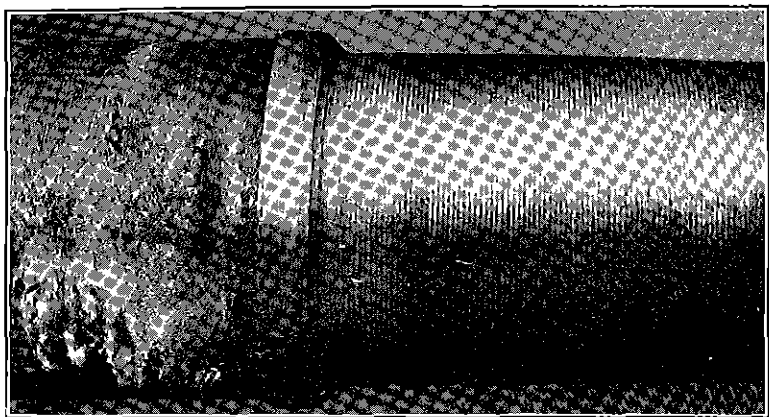
Failures of other axles have furnished examples in which features of design and mechanical matters have been overlooked, the omission of which led to premature rupture. Figure No. 7 shows the appearance of a trailer axle which ruptured from apparently preventable causes. This axle failed at the end opposite that shown by the cut, at the junction of the rough turned central portion and the abrupt shoulder next the wheel seat. A rough cut had been taken across the middle of the length of the axle, and an abrupt shoulder left at the end of the turned portion. Each of these features doubtless had an influence in promoting early failure. Figure No. 8 shows the appearance of the fracture of this axle. This failure was a progressive one, beginning at the circumference of the axle at a distance of 2½ inches from the inside face of the hub of the trailer wheel. The diameter of the axle at the place ruptured was 8½ inches.

This axle was furnished by its manufacturer in the condition it was expected to be used, excepting the fitting of the wheel seats and journals. It was finished on those surfaces in the shops of the railroad on which it failed. The responsibility for its rough turned section rests primarily upon the manufacturer of the axle.

Fig 7 —Appearance of a trailer axle which fractured at the shoulder at end opposite that here shown. Its failure attributed to a rough cut in the lathe used in turning the middle of the length of the axle together with the abrupt shoulder next wheel seat
