REPORT OF THE DIRECTOR OF THE BUREAU OF SAFETY IN RE
INVESTIGATION OF AN ACCIDENT WHICH OCCURRED ON THE
ST. LOUIS-SAN FRANCISCO RAILWAY AT MONETT, MO., ON
JANUARY 23, 1930.

March 22, 1930.

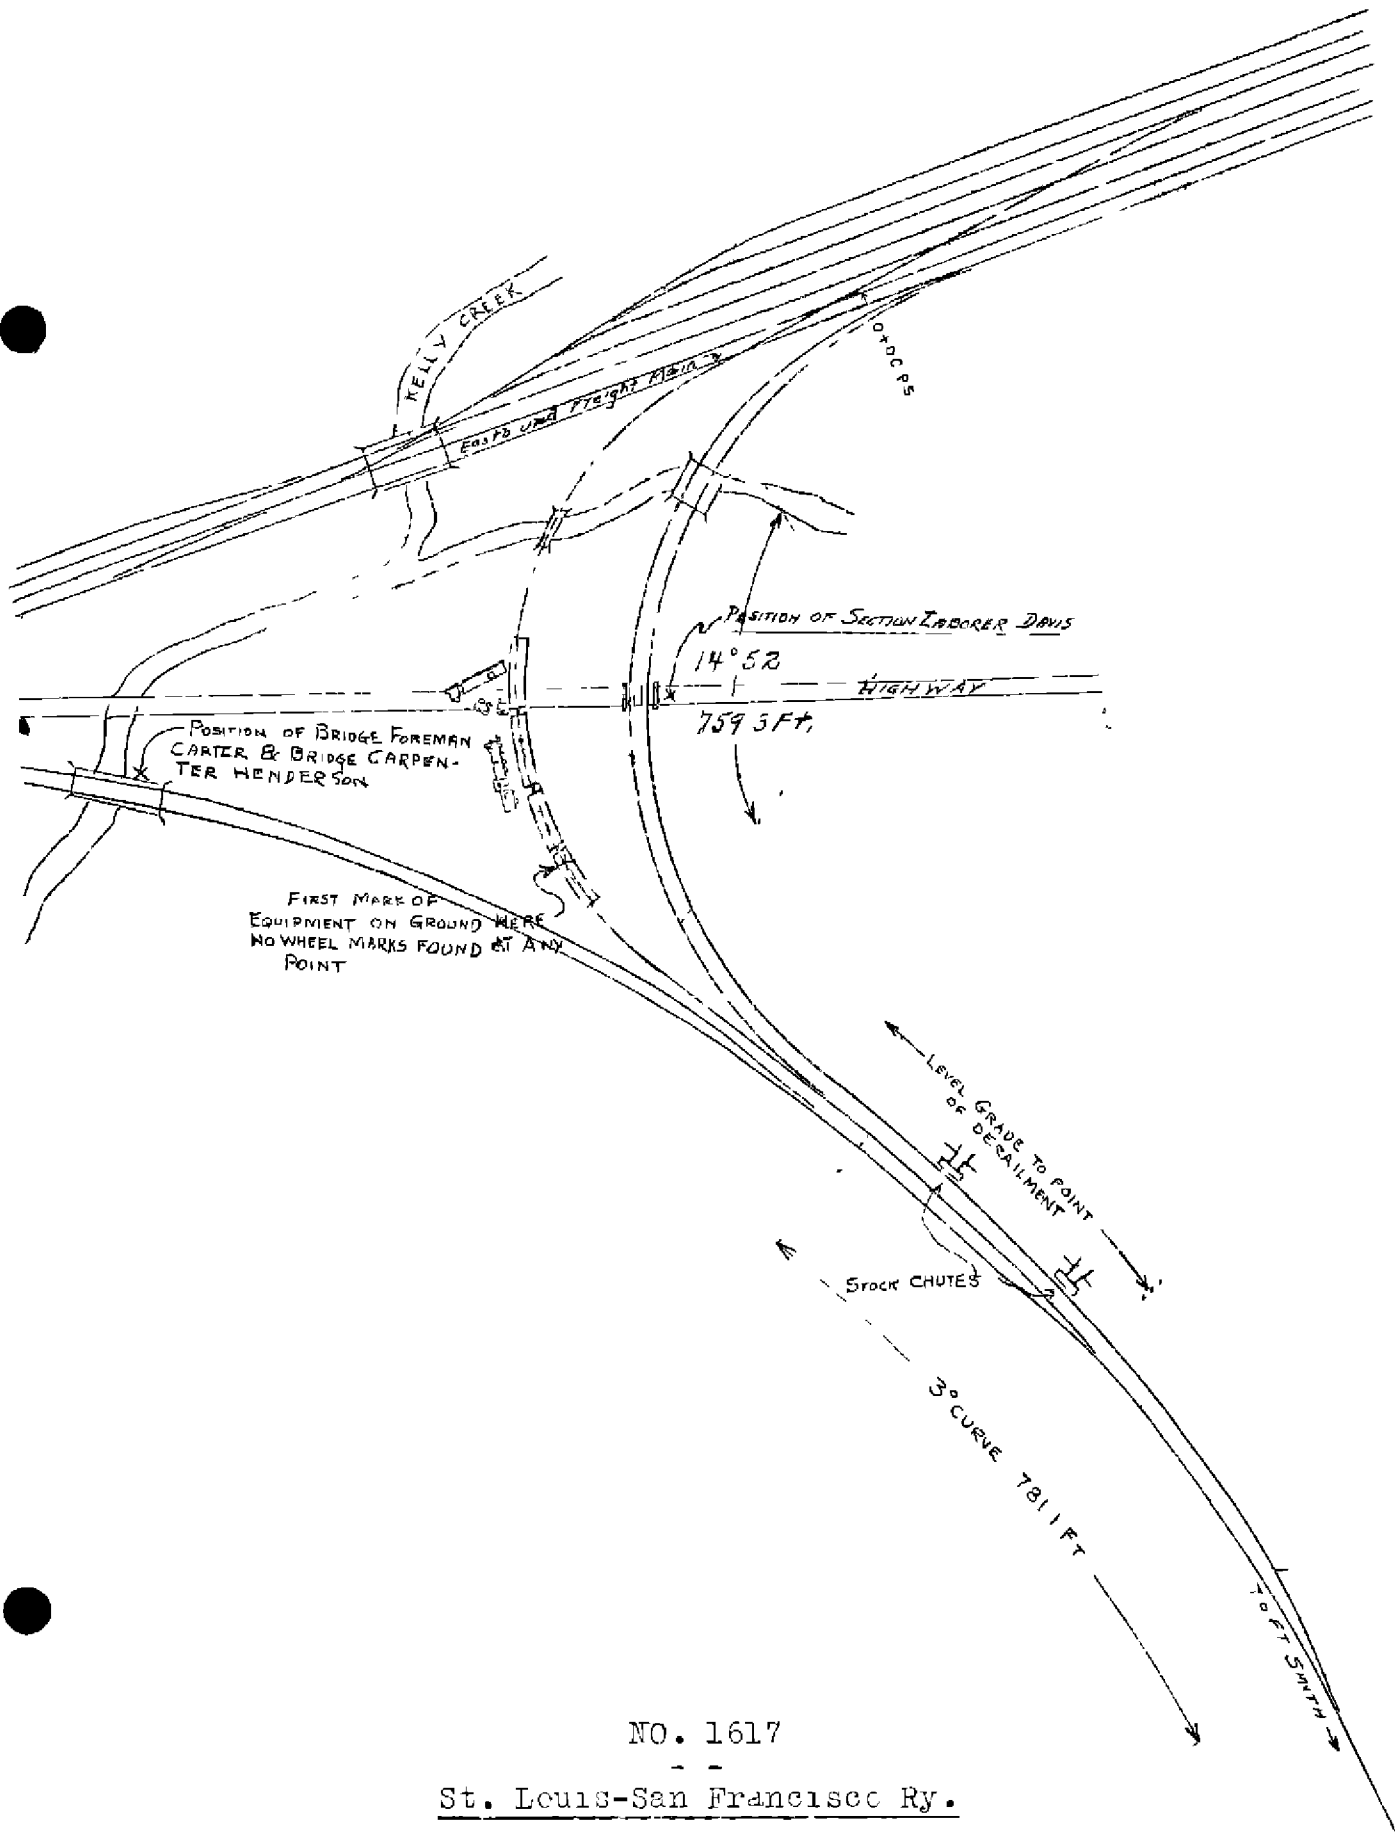
NO. 1617

The engine and tender were derailed to the left, the engine coming to rest on its left side at a point 137 feet north of the first mark of derailment, with the tender bottom up, directly behind the engine. The first car and the rear truck of the second car were also derailed, the first car resting on its right side beyond the engine, clear of and nearly at a right angle to the track. The train stopped with the head end of the fourth car nearly opposite the rear of the engine. The employee killed was the fireman and the employee injured was the engineman.

This accident is believed to have been caused by excessive speed.

An examination of the track and equipment failed to disclose anything which could have contributed to the accident, and while damage to air hose and brake beams had resulted due to the train having passed over the blow-off muffler box while en route, yet there was ample evidence to indicate that the brakes were in proper working order when approaching the point of accident. The train crew

Rule 93 of the Rules of the Transportation Department requires trains to approach railway crossings at grade prepared to stop, and such a crossing is located 892 feet beyond the point of derailment, for which trains of this division were required to stop unless a proceed signal were received. This situation, coupled with circular instructions addressed to engineers and calling attention to the fact that passenger trains were approaching Monett yard at too high a rate of speed, which circular was re-issued approximately every six months, appeared to have been considered sufficient to cause trains to be operated on this curve at a safe rate of speed. Rule 841 of the Rules for the Maintenance of Way and Structures, however, provides that where the speed permitted by the time-table is higher than the elevation of curves will permit, speed must be reduced accordingly, and this rule also provides that signs "shall" be placed one-fourth mile from the beginning of each curve where the speed is to be reduced, showing the maximum permissible speed. In this particular case, the permissible speed under the time-table is 50 miles per hour, and the elevation on a curve of this degree obviously could never be made safe for such a rate of speed, yet no sign had been put up in accordance with the requirements of rule 841. The installation of such a sign would provide a guide for the benefit of engineers entering Monett over this line and would eliminate the necessity for re-issuing the circular instructions to engineers referred to above.
