INTERSTATE COMMERCE COMMISSION

REPORT OF THE DIRECTOR OF THE BUREAU OF SAFETY IN RE
INVESTIGATION OF AN ACCIDENT WHICH OCCURRED ON THE
TEXAS & PACIFIC RAILWAY AT DENTON, TEXAS, ON APRIL
3, 1929.

July 31, 1929.

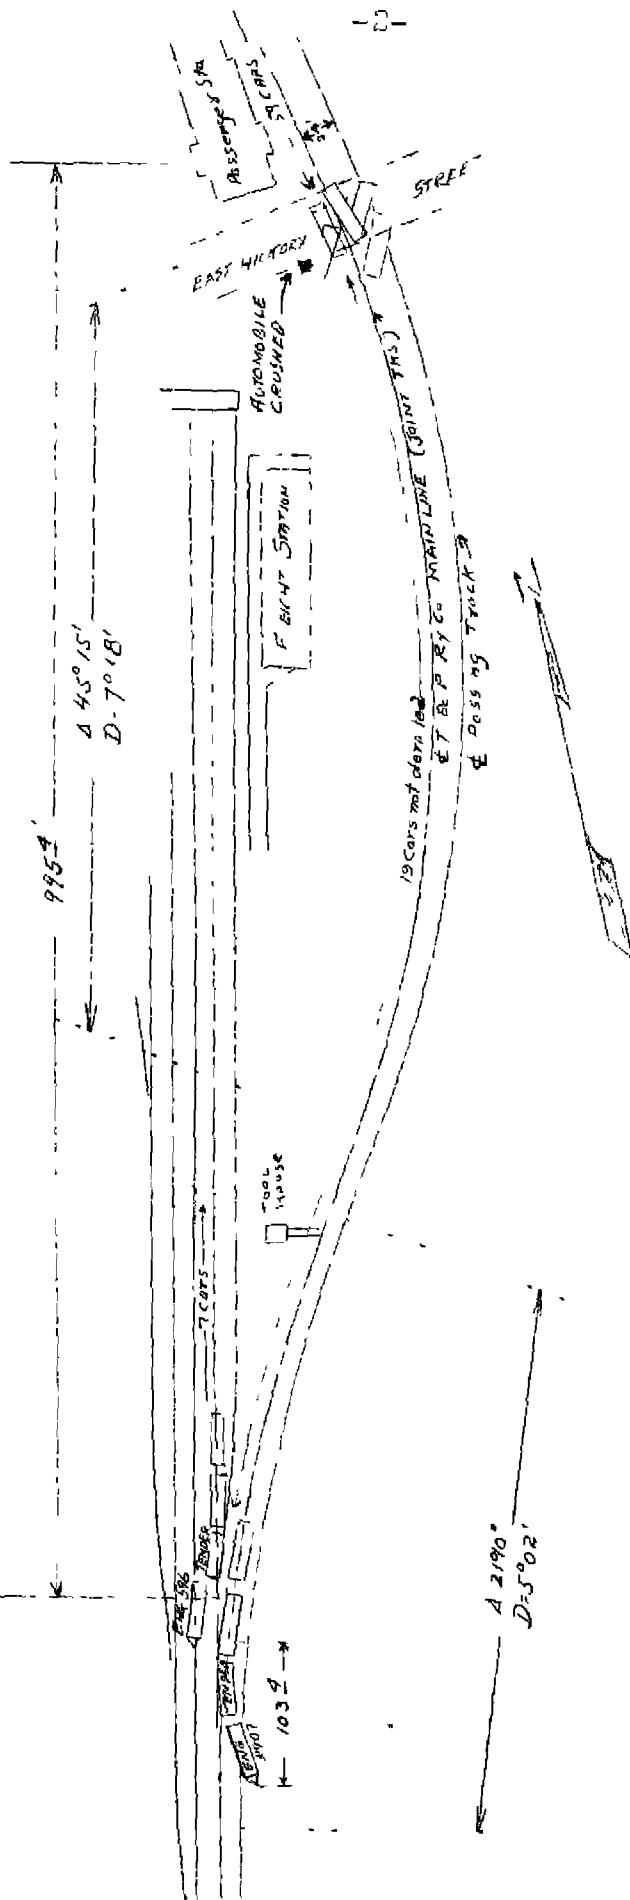
Point of
accident -

Engine 596 was overturned and came to rest on its right side on track 2, quite badly damaged, the tender remained upright but was derailed and slightly damaged. Engine 907 came to rest in an almost upright position east of the main track and was also considerably damaged. The tender and one truck of the first car were derailed while impact caused the train to buckle, derailing the 21st to the 25th cars, inclusive, one being demolished and the others more or less damaged. One of these cars fell on an automobile which was parked alongside the station platform, killing one of its occupants and injuring another occupant. The employee killed was the engineman of engine 596.
