**REPORT OF THE CHIEF OF THE BUREAU OF SAFETY COVERING  
THE INVESTIGATION OF AN ACCIDENT WHICH OCCURRED ON  
THE UNION PACIFIC RAILROAD NEAR BELOIT, KANS, ON  
JANUARY 15, 1918.**

SEPTEMBER 16, 1918

On January 15, 1918, there was a derailment of a passenger train on the Union Pacific Railroad near Beloit, Kans, which resulted in the death of 4 passengers and the injury of 22 passengers and 3 employees. After investigation, I beg to submit the following report.

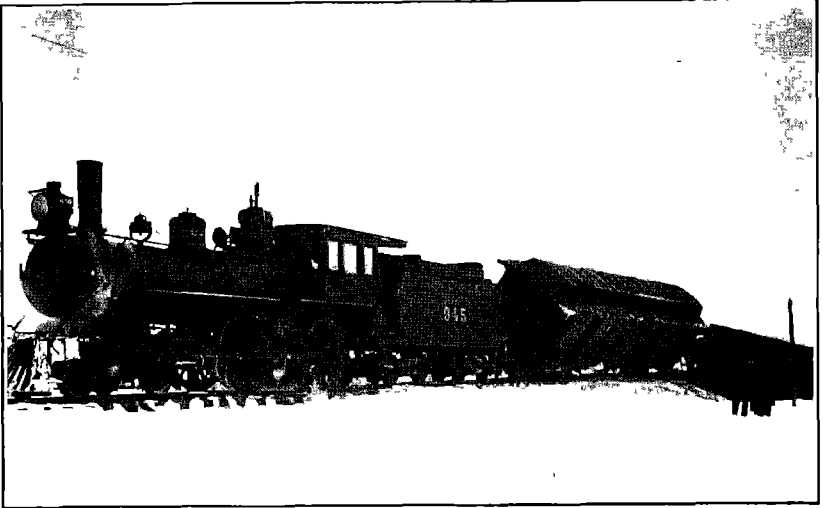
FIG 1 —View of locomotive, engine, and tender on the rails, with derailed mail and baggage cars on east embankment

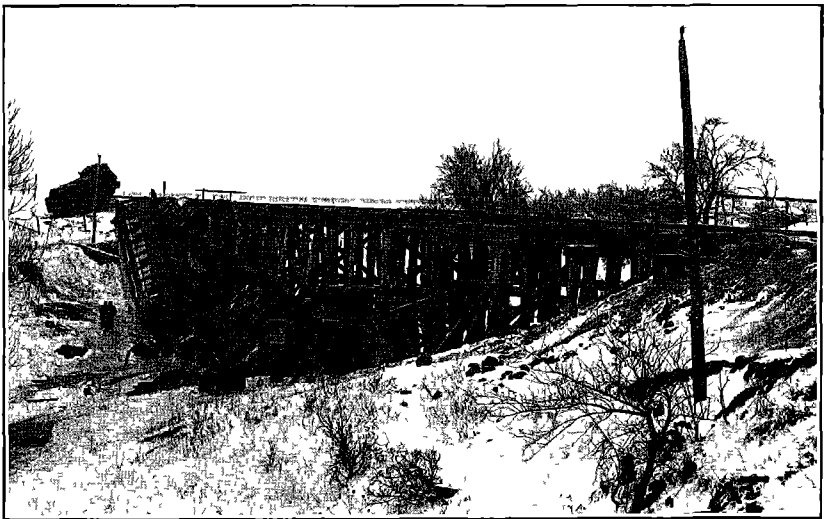
The locomotive, combination car, and baggage car crossed the bridge, the locomotive coming to a stop with its front trucks about 380 feet beyond the initial point of derailment; the combination car was derailed immediately behind the locomotive and tilted toward the left; the baggage car was derailed to the left and lay on its side just behind the combination car. Figure 1 is a view of the locomotive, combination car, and baggage car after the derailment. Both coaches ran a short distance and then fell off the bridge, and landed on their roofs in the bottom of the creek and were demolished, as shown by figures 2 and 3.

FIG 2 —View of bridge and derailed cars from west embankment

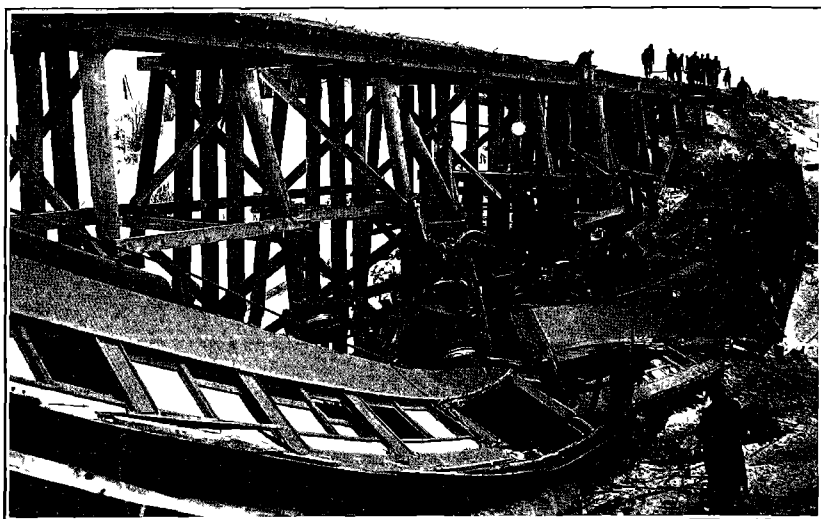
FIG 3 —Demolished coaches in bed of creek

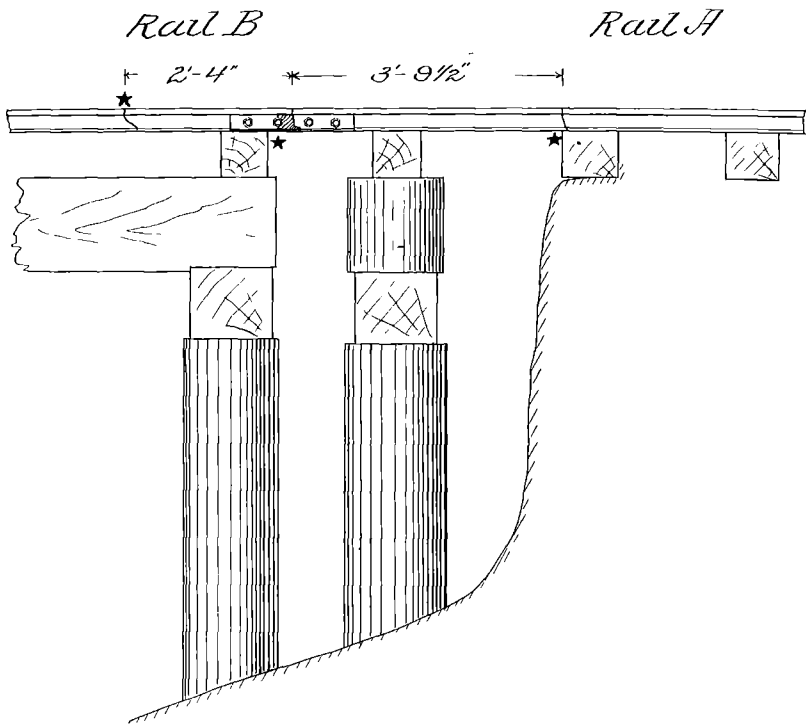
The bridge was undergoing repairs, work being in progress at the time of derailment. Figure No. 4 indicates the manner in which the work was being executed at the westerly end. Frozen ground had been excavated and a new bulkhead bent had been placed between the old one and the westerly embankment. Piles 17 inches in diameter were used in the new bulkhead, on which was placed a 12-inch cap, the latter carrying 16-inch pile blocks. A  $7\frac{1}{2}$  inch by 8 inch tie was supported by the pile blocks.

The conditions which were present prior to the time of derailment present a number of features of interest in track maintenance. There was a weakened joint at this place. The outer splice bar was partially fractured, old surfaces of rupture existing on each side of the bolt hole next the end of rail marked "B". Part of the flange of

FIG 4.—Diagram illustrating manner of inserting new bulkhead bent in bridge. Stars on diagram show places of rupture at joint and in the rail.

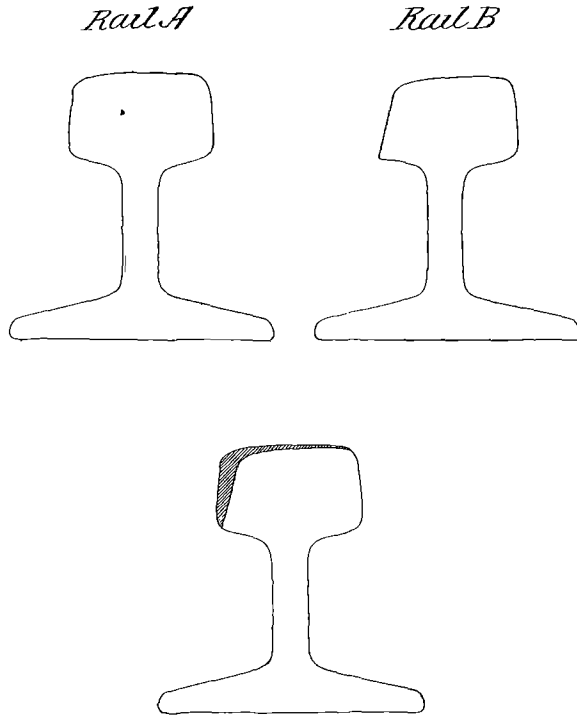
The shapes of the heads of the two rails are shown by figure No. 5. Section A represents the westerly rail, which was branded

"E T 85 IIIIIIIII"; section B the easterly rail, the brand mark on which was not ascertained. The outlines of these rails are drawn superimposed on this cut, the shaded portion of which represents the area of metal which had been worn away at the immediate end of rail A by successive blows of wheel flanges. The prism of metal removed was a tapering one, the normal shape of the head being retained up to a distance of about 8 inches from its junction with rail B

Fig 5—Diagram showing cross sections of rails A and B, shaded portion of the head, lower figure of the cut, indicating their difference in shape

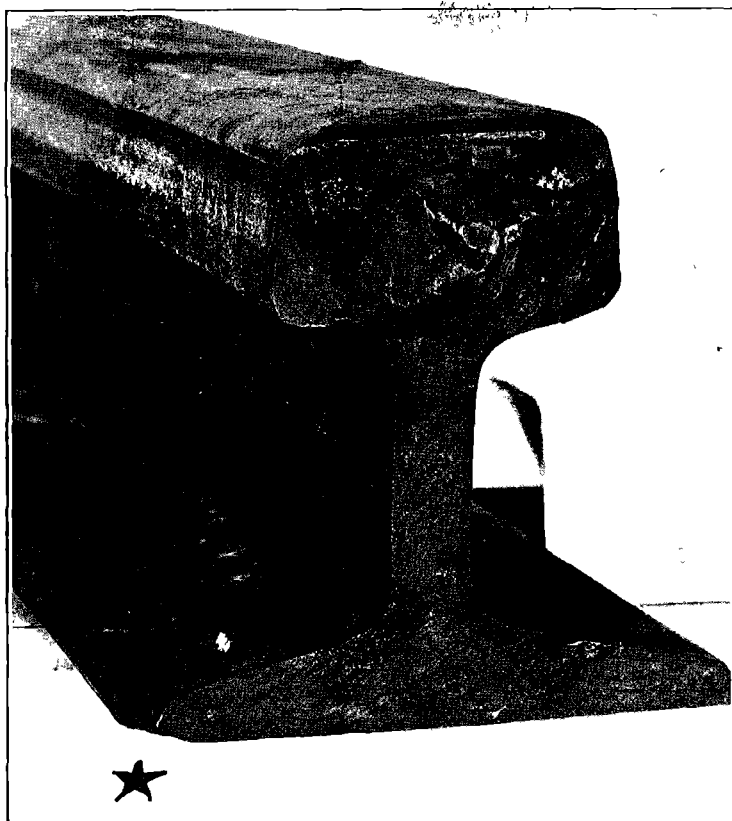
Figure No 8 shows the appearance of the leaving end of the short fragment which was broken from rail B. Rupture began at the inside of the head, lower corner, as indicated by the star marked on the cut. The metal in the heads of rails becomes embrittled by the cold rolling action of the wheels; the brittleness displayed by this rail is therefore without unusual significance. The incipient point was at the corner of the head, gauge side, extending thence through the head, obliquely through the web, and finally through the base.

FIG 8 —Leaving end of short fragment of rail B. Fracture started at lower corner of head, gauge side

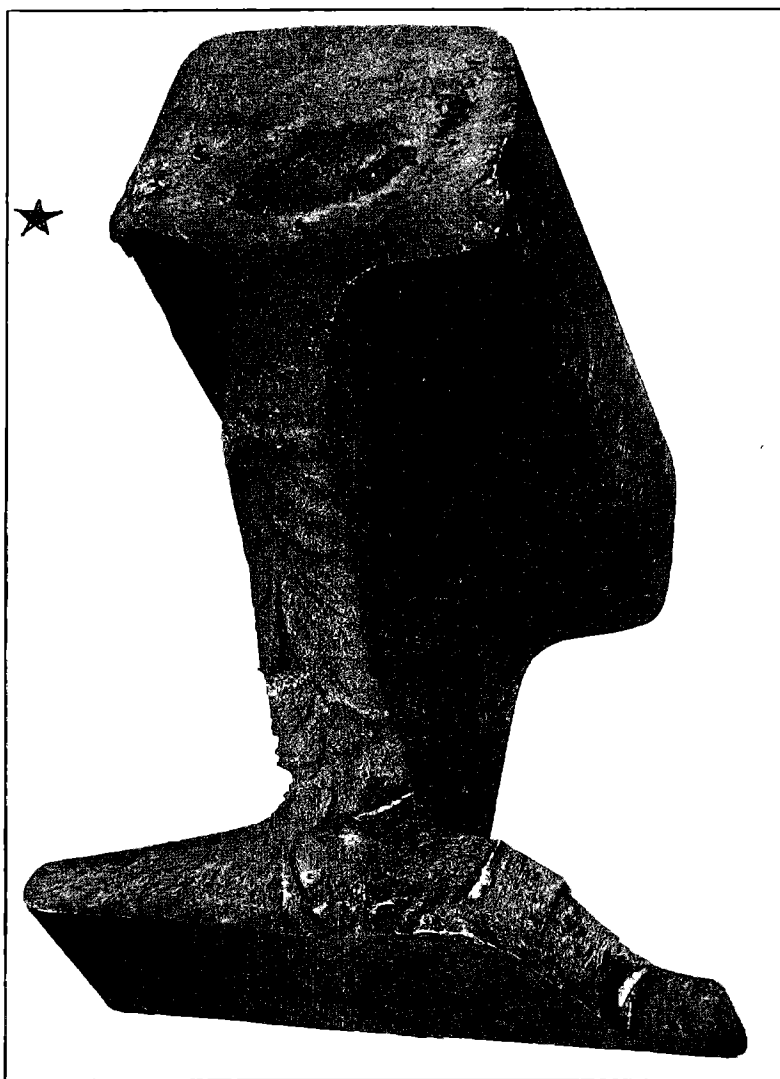
Examples of rails which have failed by reason of injuries received at the edges of their flanges are met from time to time. Figure No 9 illustrates a square break, one of a number which occurred in some 90-pound rails of more recent fabrication than those involved in the present derailment. The star marked on the cut indicates the initial point of rupture. The bolt holes shown in the web were drilled for attaching splice bars for temporary repairs to the track.

FIG 9 —Fracture of a 90-pound Bessemer rail Illustrating a fracture caused by injured flange
