INTERSTATE COMMERCE COMMISSION

REPORT OF THE CHIEF OF THE BUREAU OF SAFETY IN RE INVESTIGATION OF ACCIDENTS WHICH OCCURRED ON THE UNION PACIFIC RAILROAD, AT HILLSDALE, WYO, ON NOVEMBER 4, AND AT BORIE AND BUFORD WYO, ON NOVEMBER 5, 1922

DECEMBER 20 1922

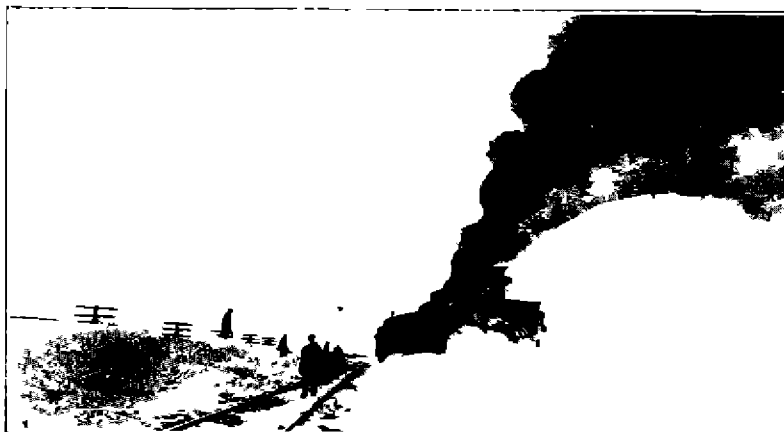
FIG. 3—Rotary plow at work at Hillsdale
