# INTERSTATE COMMERCE COMMISSION

## REPORT OF THE CHIEF OF THE BUREAU OF SAFETY IN RE INVESTIGATION OF ACCIDENTS WHICH OCCURRED ON THE UNION PACIFIC RAILROAD, AT HILLSDALE, WYO, ON NOVEMBER 4, AND AT BORIE AND BUFORD, WYO, ON NOVEMBER 5, 1922

DECEMBER 20, 1922

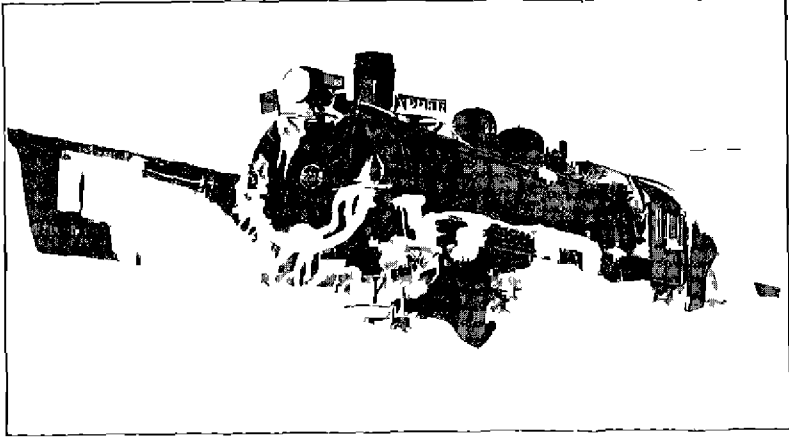
FIG 1—Engine and train snowed in at Hillsdale

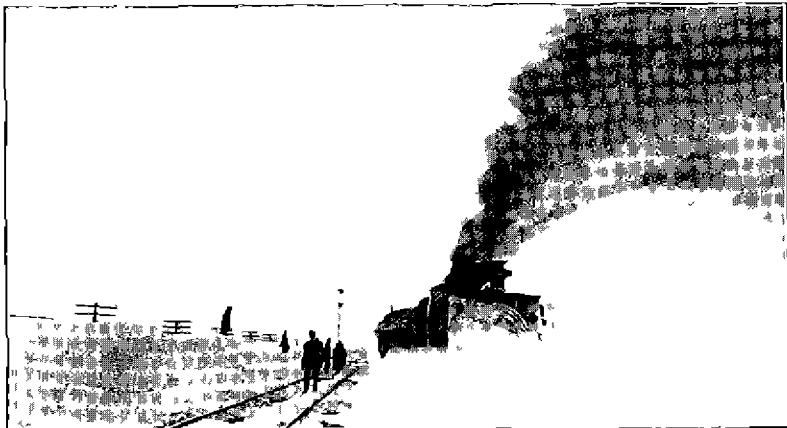
FIG 3—Rotary plow at work at Hillsdale
