# INTERSTATE COMMERCE COMMISSION.

## REPORT OF THE CHIEF INSPECTOR OF SAFETY APPLIANCES COVERING HIS INVESTIGATION OF AN ACCIDENT WHICH OCCURRED ON THE UNION PACIFIC RAILROAD AT GOTHEN- BURG, NEBR., ON MARCH 14, 1913.

APRIL 16, 1913.

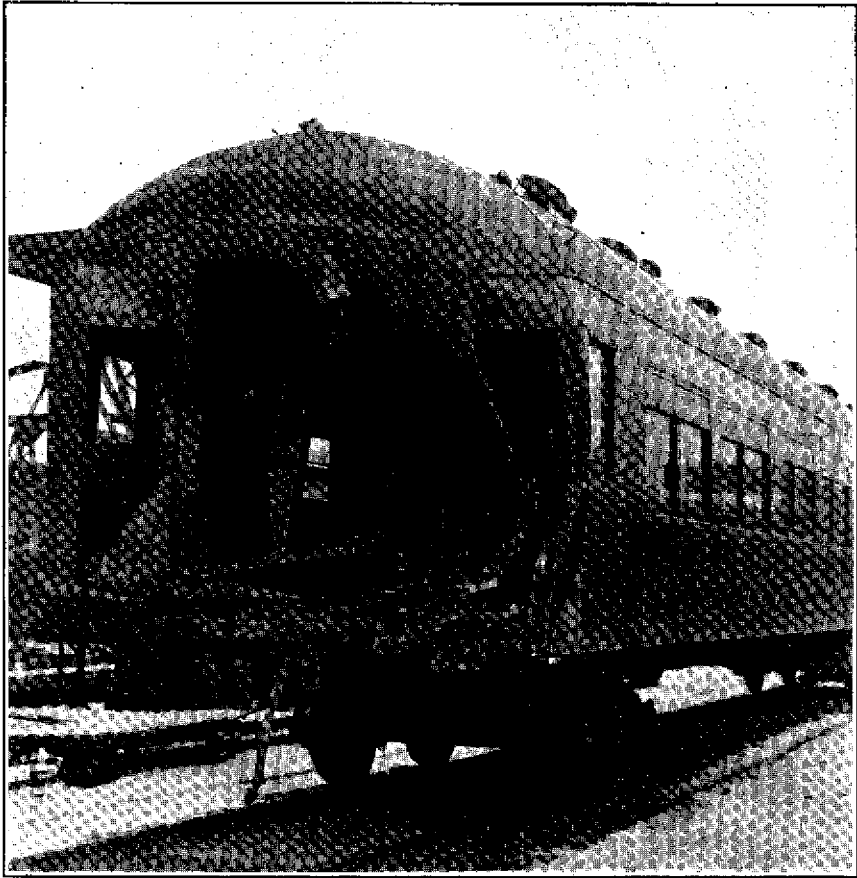
very little damaged. The condition of this car is shown by illustration No. 2. The mail car in train No. 4 and the forward end of engine No. 133 were slightly damaged. The speed of train No. 12 was probably about 15 miles per hour at the time of the collision. Estimates as to how long train No. 4 had been standing at the station at Gothenburg varied from one to two minutes, the majority placing it at the latter figure.

FIG. 2.—END OF STEEL COACH WHICH WAS JUST AHEAD OF THE SLEEPING CAR.
