INTERSTATE COMMERCE COMMISSION

REPORT OF THE CHIEF OF THE BUREAU OF SAFETY IN RE INVESTIGATION OF ACCIDENTS WHICH OCCURRED ON THE UNION PACIFIC RAILROAD, AT HILLSDALE, WYO, ON NOVEMBER 4, AND AT BORIE AND BUFORD, WYO, ON NOVEMBER 5, 1922

DECEMBER 20, 1922

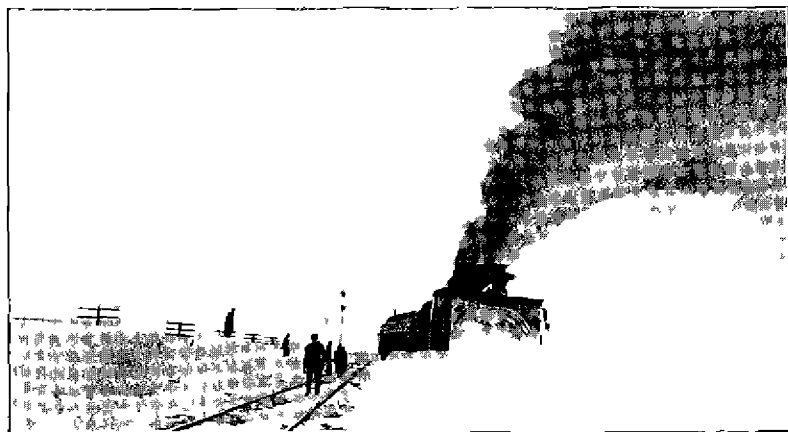
FIG 3—Rotary plow at work at Hillsdale
