INTERSTATE COMMERCE COMMISSION

REPORT OF THE DIRECTOR OF THE BUREAU OF SAFETY IN RE INVESTIGATION OF AN ACCIDENT WHICH OCCURRED ON THE LINE OF THE UNION TRACTION COMPANY OF INDIANA NEAR INGALLS, IND , ON FEBRUARY 2, 1924

MARCH 10, 1924

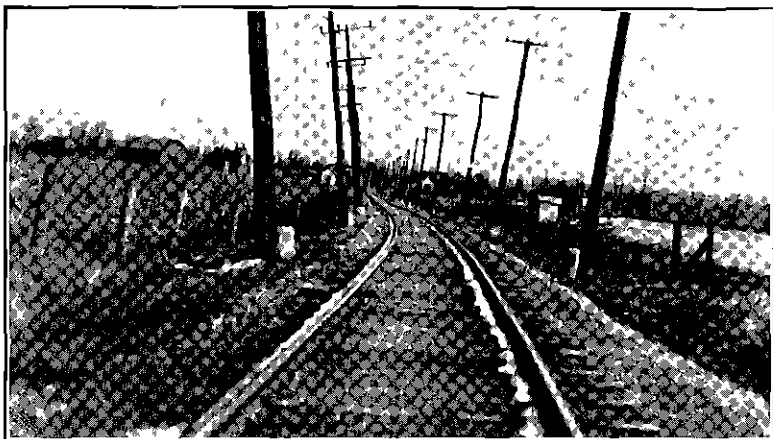
FIG No 1—View of point of accident from first curve west thereof

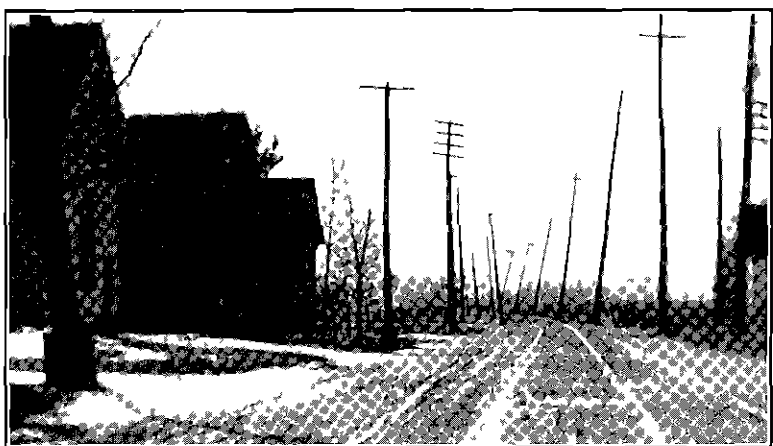
The point of accident was about 3,800 feet west of Ingalls, approaching from the west beginning at the middle of the siding at Dent, there are about 2,000 feet of tangent and a curve of 1° to the left, which is about 400 feet in length, followed by about 1,000 feet of tangent extending to the point of accident. Approaching from the east there are about 2,000 feet of tangent, and a curve of 1° to the left, about 300 feet in length, followed by about 150 feet of tangent extending to the point of accident. The grade from each direction is ascending and then slightly descending practically to the point of accident. The view approaching from either direction is materially obscured by houses, shrubbery, and a pole line on the south side of the track, from a point 600 or 700 feet east of the point of accident it is practically impossible to see a one-car train located about the same distance west of the point of accident.

FIG No 2—Approaching from east point of accident just beyond curve there is a one car train a short distance beyond point of accident obscured by pole line
