## INTERSTATE COMMERCE COMMISSION

### REPORT OF THE CHIEF OF THE BUREAU OF SAFETY COVERING INVESTIGATION OF AN ACCIDENT WHICH OCCURRED AT AN INTERSECTION OF THE VICKSBURG, SHREVEPORT & PACIFIC RAILROAD AND THE LOUISIANA & NORTH WEST RAILROAD AT GIBBSLAND, LA, ON FEBRUARY 18, 1920

MARCH 24, 1920

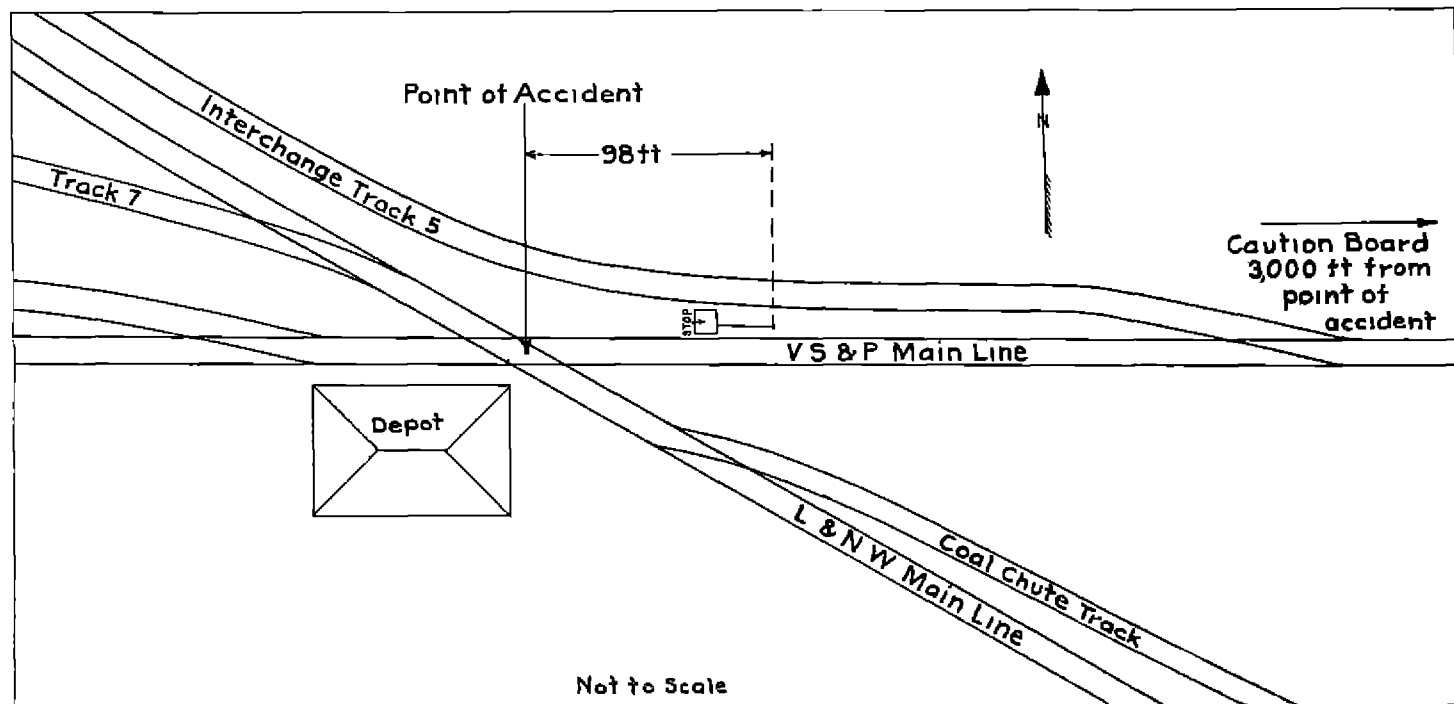
Diagram showing relative position of the tracks in the vicinity of the crossing

a stop board about 98 feet east thereof The accompanying diagram shows the relative position of the tracks in the vicinity of the crossing Illustration No 1 shows the clear view had by approaching trains on the Vicksburg, Shreveport & Pacific Railroad, on the right is the caution board Illustration No 2 is a view taken from the track of the same railroad about 200 feet from the crossing, on the

right of the track is the stop board On the line of the Louisiana & North West Railroad, at a point about 40 feet north of the intersection yard track 7 leads off from the main line to the west and about 50 feet south of the intersection a coal-chute track leads off to the east of the main track With the exception of the engine crew of one of the trains involved, the statements of the employees of the two trains indicated that the weather was clear

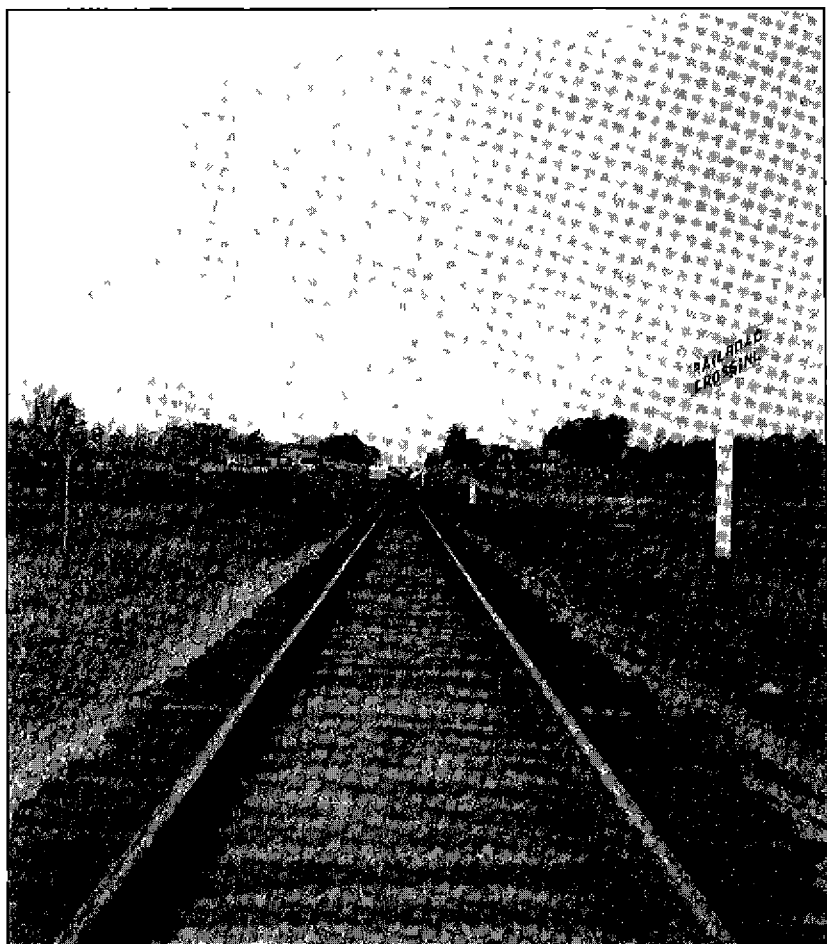
Approaching the point of accident from the east on the Vicksburg, Shreveport & Pacific Railroad the track is straight for about 2½ miles. The grade is level a distance of about 1,000 feet, followed by 2,900 feet of 0.25 per cent descending grade and then about 3,300 feet of 0.06 per cent ascending grade to the point of accident. A caution board is located about 3,000 feet east of the intersection and

FIG 1—View approaching crossing on line of the V, S & P R R, taken from point 3,000 feet distant, on the right is the caution board

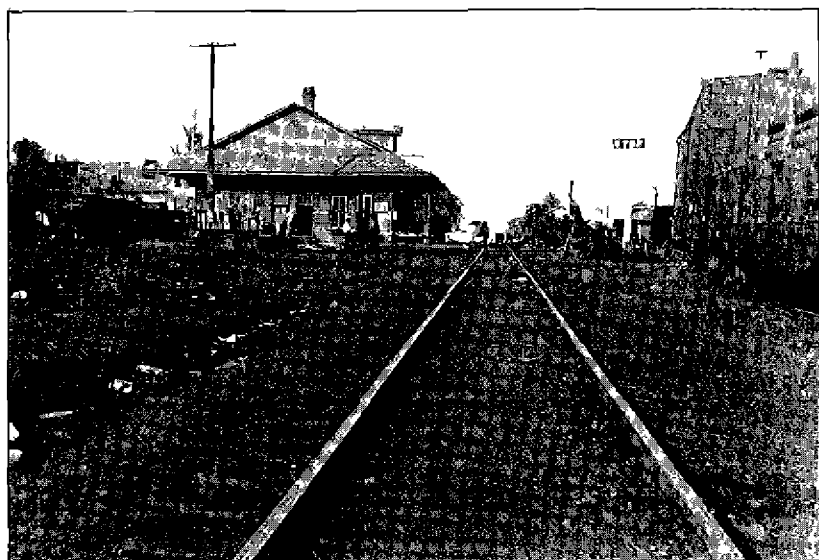
FIG. 2—View approaching crossing on line of the V S & P R R, taken from point 200 feet distant on the right is the stop board

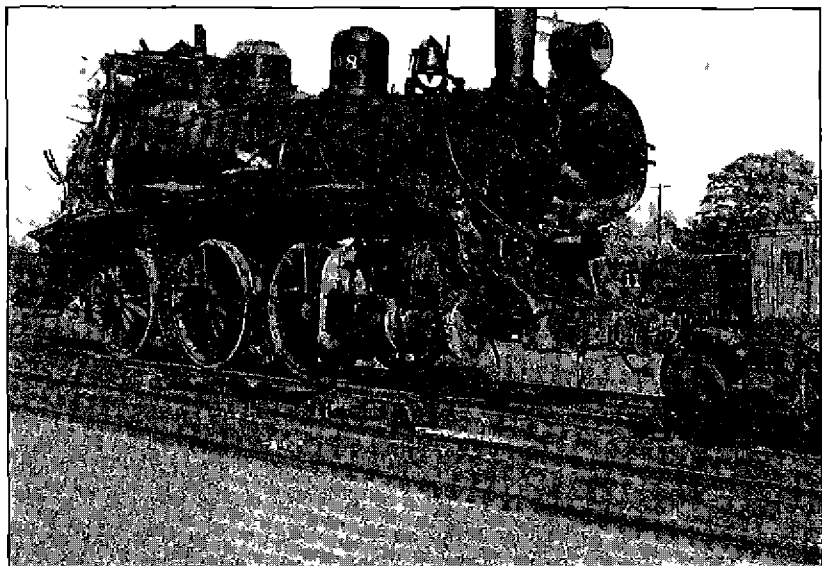
The gondola was knocked from its trucks and pushed along the station platform, coming to rest with one end across the main line while the other end crashed into the front of the station. The three cars directly behind this car and the front end of the coach were derailed, but remained in general line with the track. The coach was quite badly damaged as was also the caboose behind it, which was standing against a cut of loaded coal cars. The engine of the passenger train was derailed and quite badly damaged, coming to rest on its right side with the smokestack inside the station and the cab across the main track. Illustration No 3 shows the condition of the engine after it had been rerailed. The tender remained coupled to

FIG 3—Engine 308 of V, S & P passenger train No 11

the engine and lay on the north side of the track on its right side, the tender frame was demolished and the cistern was badly crushed. The mail and express car, the second car in the passenger train, was derailed but none of the remaining cars in this train was derailed or damaged. Illustration No 4 is a general view of the crossing after it had been cleared of the wreckage. The damaged coach in the background is the coach which was on the rear end of Louisiana & North West extra 22 and is in the same place it stood at the time of the accident.
