INTERSTATE COMMERCE COMMISSION

REPORT OF THE CHIEF, DIVISION OF SAFETY, COVERING THE INVESTIGATION OF THE ACCIDENTS WHICH OCCURRED ON THE WABASH RAILROAD AT ATTICA, IND., ON APRIL 5, 1914.

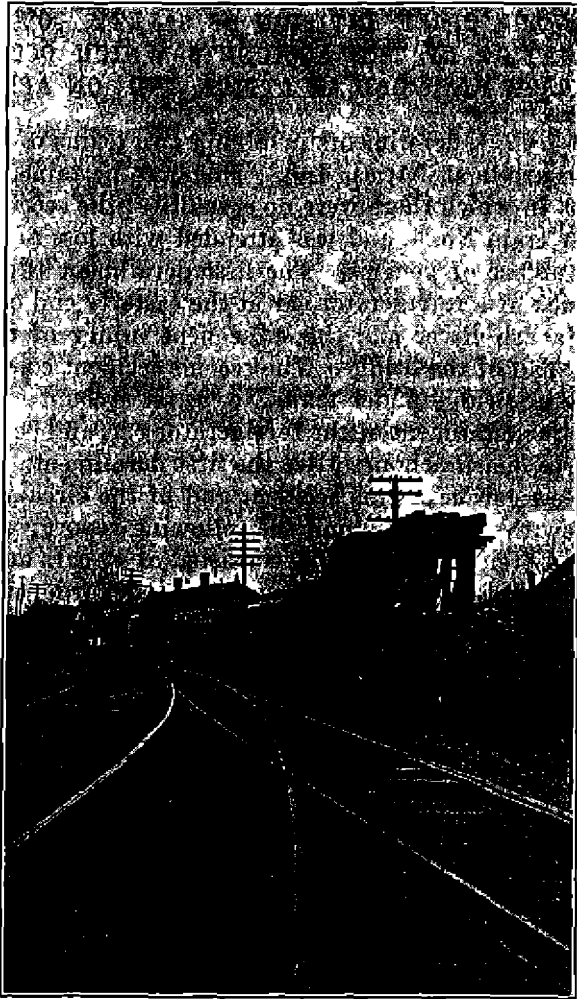
The train was brought to a stop with the disabled car about 200 feet west of the eastern end of the bridge, none of the other cars in the train being derailed. Examination of the derailed truck showed all of the wheels to be in good condition and no defects were discovered on any other part of the truck. The frog at which the car was derailed is located on a curve of 5° , and the empty refrigerator car was derailed as the train rounded this curve at a speed estimated to have been between 15 and 20 miles per hour. Illustration No 1 is a view of the frog at which the derailment occurred, looking in the direction opposite to that in which the train was traveling at the time.

NO 1—VIEW OF FROG AT COVINGTON BRANCH LOOKING EAST

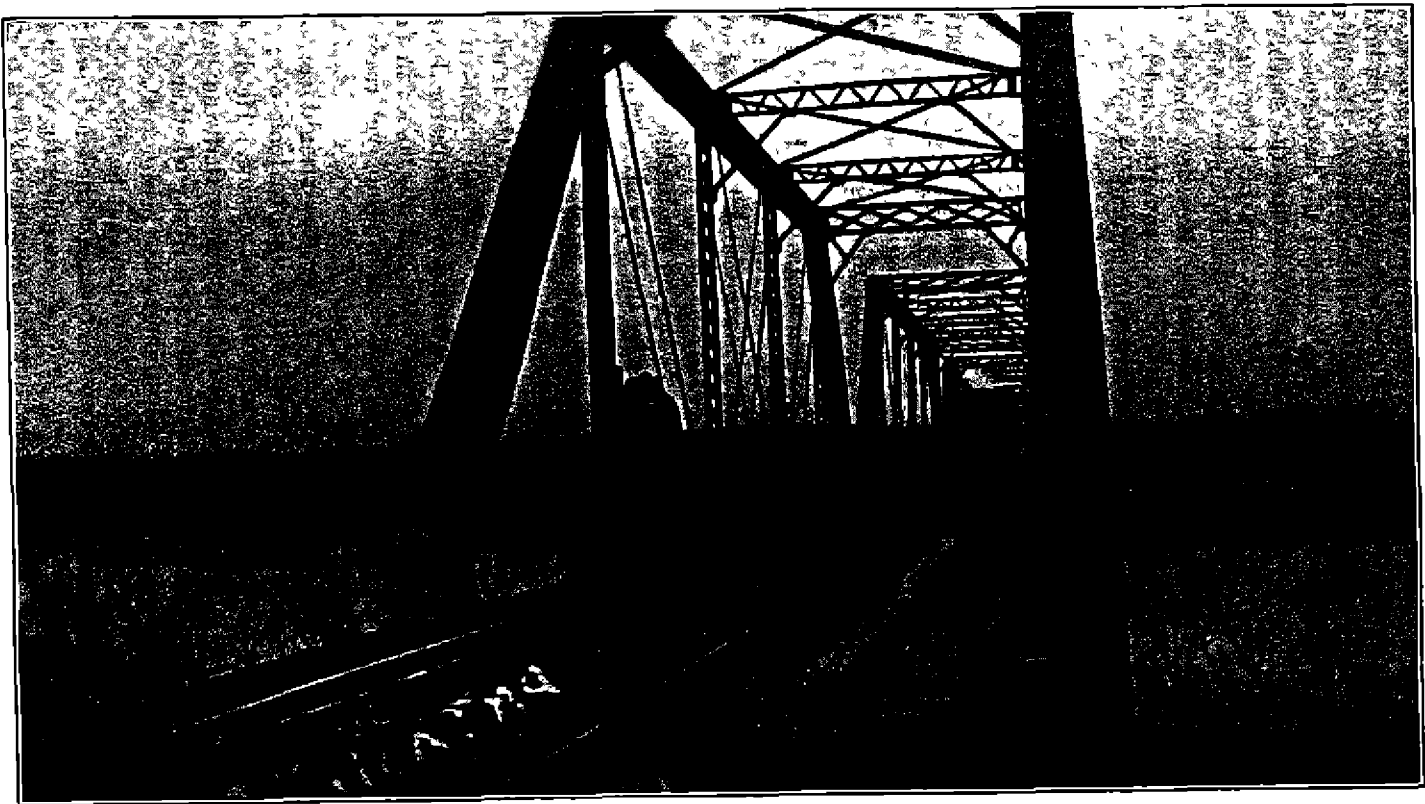
NO 3—VIEW OF DAMAGED_END POST.

Photographic evidence was secured showing the appearance of the end post after it had received the blow from the truck of the refrigerator car. Illustration No 3 is reproduced from the photograph which was then taken. Two of the principal parts of the post, namely, the cover plate and one web plate were practically destroyed, while the other web plate was considerably bent. In consequence of these injuries the post was incapable of offering normal compressive resistance in any of its parts. No visual evidence was lacking at this time to indicate the seriously weakened condition of this important member.

An examination of the photographic print showed that the cover plate was split along its south edge for a distance of 30 rivet pitches or 11 feet 3 inches. Along its north edge it was split a distance of 8 feet 3 inches. Across its width it was torn apart, all but a narrow strip on its south edge. On the north edge the plate and outstanding leg of one of the 3 by 3 by $\frac{3}{8}$ inch angles was completely carried away for a short distance.

On the north side the web was split and distorted. It was evident from its appearance that the south web and angles were also considerably buckled. The injury to the post could hardly have been greater.

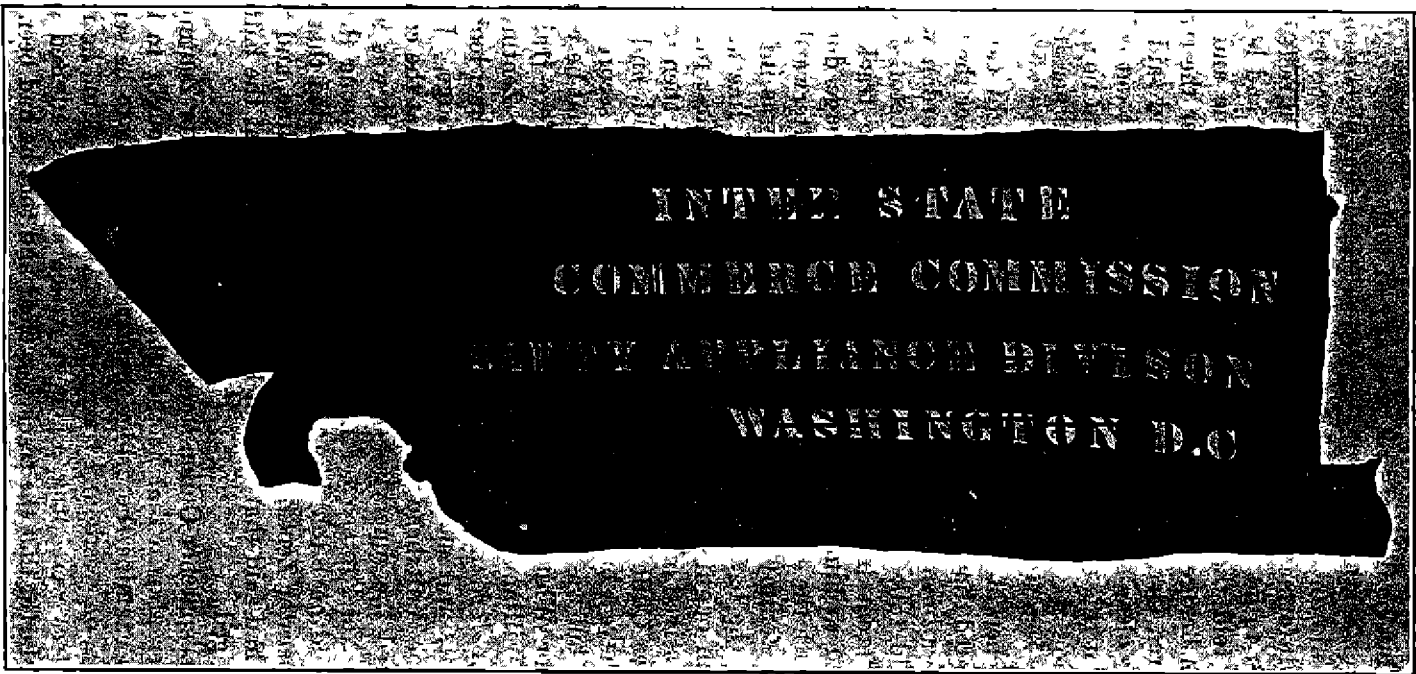
NO 4—PHOTOGRAPH OF FRAGMENT OF COVER PLATE FROM WHENCE TENSILE TEST PIECES WERE TAKEN

The following table shows the results of tensile tests on the metal of the cover plate. The fragment from whence these specimens were taken is shown by figure No 4 and is believed to have been a part of the end post in question.

In a crosswise direction the iron displayed low strength and was further characterized by fracturing without the development of appreciable extension. The tensile strength in this direction did not reach the normal elastic limit of the material. Lengthwise the iron displayed tensile strength usual to wrought-iron plate.

Bending tests were made on the stems of the crosswise specimens The metal fractured crosswise the grain without bending through an appreciable angle

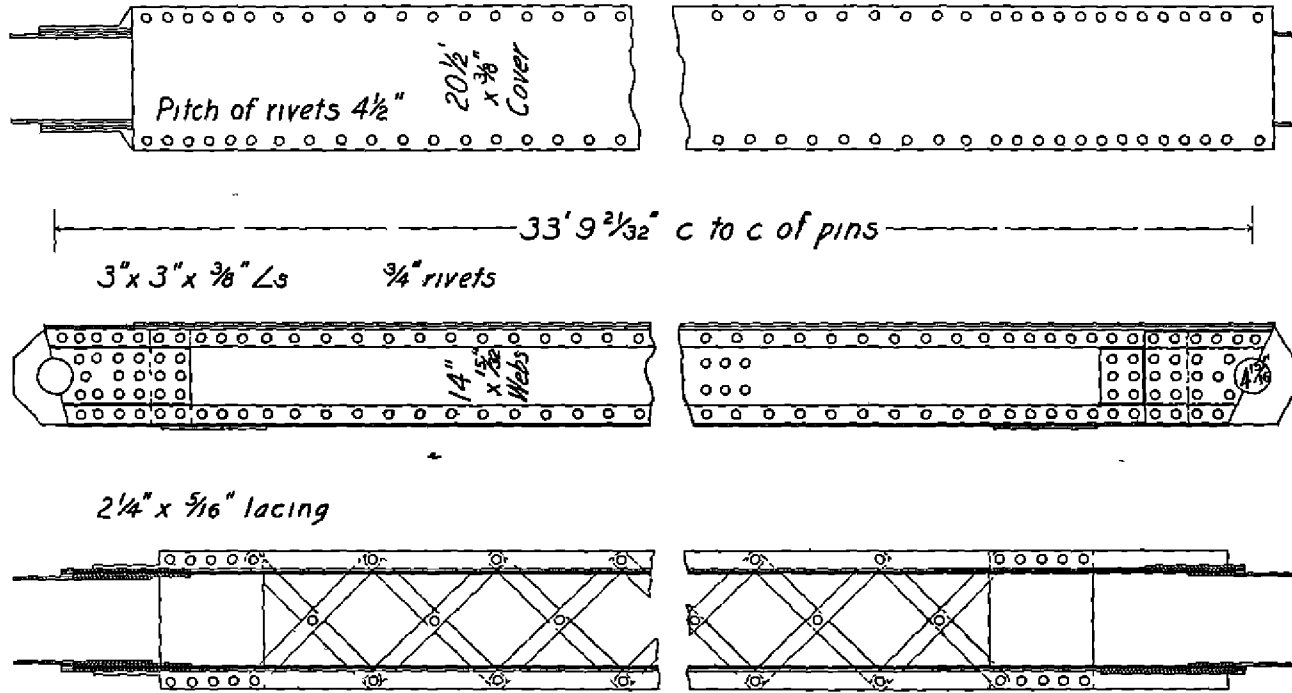
NO 5—DETAILS OF END POST WHICH WAS INJURED

The entire cross section of the post was either seriously injured or totally destroyed, none of the component parts of this batter post escaped without some injury. Evidently the bridge itself barely escaped immediate destruction, so extensive was the injury received by the damaged member.

Figure No 5 is a drawing of the end post, showing the details of its construction, which was made up of a cover plate, two web plates, and four angles. The fourth side was latticed. The pins were placed in the middle of the width of the webs. Its ratio of slenderness was 72 1/r, which places it among relatively short columns. An ultimate compressive strength of at least 30,000 pounds per square inch would be expected in this post in its original condition.

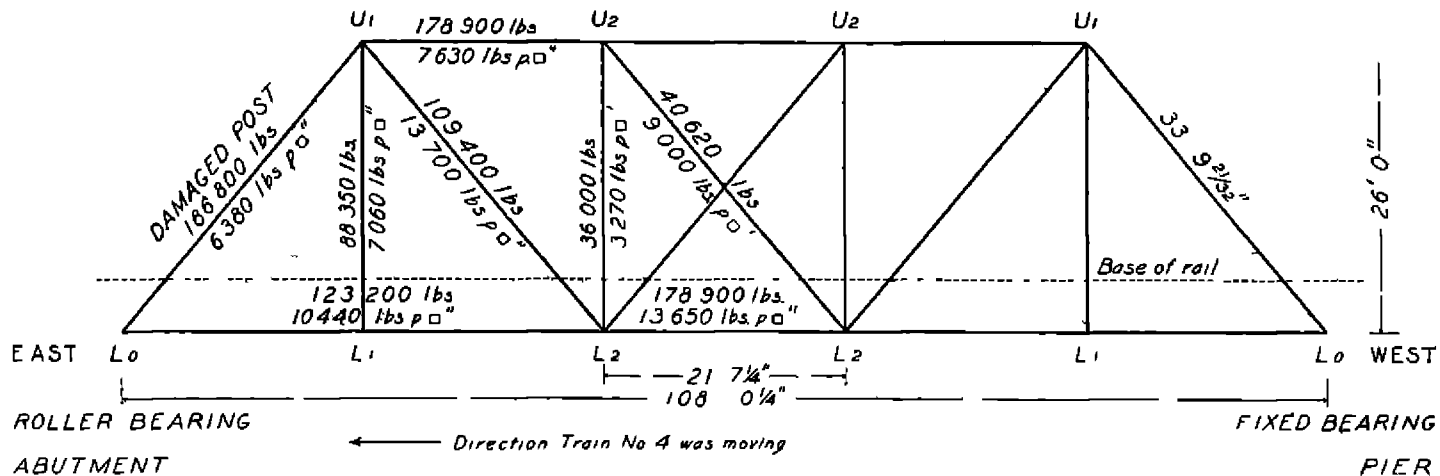
NO 6

Diagram figure No 6 shows the stresses which would come upon the different members of the east span under the combined weight of the locomotive of train No 4 and the forward truck of the postal car, which was in the train next behind the tender. The computed stress on the post caused by this load was 6,380 pounds per square inch. This must be regarded as a very moderate stress for the intact member to sustain. The stresses entered on this diagram, and others which accompany herewith, are from data furnished by the Wabash Railroad Co.

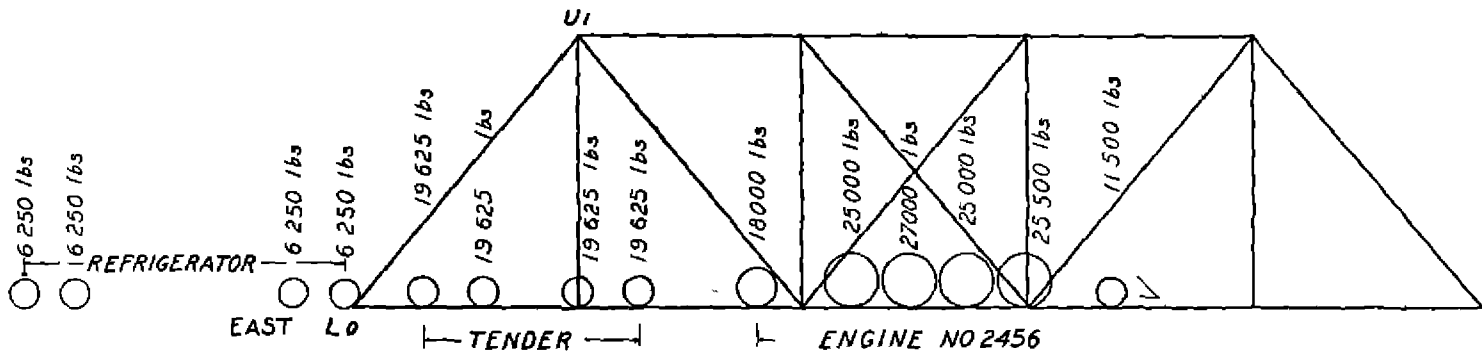
NO 7

EAST SPAN, ATTICA BRIDGE
 POSITION OF LOCOMOTIVE NO 2456 CAUSING MAXIMUM STRESS IN END POST

DEAD LOAD	47 000 LBS
LIVE LOAD	<u>100,800 LBS</u>
TOTAL	147,800 LBS

On diagram No 7 it will be seen that locomotive No. 2456, of train No 69, had at this time just pushed the refrigerator car off the east end of the bridge. The locomotive alone stood on the bridge at the time. With this locomotive on the bridge the sum of the live and dead loads on the post was 147,800 pounds. This load represents the highest which the bridge was called upon to sustain, during the interval succeeding the injury to the batter post and preceding its loading by passenger train No 4, which latter train applied a heavier load.

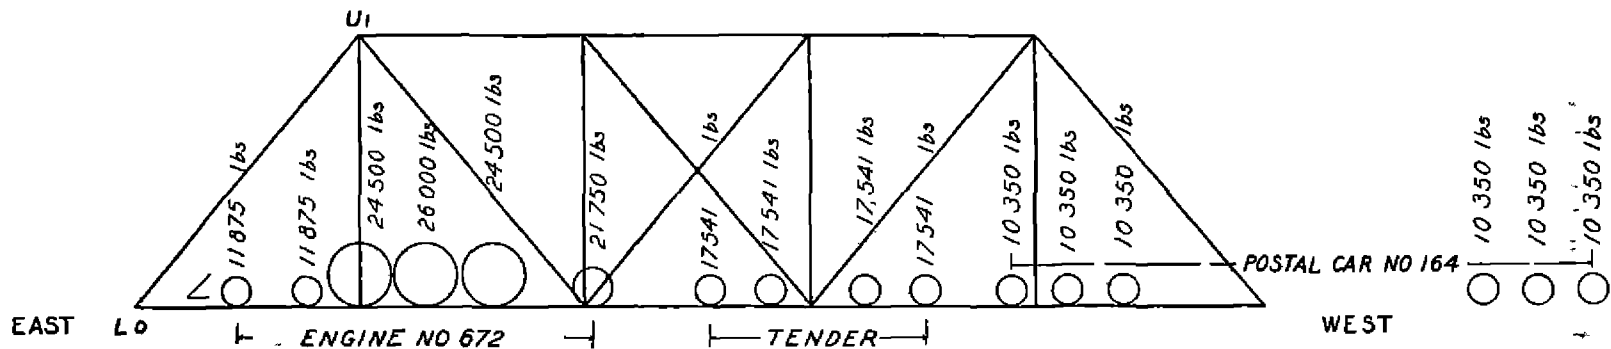
NO 8

EAST SPAN ATTICA BRIDGE
 POSITION OF LOCOMOTIVE NO 672 CAUSING MAXIMUM STRESS IN END POST

DEAD LOAD	47,000 LBS
LIVE LOAD	<u>139,800 LBS</u>
TOTAL	186,800 LBS

Diagram No 8 shows the position of locomotive No 672, of train No 4, giving the maximum load on the end post. The forward truck of postal car No 164 was upon the east span of the bridge at this time. The rear truck of the car was upon the second span. In this position the load upon the end post would have been 186,800 pounds, or 39,000 pounds more than the load caused by the freight locomotive. Train No 4 was proceeding slowly at the time of the collapse and, as it appears from the testimony, the locomotive had nearly or quite reached the position indicated on the diagram when the structure gave way.
