INTERSTATE COMMERCE COMMISSION

REPORT OF THE DIRECTOR OF THE BUREAU OF SAFETY IN RE INVESTIGATION OF AN ACCIDENT WHICH OCCURRED ON THE WABASH RAILWAY NEAR TOLONO, ILL., ON JULY 29, 1925

MARCH 16, 1926

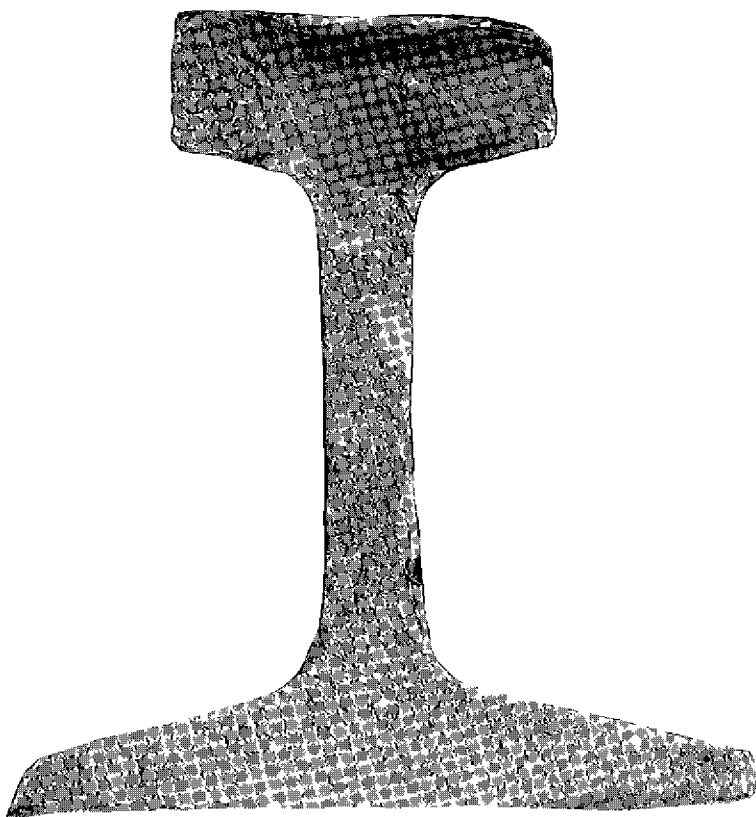
Photographic prints are introduced to illustrate the appearance of transverse fissures. Figure No. 1 shows a transverse figure which was displayed by a 90-pound rail on the Chicago & Alton Railroad. This fracture, originating in the head over the gauge side of the web, separated the larger part of the cross section of the head. It had reached the peripheral surface when it fractured under a train. This rail had been in the track 7 years and 10 months.

FIG. 1—Appearance of a transverse fissure in the head of a 90 pound rail

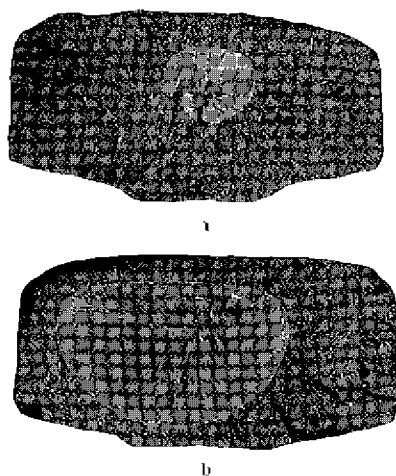
Figure No. 2, *a* and *b*, illustrates two other transverse fissures, from another rail, at earlier stages of development. These fissures presented a silvery luster, common to incipient fissures before exposure to the air. The surfaces are commonly darkened when viewed on transverse fissured rails which have caused a separation of the rail in the track.

FIG. 2 (a and b)—Appearance of two transverse fissures at different stages of development in the same rail
