REPORT OF ACCIDENT
ON THE WABASH RAILROAD NEAR
WEST LEBANON, IND
MARCH 7, 1912

REPORT OF THE CHIEF INSPECTOR OF SAFETY APPLIANCES COVERING HIS INVESTIGATION OF AN ACCIDENT WHICH OCCURRED ON THE WABASH RAILROAD NEAR WEST LEBANON, IND., MARCH 7, 1912, ACCOMPANIED BY REPORT OF THE ENGINEER-PHYSICIST OF THE BUREAU OF STANDARDS COVERING HIS INVESTIGATION OF THE BROKEN RAIL CAUSING THIS ACCIDENT

REPORT OF THE ENGINEER-PHYSICIST

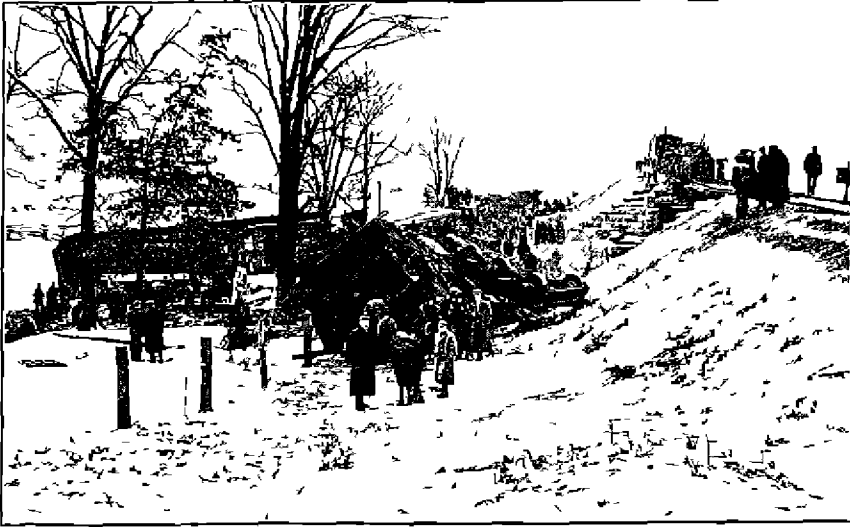
No 1—General view of the wreck looking east

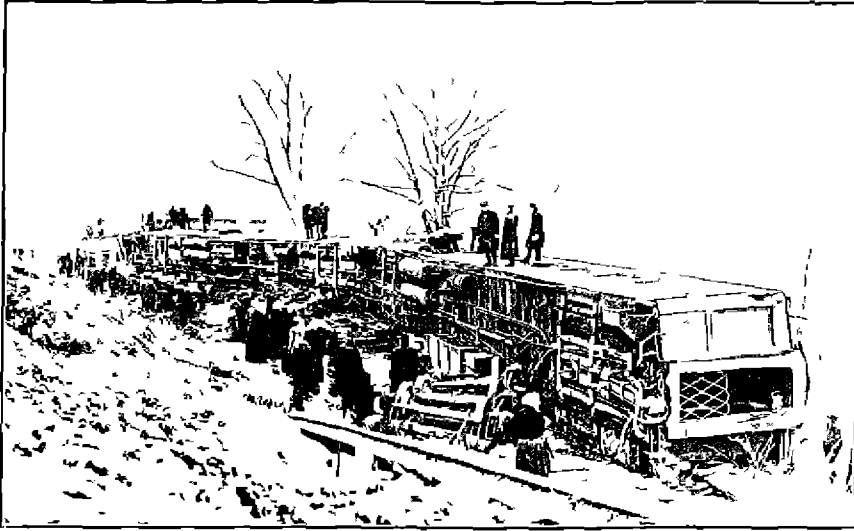
No. 2—General view of the wreck, looking west

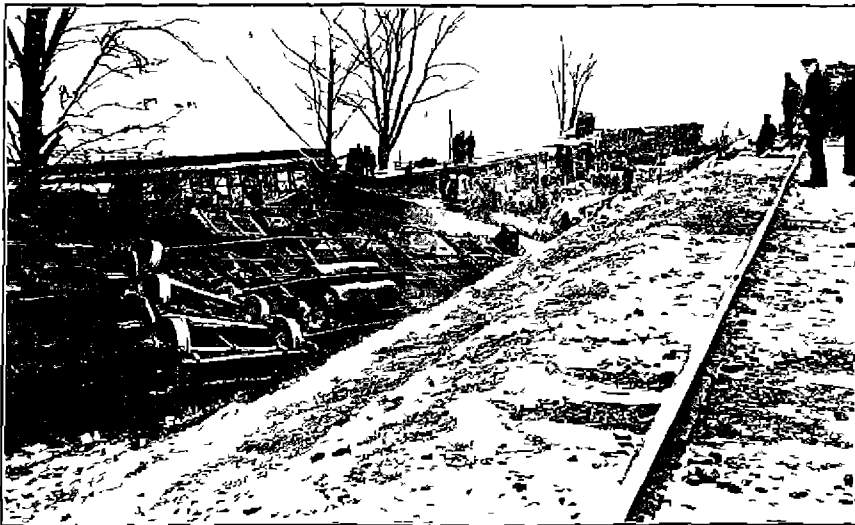
No. 3—General view of the wreck, looking east

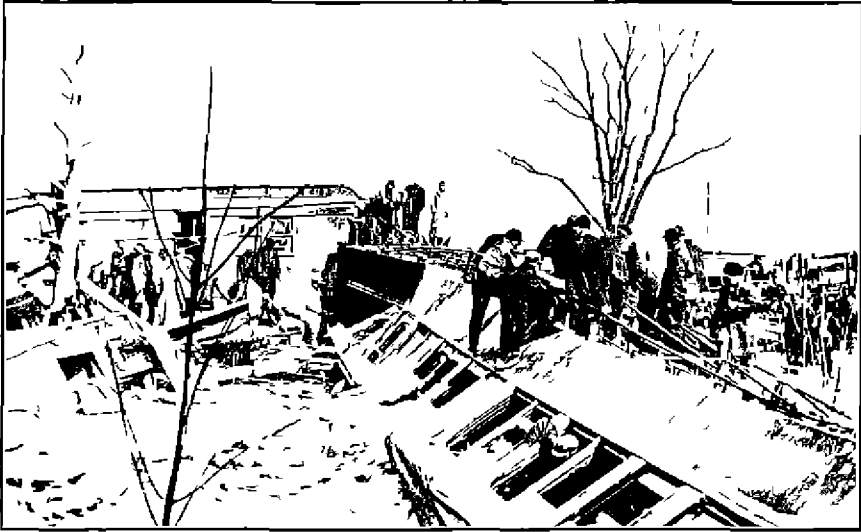
No. 1—General view of the wreck, looking east

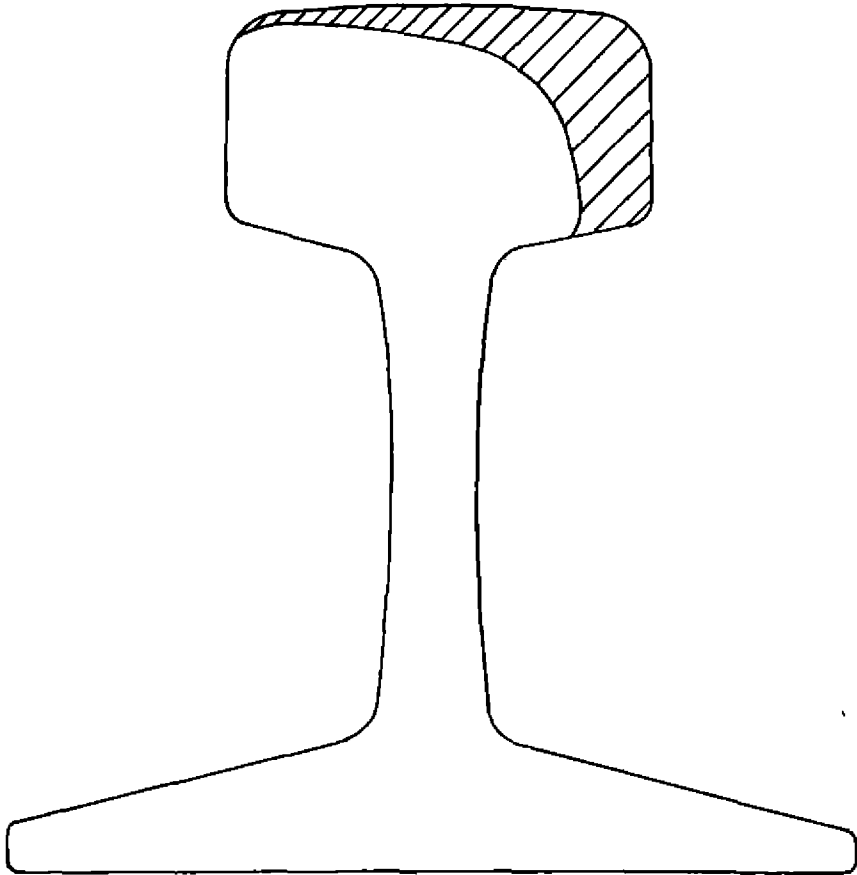
The rail showed considerable flange wear, as indicated by Figure No. 5. It was estimated that 12 per cent of the whole section or 27 per cent of the metal of the head, had been worn away during its period of service.

No 5—Cross section of rail which fractured at Redwood Curve March 7 1912. Fifty pounds American Society of Civil Engineers section. 12 per cent of whole section or 27 per cent of head worn away in service. Part worn away indicated by shaded section.

It will be noted that this rail was very much worn, since some 27 per cent of the metal of the head had been lost by abrasion and wear. Furthermore that there was evidence in the indented condition of the outer flange of the base that the rail had endured an outward

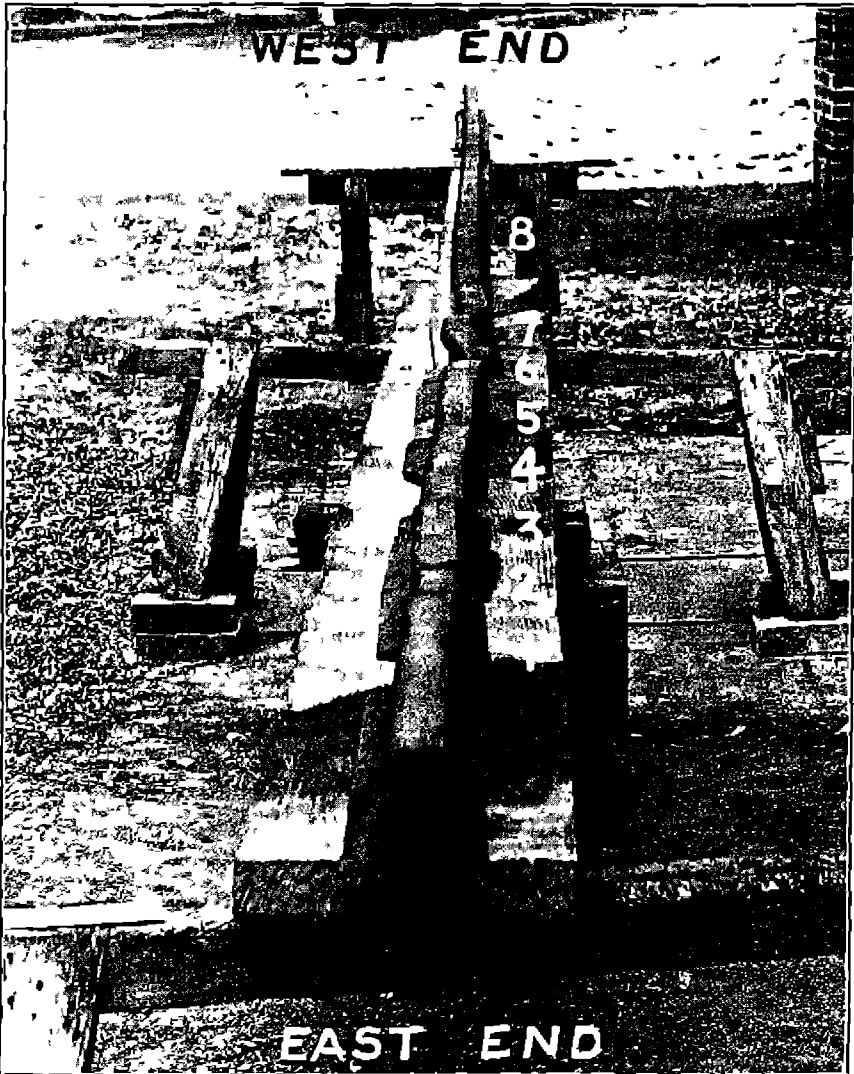
A series of photographic cuts shows the appearance of the broken rail as received for examination. Figure No 6 is a general view of the rail looking upon it from east to west. The several fragments are marked for identification from 1 to 8, inclusive. Piece No 8 was 22 feet 9 inches long, the others were comparatively short.

In regard to the condition of these fragments the heads of pieces Nos 1, 2 and 3 were nearly straight in respect to alignment. The

receiving ends of each of the other pieces were bent outward and also downward. Fragments Nos 6 and 7 were the most distorted, the head of No 6 being detached from the web. Doubtless fragments Nos 4, 5, 6, and 7 were in succession detached from the forward part of the rail. Such short bends as these pieces assumed could have been formed only when each was attached to the main part of the rail. It would seem furthermore, that the wheels which

No 6.—General view of fractured rail from east end. Piece marked 1 is 2 feet 3 inches long. Piece marked 8 is 22 feet 9 inches long. Total length of rail is 32 feet.

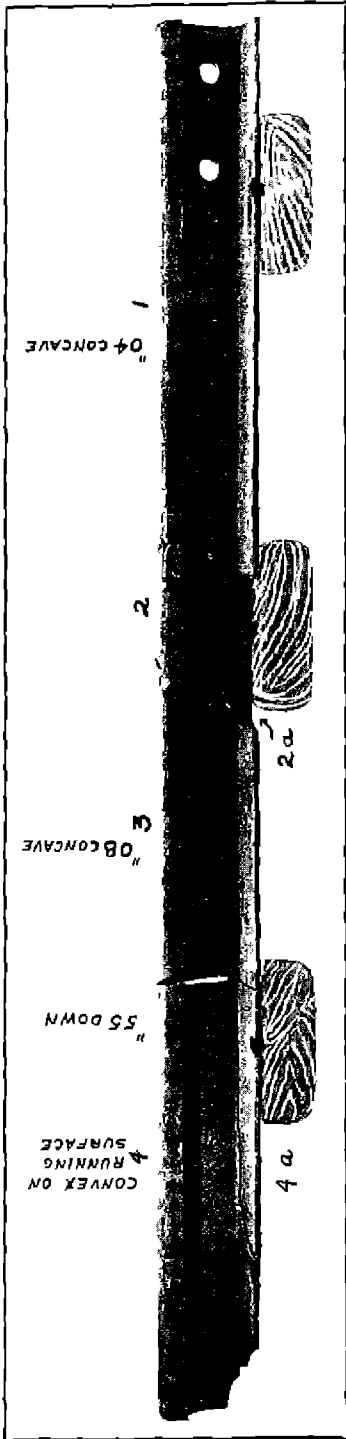
Figure No 8 shows fragments Nos 1 to 4 inclusive viewed from the gauge side of the rail. The initial fracture is believed to have been the base fracture under piece marked 2. There was a seamy streak at the under surface of the base at this place 7.8 inches long, where the fracture had its origin, separating flange fragment 2a from a missing fragment of the inner flange. This line of rupture occurred over a tie.

The rupture of the rail was completed, the lines of fracture at each end of piece No 2 extending from the upper surface of the base through the web and then the head. It is probable that these two lines of fracture occurred nearly simultaneously.

The base fracture, between fragments 4a and 4b, appears to have been the next to develop. This line of rupture occurred over a tie and where there was a longitudinal streak or seam 11 inches long which opened but could be traced a further length of 3 inches in the base of piece No 4, making a total length of 14 inches.

Next followed the upward line of rupture through the web and head between pieces Nos 3 and 4. These three lines of rupture through the web constitute all of this class of fractures displayed by the rail. The other fractures were formed in quite a different manner.

The running surface of fragments 1 and 3 was decidedly concave, that of No 2 slightly so. All other pieces were convex on the running surface of the head and with the receiving end of each bent downward.

No. 8—View of fragments marked 1 to 4 inclusive at east end of fractured rail taken from gauge side. Position of the sketches on the cut found rupture of rail believed to be the base fracture under fragment marked 2 occurring at a sandy strip in the steel

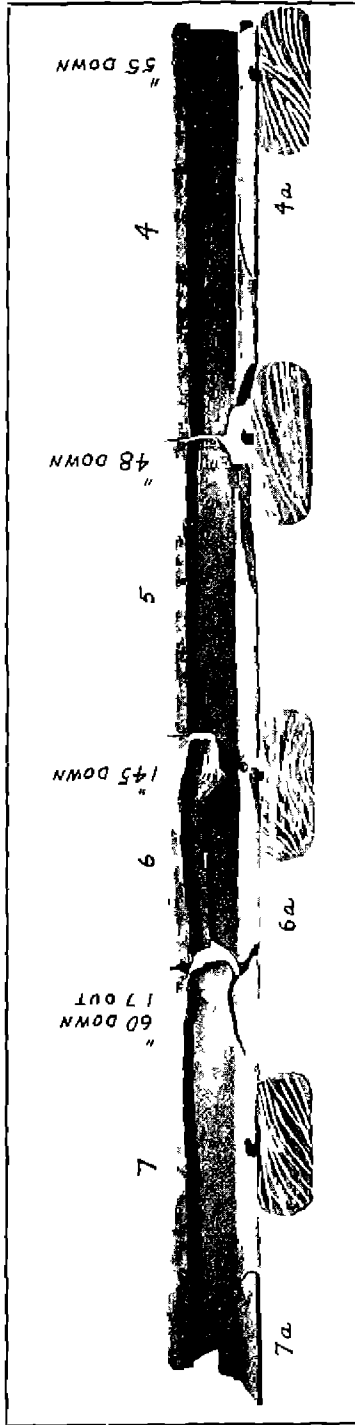
Pieces Nos 4, 5, 6, and 7 were detached by fractures having their origins at the lower edge of the head at the gauge side—that is, each of these fragments was broken by a horizontal force or one having a horizontal component.

Figure No 9 shows fragments Nos 4 to 7, inclusive, viewed from the gauge side of the rail. The receiving ends of these pieces were bent downward 0.55, 0.48, 1.45, and 0.60 inches respectively. The receiving end of the long piece, marked 8, was bent downward 0.70 inch. The positions of the ties are sketched on cuts 8 and 9.

No. 9—View of fragments of rail marked 4 to 7 inclusive, taken from the gauge side. Position of the sketches on the cut

There next followed the several lines of rupture which detached pieces 4, 5, 6, and 7 in succession from the main part of the rail. The receiving ends of these fragments were bent outward and downward. Comparatively very short bends were introduced in the head of the rail at pieces 6, 7, and 8. The weight of the drivers of the engine would seem adequate to cause these short bends, but the spiking would, unaided, be insufficient to hold the rail against the force necessary to bend the rail. The weight of the front truck, 46,000 pounds, would, however, supplement the strength of the spiking in holding the rail at its leading end and was probably sufficient to enable the observed results to be accomplished in the manner here suggested.

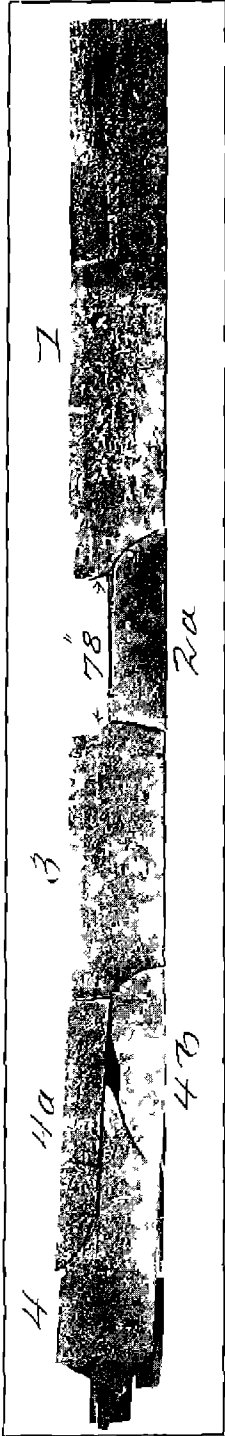
Figures Nos 10 and 11 are views of the base of the rail along the ruptured section. The initial line of rupture at 2a and the second base fracture at 4a appear on figure No 10. The subsequent lines of rupture were of a different order. They are shown on figure No 11.

No. 10—View of fragments marked 1 to 4 inclusive, at east end of fractured rail showing under surface of the base. Initial rupture of rail believed to be the base fracture of fragment marked 2a. It is seven 78 inches long.

The weight on the drivers caused the initial line of rupture—a base fracture, along the line of a seam, under piece marked 2. The rail was weakened by reason of the presence of the seam in the base and yielded under a load which structurally sound metal would have sustained without fracture. Base fracture at 4a followed that at 2a and was in turn followed by the fracture through the web and head between pieces Nos. 3 and 4, piece No. 2 having been entirely detached prior to these events.

In conclusion, it is believed that the direct cause of the rupture of the rail which occasioned the wreck of this train was the defective metal in the base of the rail. The steel was seamy and the initial line of rupture occurred along the line of a seamy streak.
