INTERSTATE COMMERCE COMMISSION

REPORT OF THE CHIEF OF THE BUREAU OF SAFETY COVERING INVESTIGATION OF AN ACCIDENT WHICH OCCURRED ON THE WEST JERSEY & SEASHORE RAILROAD NEAR ELWOOD, N J, AUGUST 24, 1919

SEPTEMBER 2, 1919

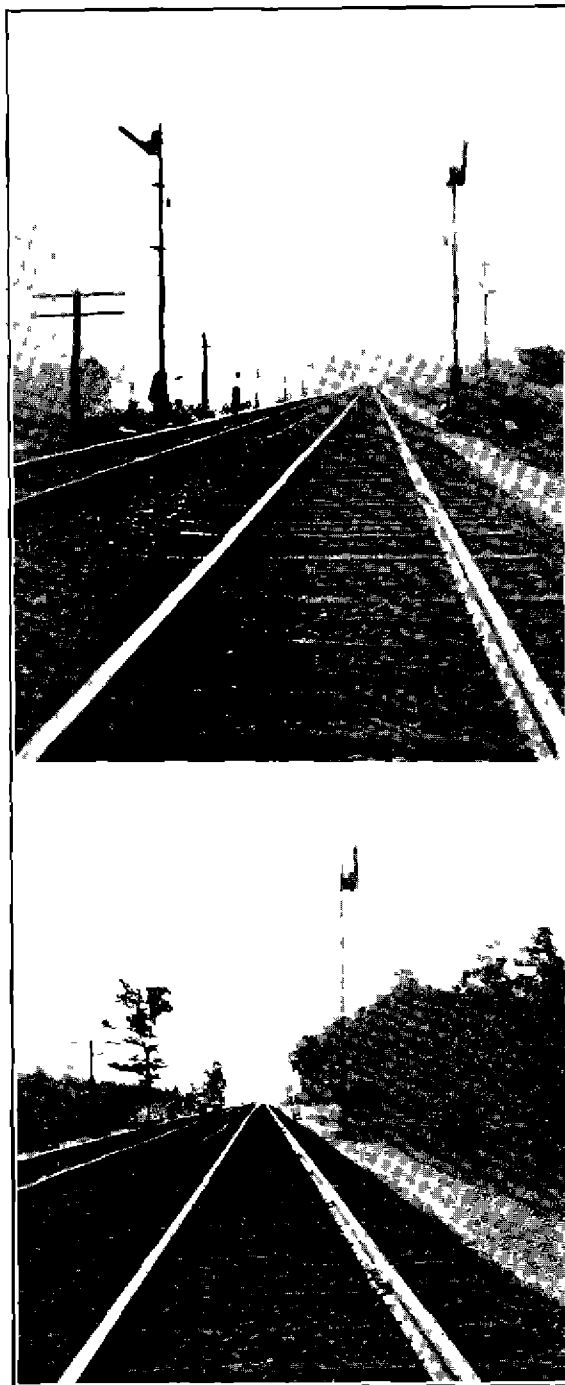
The signals near the scene of the accident are of the upper quadrant three-position semaphore type, signal 349 at Magnolia being located 4,440 feet north of signal 357 which is located 2,254 feet north of the point of accident and 4,560 feet north of the signal at Elwood station At the time of the accident the weather was foggy The unobstructed view approaching these signals is shown by the accompanying illustration

FIG 1—Signal 349 (lower) and signal 357 (upper), cut shows unobstructed view

Shortly after the accident occurred signal 349 was found in caution position and signal 357 was in stop position, which were the proper indications for those signals in view of conditions existing at that time. Statements of the enginemen of preceding trains show that both of these signals were operating properly before extra 5342 approached and that the signal lamps were burning and gave good indications. After the accident occurred the signals, which had been sealed, were under observation for three or four days and they operated properly without any adjustment or repair. It is therefore not questioned that the proper caution and stop indications were displayed by signals 349 and 357 for extra 5342.

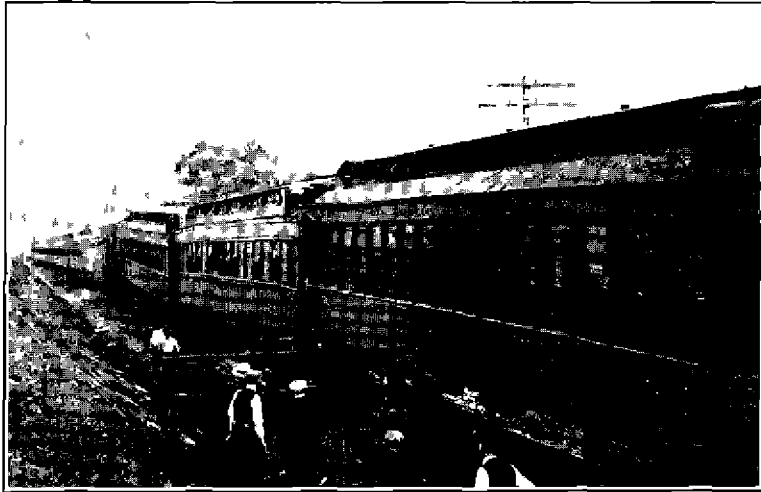
FIG. 2—Last three cars in extra 2416 and the following train showing position in which they stopped after the accident.

The front wheels of the truck of engine 5342 stopped 2 325 feet south of signal 357, and subsequent investigation indicated that it

had run a distance of 71 feet beyond the point of collision before the two trains came to a stop. In train extra 2416, the rear end of the rear car, the forward end of the second car from the rear, and the rear end of the third car from the rear were damaged. The third car from the rear sustained the greatest damage, it was telescoped for a distance of 4 or 5 feet, one of the side sills was broken and the draft rigging was torn out. The underframes of the other two cars were not materially damaged. The front end of locomotive 5342, the rear end of the tender and the forward end of the first car in train extra 5342 were slightly damaged. Two car trucks were derailed but there was only very slight damage to the track.
