# INTERSTATE COMMERCE COMMISSION

## REPORT OF THE CHIEF OF THE DIVISION OF SAFETY REGARDING THE INVESTIGATION OF AN ACCIDENT ON THE WESTERN MARYLAND RAILWAY, NEAR CUMBERLAND, MD, ON OCTOBER 12, 1916

OCTOBER 24, 1916

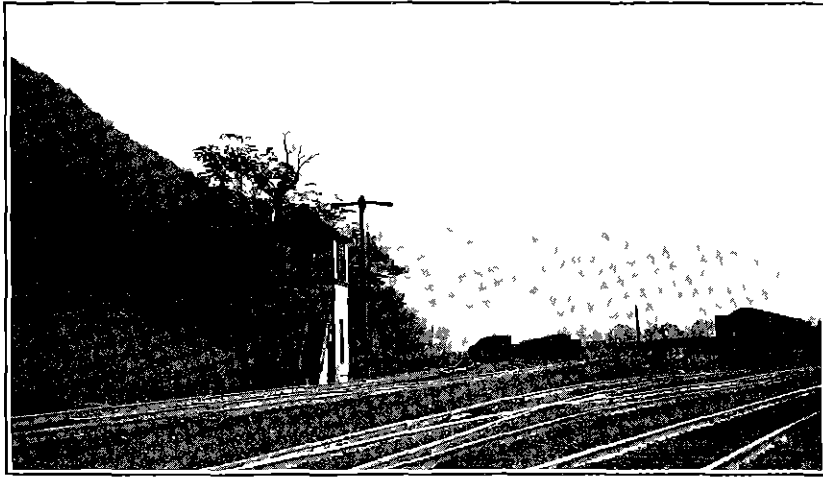
lies on practically level land of the river bottom, the grade being approximately 0.2 per cent descending eastward. Illustration No. 1 is a view looking toward the point of accident from the vicinity of Knobmount tower.

No. 1—Knobmount tower and main track looking west toward point of accident.

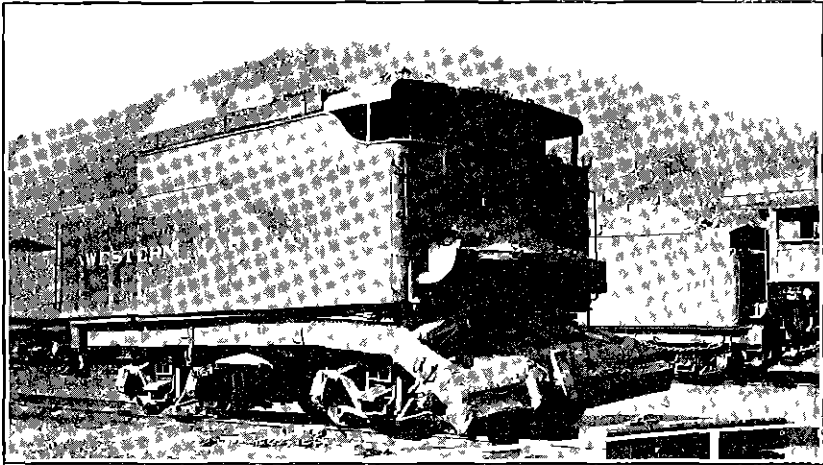
Both engines bore the brunt of the collision. The truck of engine 157 was practically destroyed, the engine frames were broken and badly bent, the engine was derailed with the exception of one pair of driving wheels, and the front portions of the steel tender frame, as well as the drawbar between the engine and tender, were bent and broken. This condition is shown by illustration No. 2. The cars of the excursion train were only slightly damaged. All of the passengers on the excursion train, 48 in number, were riding in the fourth and fifth cars, and none of them sustained serious injuries. Yard engine 1010 was broken loose from its tender, the tender being derailed and thrown at an angle across the roadbed near the point of collision. The locomotive and two coaches were driven backward a distance of 352 feet east of point of collision. The leading truck of the first car and the rear truck of the rear car were derailed, the cars coming to a stop in an upright position. The platforms of the leading car were crushed and the car body was slightly damaged. In clearing up the wreckage this car was lifted to one side of the roadbed and burned. The rear car was practically undamaged. All

No. 2—Tender of locomotive 157

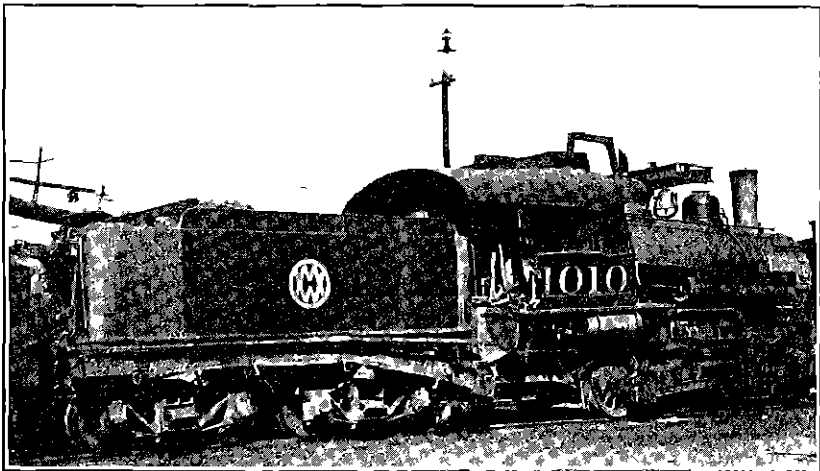
No. 3—Locomotive 1010 of employees' shop train

Illustration No. 3 is a view of locomotive 1010 after having been removed from the point of collision.
