## INTERSTATE COMMERCE COMMISSION

REPORT OF THE DIRECTOR OF THE BUREAU OF SAFETY IN RE  
INVESTIGATION OF AN ACCIDENT WHICH OCCURRED ON THE  
WESTERN PACIFIC RAILROAD AT SUNOL, CALIF., ON NOVEM-  
BER 28, 1930.

December 31, 1930.

Inv. No. 1679  
Western Pacific Railroad  
Sunol, Calif.  
November 28, 1930

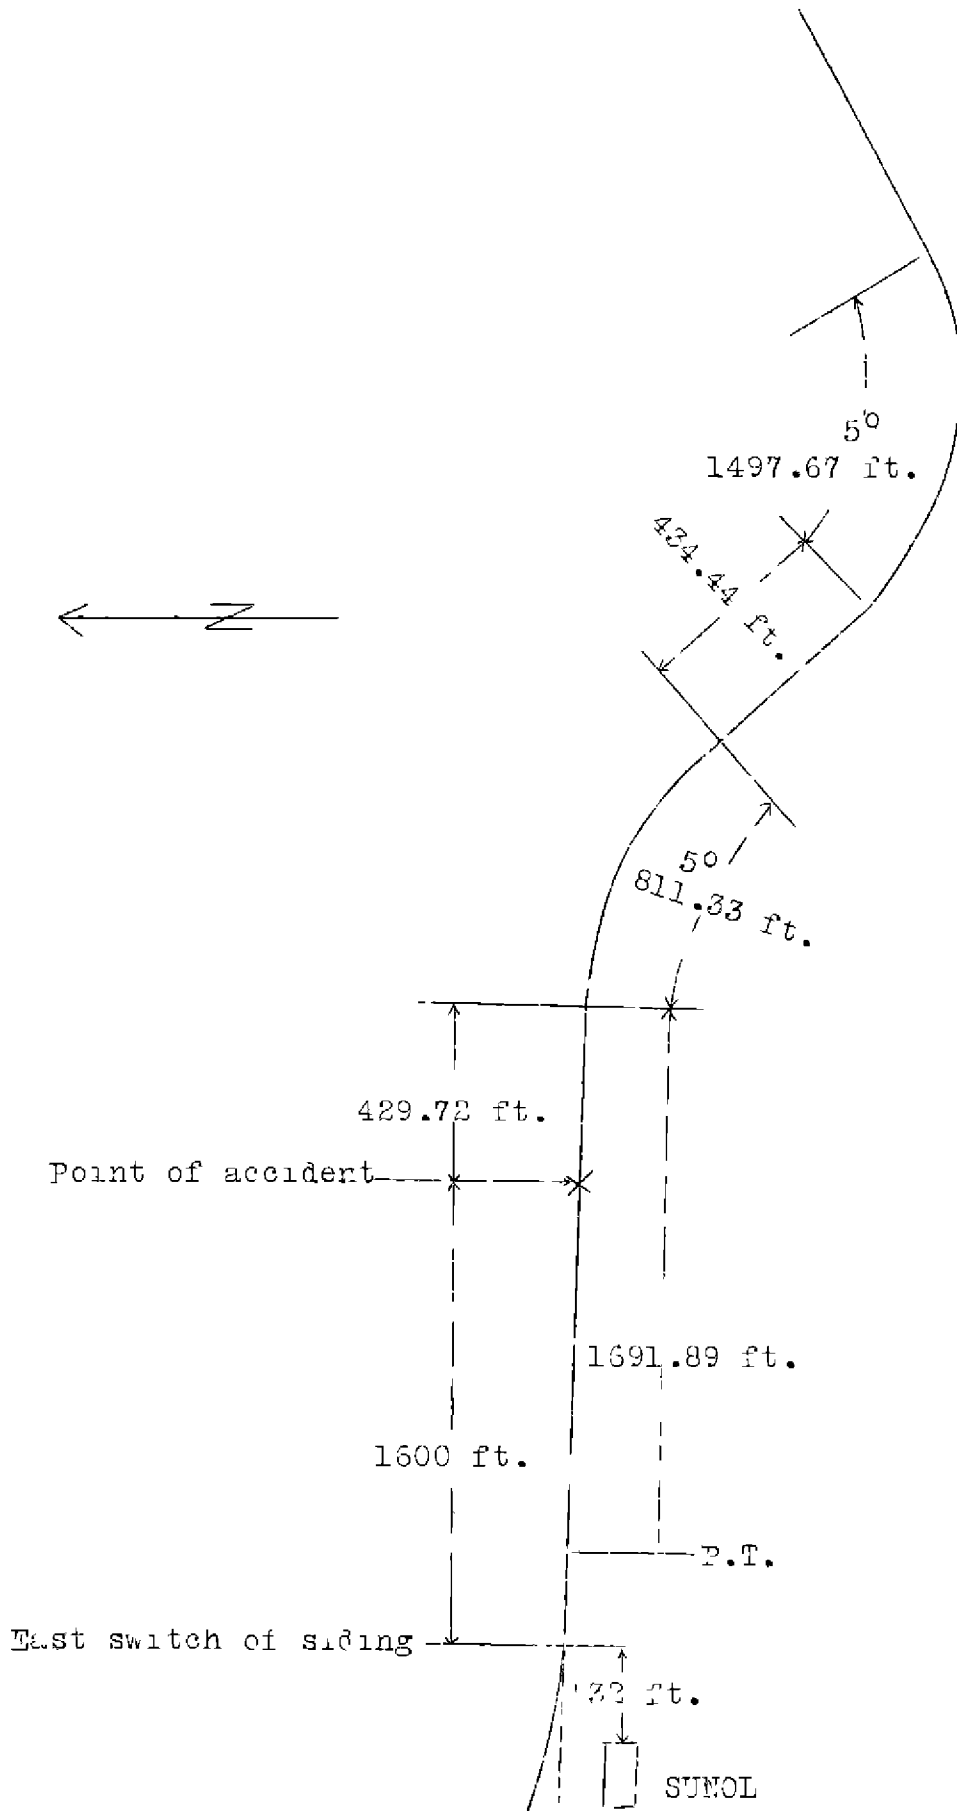
Approaching the point of accident from the east, a view of the markers on a caboose at that point could be had from the fireman's side of an engine for a distance of approximately 2,000 feet, and an entirely unobstructed view could be had from the fireman's side for a distance of 1,015 feet; a direct view could be had from the engineman's side for a distance of approximately 568 feet.
