INTERSTATE COMMERCE COMMISSION

REPORT OF THE DIRECTOR OF THE BUREAU OF SAFETY IN RE
INVESTIGATION OF AN ACCIDENT WHICH OCCURRED ON THE
YAZOO & MISSISSIPPI VALLEY RAILROAD NEAR HARRISTON,
MISS., ON MAY 11, 1930.

June 16, 1930.

No. 1337
Yazoo & Mississippi Valley R R ,
Harriston, Miss ,
May 11, 1930

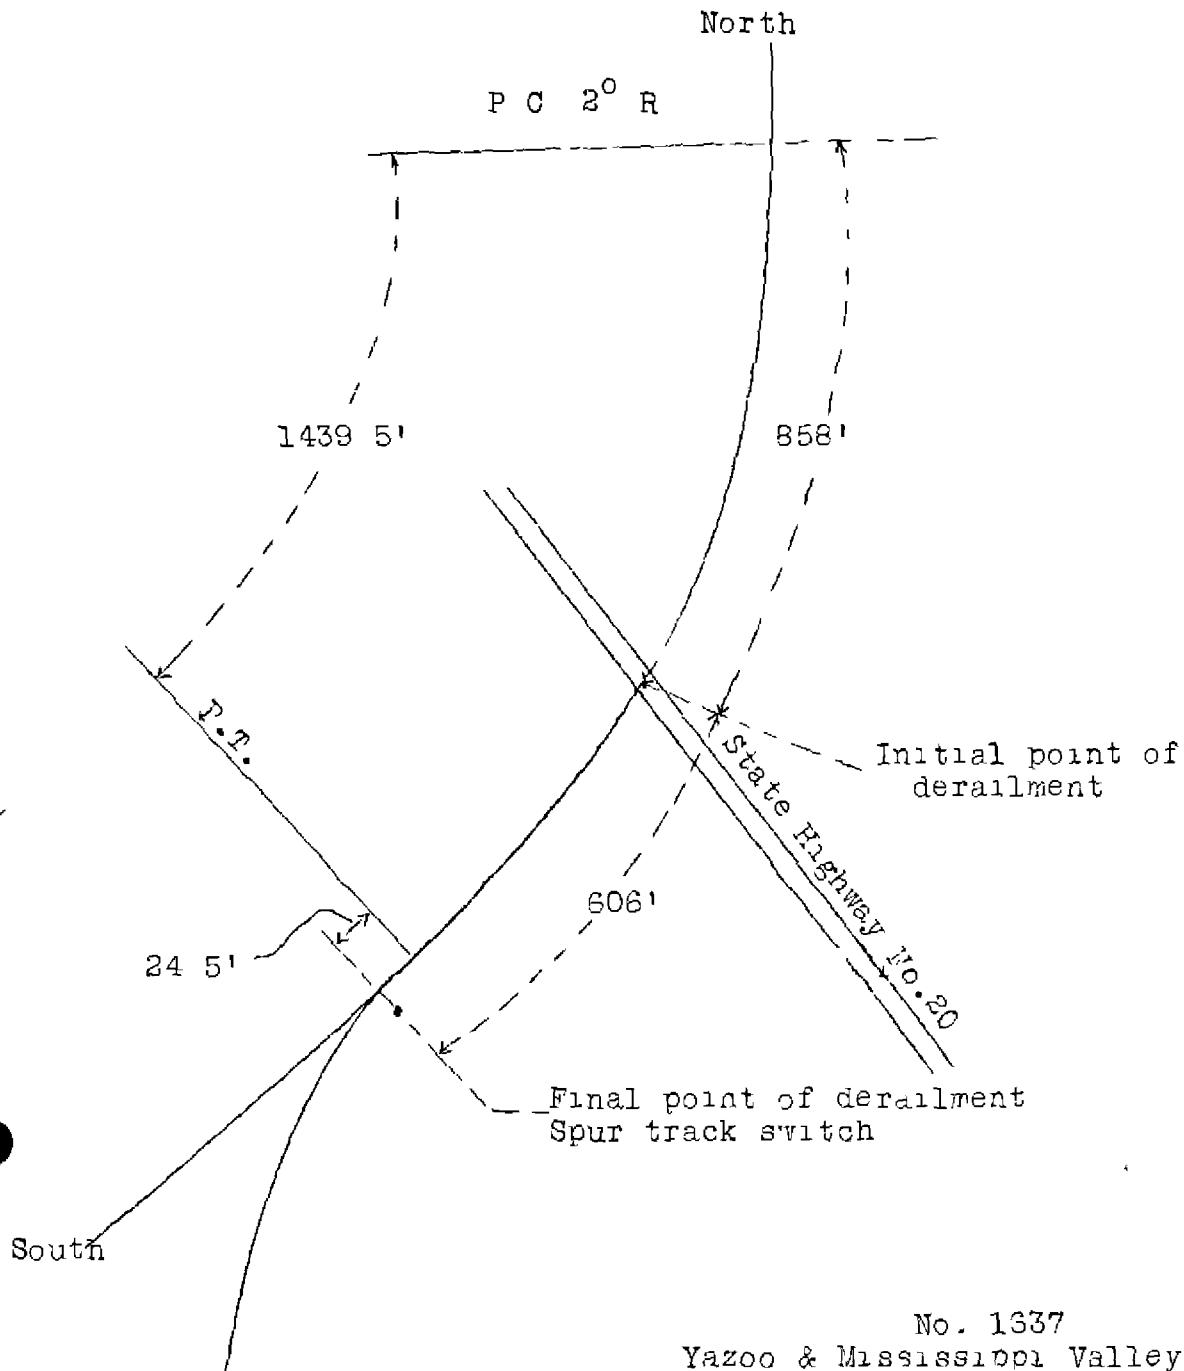
The highway crosses the track from northwest to southeast, and the facing-point switch involved is located 24.5 feet south of the curve, on tangent track, and leads off the main track to the left. The crossing planks between the rails consist of oak timbers, 4" x 10", laid between the rails; the flangeways, between the rails and crossing planks, are $2\frac{1}{2}$ inches in width. The first mark of derailment appeared on the crossing plank on the east side of the track, the high rail of the curve, at a point 6 inches south of the center line of the crossing.

The accident was caused by obstructions on both rails of a curve at^a highway grade crossing, apparently having been placed there by someone with malicious intent.
