INTERSTATE COMMERCE COMMISSION

REPORT OF THE DIRECTOR OF THE BUREAU OF SAFETY IN RE
INVESTIGATION OF AN ACCIDENT WHICH OCCURRED ON
THE YAZOO & MISSISSIPPI VALLEY RAILROAD AT WEBB,
MISS., ON JULY 9, 1929

November 5, 1929

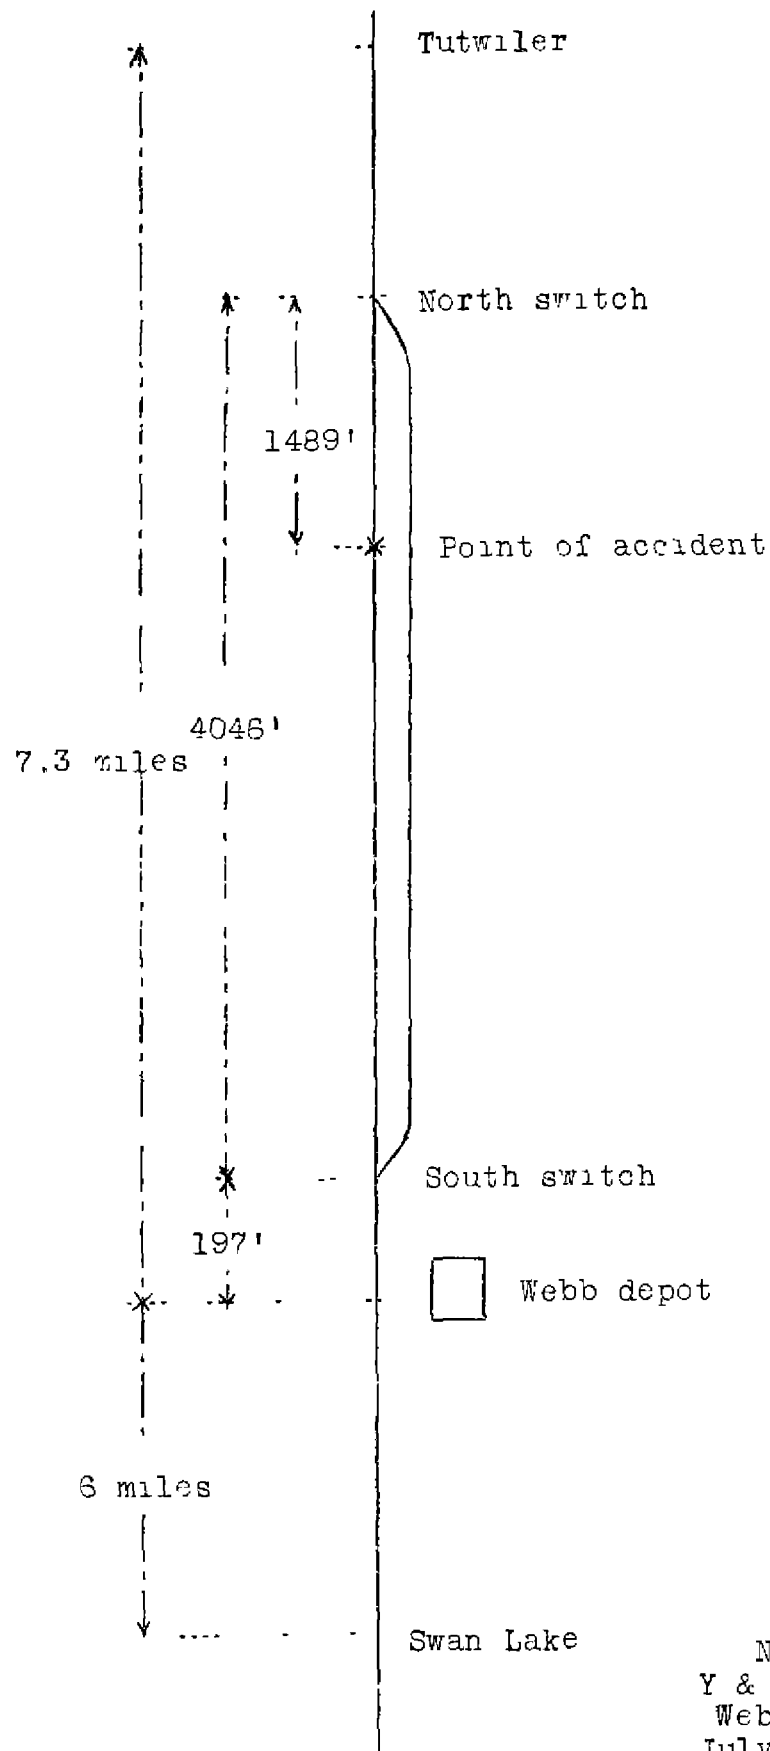
No. 1537
Y & M V R.R.
Webb, Miss.
July 9, 1929.

"No. 324 Eng 1009 meet No. 323 Eng 1011
at Webb"

This accident was caused by failure to include in a meet order as issued to the superior train a provision requiring that train to take siding.
