INTERSTATE COMMERCE COMMISSION

REPORT OF THE DIRECTOR OF THE BUREAU OF SAFETY CONCERNING AN
ACCIDENT ON THE CENTRAL OF GEORGIA RAILWAY NEAR MARICOPA,
ALA., ON AUGUST 18, 1932

November 9, 1932.

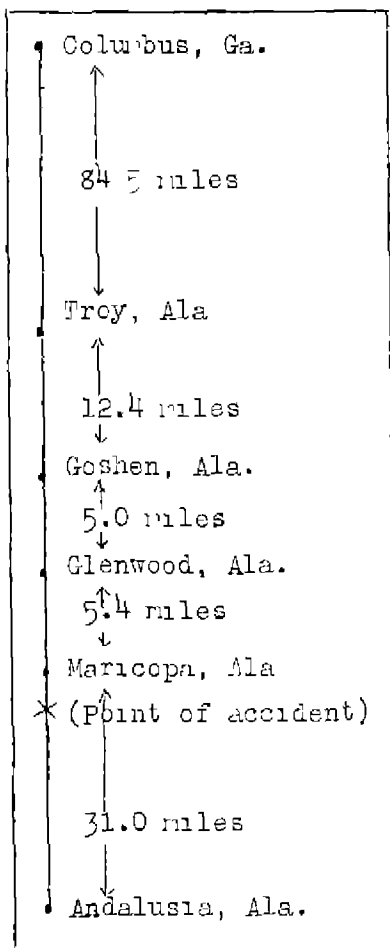
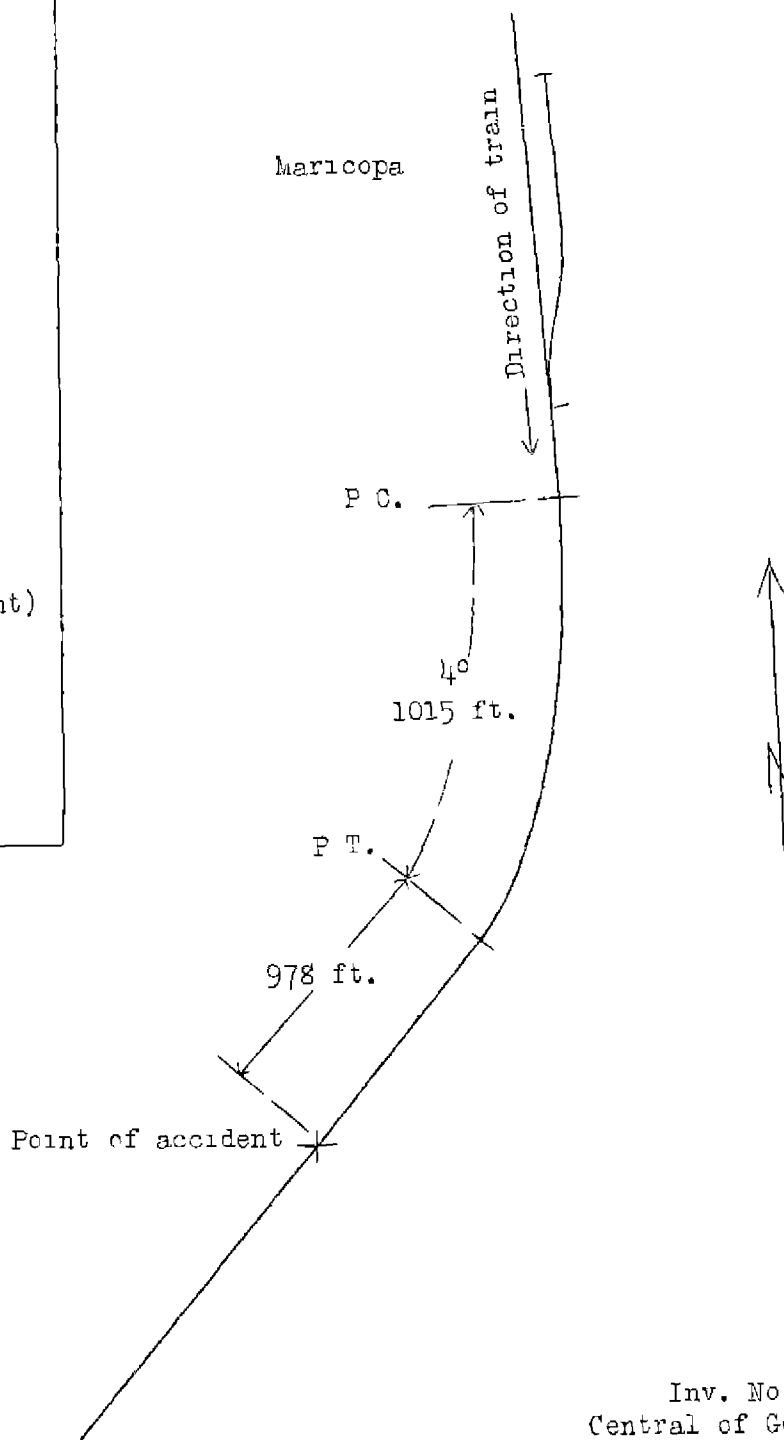
Inv. No 1780
Central of Georgia Ry ,
Maricopa, Ala.,
August 18, 1932

Engine 419 and the first five cars were not derailed, the scale test car and the following four cars were derailed to the left or south and stopped parallel with the track. The scale test car was bottom up, with its front end 331 feet west of the first wheel mark of derailment, and the remaining four cars were behind it and on their left sides. The employees injured were the conductor, brakeman, baggage master, mail clerk and the scale tester

In regard to the track being spread out of gauge in numerous places, first on one side and then on the other, apparently due to unusual lateral thrusts of the scale test car, it was found that this condition extended as far back as 12 miles east of where the accident occurred, almost to Troy, where the scale test car had been placed in the train, and these spreads measured from one-half to $1\frac{1}{2}$ inches and ranged from 20 to 24 feet in length, shoving the spikes from the ties. All of these places where the track was spread out of gauge occurred on tangent track and were either on descending grades or on level track immediately following a descending grade, where the train was drifting or a light throttle only being used and the slack bunched in the train.

This accident is believed to have been primarily caused by excessive speed.

Passenger trains handling freight cars are restricted to the permissible freight train speed of the district involved, and on the Andalusia District freight trains are limited to a speed of 30 miles per hour in the territory in question. There was no further restricting speed for the scale test car, nor were there any instructions as to where it should be placed in the train, although there was painted on the side of the car, in large letters, the words "MUST BE PAULED ON REAR OF TRAIN". This is a car of unusual type, and proper instructions should be issued to insure its safe handling when moving it around over the system.
