INTERSTATE COMMERCE COMMISSION

REPORT OF THE DIRECTOR OF THE BUREAU OF SAFETY CONCERNING AN
ACCIDENT ON THE CHICAGO, ST. PAUL, MINNEAPOLIS & OMAHA
RAILWAY NEAR MARSHFIELD, WIS., ON SEPTEMBER 21, 1932.

November 23, 1932.

Inv No. 1786
Chicago, St. Paul, Minneapolis & Omaha Ry.,
Marshfield, Wis.
September 21, 1932.

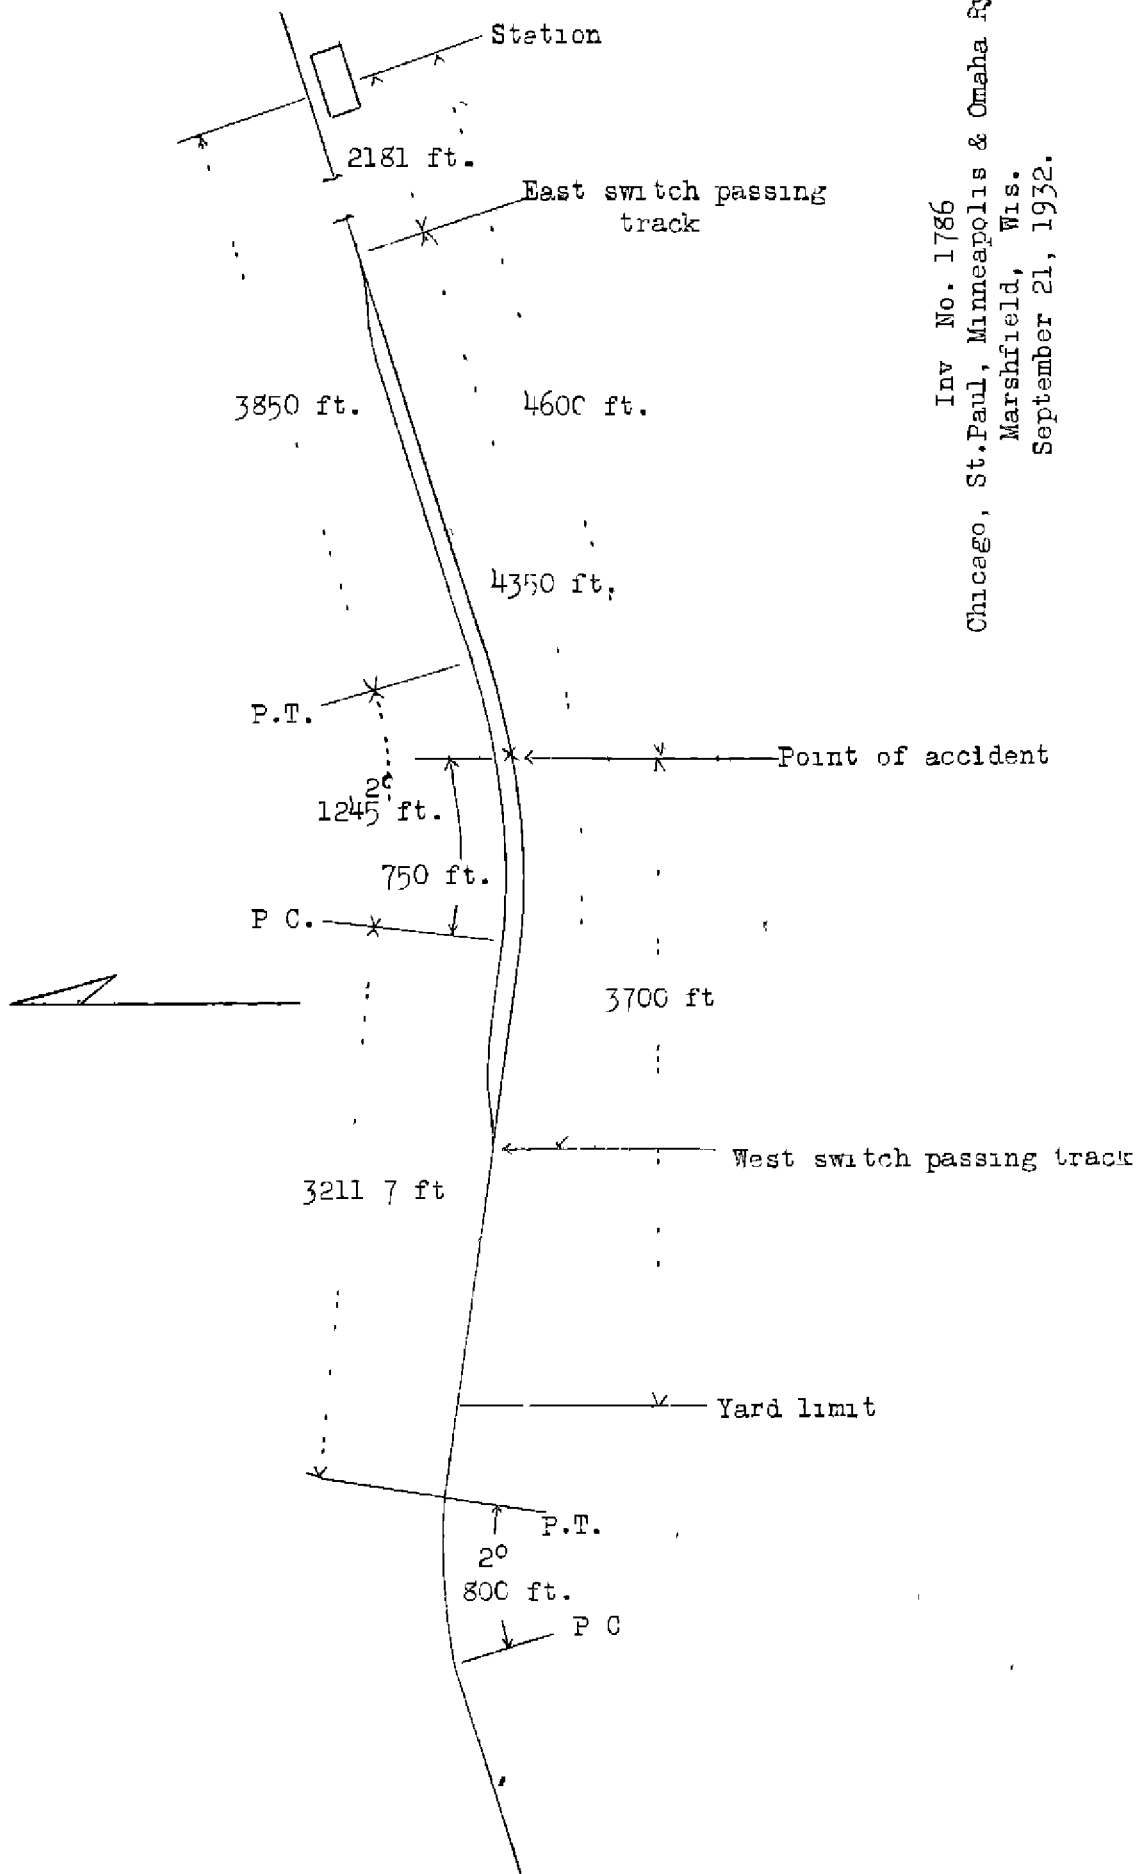
This accident occurred on the Marshfield Sub-division of the Eastern Division, which extends between Merrillan and Marshfield, Wis., a distance of 37.9 miles, and is a single-track line over which trains are operated by time-table and train orders, no block-signal system being in use. The point of accident was within yard limits, about 3,700 feet east of the west yard-limit board and approximately 4,600 feet west of the station at Marshfield. Approaching the point of accident from the west, there is a 2° curve to the right, 800 feet in length, followed by 3,211.7 feet of tangent track and then a 2° curve to the left 1,245 feet in length, the accident occurring on this latter curve approximately 750 feet from its western end. The grade is 0.802 per cent ascending for eastbound trains for a distance of approximately 4,100 feet to within 300 feet of the point of accident, and it is then level to the point of accident. A passing track 4,350 feet in length parallels the main track on the north, the east switch being located 2,181 feet west of the station.
