ACCIDENT ON THE  
UNION PACIFIC RAILROAD

DECKER, COLO.

NOVEMBER 7, 1936.

INVESTIGATION NO. 2119

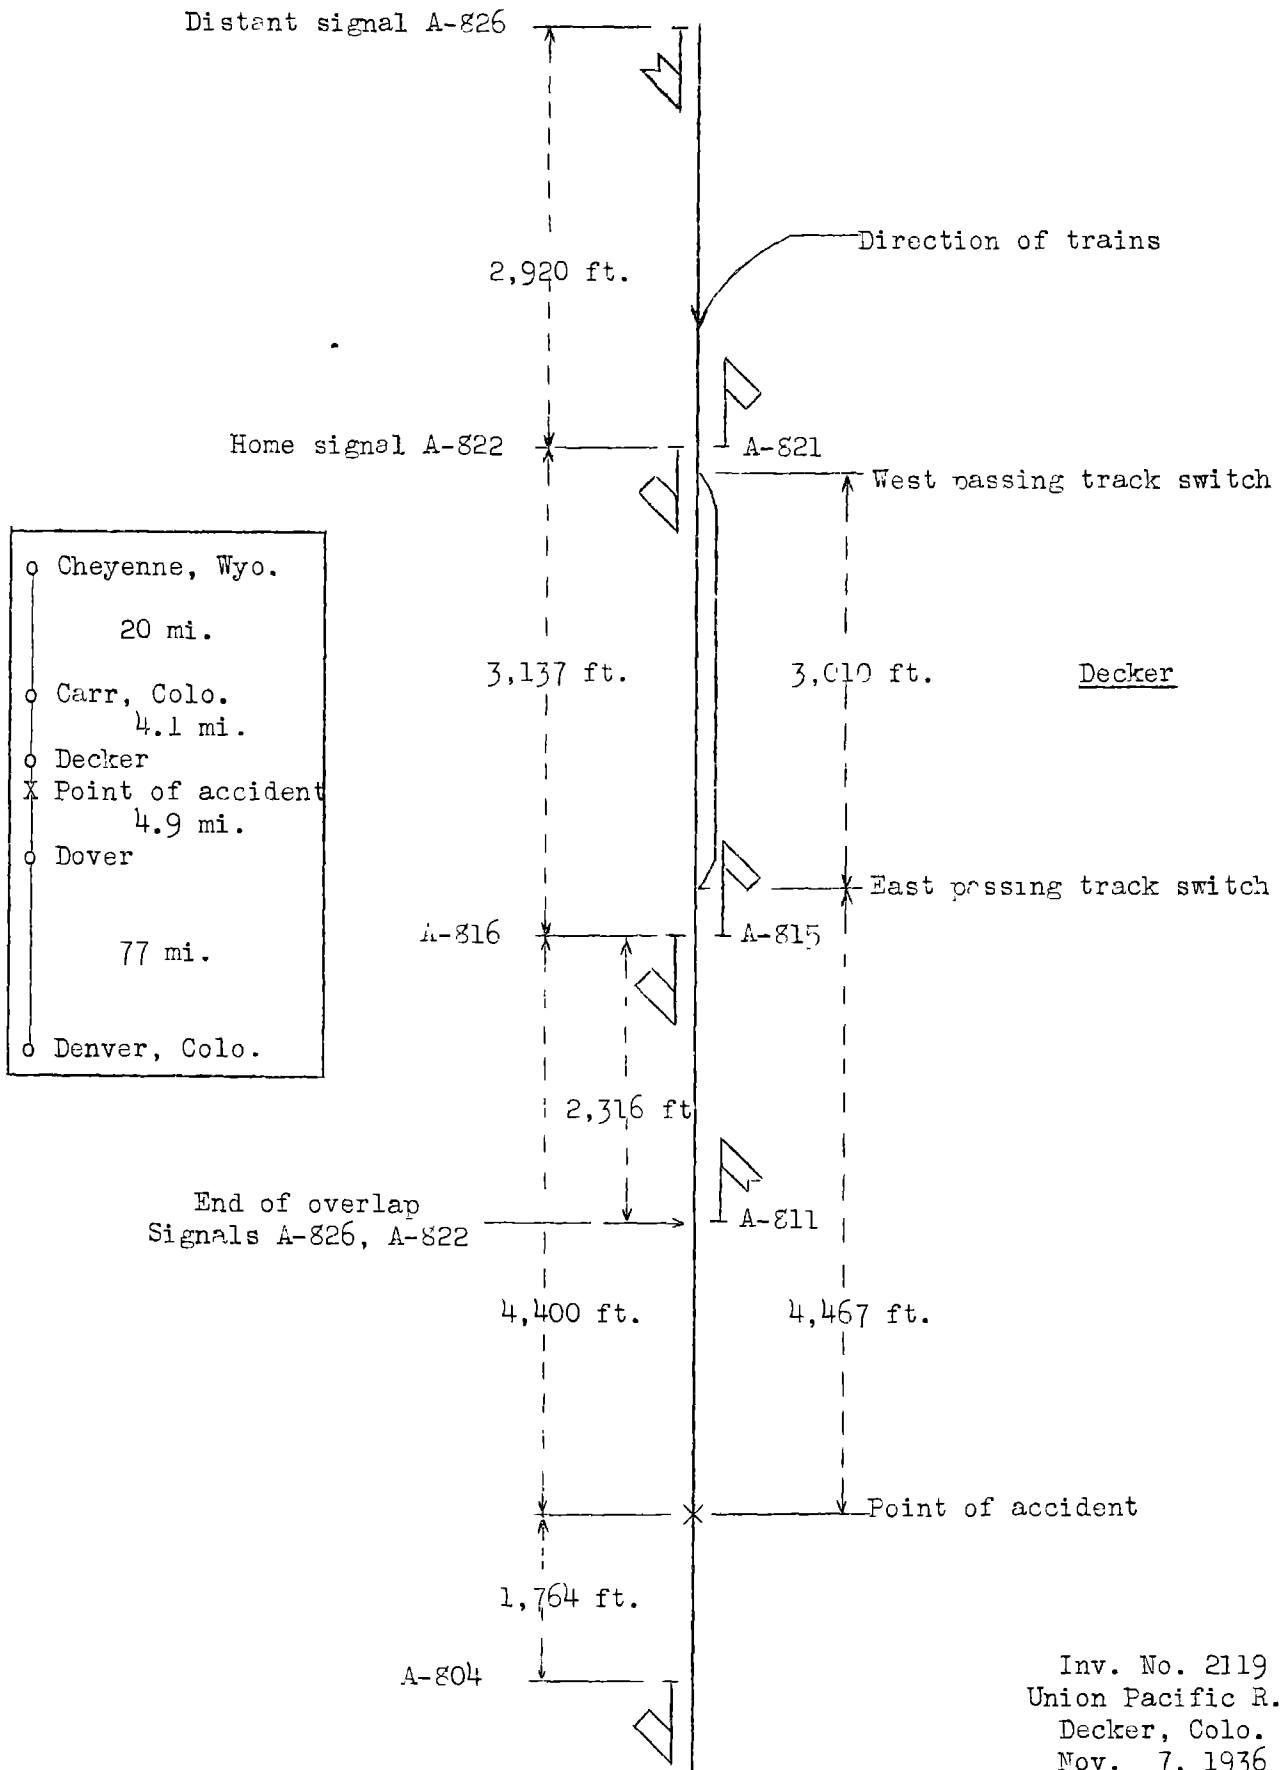
Inv. No. 2119  
Union Pacific R.R.  
Decker, Colo.  
Nov. 7, 1936

The signals involved are automatic signals A-826, A-822, A-816 and A-804. These are approach lighted signals of the lower quadrant, 2-position, semaphore type. Signal A-826, a distant signal, is located 2,920 feet west of signal A-822 and near the west passing track switch at Decker and displays green and yellow for "proceed" and "approach next signal prepared to stop", respectively. Signal A-822, a home signal, is located at the west switch of the passing track and displays green and red for "proceed" and "stop", respectively. Signal A-816, a similar home signal, is located at the east end of the passing track, 3,137 feet beyond, or 4,400 feet west of the point of accident. Signal A-804, another home signal, is located 1,764 feet east of the point of accident. The overlap for signals A-826 and A-822 extends to a point 2,316 feet east of signal A-816, and when an east-bound train passes that point, home signal A-822 and distant signal A-826 assume proceed positions; signal A-816 remains at stop.
