INTERSTATE COMMERCE COMMISSION

ACCIDENT ON THE

ERIE RAILROAD

INVESTIGATION NO. 2147

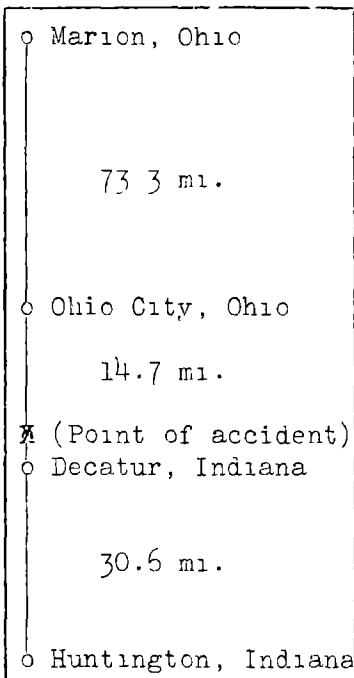
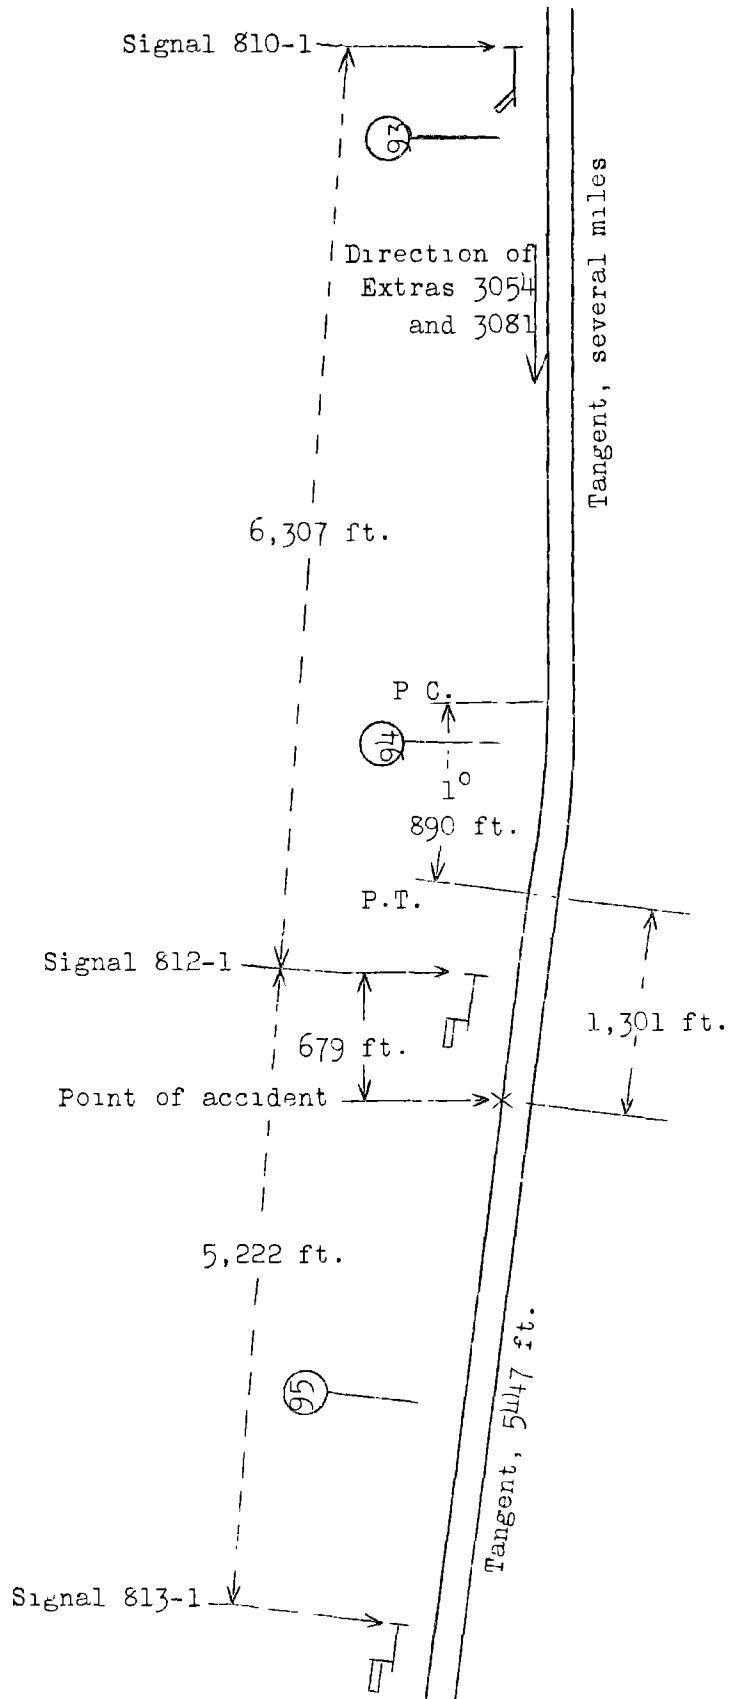
Inv. No. 2147
Erie Railroad
Decatur, Ind.
Feb. 14, 1937

The signals involved are automatic signals 810-1 and 812-1. These are 3-position, upper quadrant, semaphore signals showing green, yellow or red, for proceed, approach, and stop and proceed, respectively. Signals 810-1 and 812-1 are located 6,986 feet, and 679 feet, respectively, east of the point of accident. To the Engineman of a west-bound train an unobstructed view of signal 812-1 is restricted to 1,581 feet, because of a telegraph line, with poles spaced 125 feet apart, which parallels the tracks at a distance of 40 feet from the center of the west-bound track, but between points 2,681 feet and 1,681 feet east of that signal it is visible through the spaces between the poles. The maximum distance at which this signal can be seen by the fireman of a west-bound train is 1,031 feet.
