## INTERSTATE COMMERCE COMMISSION.

### REPORT OF THE DIRECTOR OF THE BUREAU OF SAFETY IN RE INVESTIGATION OF AN ACCIDENT WHICH OCCURRED ON THE PHILADELPHIA & READING RAILWAY NEAR ANNVILLE, PA., ON NOVEMBER 21, 1923.

FEBRUARY 18, 1924.

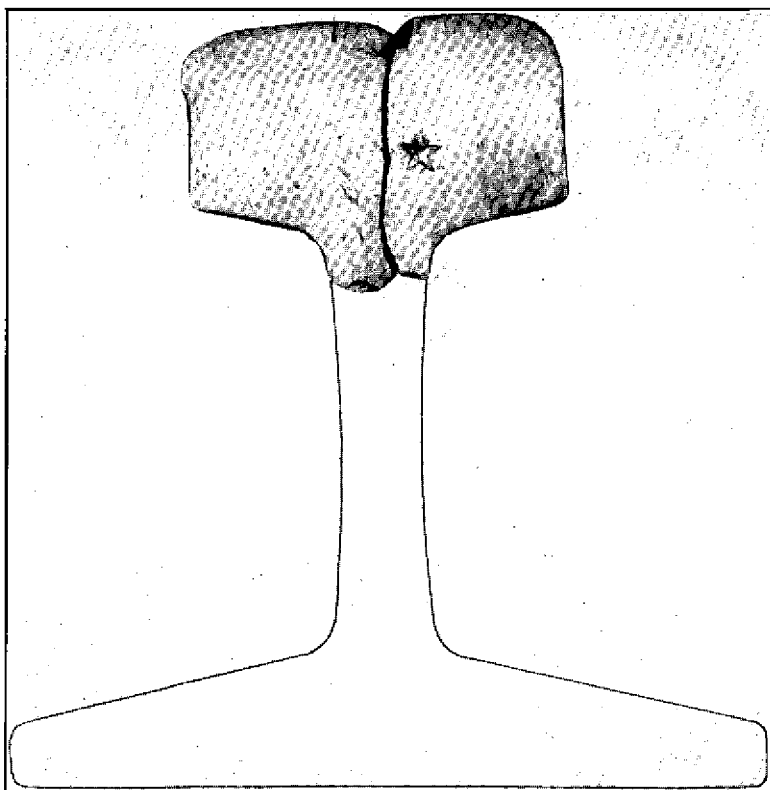
Describing the photographs and micrographs reproduced herewith illustrating this rail and one other, each of which displayed a fracture of this kind, Figure 1 shows a cross section of the halves of the head of the rail involved in the present accident as they appeared after polishing and etching with tincture of iodine. The web and base of the rail are shown in outline.

The place of rupture, in vertical direction, had its origin at a longitudinal seam at the center of the head. A star is placed on the cut at the side of the seam, for identification.

FIG. 1. Cross section of head of rail with outlines of web and base, surface polished and etched with tincture of iodine. Fracture began at seam at the center of the head, abrest star placed on the cut for identification.

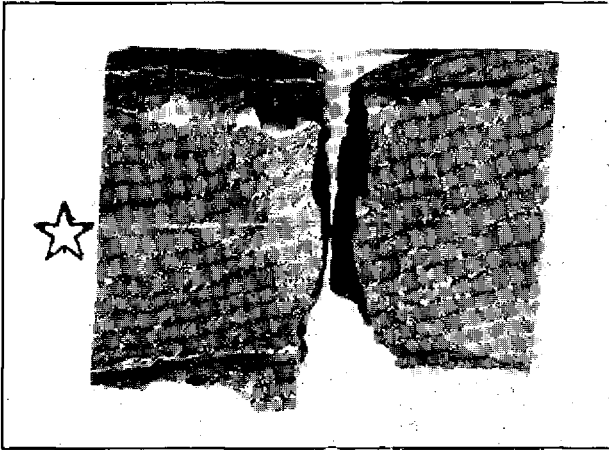
Figure 2 shows the appearance of the ruptured surfaces of these two fragments, a star being placed on the cut opposite the seam for identification. The radiant appearance of the ripples on the fractured surface indicate the plane of rupture traversed the head of the rail in lengthwise direction, as well as separating it vertically.

Just below the fillet of the head the plane of rupture bifurcated separating the halves of the head from the web. At this particular place in the rail the half of the head on the gauge side was the first to be detached, followed by the outer half. A number of small fragments were successively detached from the intermediate part of the

FIG. 2.—Pieces of the head of the rail, showing the longitudinal seam responsible for the split head fracture. A star is placed opposite the seam for identification.

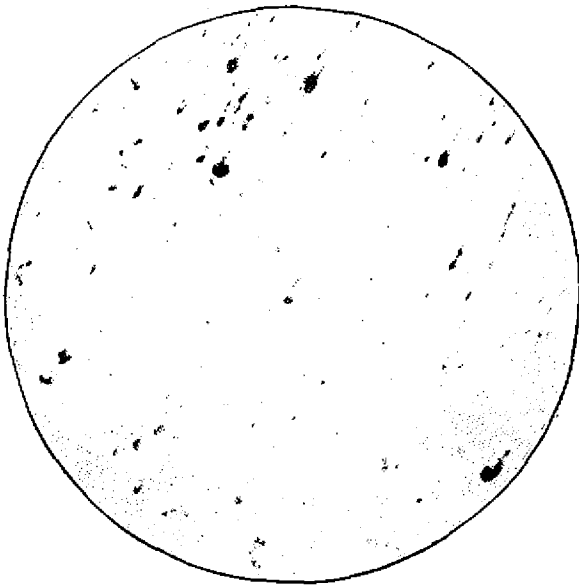
Figures 3 and 4 are photomicrographs showing the appearance of the metal adjacent to the longitudinal seam in the head. There were minute slag inclusions in this vicinity, but not in segregated areas. The contiguous metal, judged by its appearance, would not be expected to display a streak of the character of the one which precipitated the accident.

FIG. 3.—Photomicrograph of head of rail adjacent to the longitudinal seam at center of head. Surface polished but not etched, minute slag inclusions shown. Transverse section. 100 diameters magnification.

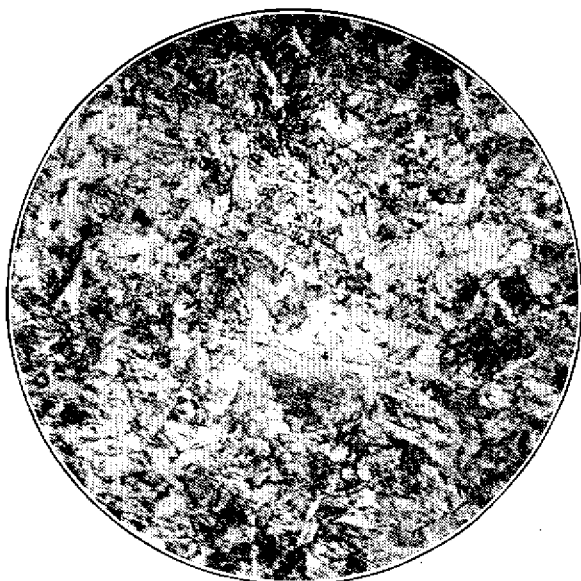
FIG. 4.—Photomicrograph of lead immediate vicinity of fig. 3. Surface polished and etched with picric acid. Transverse section, 100 diameters magnification.

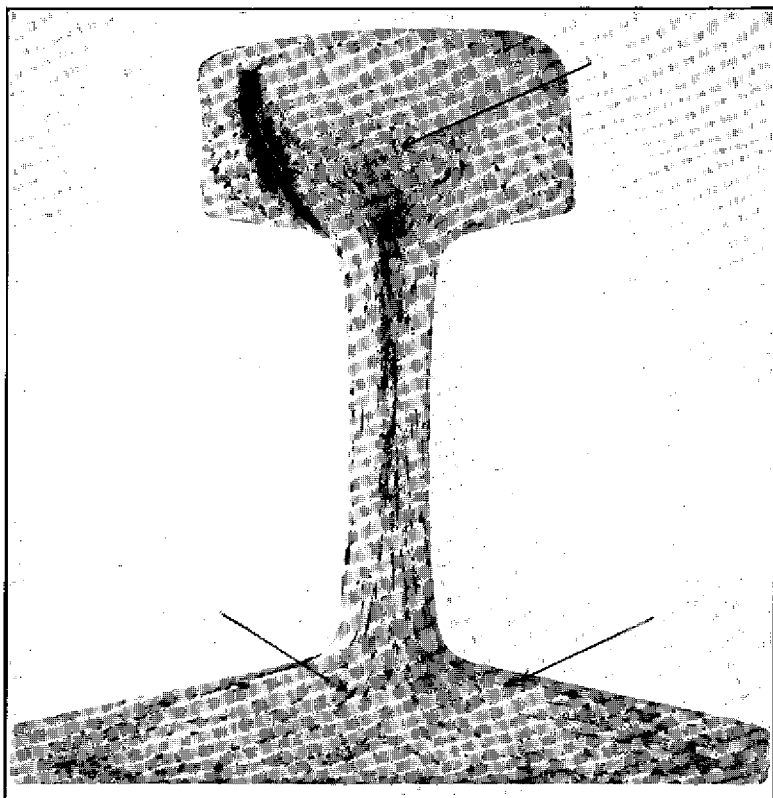
Figure 5 shows a cross section of the rail near the receiving end, as it appeared after polishing and etching with tincture of iodine. At this place the plane of rupture has approached within three-eighths inch of the gauge side of the head.

Pronounced markings appeared on this iodine etched cross section; darkened areas, dots, and dashes. Each mark has some significance but for the most part they would hardly exert an appreciable influence in promoting rupture of a rail, the gravity of their presence depending upon their position and size. In the earlier stages of the attack of the staining liquid the dots and dashes are more sharply defined. They acquire an exaggerated appearance when the etching is continued, and the surface darkened sufficiently for photographic purposes.

The dark zones bordering upon the edges of the split head plane of rupture are without significance in respect to the development of the fracture. The illustration shows how an erroneous aspect may be given a portion of the etched surface through the presence of some foreign substance. The metal in the opposite halves of the head was substantially alike in structural appearance. In general, rails are remarkable for their symmetry of appearance on opposite sides of a vertical center line.

FIG. 5.—Cross section of rail near receiving end. Split head fracture had approached within three-eighths inch of gauge side of the head. Surface polished and etched with tincture of iodine. Dark borders of fracture not significant.

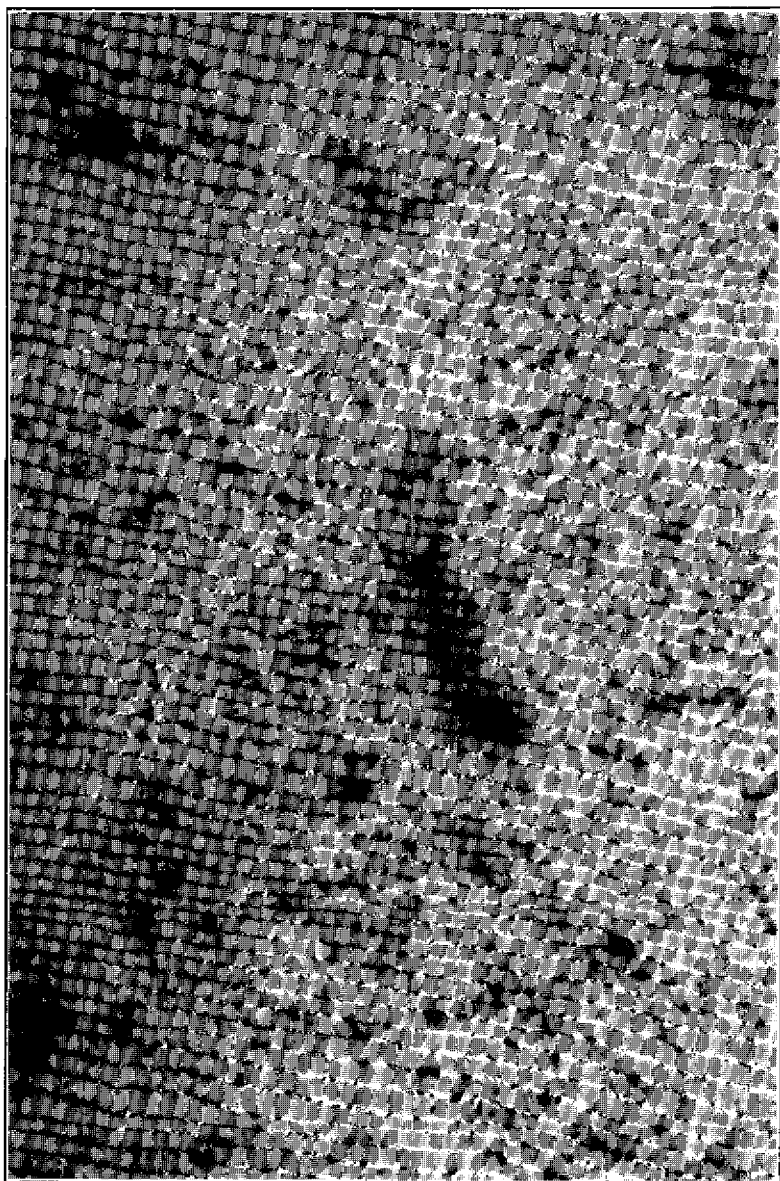
The markings on the cross section of the rail shown by Figure 5 were microscopically examined in three places. Near the center of the head a darkened spot was displayed, occupying a place near the element on which the seam causing the split head was located. This spot, toward which an arrow points on the cut, was photographed oversize and enlarged to 8 diameters appearing as shown by Figure 6.

FIG. 6.—Appearance of a darkened spot near center of head of rail enlarged 8 diameters. See arrow on fig. 5 pointing to this spot.

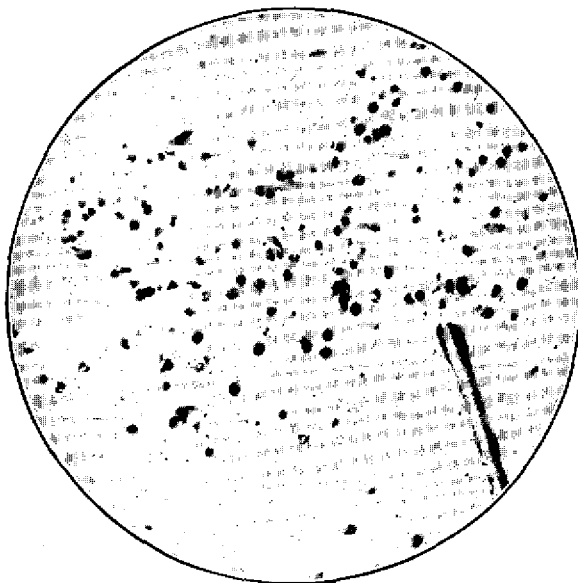
The metal was repolished and again etched with tincture of iodine, developing a cloudy zone when lightly etched. A spot on this zone was marked with a needle for identification, photographed, and shown by photomicrograph Figure 7. Polishing off the iodine etched surface a group of minute inclusions appeared, shown by Figure 8. The surface was etched with picric acid, displaying the

FIG. 8.—Photomicrograph of darkened spot near center of head of rail, shown by fig. 7. Appearance of surface after iodine staining was polished off. Transverse section, 100 diameters magnification.

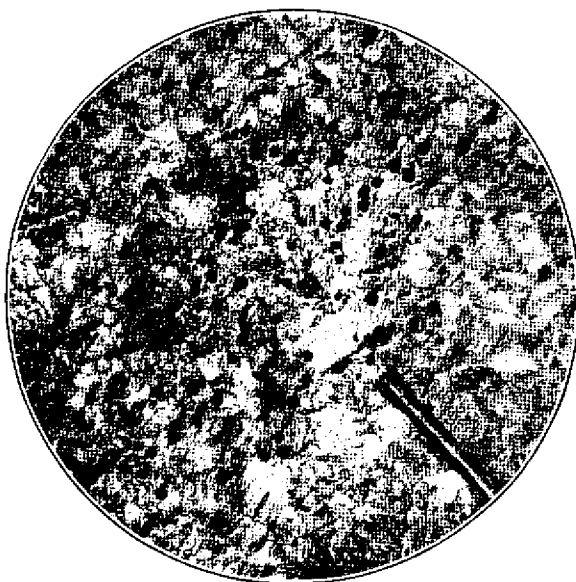
structure shown by Figure 9, on which also appear dots representing the slag inclusions. These inclusions would be expected to impair the strength of the metal in its resistance of lateral strains, and lead to the formation of a split head fracture.

FIG. 9.—Photomicrograph of darkened spot near center of head, etched with picric acid. Transverse section, 100 diameters magnification.

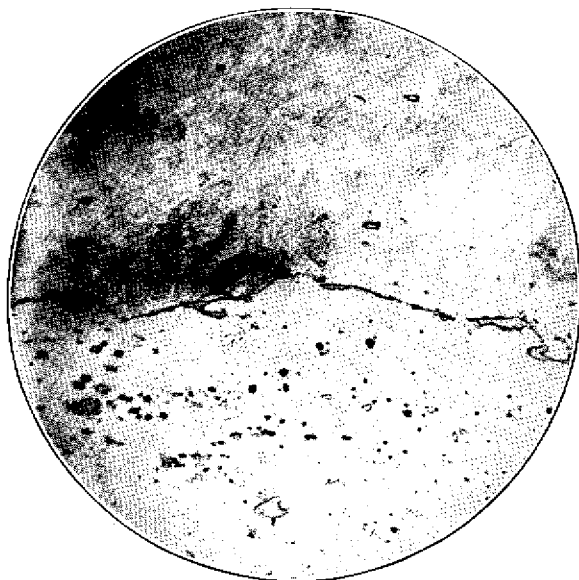
Figure 11 represents the darkened spot, near the junction of the web and the base, after etching five seconds in picric acid. The picric acid etch was next polished off. Slag streaks continuous and interrupted forming unwelded seams were found in this locality. Figures 12 and 13 represent these seams. They constituted the edge of a zone containing groups of minute inclusions outside of which the metal was quite free from them.

FIG. 12.—Photomicrograph of spot in base of rail darkened by iodine (see fig. 5) appearing on fig. 11, shown to be a slag streak when picric-acid etching was polished off. Seam located at edge of a group of minute slag inclusions. Transverse section, 166 diameters magnification.

FIG. 13.—Photomicrograph of same streaked metal shown by fig. 12. Transverse section, 166 diameters magnification.

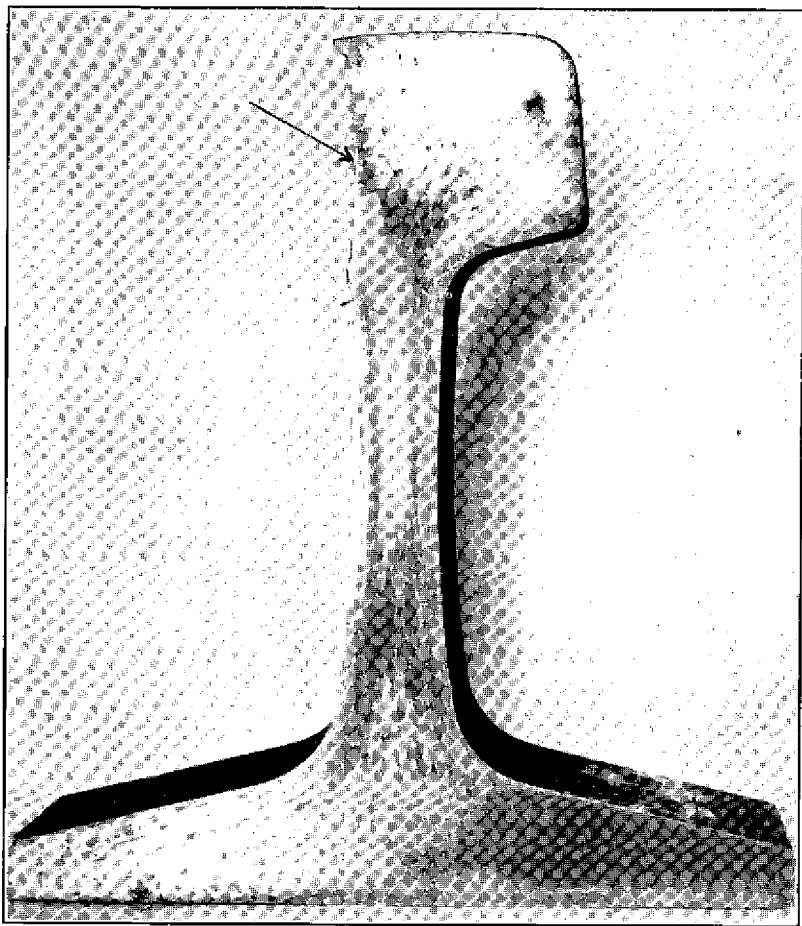
Figure 14 shows a cross section of the 130-pound rail after polishing and etching with tincture of iodine. An arrow on the cut points to the position of the seam, located a little above the limits of the segregated area.

FIG. 14.—Cross section of a 130-pound rail, which displayed a split head fracture caused by the presence of a longitudinal seam. An arrow marked on the cut shows location of seam. This was a segregated rail, the segregation not being the cause of its fracture.
