## INTERSTATE COMMERCE COMMISSION

### REPORT OF THE DIRECTOR OF THE BUREAU OF SAFETY IN RE INVESTIGATION OF AN ACCIDENT WHICH OCCURRED ON THE NEW YORK CENTRAL RAILROAD NEAR FORSYTH, N Y, ON DECEMBER 9, 1923

JANUARY 5, 1924

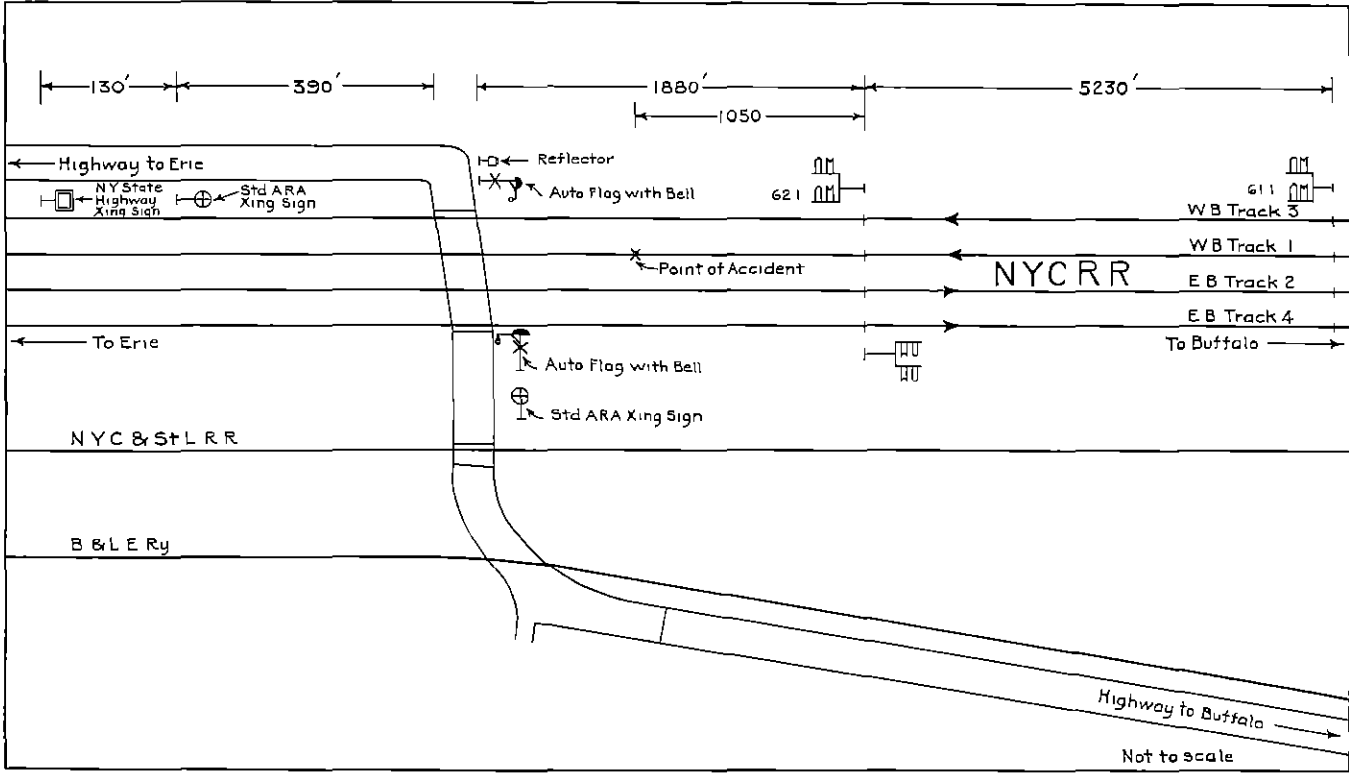
FIG. No 1—Diagram showing relative location of tracks and signals involved

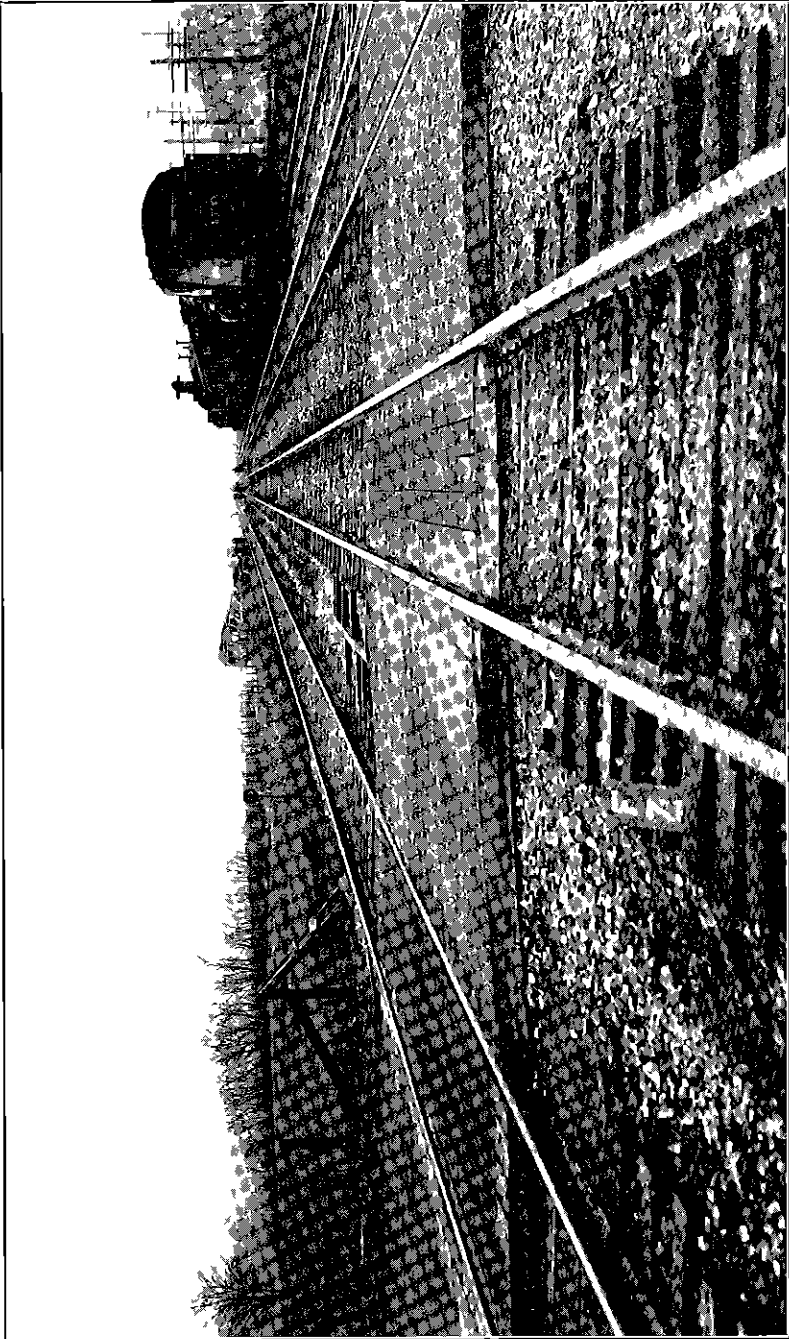
FIG No 2—View from crossing looking east toward point of accident, signal 621 in the distance

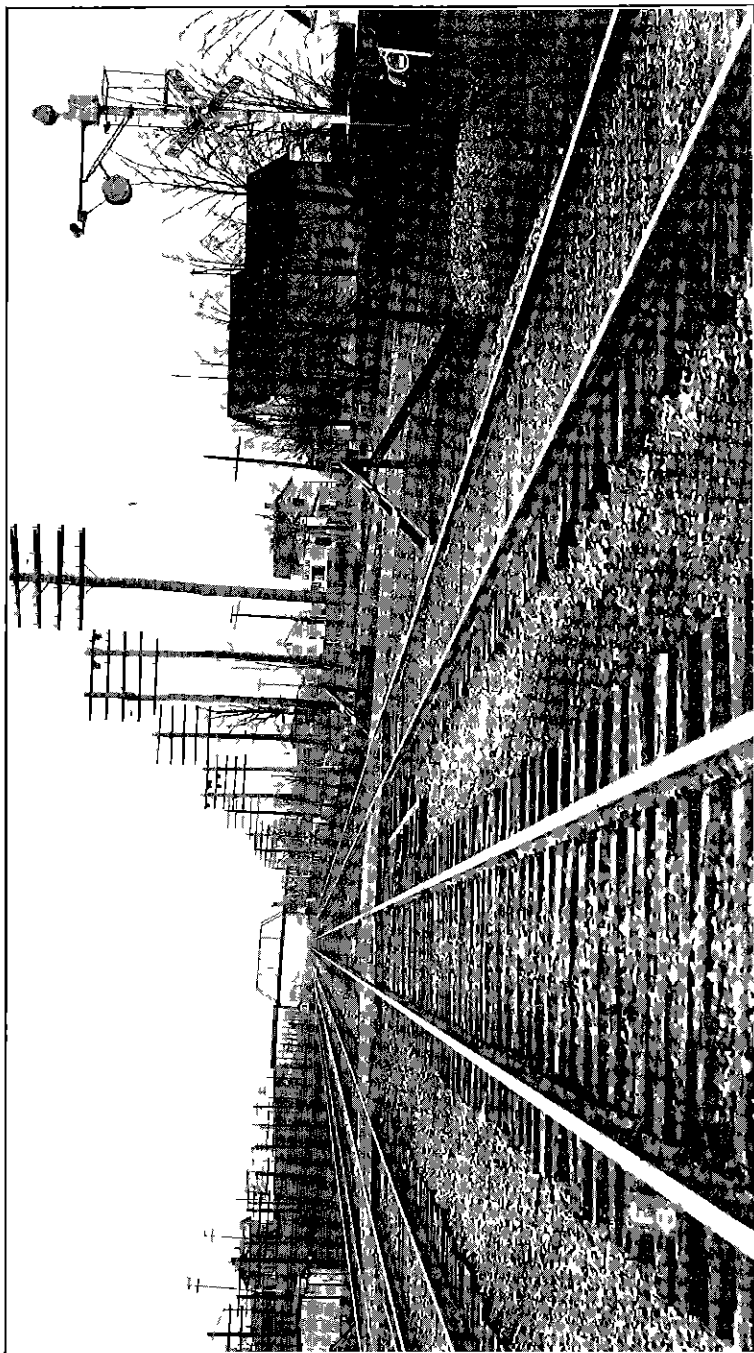
Fig No 3—View looking toward direction from which automobile approached crossing

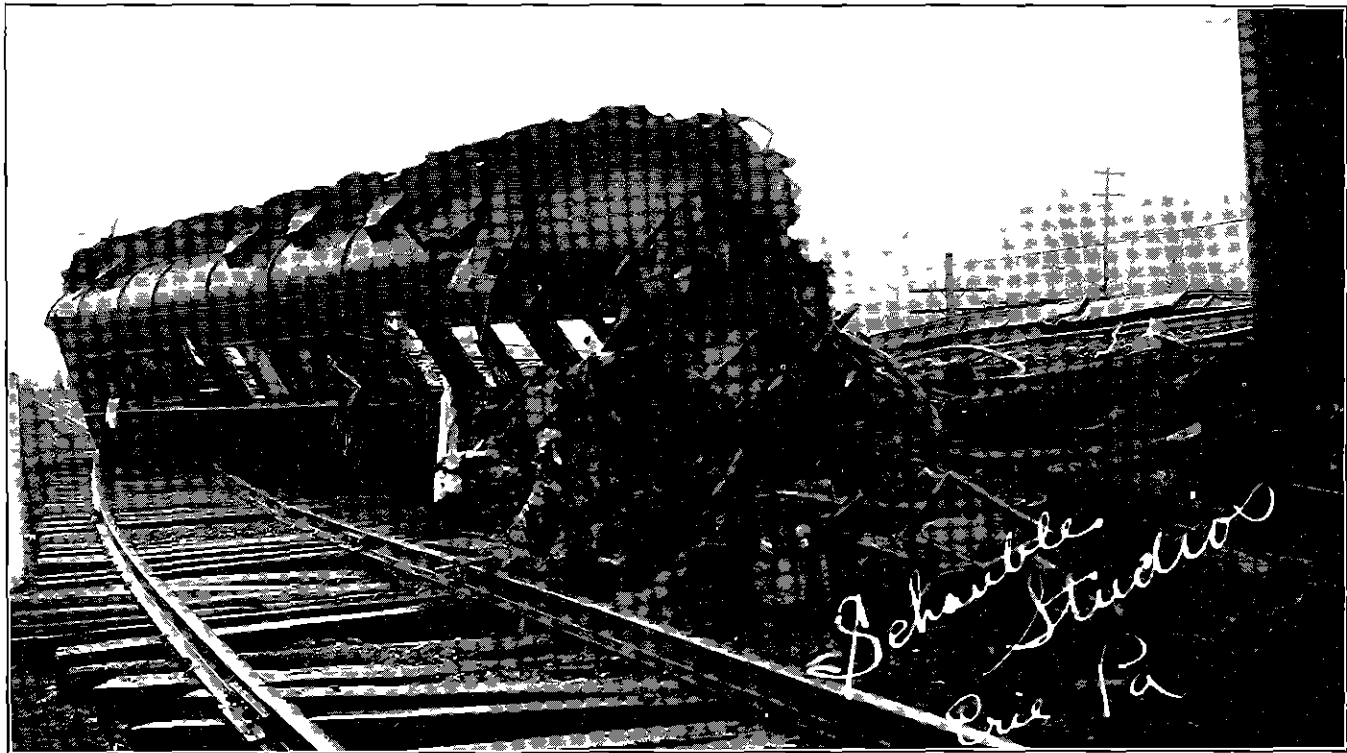
The rear car of train third No 5 was demolished, being telescoped practically its entire length by the car immediately ahead of it. All of those killed were in the rear car. The third car from the rear was derailed and considerably damaged. Engine 3316 was considerably damaged, but none of the cars in this train was derailed or materially damaged.

FIG No 4—Wreckage of rear car of train thrd No 5
