**APPLICATION OF ACOUSTIC, STRAIN, AND OPTICAL  
SENSORS TO NDE OF STEEL HIGHWAY BRIDGES**

**By David W. Prine**

**Technical Report #12**

Originally presented at Sensors Expo Conference in Boston, MA May 16-18, 1995

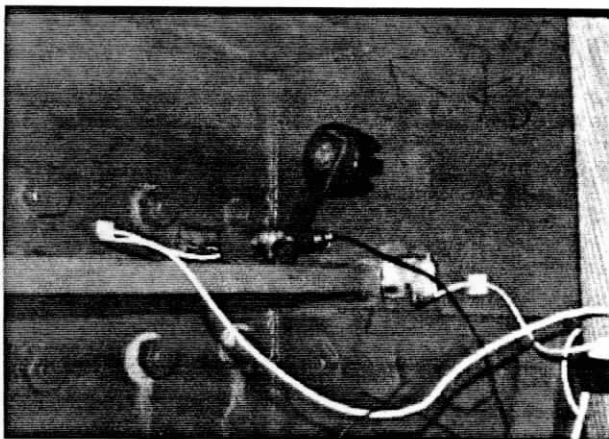
Figure 1 Close-up of Cracked Detail

In-depth inspection of the bridge by WIDOT personnel detected visual cracks inside the tie girders in the tied arch. Figure 1 shows a close-up of this detail.

The cracks were located in welds at the ends of 1 by 6 inch bars that join the bars to the hanger diaphragms at two sites. The bars, which serve as horizontal stiffeners, are welded to the inside of the tie girder at the point of attachment of the floor beams. The welds that join the 1 by 6 inch bars to the tie girder web and the hanger diaphragm were fabricated using shielded metal arc welding (SMAW) and have rough unfinished reinforcements which makes ultrasonic inspection very difficult to perform. The welds were supposed to have been full penetration and both visual as well as ultrasonic inspection indicate that this is not true.

loading during the tests included many large and obviously heavy loads. A wide range of environmental conditions were encountered including high gusty winds and temperatures ranging from 37 degrees F. to 80 degrees F. Test results are summarized in Table 1 below. These results show no detectable crack activity at any of the test sites and very low live strains. These test results imply that some other mechanism besides fatigue is responsible for the visible cracks.

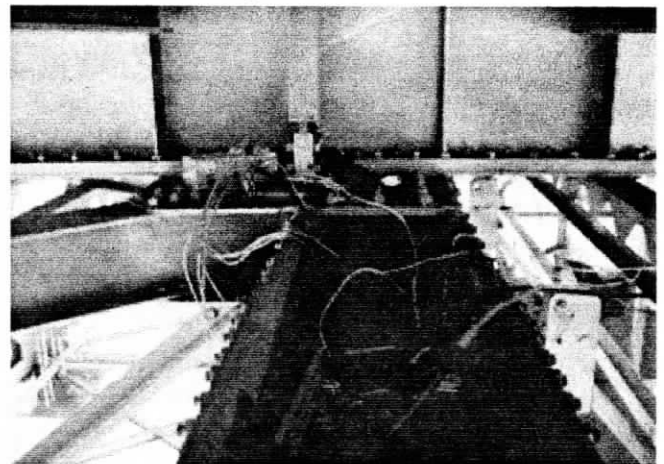
Figure 3 Typical Crack Site

location U14, top. This crack was approximately 3/4 inch long. The test results are summarized in Table 2 below.

The U14 Flaw indications were at the end of the weld and near its midpoint. The AE indications coupled with relatively high live stresses indicates that this site (U14) has an active fatigue crack and should be closely watched.

The design uses built-up steel H-sections for the truss members and bolted connections. The steel H-sections were fabricated using T-1 and ASTM A242 plates. Stay plates were welded to the flanges of the H-sections at the joints of the truss members. Cracks have been detected in these welds. Subsequent retrofit was performed on these details that included removal of the ends of the cracked plates by coring and adding bolted doubler plates. A typical crack site is shown below in Figure 3.

We applied AE and strain gage monitoring to two of these crack sites. The first site was located in span 7 of the west truss at location L11, bottom plate. This crack was approximately 1/2 inch long. The second test site was located in span 5 of the west truss at

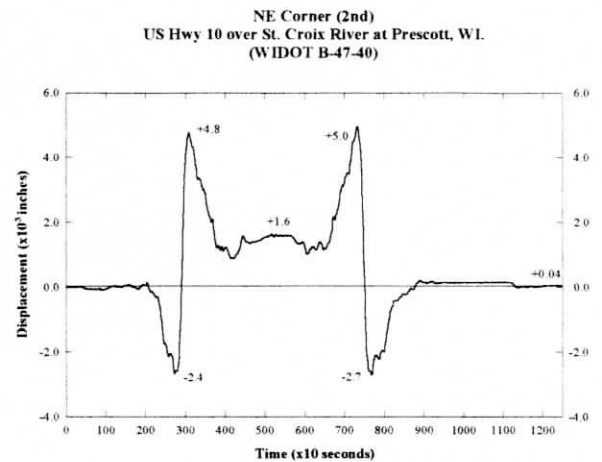
Figure 5 Typical Laser Gage Plot

The laser displacement gage (Aeromat LM300) had source and target mounted on opposite sides of the casting to girder interface and aligned parallel to this interface. It allowed us to observe the elastic deformation of the casting under dynamic loading conditions during bridge open and closure and was easily capable of detecting slippage of the casting. The shape and symmetry of both the laser gage and the strain gage data agreed well and the laser gage showed no appreciable slippage between the girder flange and the casting following a complete bridge operating cycle. A typical laser gage plot is shown in Figure 5. The laser gage typically showed some offset when the bridge was at the maximum opening point (mid-range). The gage was mounted on the center casting in all tests. We believe the offset observed at the bridge up position is the result of load sharing between the castings that is fostered by the wedges applied between castings. These test results indicate that under current operating conditions the segmental casting attachments on the Prescott

bridge (B-47-40) exhibit no abnormal behavior as evidenced by AE, strain gage, and laser displacement testing. However, future re-testing would be prudent based on past experience with this design.
