TECHNICAL REPORT 0-6804-2
TXDOT PROJECT NUMBER 0-6804

Analysis of Lightweight Transparent Noise Barriers on IH-30 Elevated Structures in Dallas, Texas

Dr. Manuel Trevino

August 2018; Published June 2019

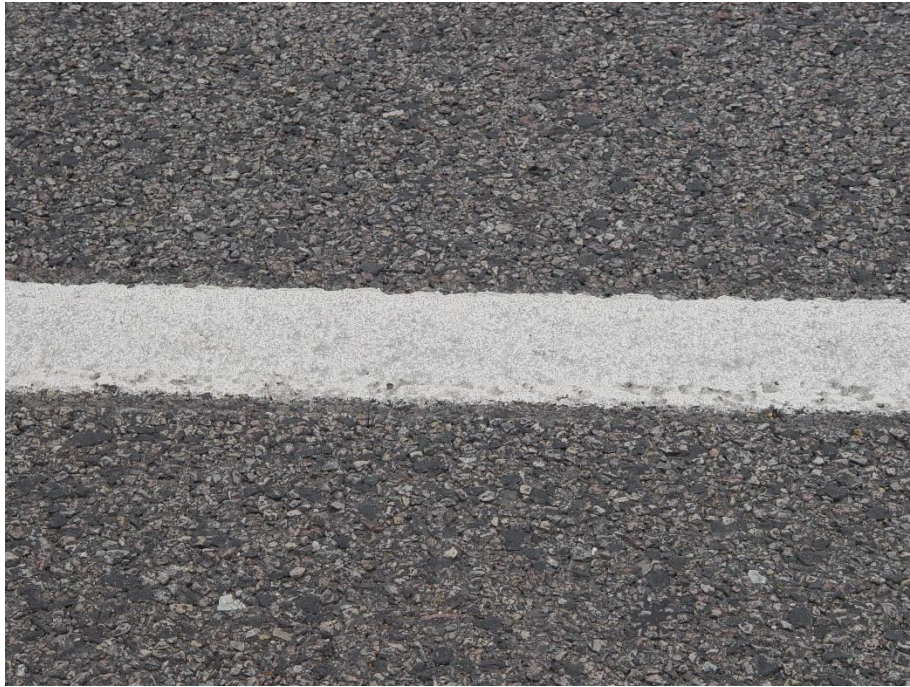
Unfortunately, this type of pavement tends to lose its acoustic benefits over time, as its void content diminishes due to clogging and compaction. Clogging occurs when debris from the road fills the original pores that make these pavements quieter, while compaction under heavy traffic loading has a similar effect of reducing the voids over time. The degradation of the acoustical properties of PFC pavement surfaces over time is documented in the literature (Arambula 2013, Smit 2016). Figures 3.24 to 3.26 illustrate this

degradation of the PFCs, showing how the pavements look similar to dense-graded asphalt surfaces after clogging and compaction have decreased their void content.

Figure 3.24: 2006 PFC in April 2011

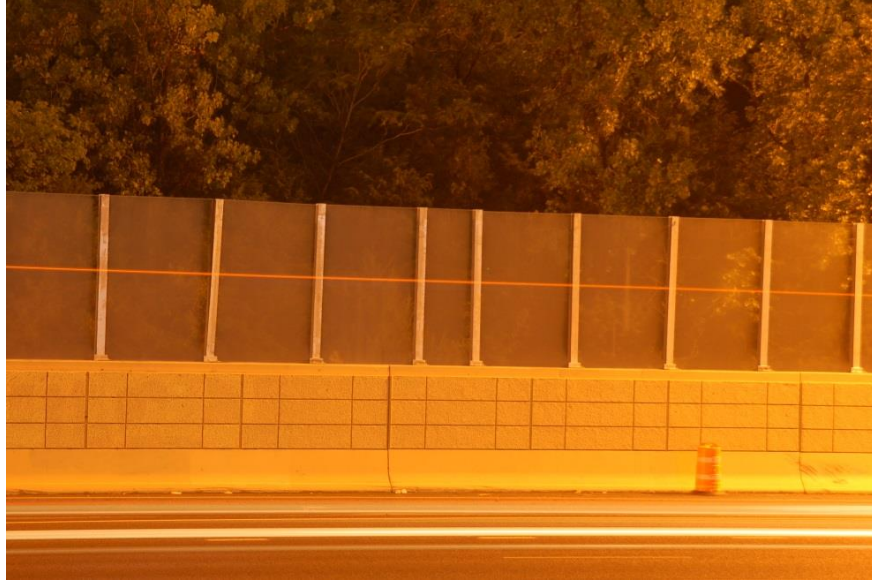
Figure 8.9: Some vertical supports off-plumb

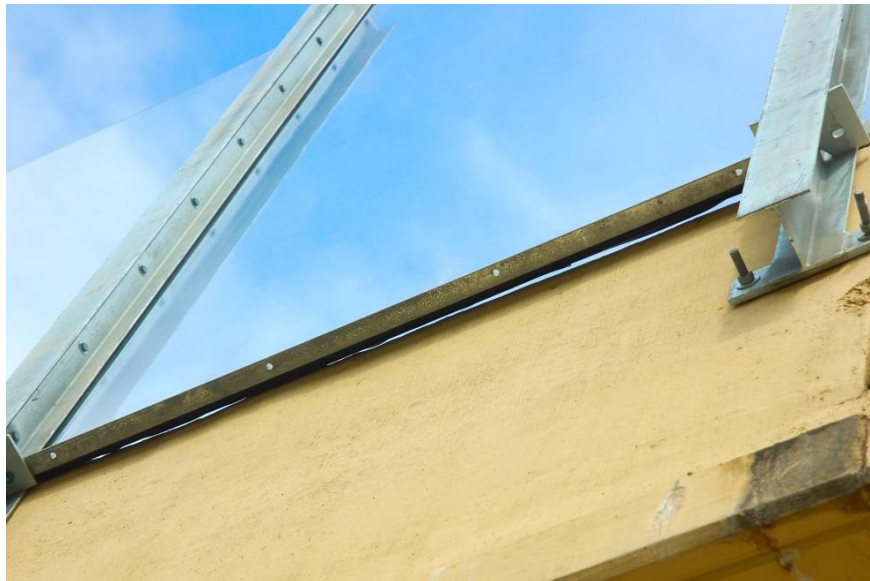
Figure 8.13: Gap between horizontal gasket and metal support

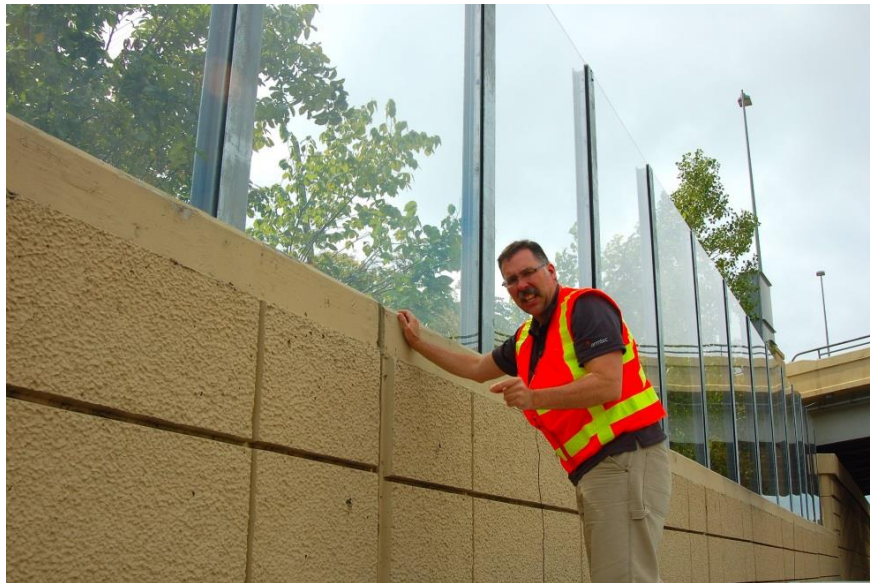
Figure 8.14: Armtec's Mark McIlheran inspecting the wall, showing the gap size between a panel and the gasket

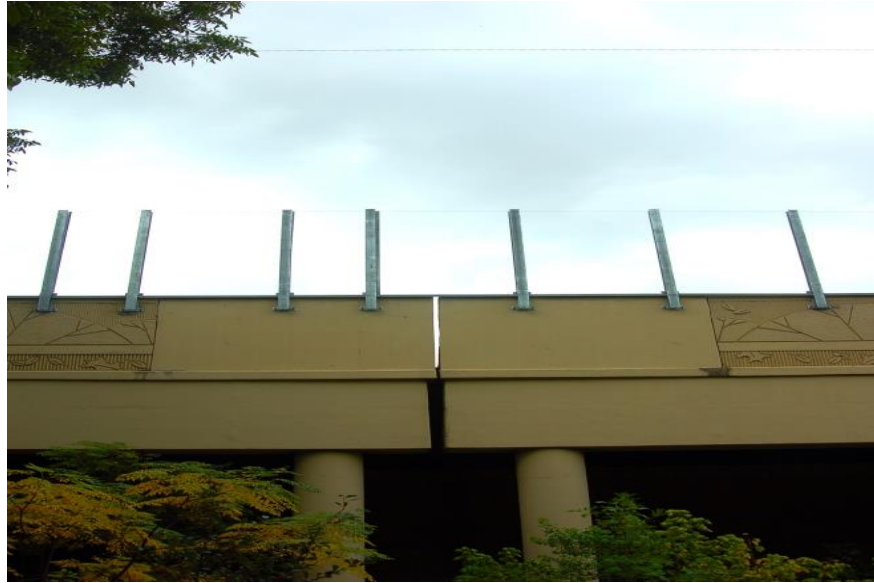
Figure 8.15: Gap in existing concrete wall at bridge expansion joint as seen from Coombs Creek

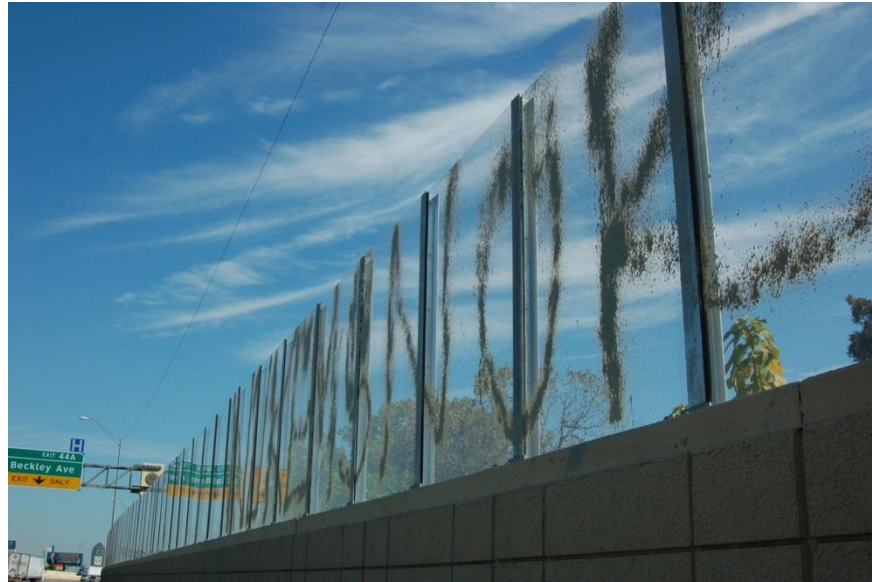
Figure 8.17: Graffiti as seen from the highway shoulder on November 11, 2013

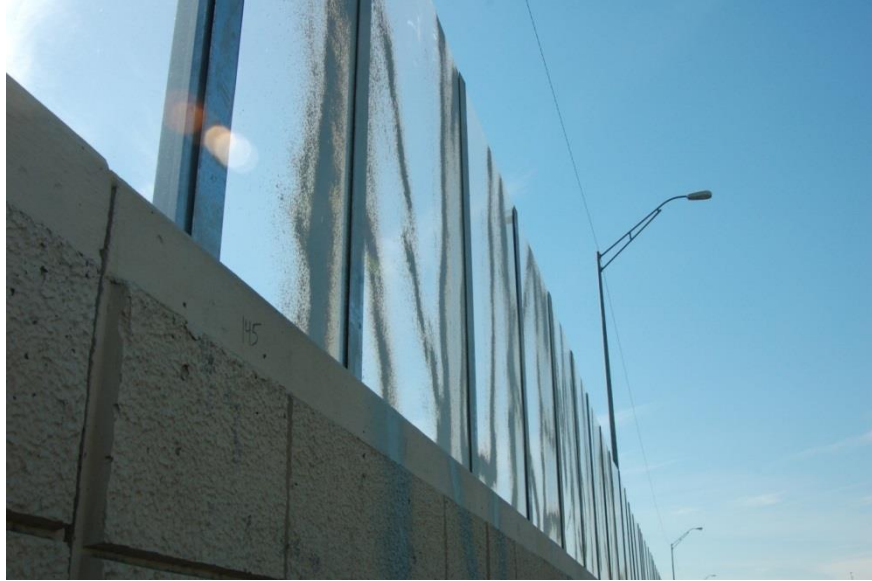
Figure 8.19: Graffiti as seen from the highway shoulder on November 11, 2013. The damage extends to the concrete wall under span #144.

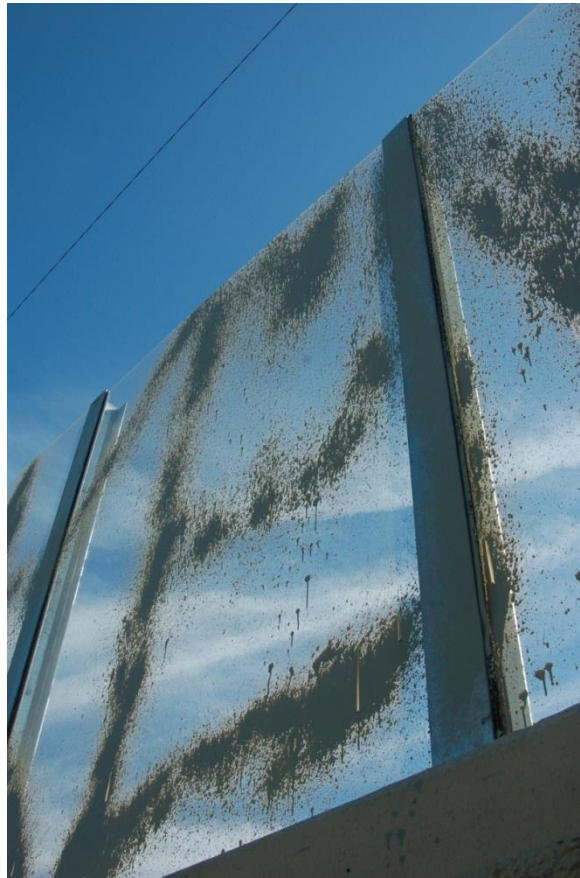
Figure 8.20: Graffiti as seen from the highway shoulder on November 11, 2013

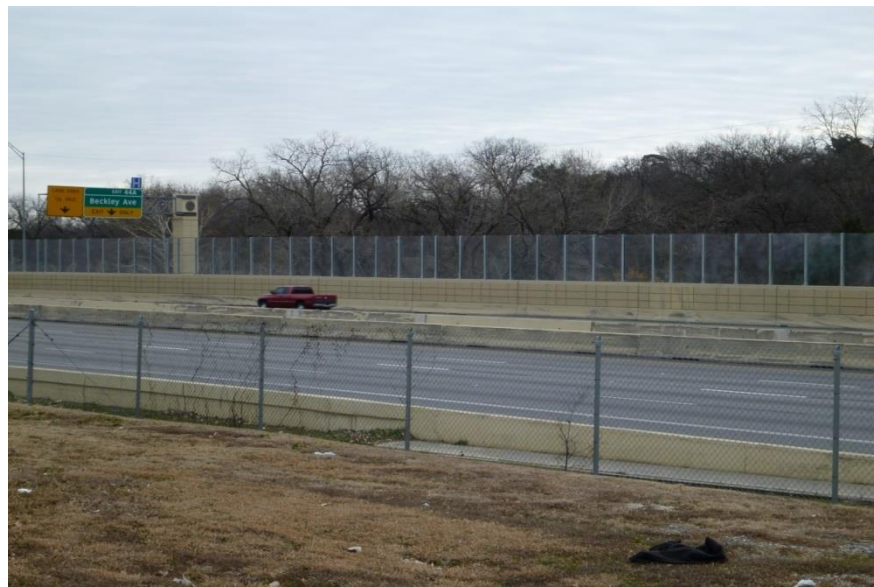
Figure 8.27: Graffiti removed from acrylic panels

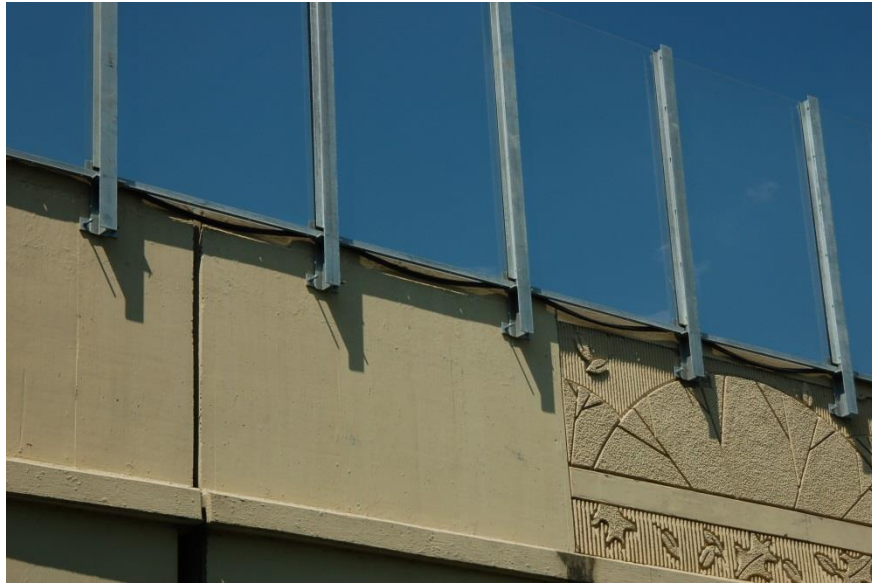
Figure 8.28: Sagging of horizontal rubber gaskets

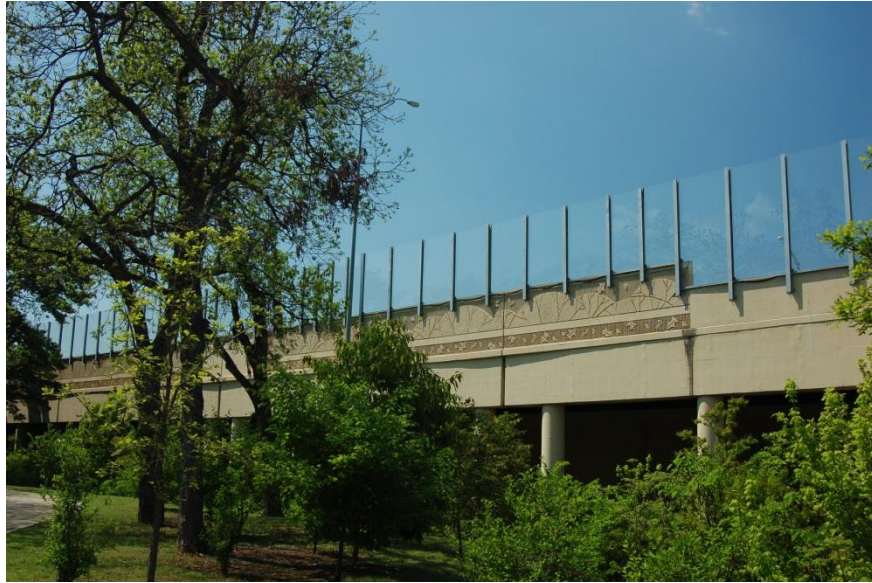
Figure 8.31: Sagging of horizontal rubber gaskets

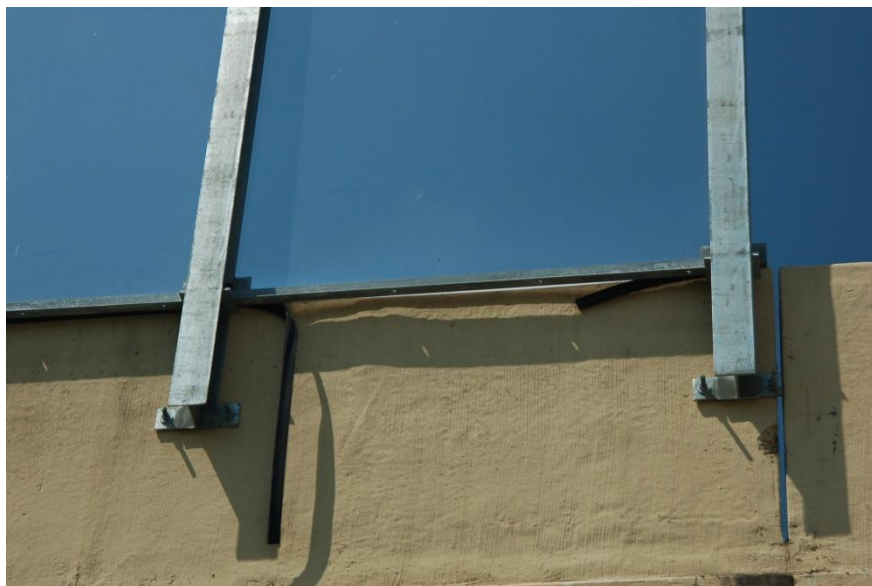
Figure 8.32: Broken horizontal rubber gasket

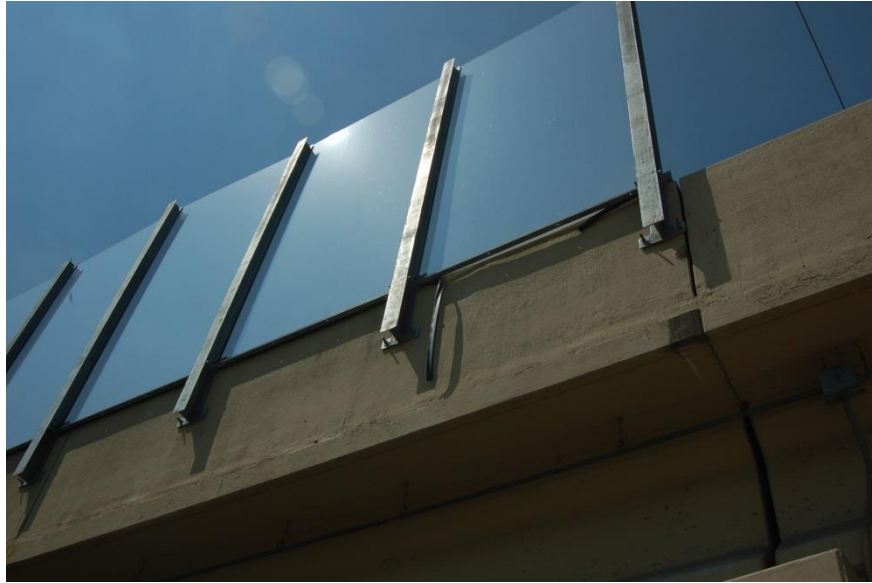
Figure 8.33: Broken horizontal rubber gasket

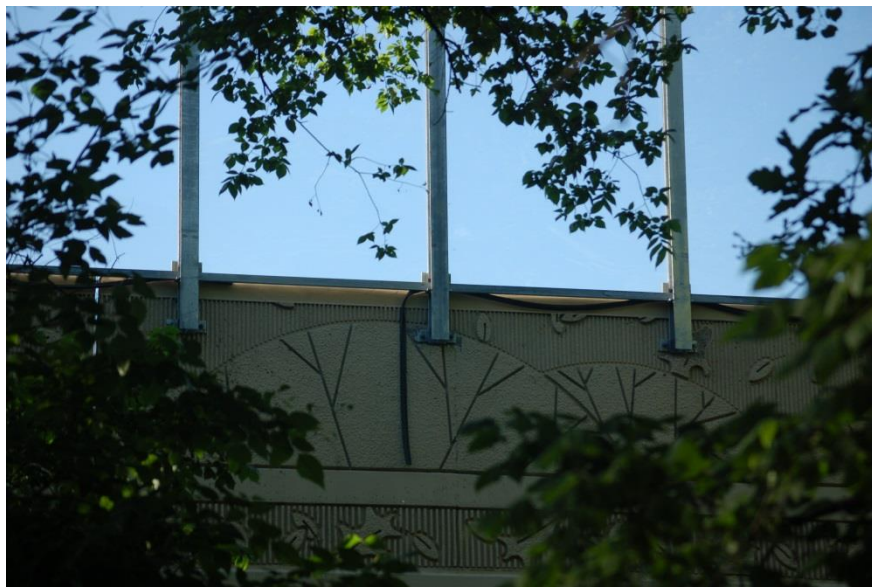
Figure 8.34: Broken horizontal rubber gasket

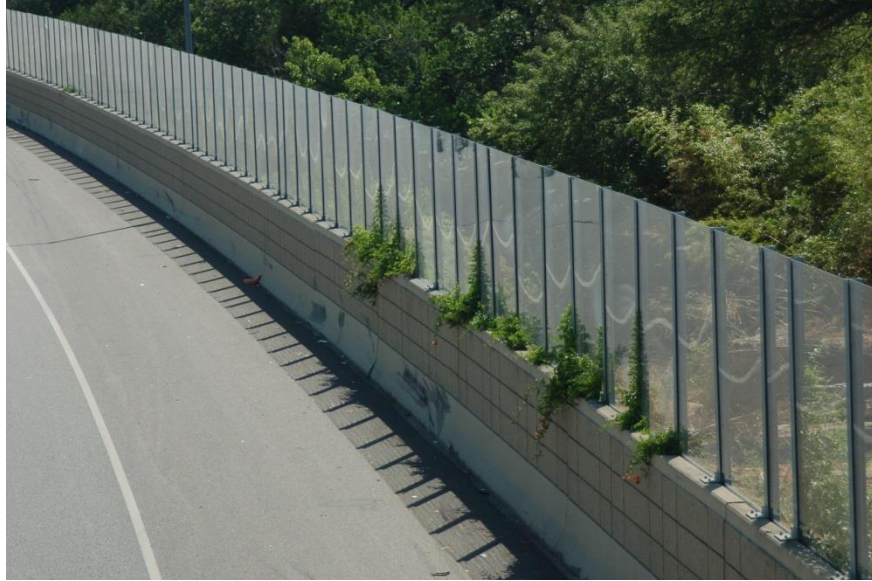
Figure 8.35: Vegetation from the creek side growing through the openings in the gaskets under noise barrier

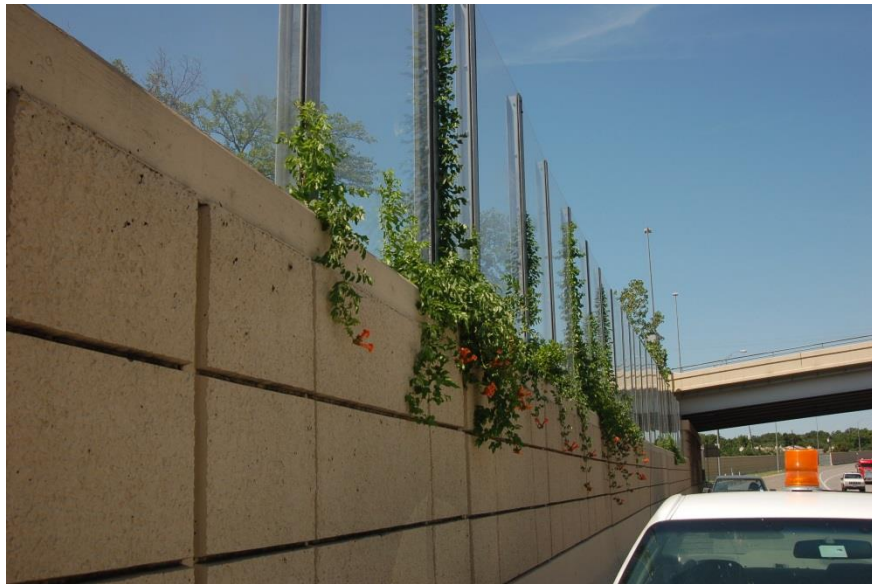
Figure 8.36: Vegetation from the creek side growing through the openings in the gaskets under noise barrier

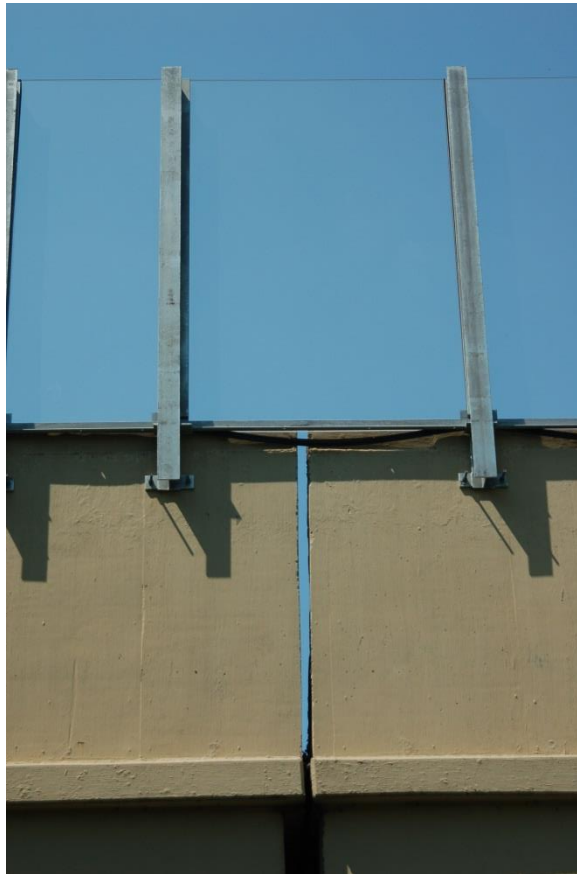
Figure 8.37: Expansion joint opening due to lack of sealant

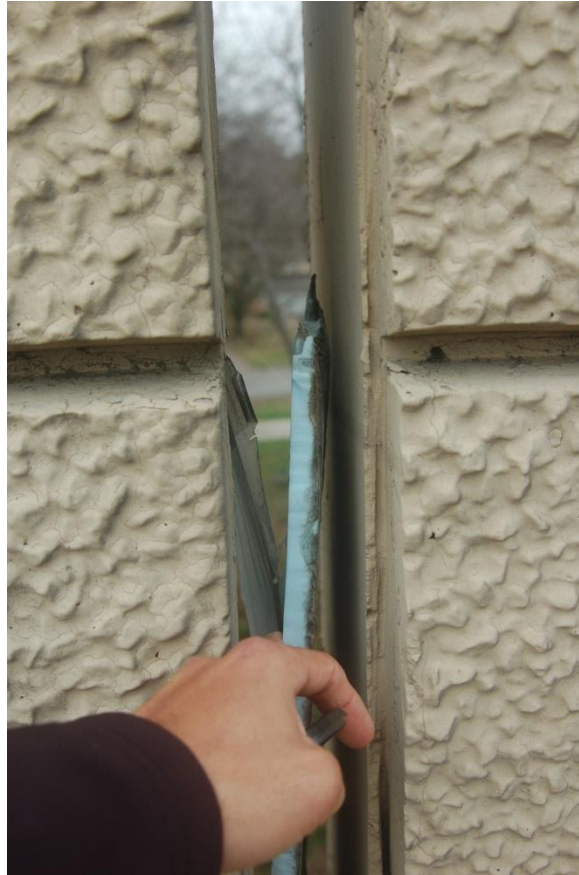
Figure 8.38: Damaged, old sealant material in the expansion joints of bridge structure

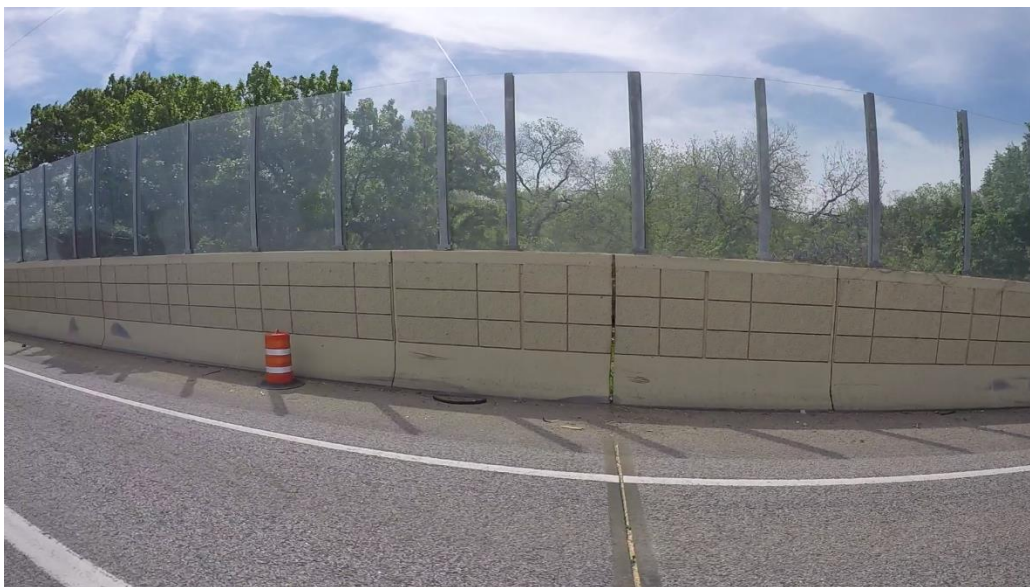
Figure 8.39: Open joint seen from the eastbound main lanes

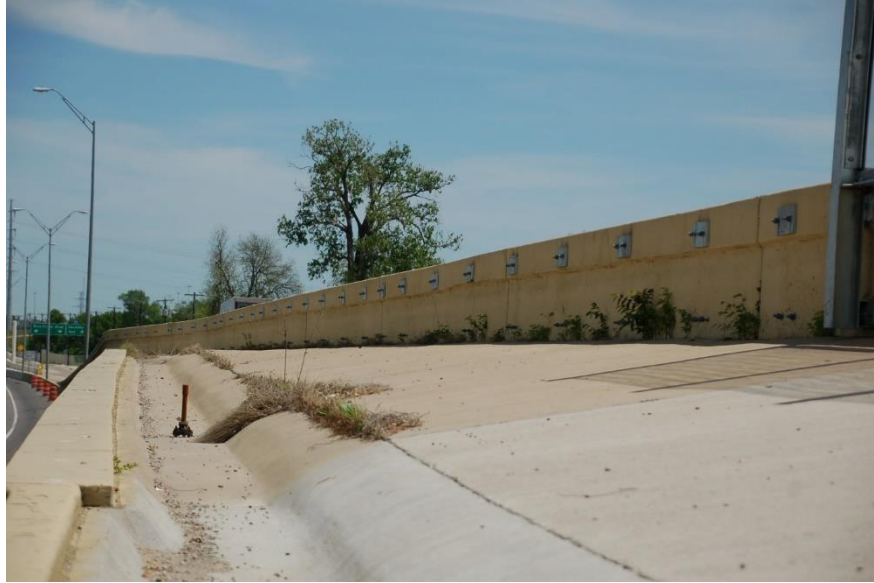
Figure 9.19: Vertical posts were removed in April to fix design problem (April 2018)

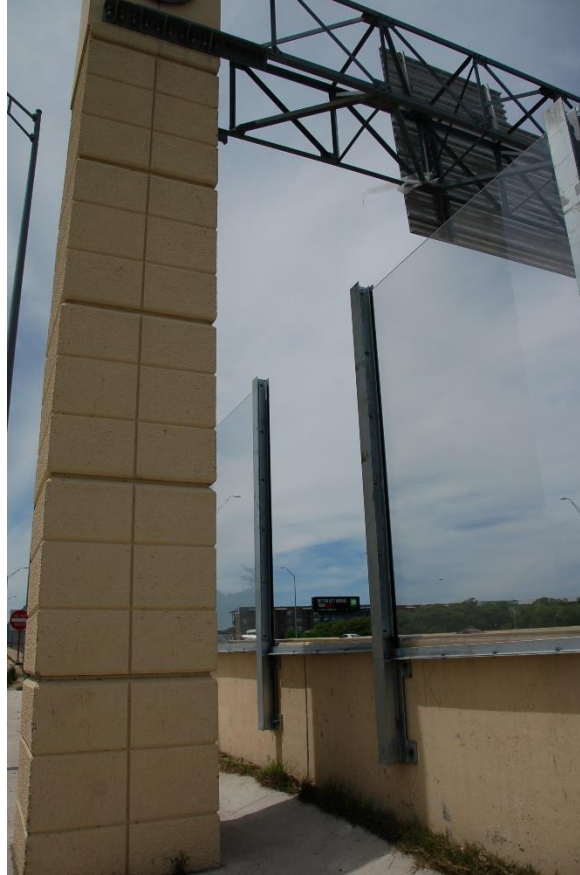
Figure 9.26: Missing panel under cantilever highway sign seen from behind the wall

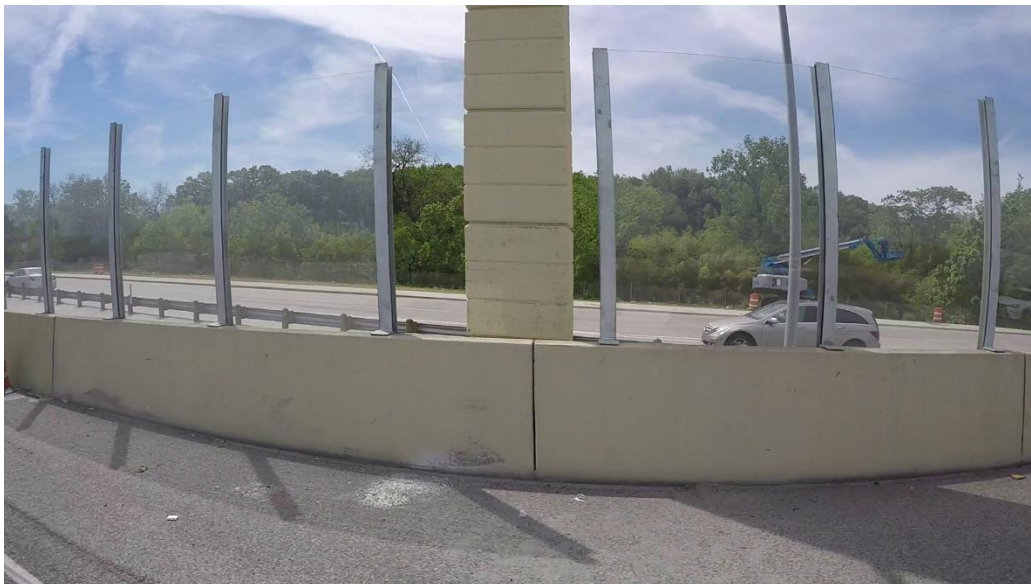
Figure 9.27: Missing panel under cantilever highway sign seen from the main lanes

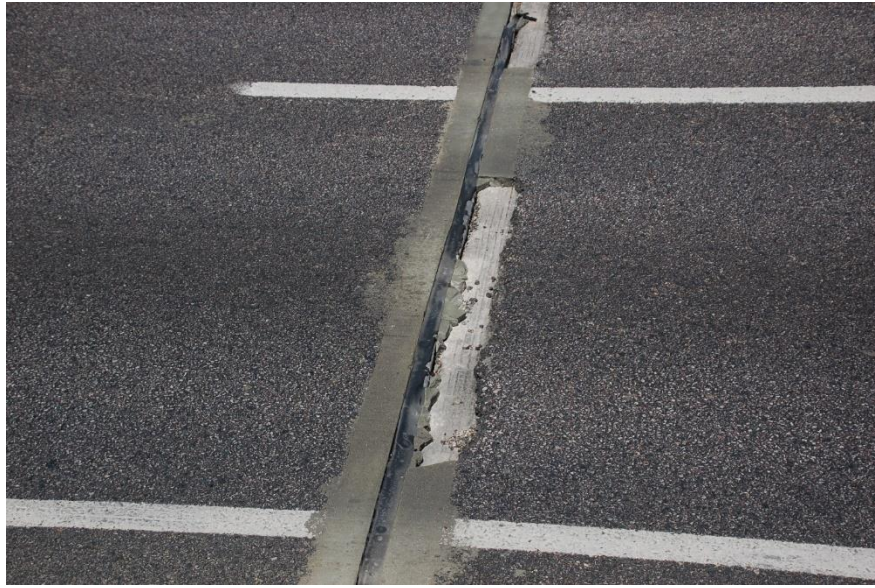
Figure 9.41: Open, damaged expansion joint in the pavement, eastbound outside lane (April 2018)

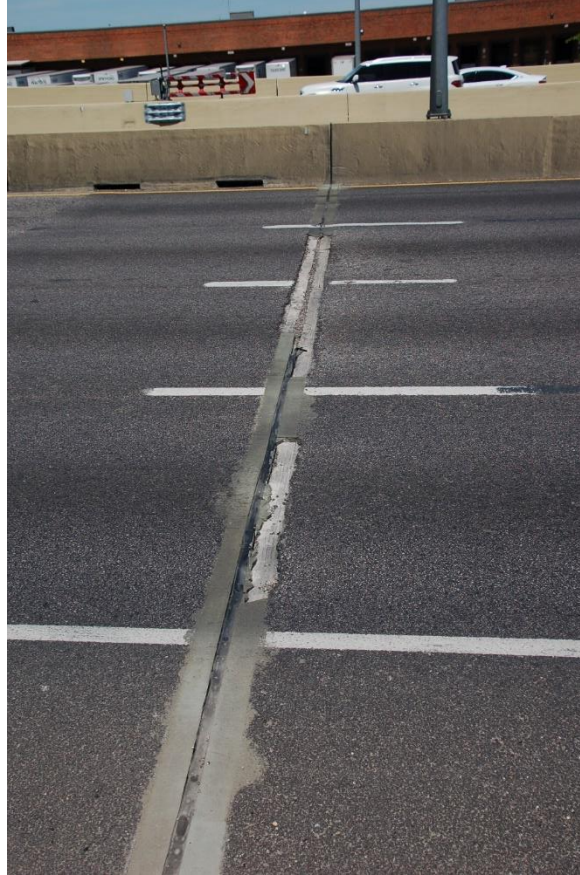
Figure 9.42: Open, damaged expansion joint in the pavement, main lanes (April 2018)

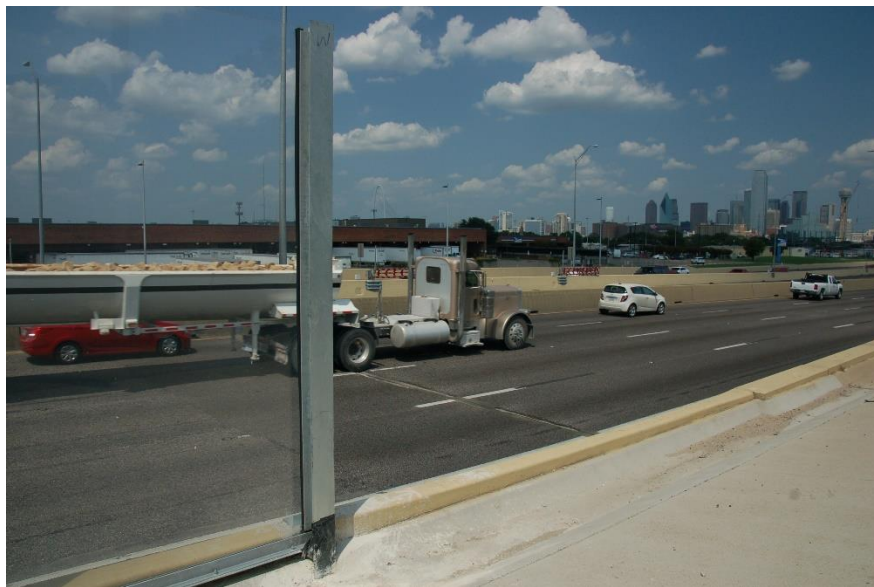
Figure 9.43: Location of the open joint in relation to the end of Segment 2
