MASH TEST NO. 3-10 OF A NON-PROPRIETARY, HIGH-TENSION, CABLE MEDIAN BARRIER FOR USE IN 6H:1V V-DITCH (TEST NO. MWP-9)

MIDWEST ROADSIDE SAFETY FACILITY

MwRSF Research Report No. TRP-03-360-18

March 30, 2018

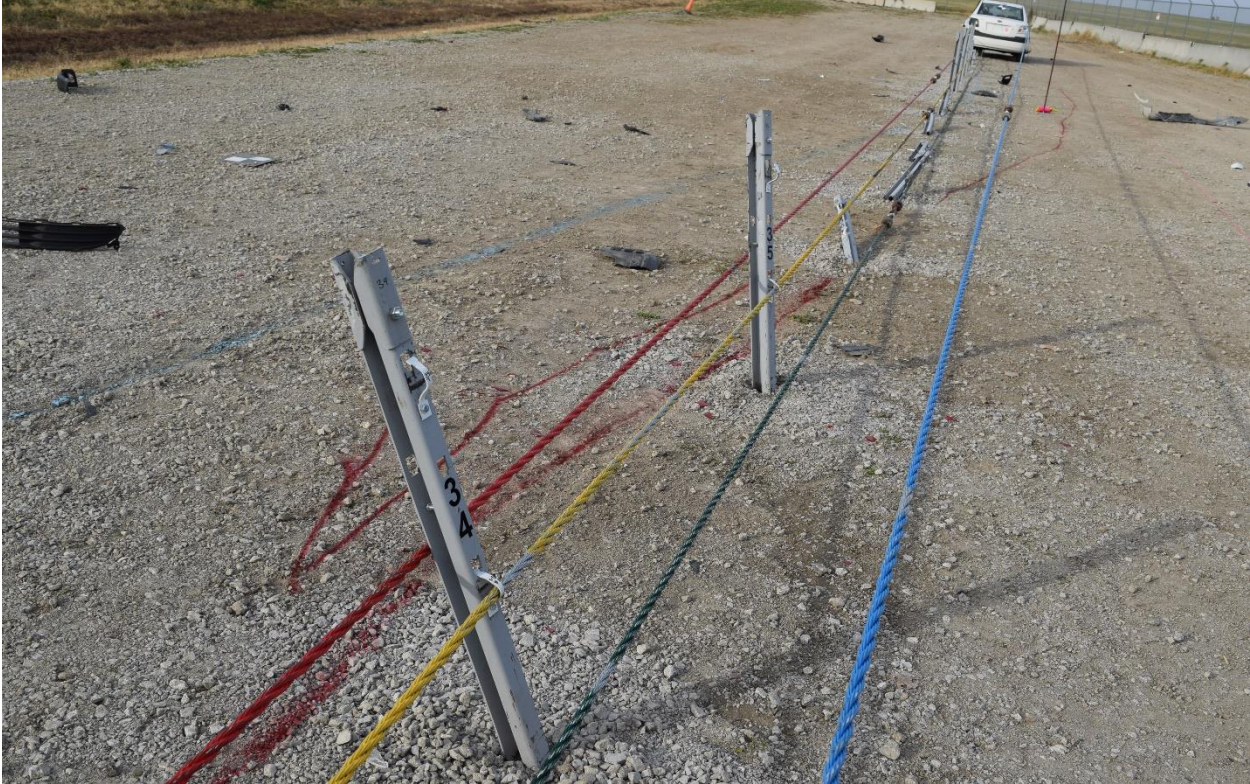
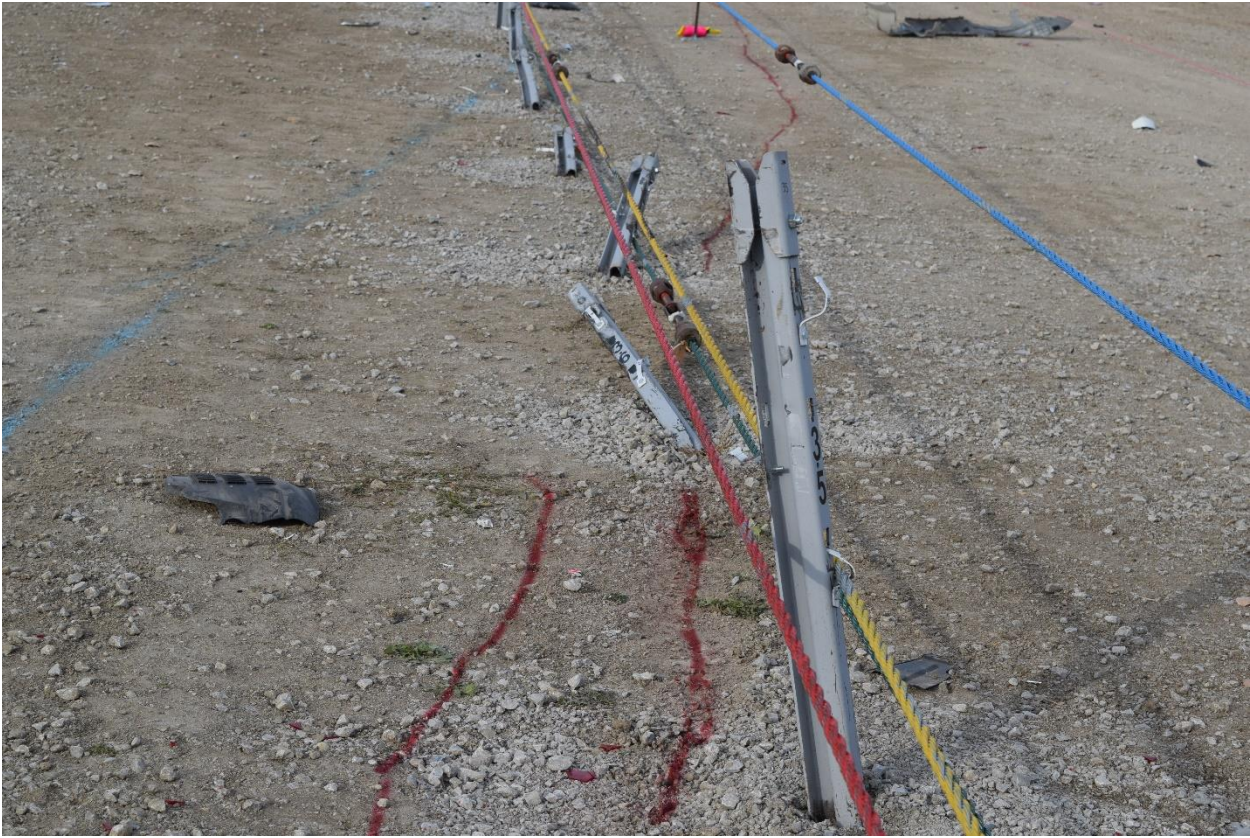
Figure 49. System Damage, Test No. MWP-9

Damage to the barrier was moderate, as shown in Figures 49 through 85. Barrier damage consisted of bent posts, disengaged cables, and deformed brackets. At its final resting position, the vehicle was still in contact with the cables. Cable nos. 1 and 3 were underneath the vehicle while cable no. 4 was on the non-impact side of the vehicle and cable no. 2 was on the impact side of the vehicle. The length of vehicle contact along the barrier was approximately 150 ft – 2 in. (45.77 m), which spanned from 3 ft – 10 in. (1.17 m) upstream of post no. 31 to between post nos. 48 and 49. The release mechanism of each cable from the posts is summarized in Table 5.

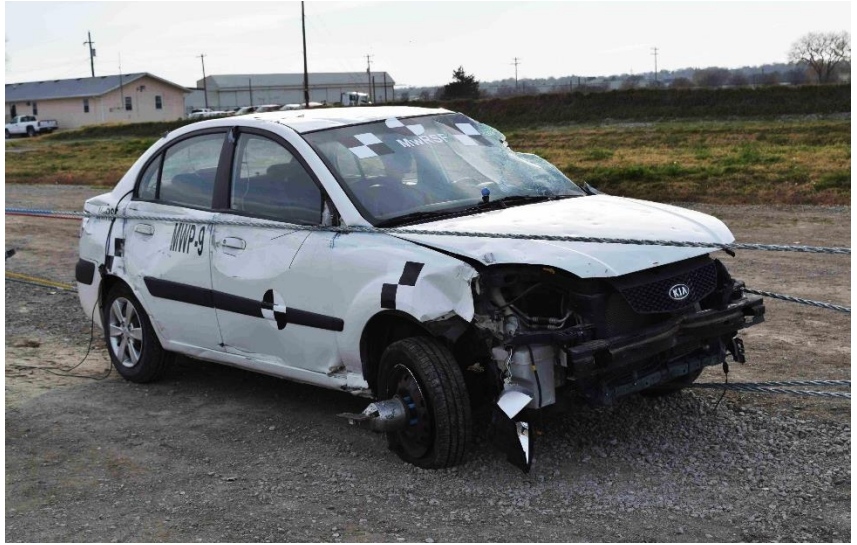
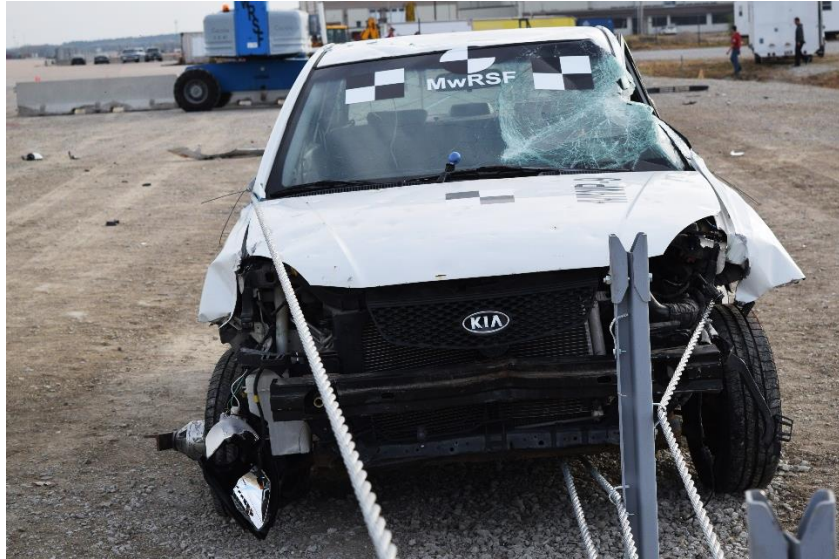
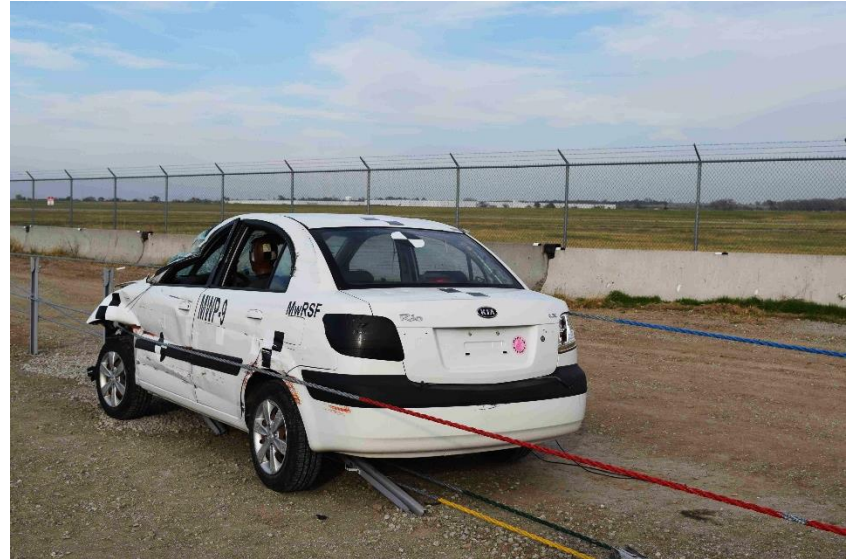
Figure 86. Vehicle Damage, Test No. MWP-9

The damage to the vehicle was moderate, as shown in Figures 86 through 88. The maximum occupant compartment deformations are listed in Table 6 along with the deformation limits established in MASH 2016 for various areas of the occupant compartment. Complete occupant compartment and vehicle deformations as well as the corresponding locations are provided in Appendix D.

The majority of the vehicle damage was concentrated on the left-front corner, where primary impact occurred, and on the right-front corner, where the vehicle redirected back into the system. The cables caused striation marks, scrapes, and gouges along the left-front and right-front fenders and up the entire length of the A-pillar, B-pillar, and C-pillar on the left side of the vehicle. As the vehicle overrode the system, cable no. 3 snagged on the cap retainer bolt and nut and induced an increased downward and lateral force to the A-pillar. Consequently, cable nos. 3 and 4 became interlocked with the A-pillar on the impact side, resulting in an excessive A-pillar crush of 3.4 in. (86 mm), which is greater than the 3-in. (76-mm) MASH 2016 limit. Contact marks were also found on the roof, which were caused by the vehicle underriding cable nos. 3 and 4. The front bumper covers, both headlights, and both side mirrors disengaged from the vehicle. The left-front side window and windshield shattered on the left side of the vehicle near the A-pillar. The left-front rim had contact marks, and the right-front tire was deflated. Several scrapes and dents were observed along both frame rails of the vehicle undercarriage. However, no visible tearing or crush on the vehicle floor pan occurred.

As a result of the unsuccessful 1100C crash test, the prototype, high-tension, four-cable, median barrier system will need to be further redesigned to prevent the excessive A-pillar crush observed in test no. MWP-9. Possible design changes may include, but are not limited to, the use of closed-section posts, reduction of weak-axis bending strength at groundline, alternative treatment of post edges, and changes to post geometry. After the cable barrier system has been redesigned, it will need to be re-evaluated according to MASH 2016 test designation no. 3-10 criteria before proceeding with the remaining tests listed within the recommended testing matrix for cable barriers installed within median V-ditches. Depending on the nature of the design changes, it may be necessary to evaluate whether prior successful crash tests need to be rerun.
