PHASE II EVALUATION OF FLOOR PAN TEARING FOR CABLE BARRIER SYSTEMS

MwRSF Research Report No. TRP-03-359-18

March 30, 2018

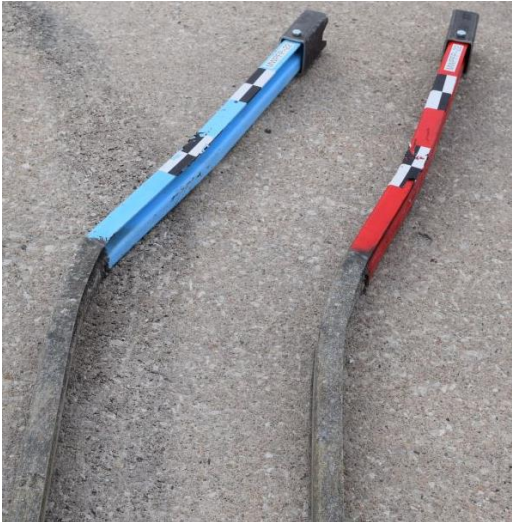
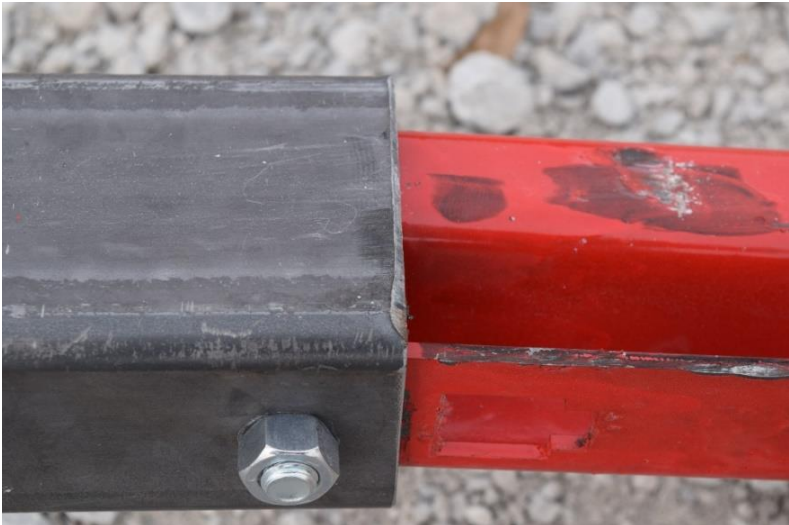
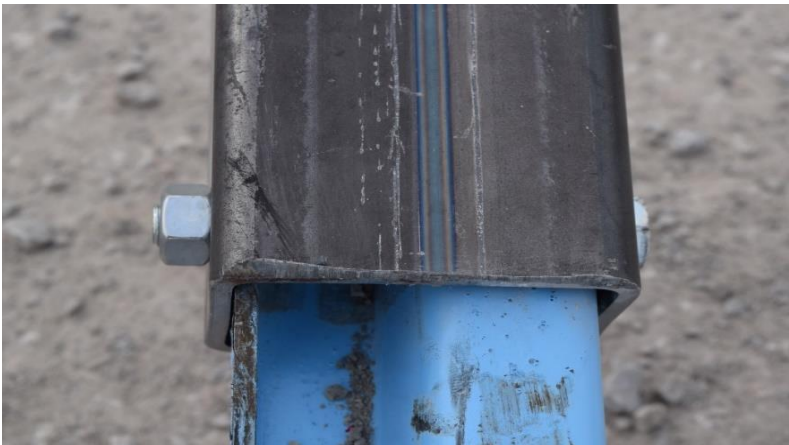
The posts were bent plastically near the ground line, and tearing was found in both posts, as shown in Figure 25. The tears initiated from the weakening holes on the impact side of the posts and extended into the webs and adjacent flanges. Contact marks were found on the top half of the posts and on the steel tube cap. The top corners of both posts left creasing on the bottom side of the simulated floor pan. Creasing was found in both the front and rear bays of the simulated floor pan, as shown in Figure 26. The cap used in test no. MWPF22 was not as tight of a fit as desired due to the use of a standard HSS tube size that was available. Consequently, extensive snagging of the cap on the underside of the bogie vehicle occurred during test no. MWPF22.

Figure 25. Time-Sequential and Post-Impact Photographs, Test No. MWPF22

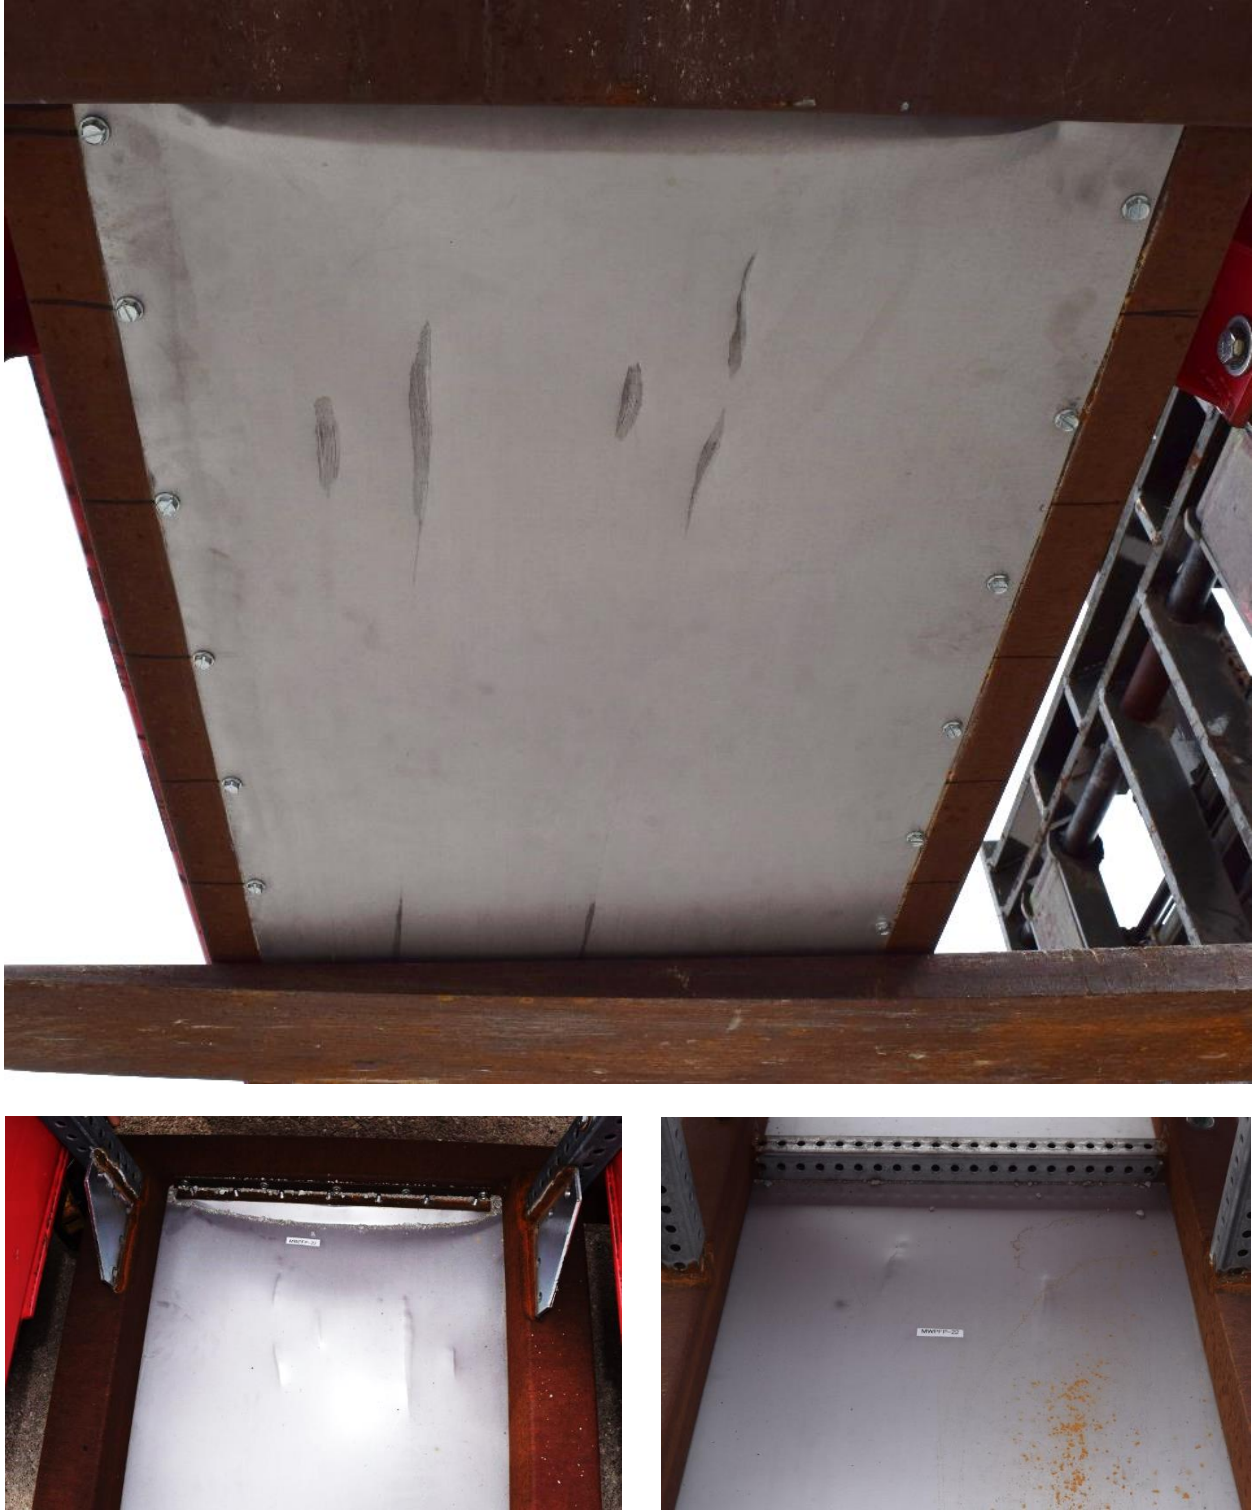
Figure 26. Simulated Floor Pan Damage, Test No. MWPFP-22

The first test, test no. MWPF22, was conducted on MWPs weakened with 3/4-in. (19-mm) diameter holes. The posts were oriented at 0 degrees with a 6-in. (152-mm) long, 3 1/2-in. x 2 1/2-in. x 3/16-in. (89-mm x 64-mm x 5-mm) thick steel tube cap affixed to the top of the posts to prevent tearing of vehicle undercarriage. During test no. MWPF22, the floor pan damage consisted of creasing, and post damage consisted of bending and tearing.

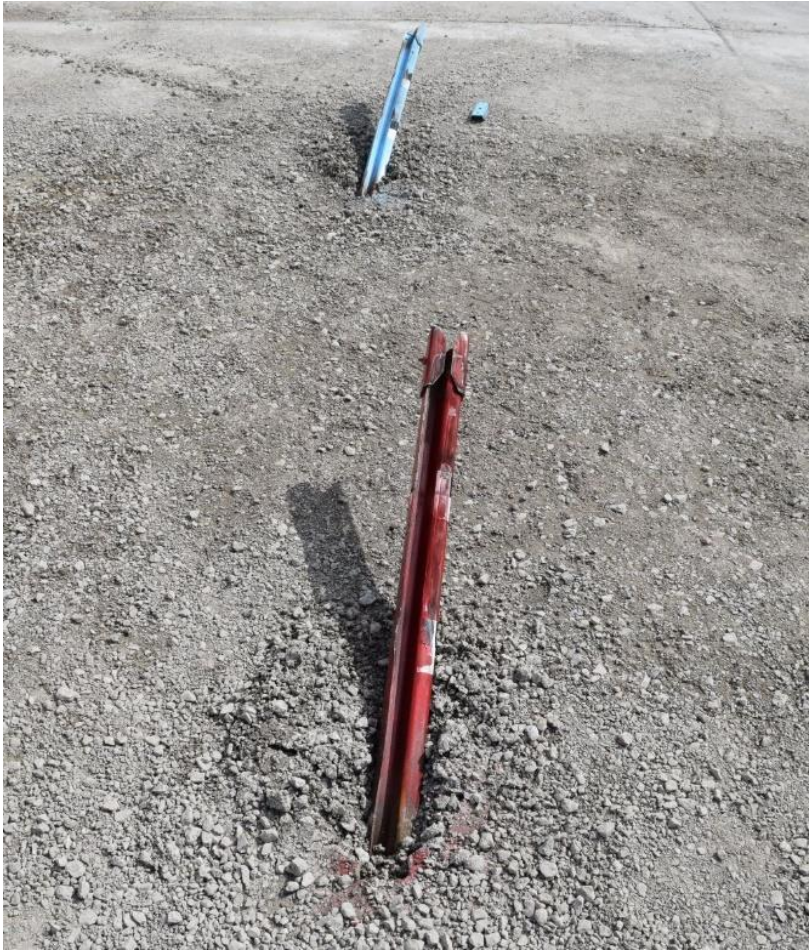
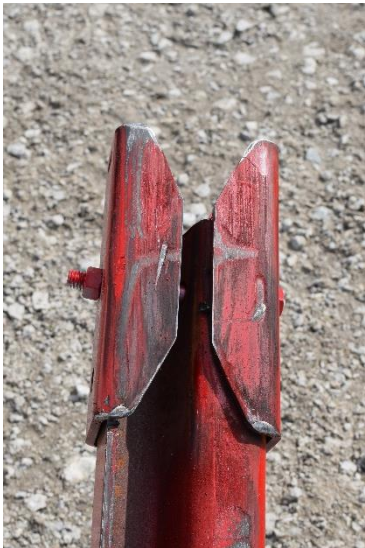
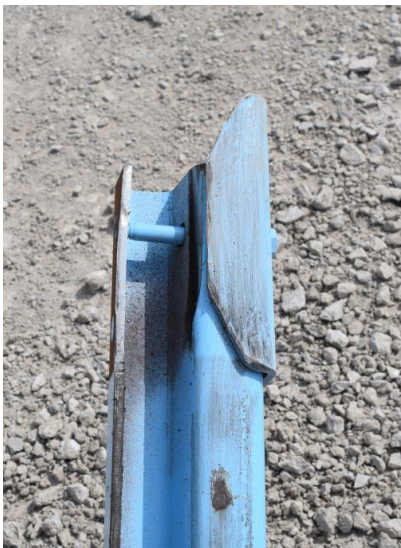
Sequential and post damage photographs are shown in Figure 28. The posts were bent plastically near the ground line, and the top corners of both posts left moderate creasing on the bottom of the simulated floor pan as well as tearing at the rear of the simulated floor pan. During test no. MWPF23, one side of the cap snagged on the underside of the bogie and the connection bolt sheared. After the cap disengaged and exposed the post edges, a tear formed in the simulated floorboard. The simulated floor pan damage is shown in Figure 29.

Figure 28. Time-Sequential and Post-Impact Photographs, Test No. MWPF23

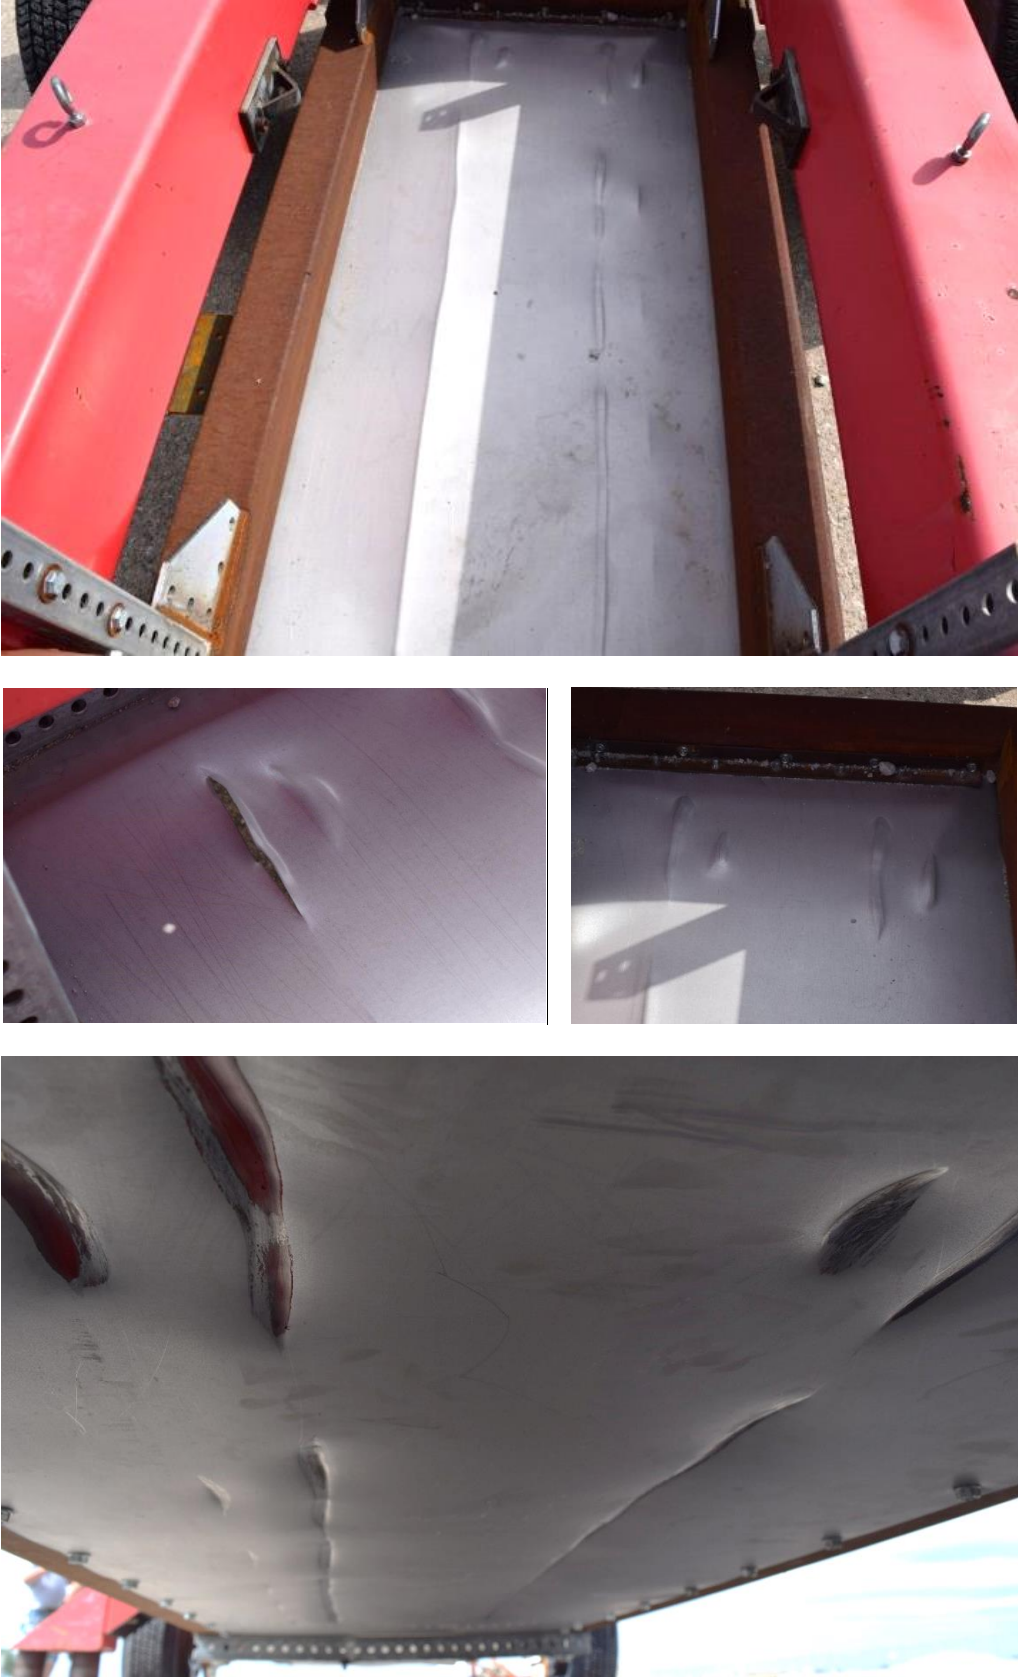
Figure 29. Simulated Floor Pan Damage, Test No. MWFPF-23

Test nos. MWPF23 and MWPF24 were conducted on MWPs with steel plate edge protectors mounted to the top of the posts. In test no. MWPF23, the posts were installed in an 18-in. (457-mm) diameter hole filled with MASH 2016 strong soil with a 0-degree orientation angle. In test no. MWPF24, the posts were installed in an 8-in. (203-mm) diameter rigid sleeve with a 0-degree orientation angle. In both tests, the edge protector connection bolt sheared and allowed the posts' free edges to contact the simulated floor pan. However, the edge protector disengagement caused floor pan tearing in only one test, test no. MWPF23.

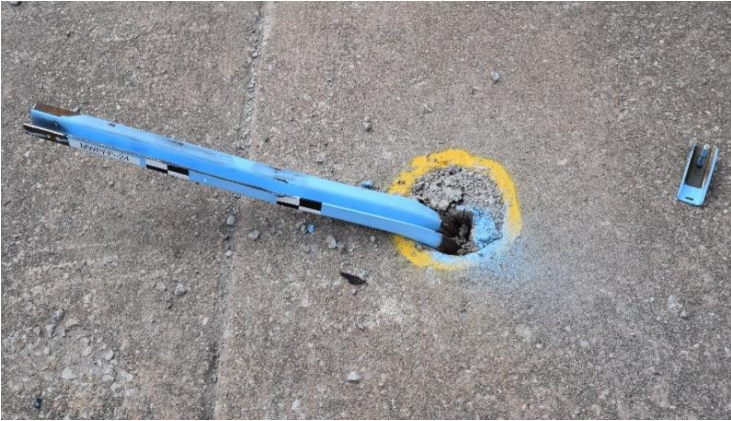
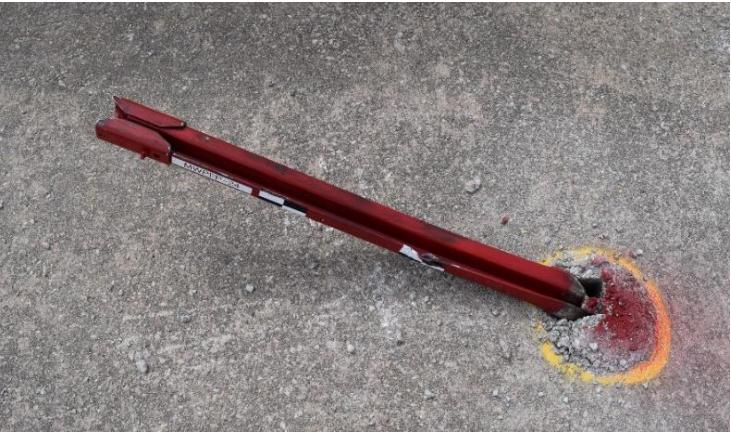
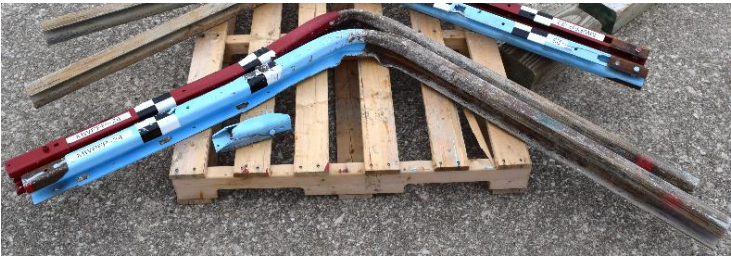
Sequential and post damage photographs are shown in Figure 31. The posts were bent plastically near the ground line, and the top corners of both posts left minor creasing on the bottom of the simulated floor pan, as shown in Figure 32. During the test, the edge protector retainer bolt for post no. 2 sheared upon impact with the second floor pan's horizontal member, which allowed both edge protectors to disengage. This disengagement allowed the posts' free edges to impact the bogie floor pan, but did not cause tearing.

Figure 31. Time-Sequential and Post-Impact Photographs, Test No. MWPF24

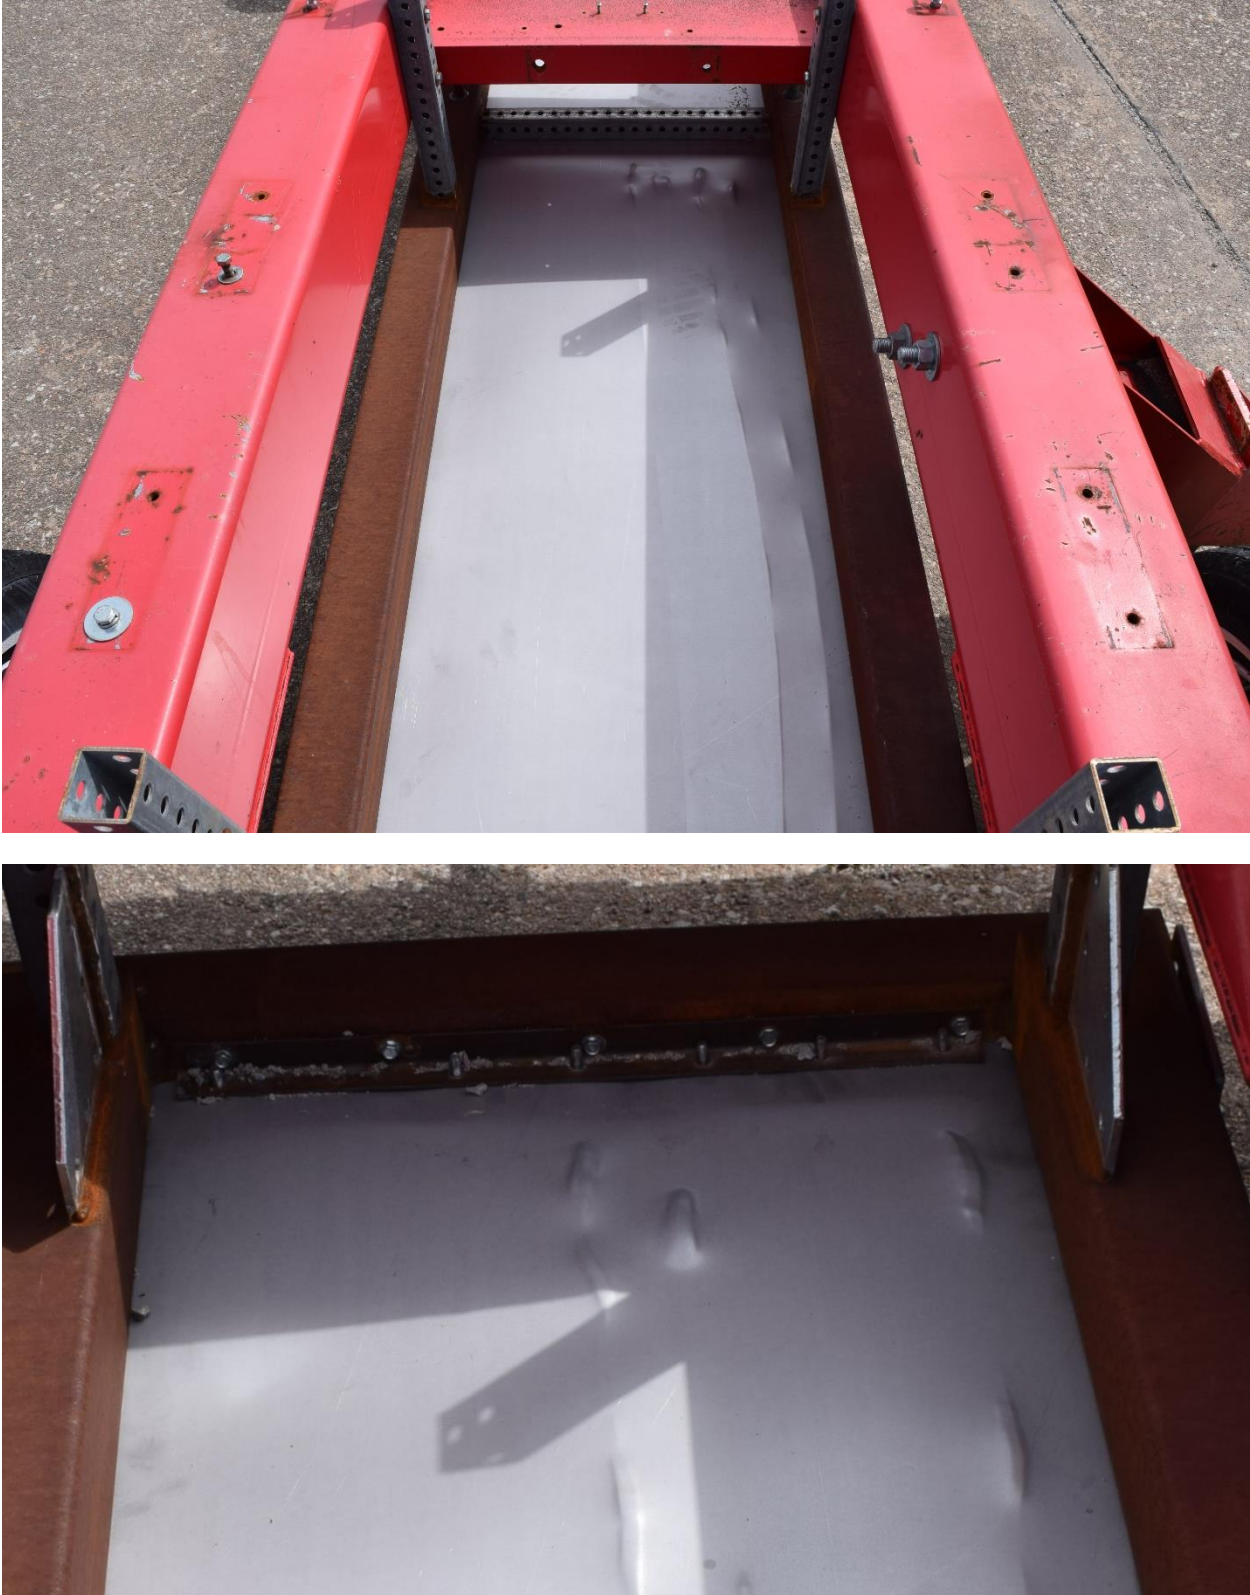
Figure 32. Simulated Floor Pan Damage, Test No. MWFPF-24

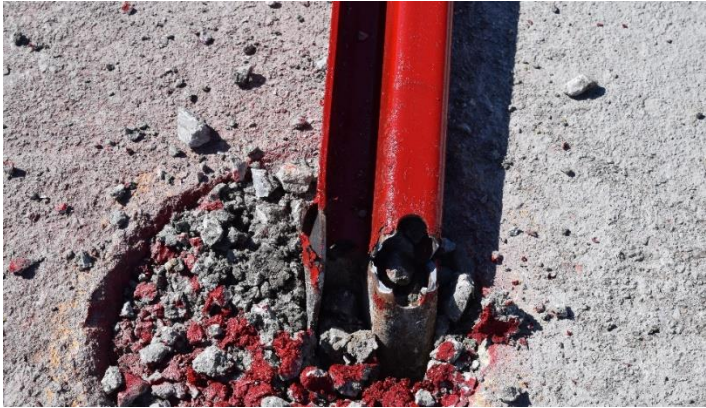
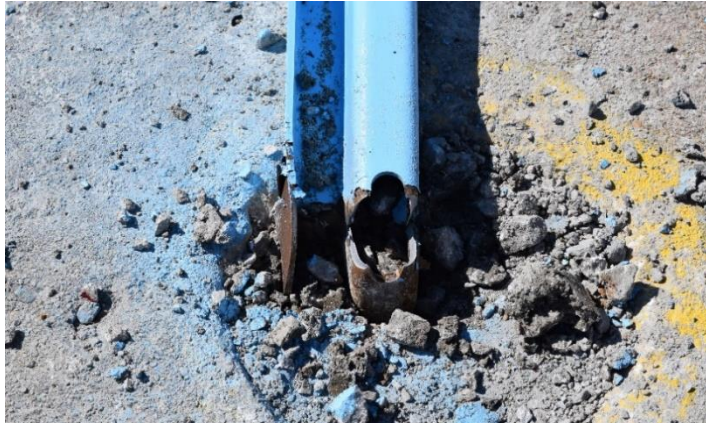
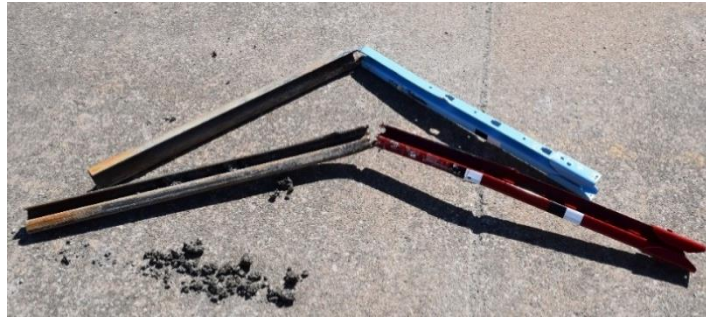
Sequential and post damage photographs are shown in Figure 34. The posts were bent plastically near the groundline, and tearing was found in both posts. The tears initiated from the weakening holes on the impact side of the posts and extended into the webs and adjacent flanges. The tears initiated from the weakening holes on the impact side of the posts and extended into the webs and adjacent flanges. Contact marks were found on the top half of the posts and on the edge protectors. Minor creasing was found in both the front and rear bays of the simulated floor pan, as shown in Figure 35. In test no. MWPF-25, minor snagging of the cap occurred on the underside of the bogie vehicle. Moreover, in reviewing the hardware after the test, the connection bolt had bent slightly.

Figure 34. Time-Sequential and Post-Impact Photographs, Test No. MWPF25

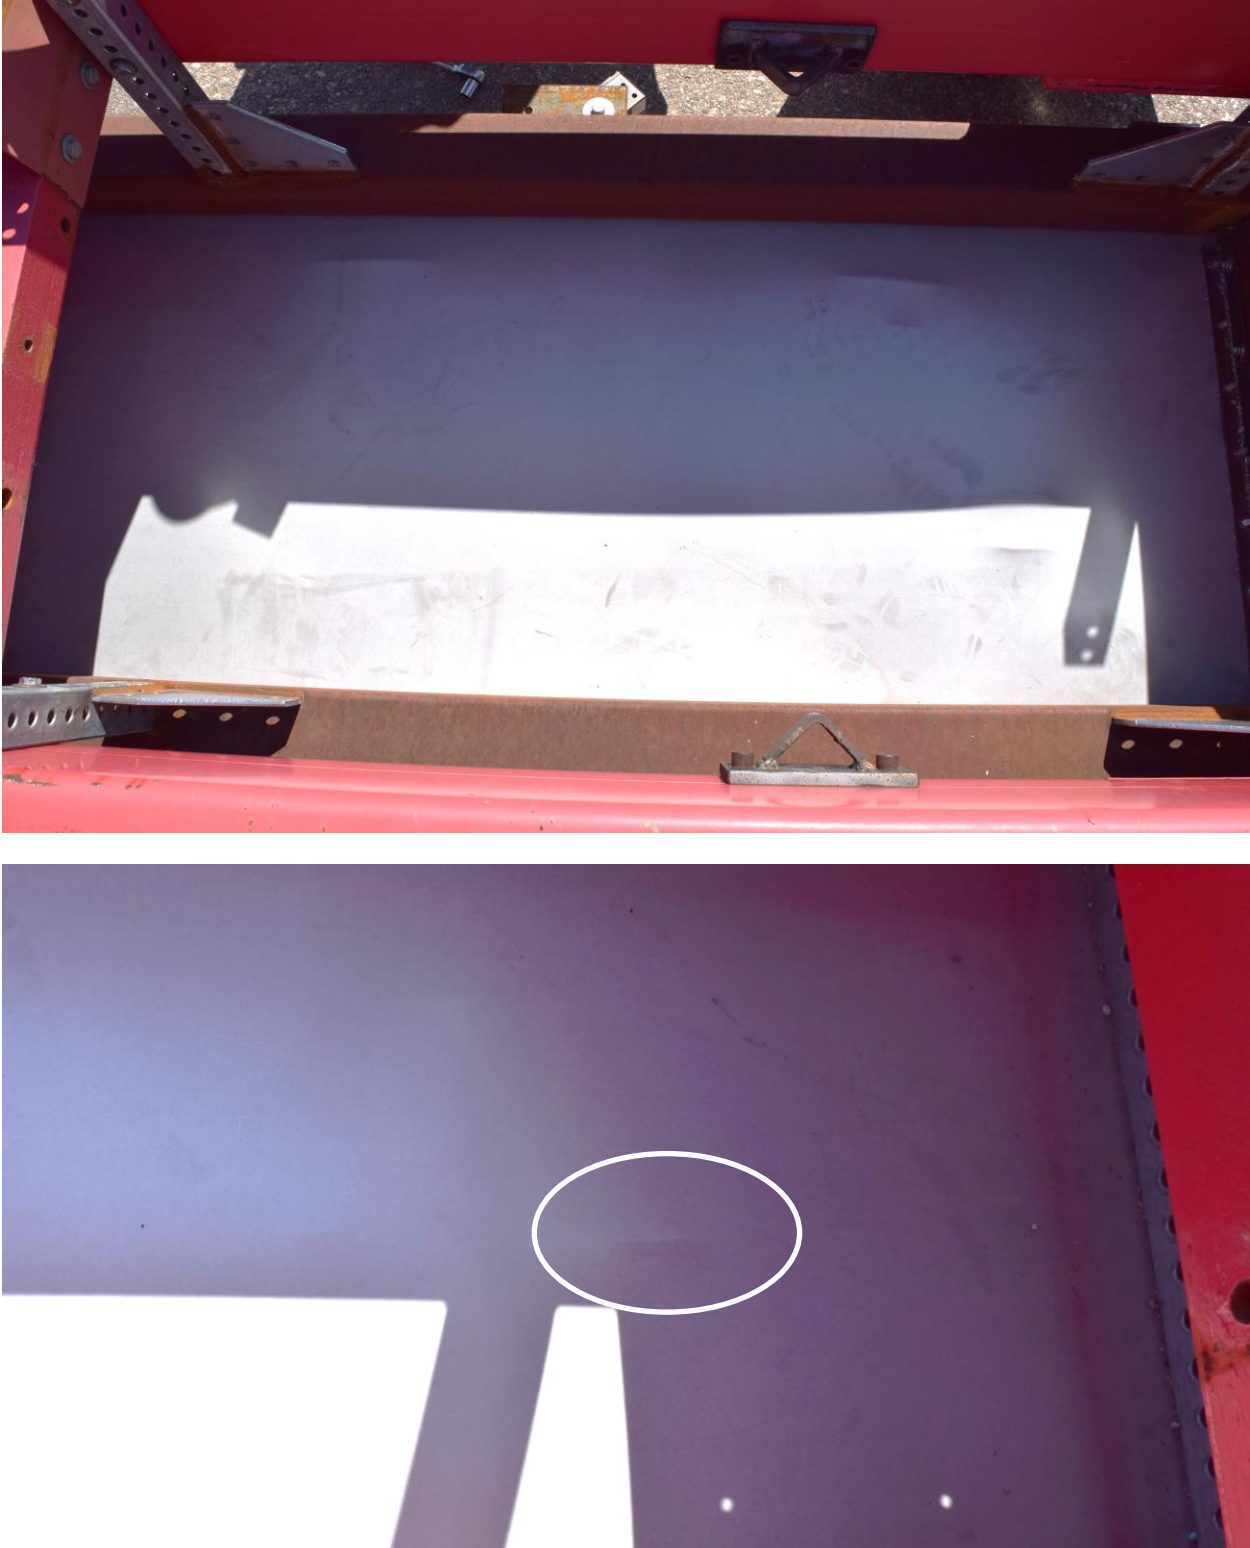
Figure 35. Simulated Floor Pan Damage, Test No. MWFPF-25

Test nos. MWPF25 and MWPF26 were conducted on MWPs with 3/4-in. (19-mm) diameter weakening holes at the groundline and edge protectors affixed to the top of the posts. In test no. MWPF25, the posts were oriented at 0 degrees, whereas in test no. MWPF26, the posts were oriented at -25 degrees. In both tests, the posts bent and tore at the groundline, and contact marks were found on the edge protectors. During both tests, the simulated floor pan was creased from the contact with the edge protectors.

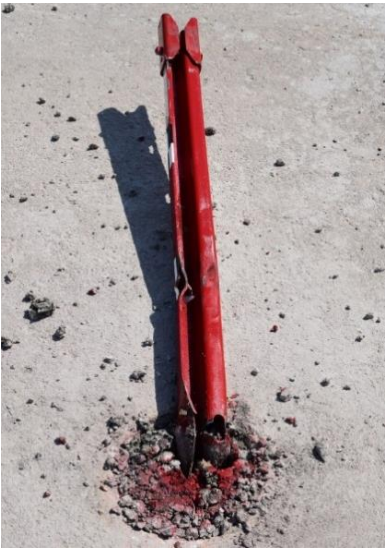
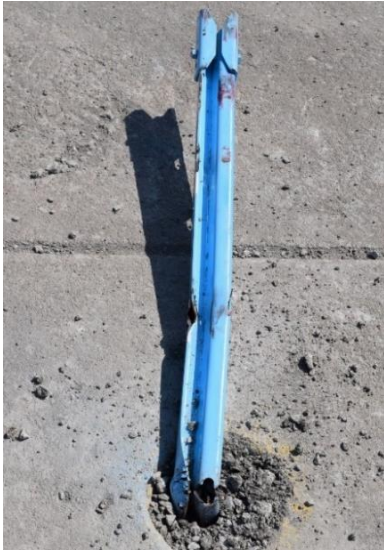
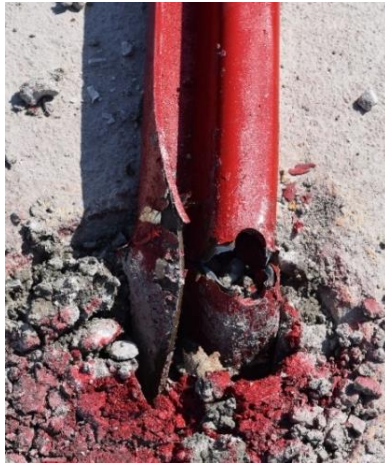
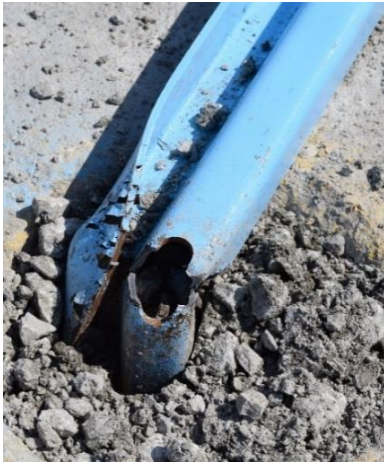
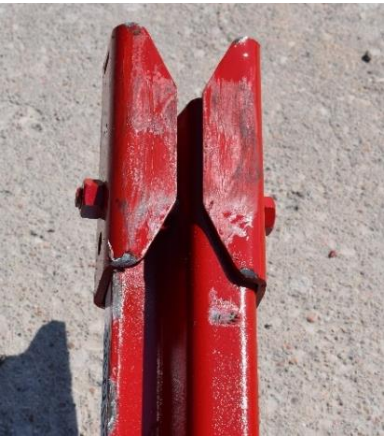
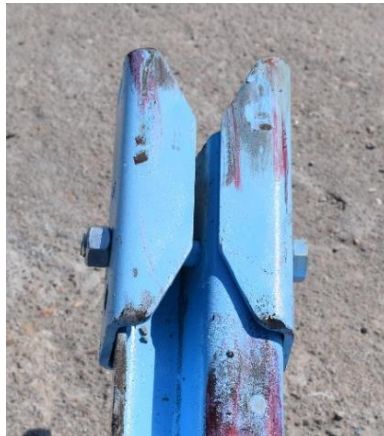
Sequential and post damage photographs are shown in Figure 37. The posts were bent plastically near the groundline, and tearing was found in both posts. The tears initiated from the weakening holes on the impact side of the posts and extended into the webs and adjacent flanges. Contact marks were found on the top half of the posts and on the edge protectors. Minor creasing was found in both the front and rear bays of the simulated floor pan, as shown in Figure 38. In addition, snagging of the cap on the underside of the bogie vehicle was reduced and connection bolt bending was eliminated.

Figure 37. Time-Sequential and Post-Impact Photographs, Test No. MWPF-26

It is believed that the edge protectors consisting of two U-shaped bent plates bolted to the weakened MWP with a 1/2-in. (13-mm) diameter through bolt placed at 4 in. (102 mm) down from the top of the cap and 2 5/8 in. (67 mm) down from the top of the weakened MWP could eliminate the floor pan tearing. It should be noted that a tube of similar shape could also reduce the propensity for floor pan tearing. Therefore, a combination of weakening holes and edge protectors using steel bent plates at top of the MWP was recommended for further evaluation through full-scale vehicle crash testing.

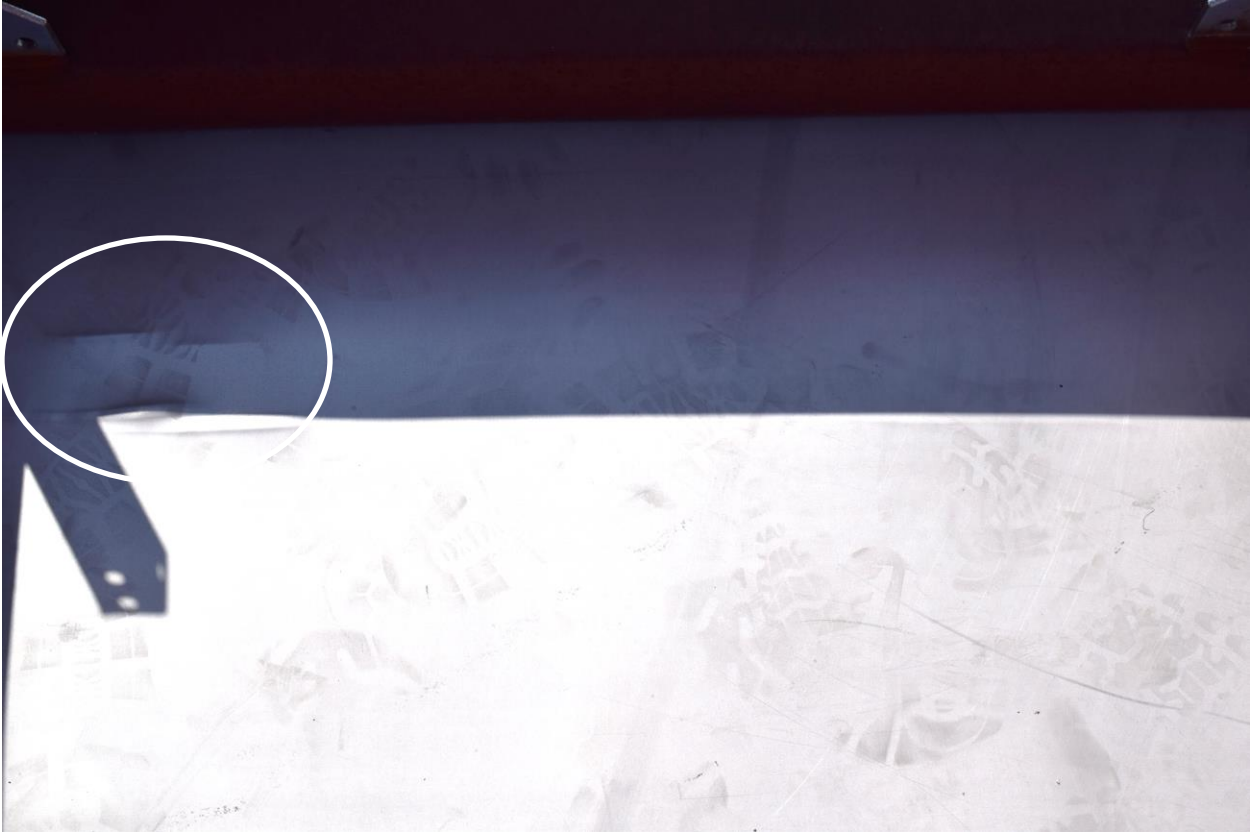
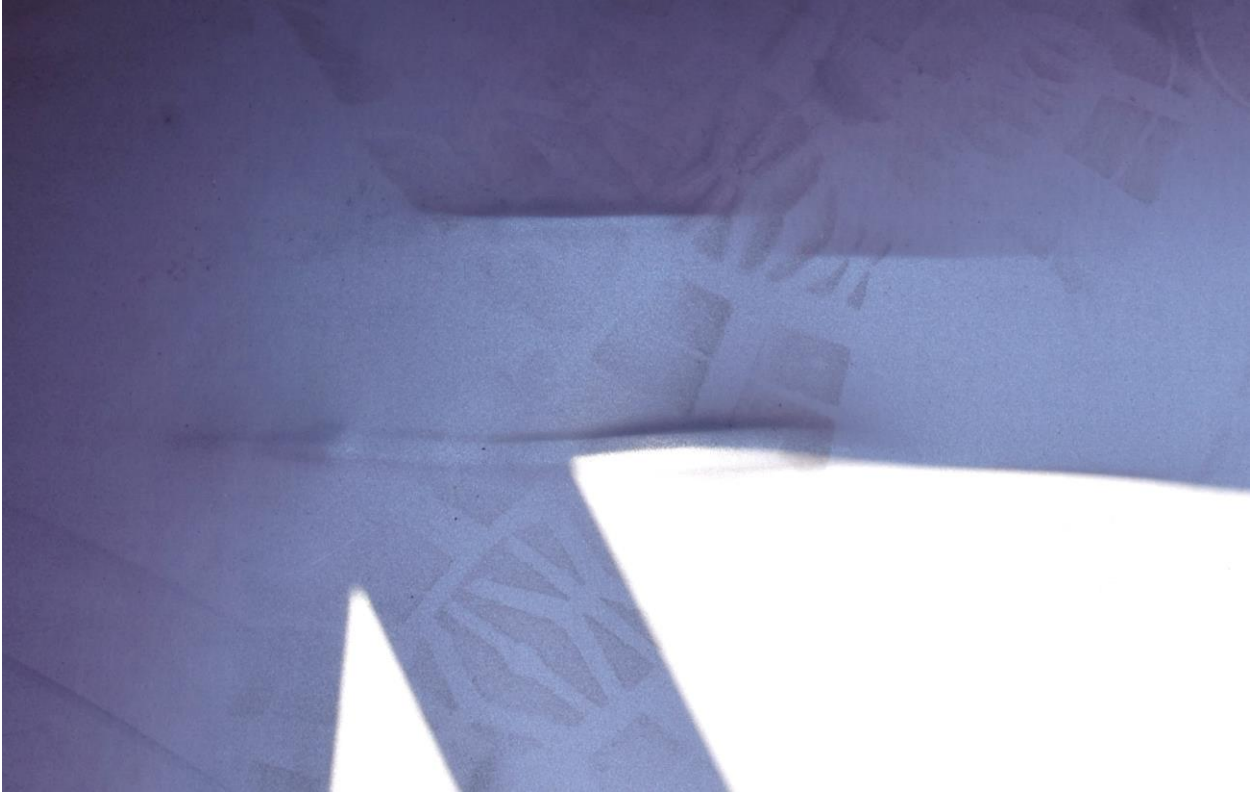
Figure 38. Simulated Floor Pan Damage, Test No. MWFPF-26
