# TESTING AND EVALUATION OF MASH TL-3 TRANSITION BETWEEN GUARDRAIL AND PORTABLE CONCRETE BARRIERS

## **MIDWEST ROADSIDE SAFETY FACILITY**

MwRSF Research Report No. TRP-03-335-17

May 2, 2017

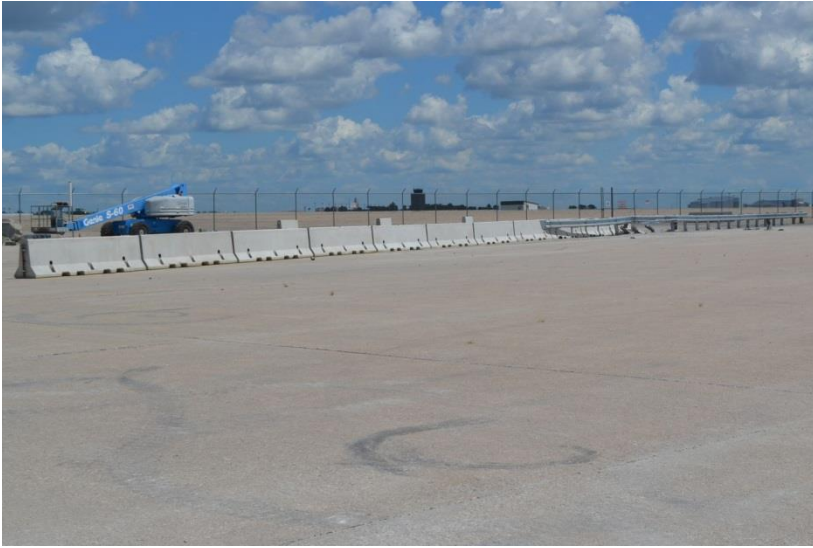
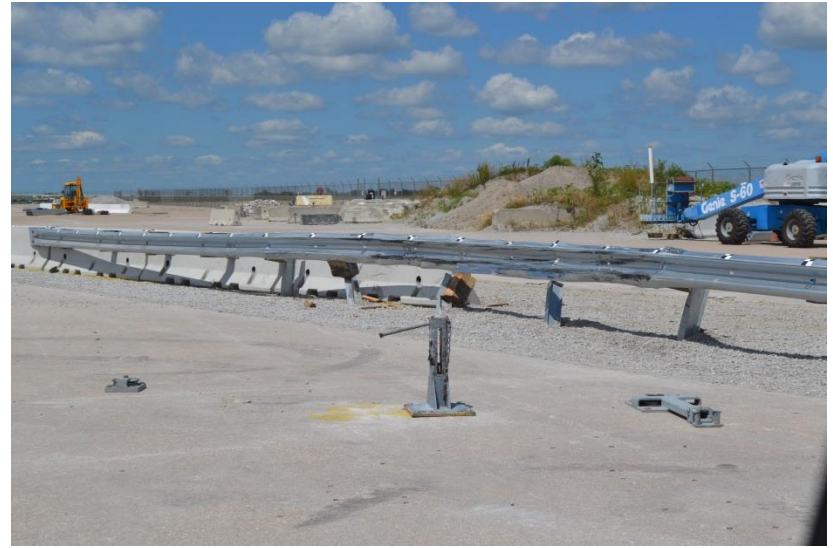
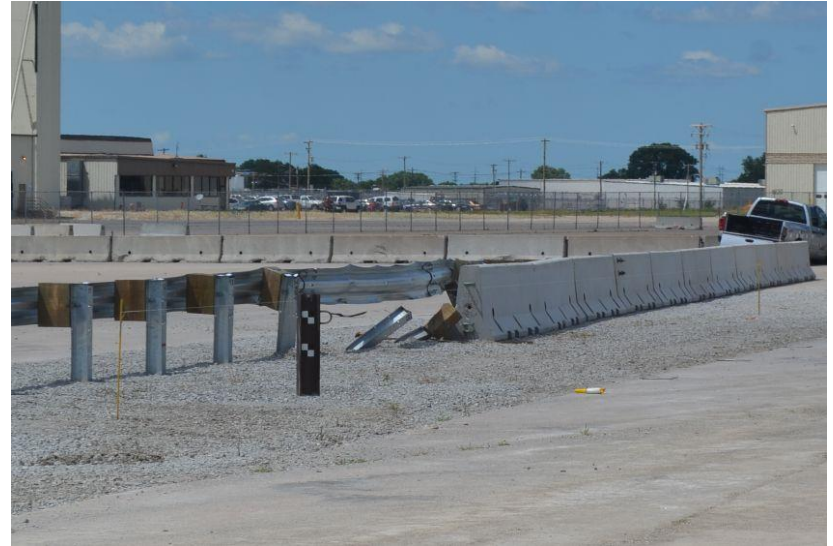
Figure 65. System Damage, Test No. MGSPCB-1

Damage to the barrier was moderate, as shown in Figures 65 through 70. Barrier damage consisted of rail deformation, bending of the steel posts, contact marks on the front face of the concrete segments, and spalling of the concrete. The length of vehicle contact along the barrier was approximately 37 ft – 8½ in. (11.5 m), which spanned from 14¾ in. (375 mm) upstream from post no. 14 to 12 in. (305 mm) upstream from blockout no. 20.

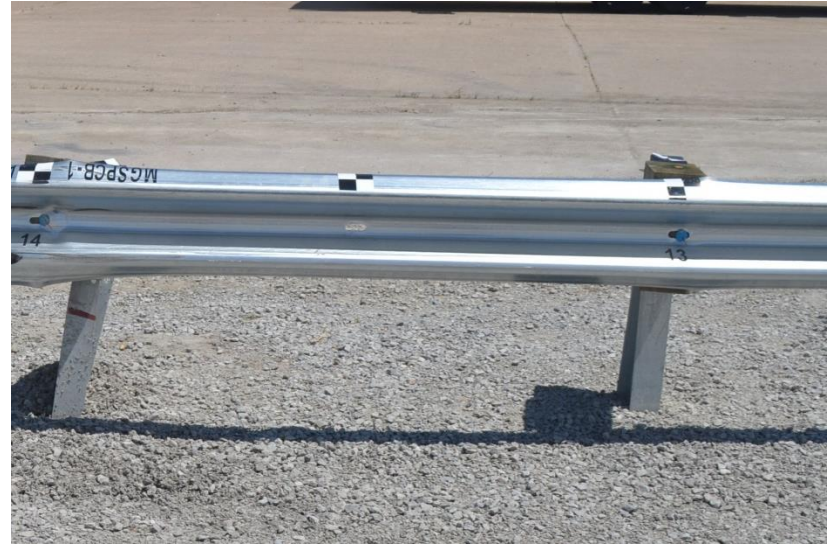
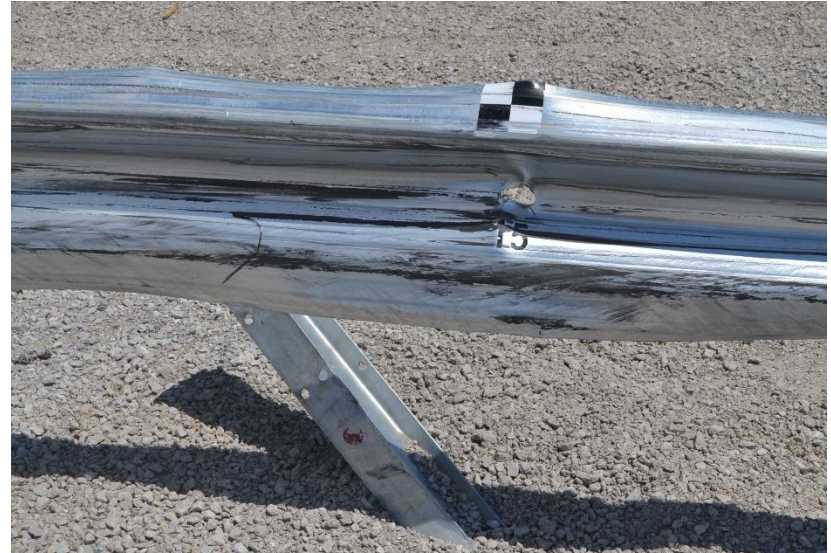
Figure 66. System Damage Between Post Nos. 12 and 15, Test No. MGSPCB-1

Post no. 1 had vertical cracking at the middle of the front face along the entire length, and post no. 2 had cracking on the upstream side extending outward from the BCT hole. Post nos. 3 through 13 twisted downstream, and the front face of their blockouts had dents and gouging from the guardrail. The front flange of post no. 14 partially twisted clockwise along the length of the

blockout, and blockout no. 14 had cracking on the bottom front upstream corner. Contact marks began 14¾ in. (375 mm) upstream of post no. 14 and were due to the right-rear corner of the vehicle slapping the guardrail after the initial impact. The bottom corrugation of the guardrail flattened from 13 in. (330 mm) upstream of post no. 15 to post no. 17. Post no. 15 had a dent in the front flange 17 in. (432 mm) from the top, and blockout no. 15 disengaged from the rail due to bolt shear. Post no. 16 twisted and bent downstream with the downstream side of the post against the upstream face of concrete barrier no. 1. The downstream flanges of post no. 16 were bent outward, and the steel fractured at the downstream bottom blockout holes. Blockout no. 16 was partially fractured, and the post bolt was bent 90 degrees. Post no. 17 bent downstream, and the blockout was partially fractured. The top back upstream flange of post no. 17 was bent inward. Post no. 18 had a dent located 2 in. (51 mm) above the ground line on the back downstream flange. A kink formed on the top corrugation, extending from 11½ in. (292 mm) upstream of post no. 18 to 17 in. (432 mm) downstream of post no. 18. The blockout mounts that connected the rail to the PCB, and the mount for the end shoe transition were undamaged.

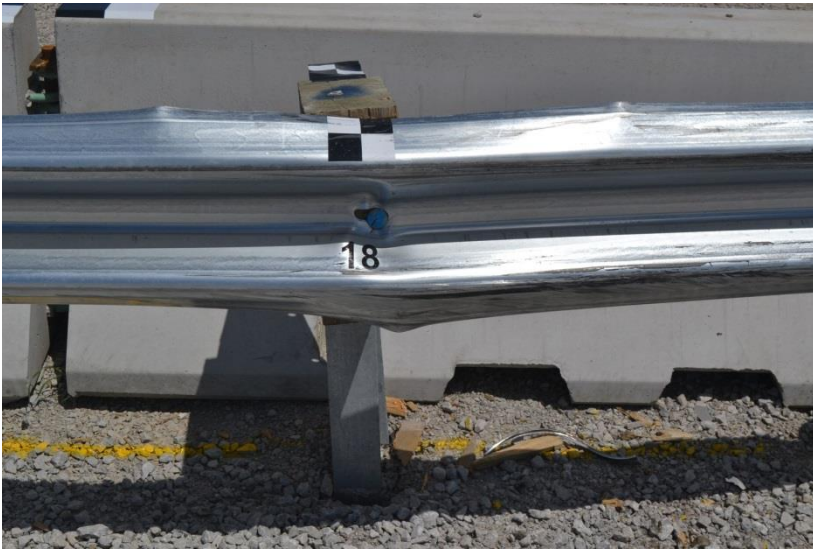
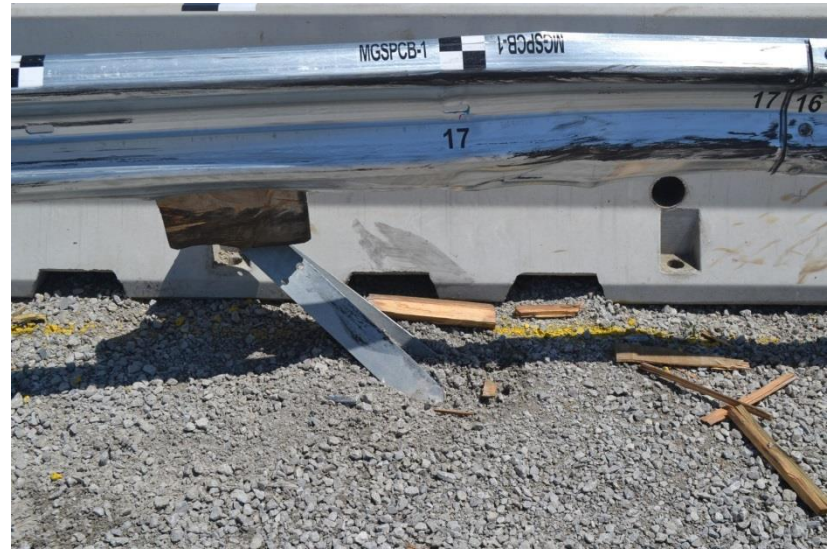
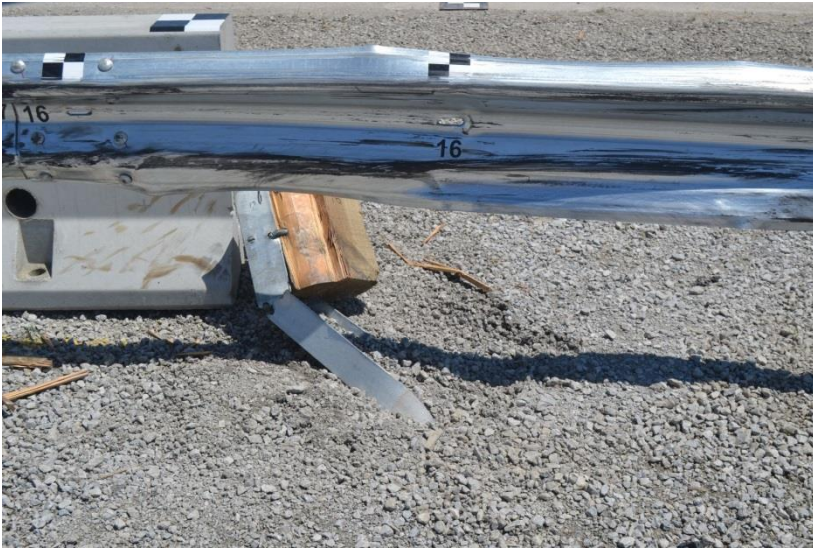
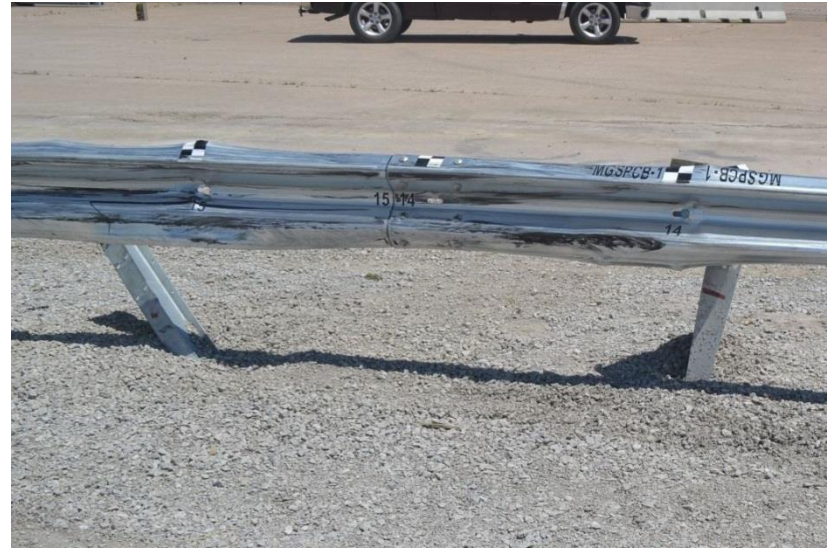
Figure 67. System Damage Between Post Nos. 14 and 18, Test No. MGSPCB-1

The maximum permanent set of the rail, posts, and concrete barriers for the system was 26¾ in. (679 mm) at the rail at post no. 16, 22½ (572 mm) at post no. 16, and 5⅝ in. (168 mm) at the downstream target on concrete barrier no. 1, as measured in the field. The maximum lateral dynamic deflection of the rail, posts, and concrete barriers was 36.1 in. (917 mm) at the rail at post no. 16, 27.7 in. (704 mm) at post no. 15, and 6.7 in. (170 mm) at the downstream end of concrete barrier no. 1, as determined from high-speed digital video analysis. The working width of the system was found to be 58.7 in. (1,491 mm), also determined from high-speed digital video analysis.

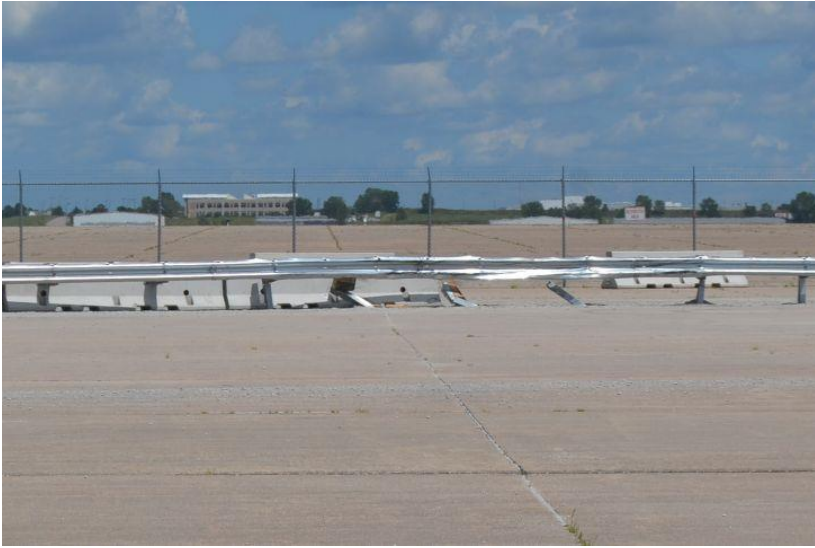
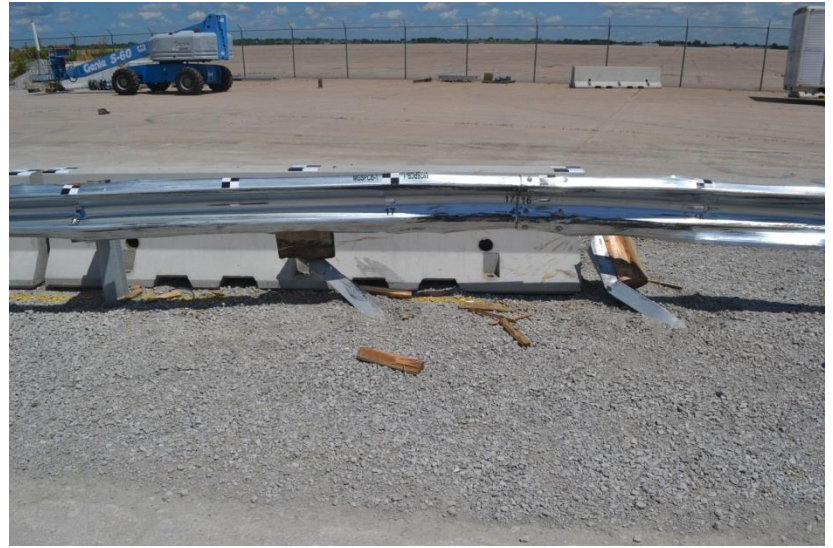
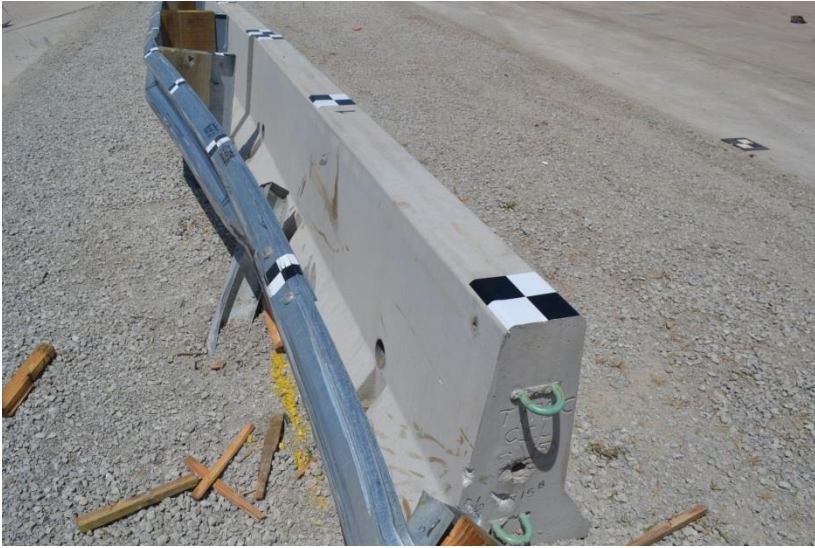
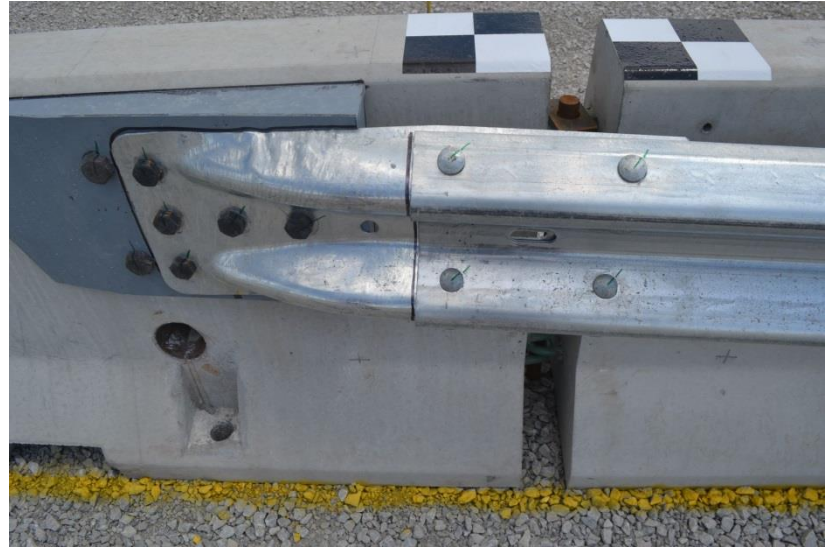
Figure 69. Transition Damage, Test No. MGSPCB-1

Contact marks on concrete barrier no. 1 extended 17 in. (432 mm) up the front face of the barrier and ran diagonally to the first anchor hole, and contact marks from the tire started 24 in. (610 mm) upstream of the midpoint on the bottom taper. An indented contact mark extended upward 28 in. (711 mm) on the front face of concrete barrier no. 1 and stopped 6 in. (152 mm) downstream of the midpoint. Concrete barrier no. 1 also had spalling on the upstream corner located 8 in. (203 mm) and 12 in. (305 mm) from the ground line. Concrete barrier no. 2 had contact marks 6 in. (152 mm) upstream from blockout no. 19 and 12 in. (305 mm) upstream from blockout no. 20.

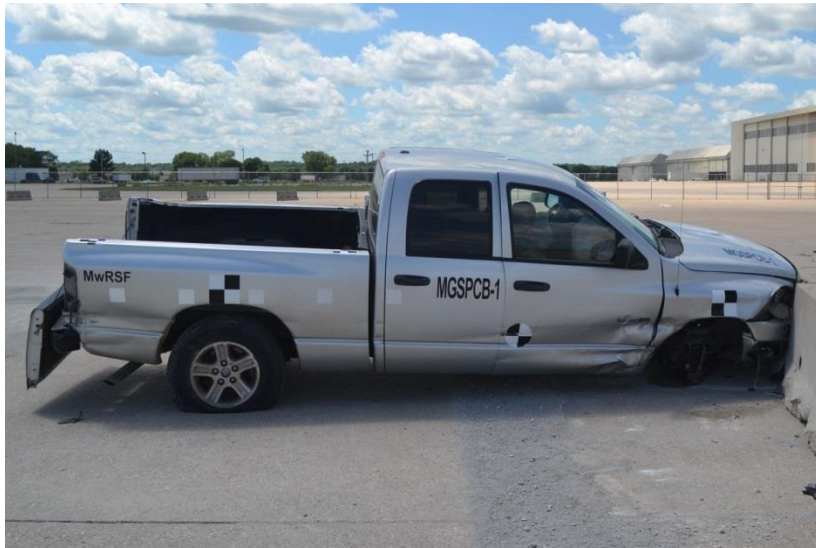
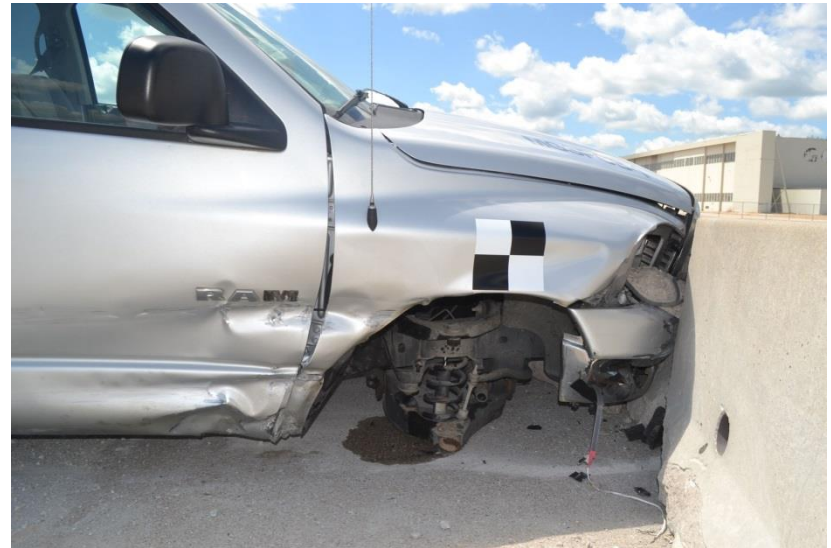
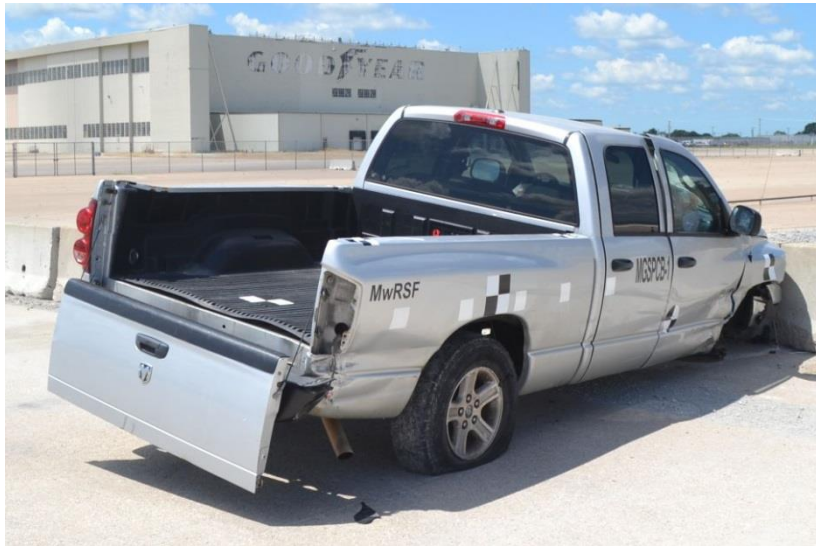
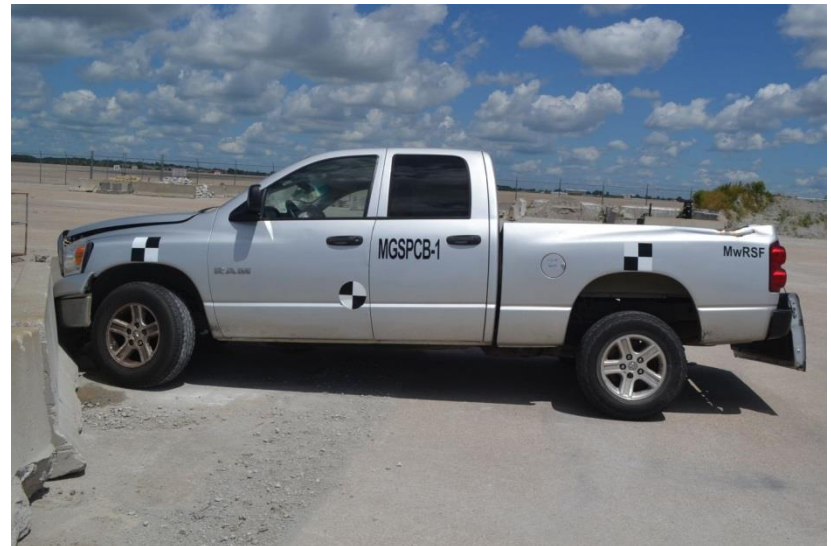
Figure 71. Vehicle Damage, Test No. MGSPCB-1

The majority of the damage was concentrated on the right-front corner and right side of the vehicle where the impact occurred. The right headlight and fog light disengaged. The right side of the front bumper was crushed inward and back. The right-front wheel detached. The right-front fender had a 14-in. (356-mm) long by 2-in. (51-mm) deep dent located above the wheel well. The right-front door had a 14-in. (356-mm) long dent along the bottom and was separated 1¼ in. (32 mm) from the door frame. Contact marks ran along the right side of the vehicle, starting at the front fender and extending 67 in. (1,702 mm) to the rear door.

The front of the right quarter panel had an 11-in. (279-mm) scrape approximately 14 in. (356 mm) from the bottom. The right quarter panel had contact marks starting behind the wheel well and extending 11 in. (279 mm) toward the rear of the vehicle and a 15-in. (381-mm) by 17-in. (432-mm) dent located behind the wheel well. The right-rear tire deflated due to a 2-in. (51-mm) cut at the outer edge, and the right-rear wheel had a 1-in. (25-mm) fracture on the outer wheel rim. The right taillight disengaged, and the right-rear bumper and tailgate partially disengaged.

The vehicle grill was partially disengaged, and the windshield had a 26-in. (660-mm) diameter crack with spidering. The airbags deployed due to impact with a secondary concrete barrier system that was set up to stop the vehicle after exiting the system and not due to impact with the MGS to PCB transition system. Although some front-end damage may be associated with this secondary impact, it is indistinguishable from the primary system impact damage.
