# **INCREASED SPAN LENGTH FOR THE MGS LONG-SPAN GUARDRAIL SYSTEM PART II: FULL-SCALE CRASH TESTING**

MwRSF Research Report No. TRP-03-339-17

April 7, 2017

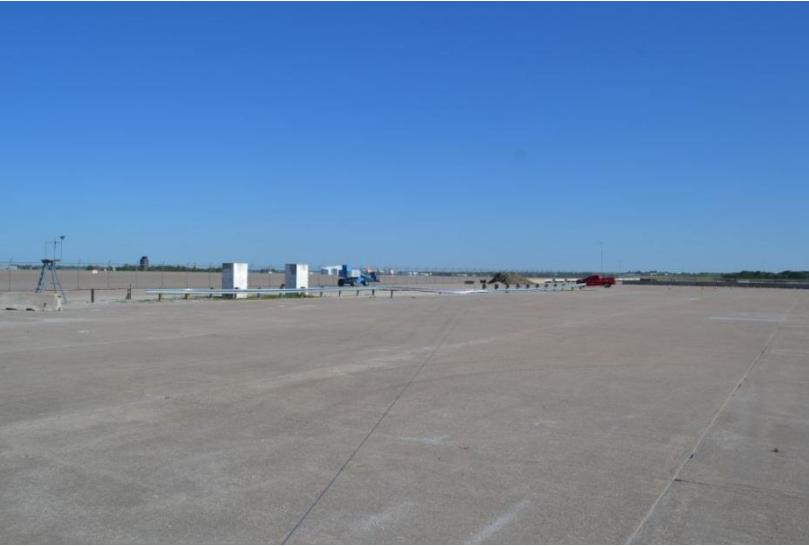
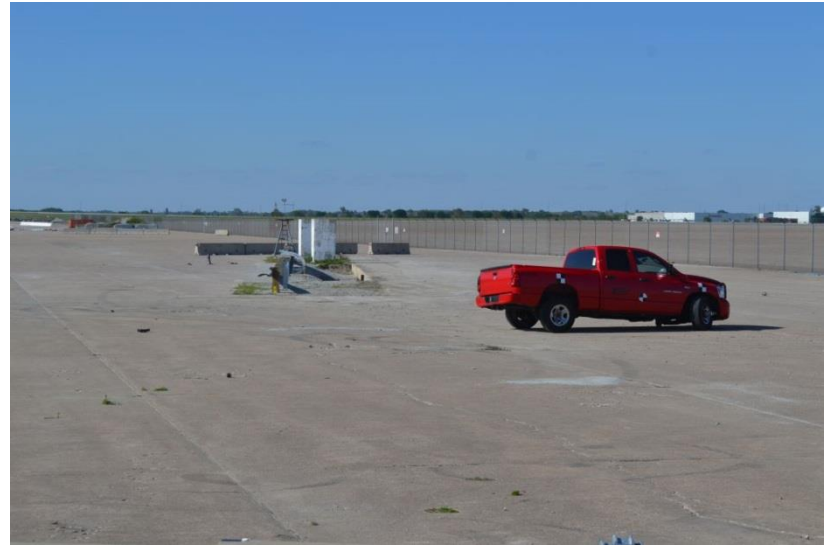
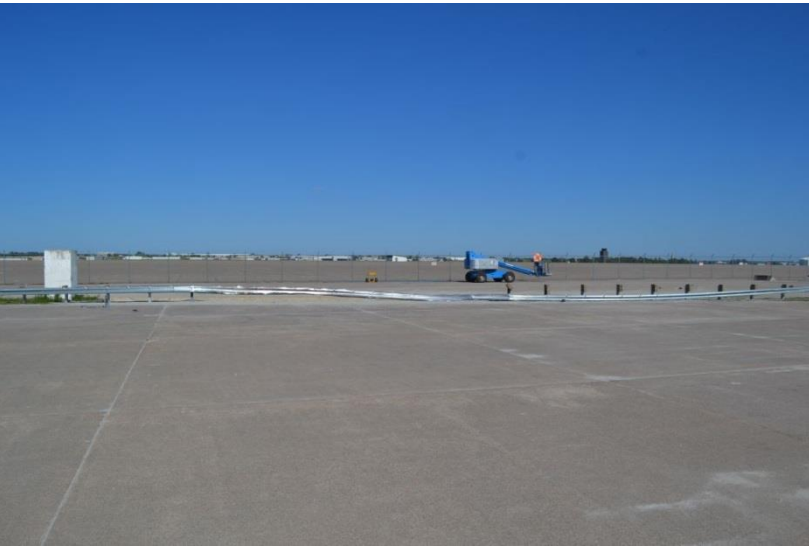
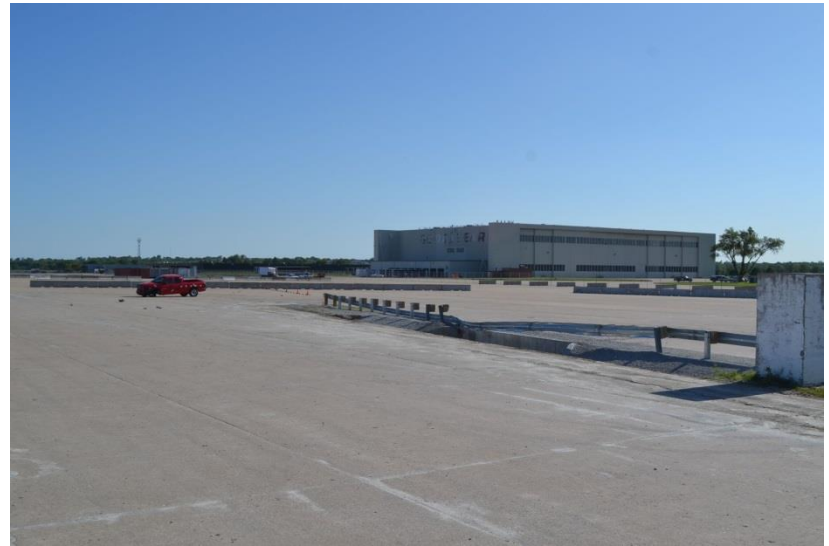
Figure 48. System Damage, Test No. MGSLs-1

Damage to the barrier was moderate, as shown in Figures 48 through 55. All system damage photographs depicted in Figures 48 through 55 were taken after the cable anchors were disassembled and removed from the system. Barrier damage consisted of rail deformation, disengagement of the W-beam rail from the posts, bending of the steel posts, fracture of the wooden posts, and damage to the culvert. The length of vehicle contact along the barrier was approximately 52 ft – 8 in. (16.1 m), which spanned from 1¾ in. (44 mm) downstream from the center of post no. 11 through 34 in. (864 mm) downstream from the center of post no. 15.

Deformation of the W-beam rail occurred between post nos. 2 through 16 with the most significant damage occurring where the vehicle initially contacted the barrier between post nos.

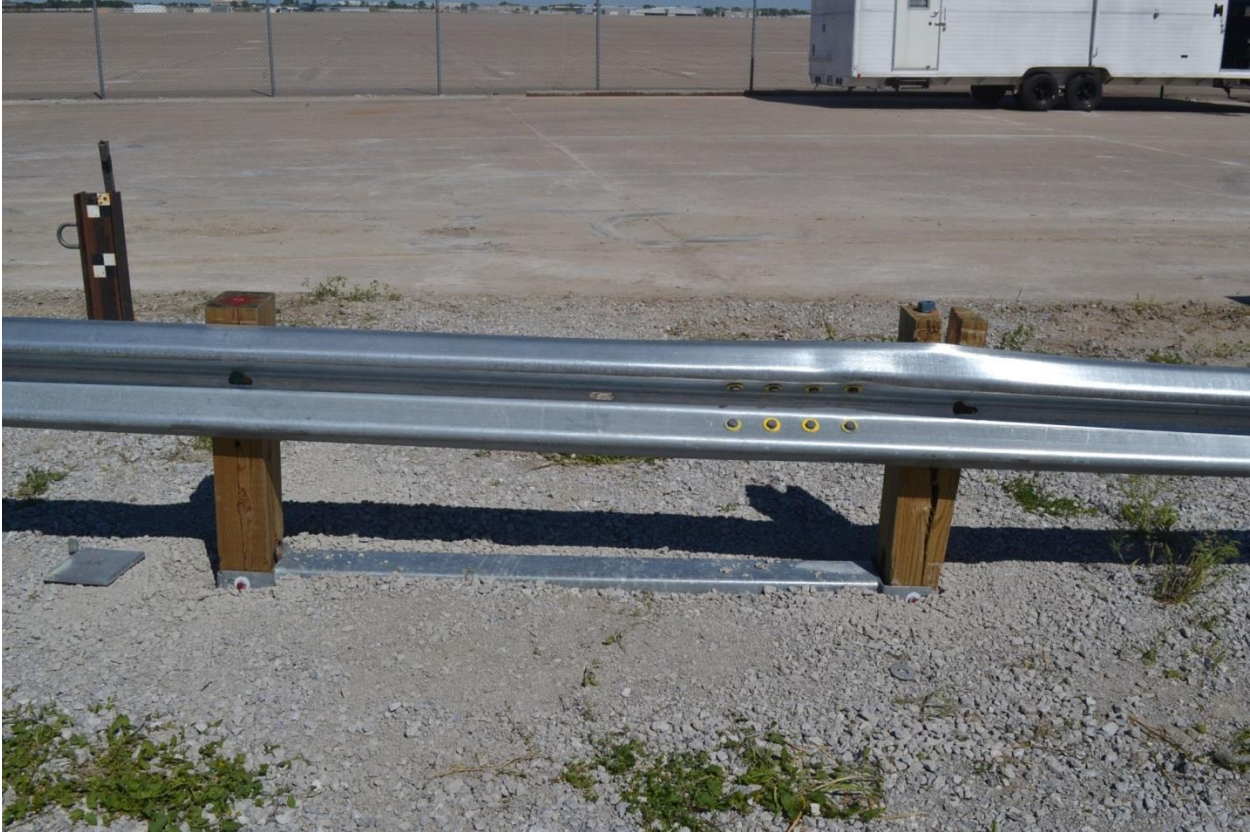
Figure 49. Upstream End Anchor Damage, Test No. MGSLS-1

Wood post damage included splitting, rotation, and displacement of the posts. Post no. 1 rotated downstream and had a 3-in. (76-mm) cut located at the top of the guardrail. A 1¾-in. (44-mm) soil gap was found on the upstream face of post no. 1. Post no. 2 had a 25-in. (635-mm) long vertical crack down the post with a 2-in. (51-mm) opening at the top. The downstream end system anchorage rotated upstream and post no. 25 had a 1-in. (25-mm) soil gap on the downstream side of the post.

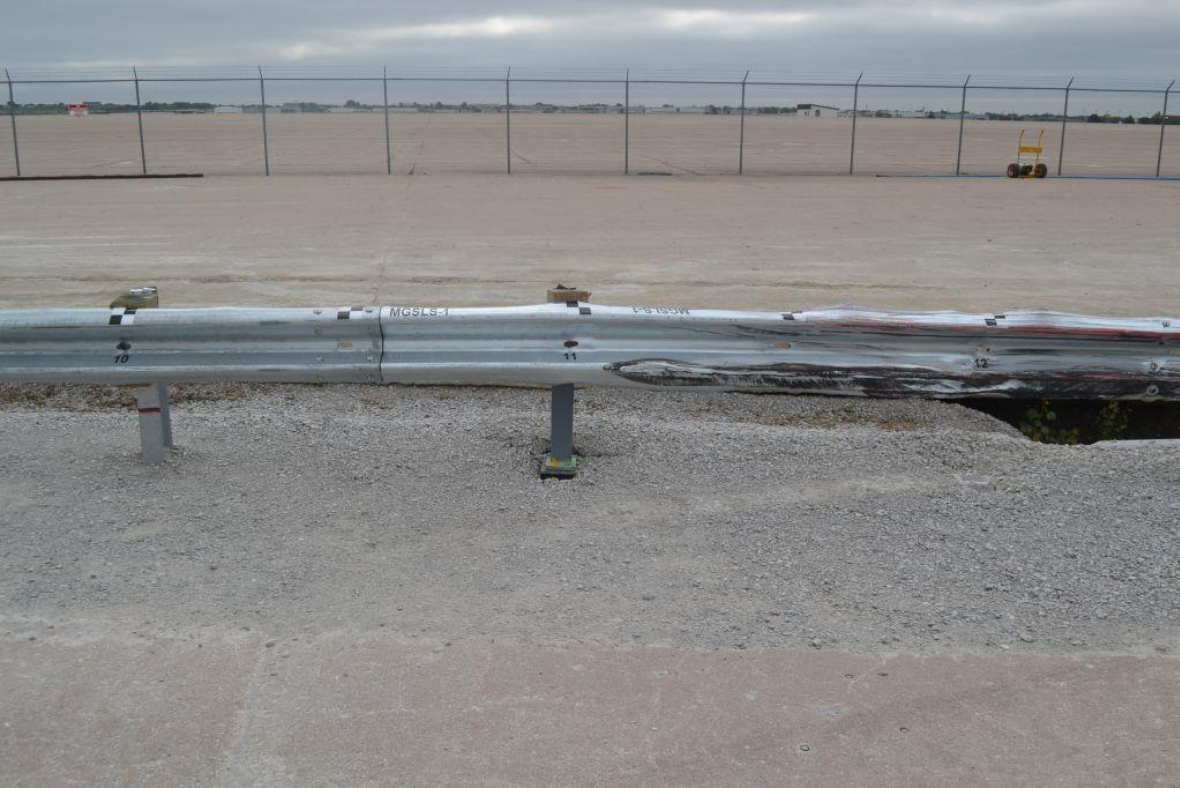
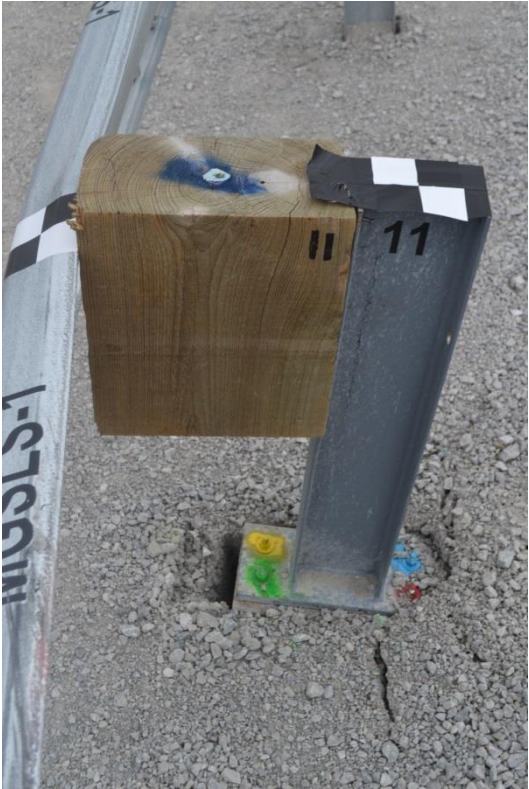
Figure 51. Damage Between Post Nos. 10 and 12, Test No. MGSL-1

Steel post damage included twisting, rotation, and detachment from the post bases. Post no. 10 twisted downstream. Post no. 11 rotated backward and twisted downstream. Post no. 15 rotated backward and downstream. Post nos. 12, 13, and 14 disengaged from the rail and the post bases. At post no. 12, the baseplate bent ¼ in. (6.4 mm) downward. At post no. 13, the lower section of the post rotated backward and was found with the two bolts on the front of the baseplate to be missing and the two bolts on the back side bent backward. Soil gaps of 1 in. (25

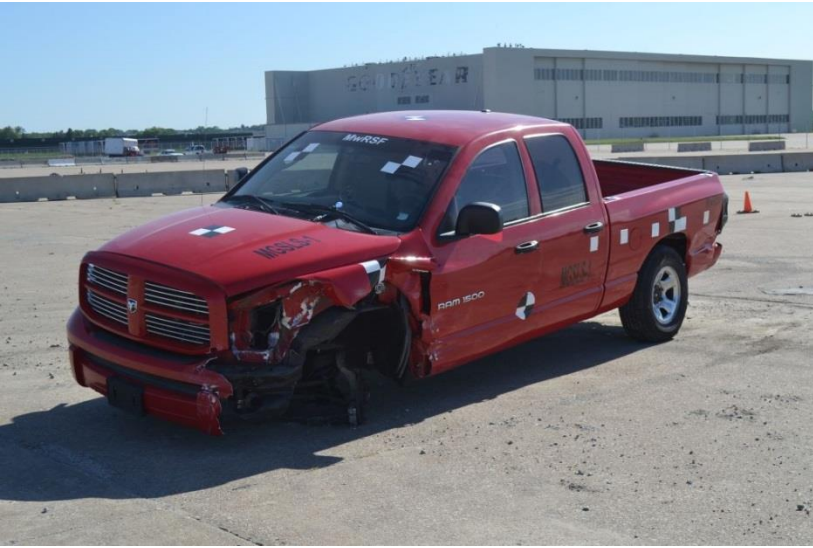
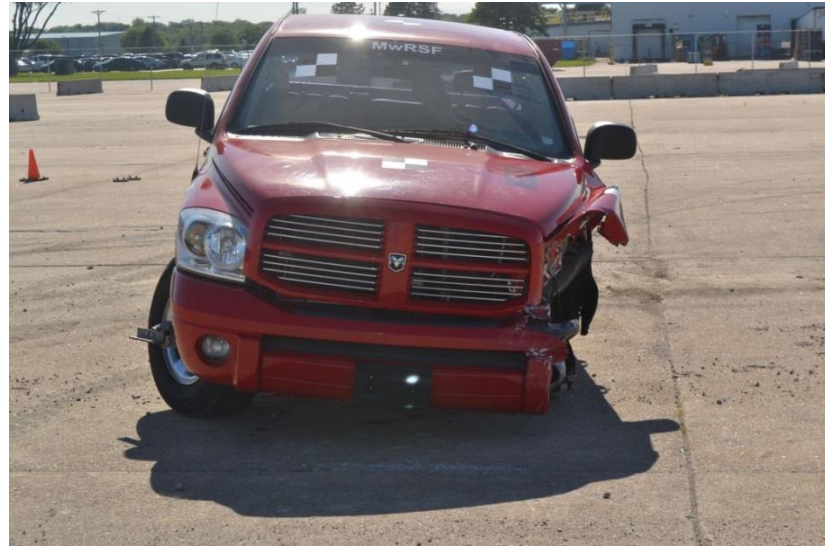
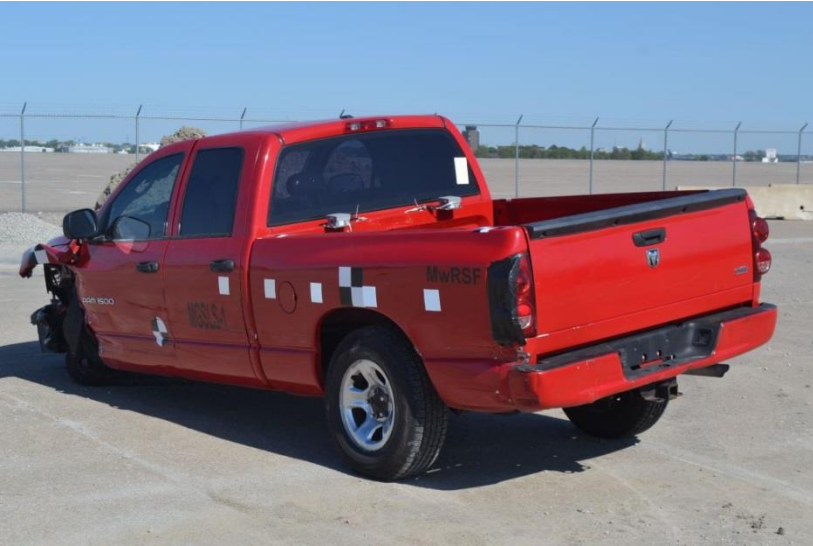
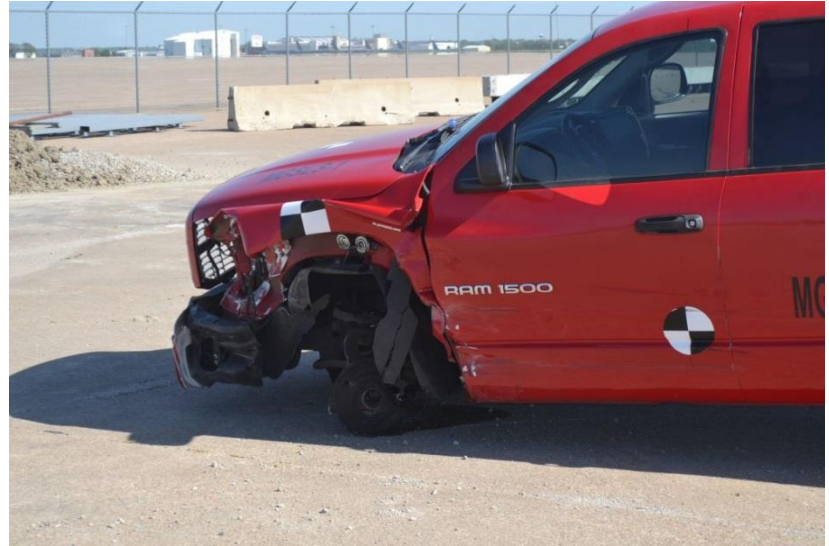
Figure 56. Vehicle Damage, Test No. MGSLS-1

The majority of the damage was concentrated on the left-front corner and left side of the vehicle where the impact occurred. The left side of the bumper fractured 23 in. (584 mm) left of center and was kinked 12 in. (305 mm) from the top. An 18-in. x 11-in. (457-mm x 279-mm) piece disengaged from the left fender starting at the hood. The left fender also had a 9-in. (229-mm) deep x 23-in. (584-mm) diameter dent. A 16-in. (406-mm) long kink occurred longitudinally in line with the base of the A-pillar, 6 in. (152 mm) down from the hood. The left fender separated 2 in. (51 mm) from the left-front door, and gouging occurred on the left fender and the left-front door. The top of the plastic wheel well on the left-front side of the vehicle had a 4-in. (102-mm) crack. The left-front rim was dented and kinked. The left-front steering knuckle cracked at the tie rod flange and the wheel bearing disengaged. The left-front wheel disengaged from the vehicle. Tears were also found on the left-front tire. Tears and gouges were found on the left side of the grill, which was partially detached from the vehicle. The left-side headlight disengaged from the vehicle. Contact marks extended the length of the left side of the vehicle. Dents were found on the left-front door near the bottom and the top of the door had separated ½ in. (13 mm). A 25-in. (635-mm) long by 4-in. (102-mm) tall by 2-in. (51-mm) deep dent

occurred on the left-rear quarter panel between the wheel well and the rear of the vehicle, 11 in. (279 mm) from the bottom of the panel. The rear bumper was slightly kinked 22 in. (559 mm) left of center. A 5-in. x 2-in. (127-mm x 51-mm) piece of the rear bumper partially disengaged. The front hood had a gap of 2 in. (51 mm) on the right side. Although the steering rack appeared to be intact, power steering fluid was found to be leaking from the vehicle. The roof and all vehicle windows remained undamaged.

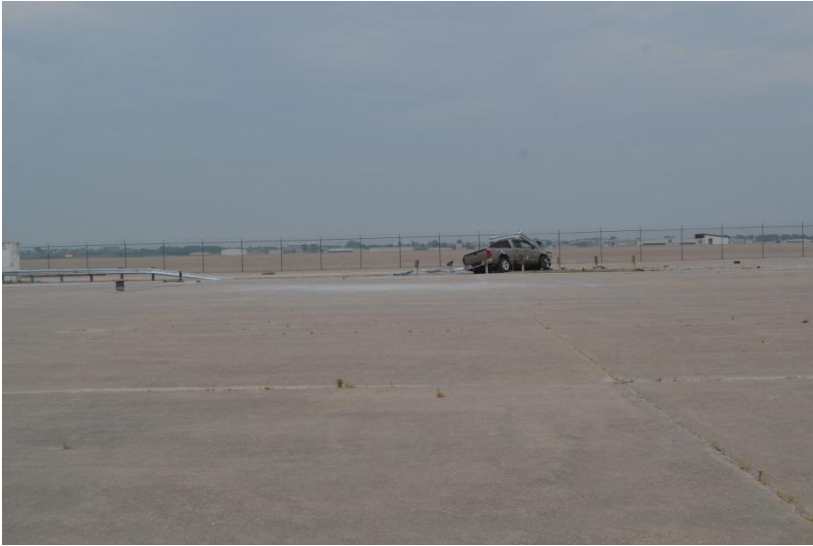
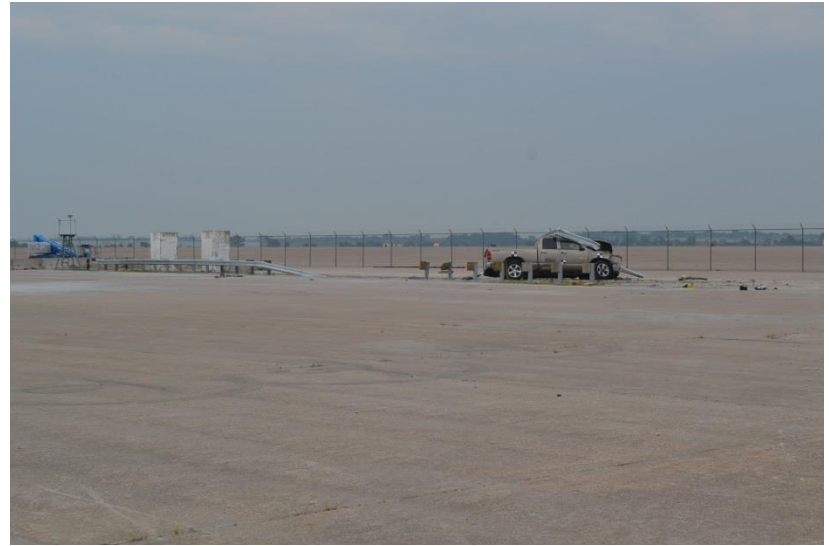
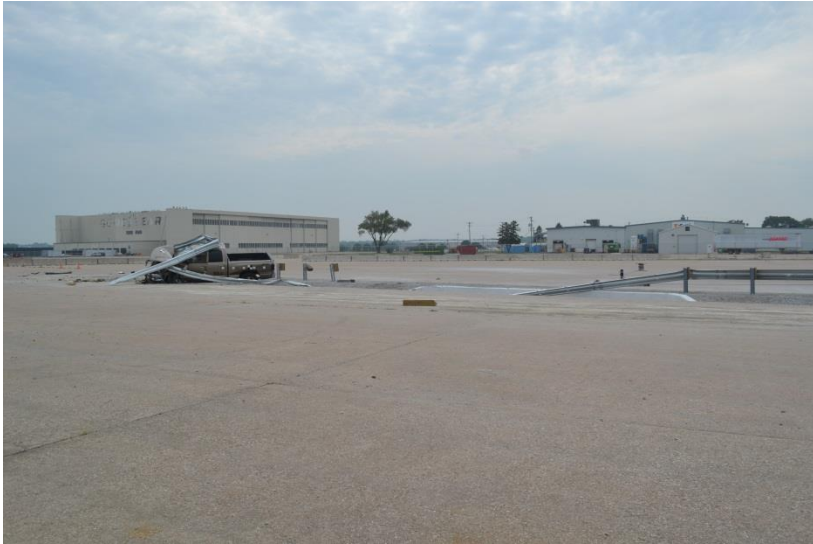
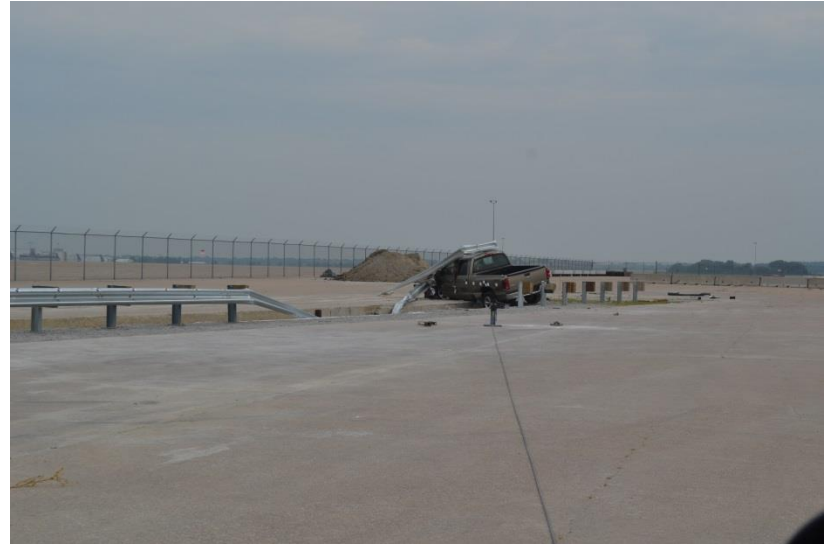
Figure 68. System Damage, Test No. MGSLs-2

Damage to the barrier system was severe, as shown in Figures 68 through 79. Barrier damage consisted of rail deformation and tearing, disengagement of W-beam rail away from posts, bending of steel posts, fracture of wood posts, and damage to the concrete culvert. The length of vehicle contact along the barrier was approximately 80 ft (24.4 m), which began 239<sup>7</sup>/<sub>8</sub> in. (6.1 m) upstream from post no. 13 and extended through the end of the barrier system.

Deformation of the W-beam rail occurred at post no. 2 as well as between post no. 13 and the downstream end of the barrier system. A majority of the damage occurred between post no. 14 and the downstream end of the system. At post no. 2, the top corrugation of the guardrail was slightly bent. At post no. 13, there was a kink in the guardrail that extended the height of the rail. Numerous kinks were found on the guardrail between post nos. 13 and 14. Flattening of the bottom corrugation on the guardrail began 15 in. (381 mm) upstream from post no. 14 and extended to 16½ in. (419 mm) downstream from post no. 16. The rail released from the posts at post nos. 1, 2, 24, and 25. The rail released from the blockouts at post nos. 3, 5, 6, 9, and 11 through 23. Tearing occurred at post no. 17 at the top corrugation that was 2 in. (51 mm) long, and there was a 1½-in. (38-mm) long tear on the bottom corrugation. There was also a ½-in. (13-mm) long tear at the bottom of the corrugation 17 in. (432 mm) downstream from post no. 16. Tearing was also present on the top of the rail 6 in. (152 mm) upstream from post no. 25 that was 3 in. (76 mm) long by 1¼ in. (32 mm) deep. There was buckling located at post no. 17 that

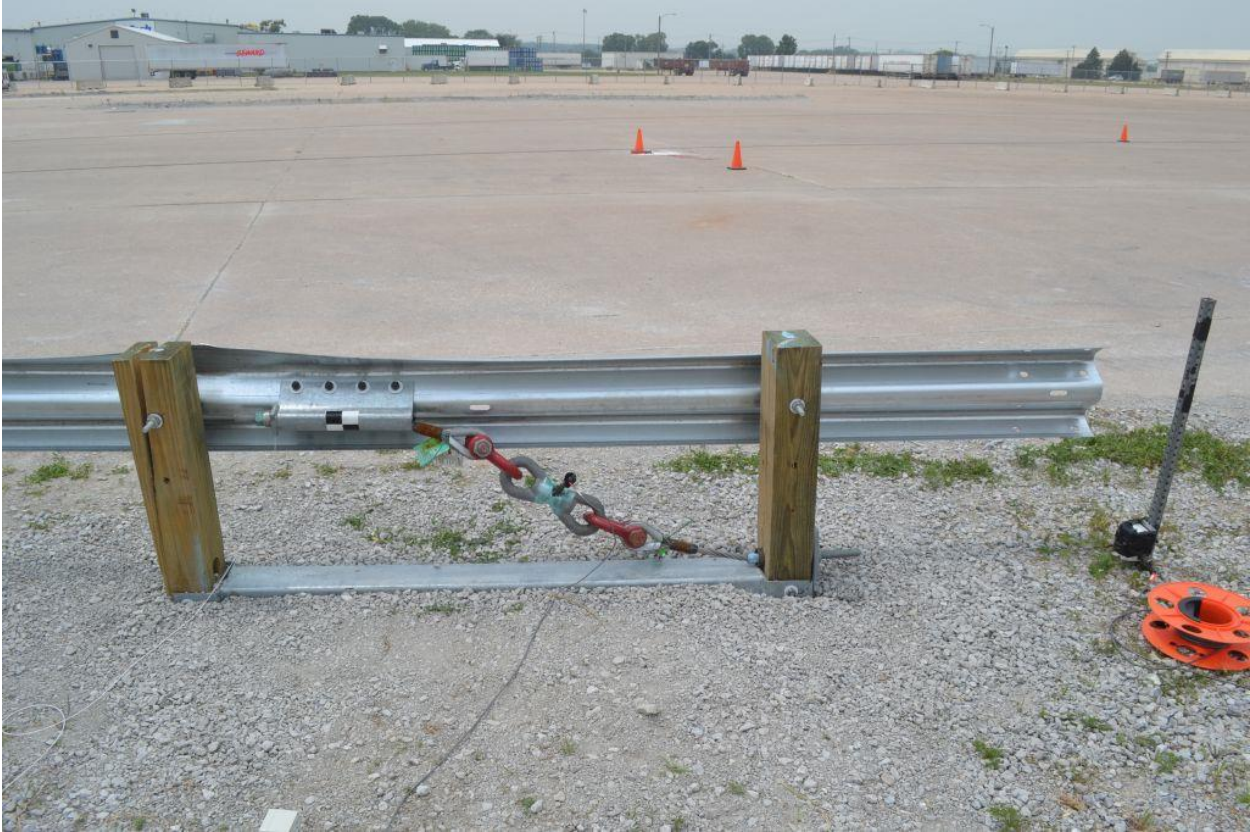
Figure 69. Upstream End Anchor Damage, Test No. MGSLS-2

Wood post damage included fracturing, gouging, and displacement of posts. Post no. 1 had gouging on the front face due to rail contact. Post no. 2 split vertically along the height of the post through the guardrail bolt hole on the front side of the post. Post nos. 24 and 25 fractured at the ground line and post no. 24 also split along the vertical plane of the centerline of the post. Post no. 25 had a 7½-in. (191-mm) deep by 3-in. (76-mm) wide crack located 2¼ in. (57 mm) downward from the top of the back face of the post, as well as a 3-in. (76-mm) diameter dent on the back downstream face of the post.

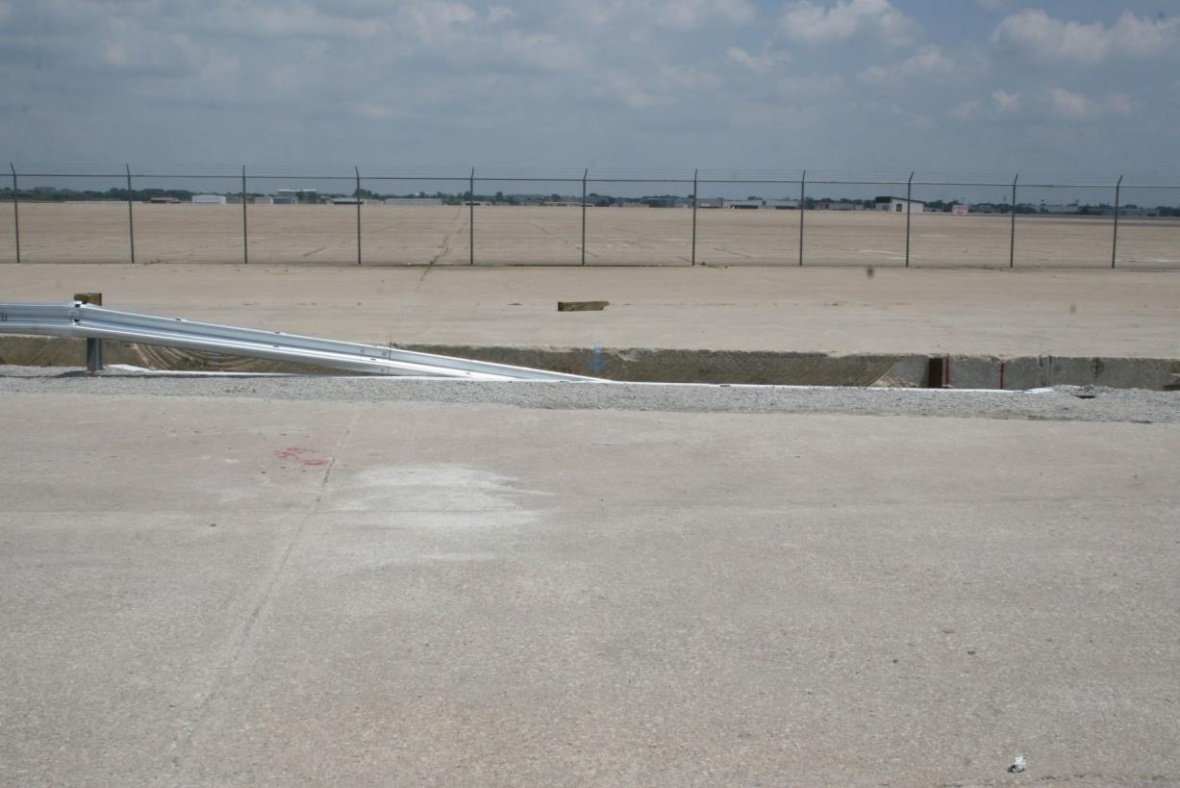
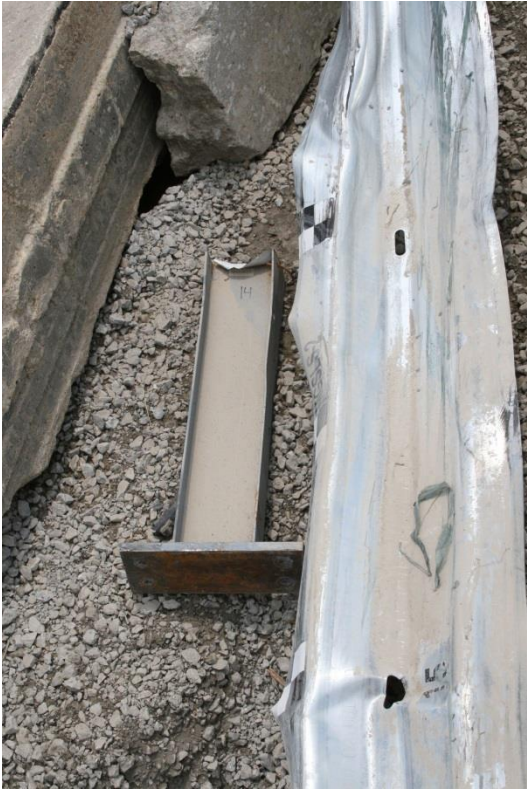
Figure 73. Damage at Post No. 14, Test No. MGSLs-2

Steel post damage included twisting, rotation, and detachment from the post bases. UBSP post nos. 14 through 16 fractured at the ground line. The baseplate for post no. 14 rotated backward, and the back-side upstream flange twisted upstream. The baseplate for post no. 14 was also dented on the back-side and the top of the downstream side. There were also contact marks on the lower 9½ in. (241 mm) of the front face of the post. The front web and flange of post no. 15 twisted upstream, and the base plate rotated backward. There were contact marks found on the top of the front flange of post no. 16 that extended 9¼ in. (235 mm) downstream. Post no. 17 bent downstream, and post no. 18 bent backward 1½ in. (38 mm) at the top of the upstream flange.

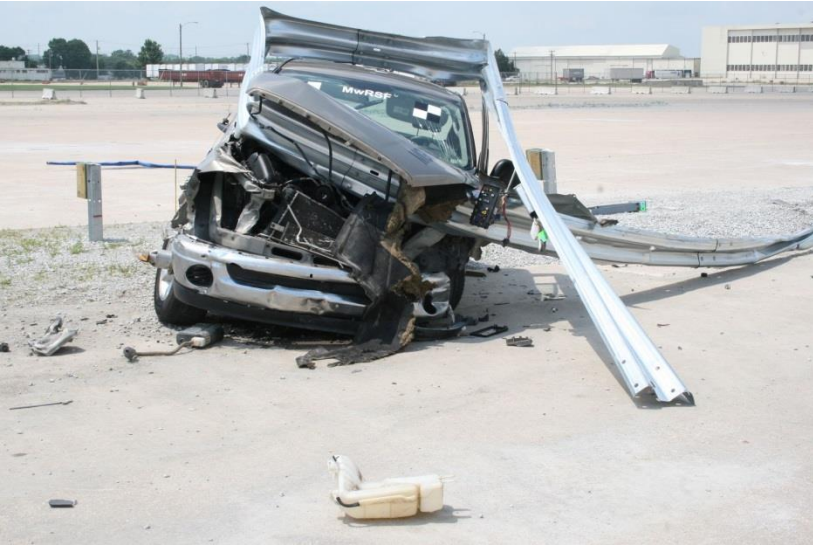
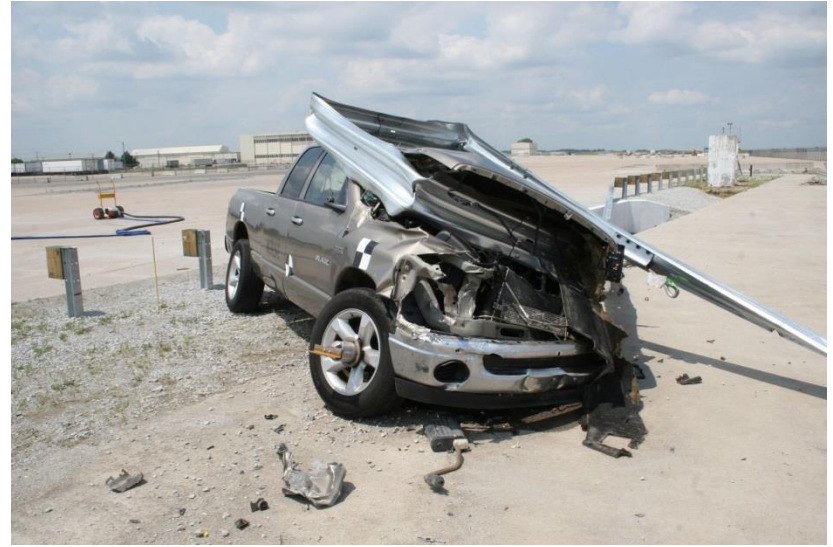
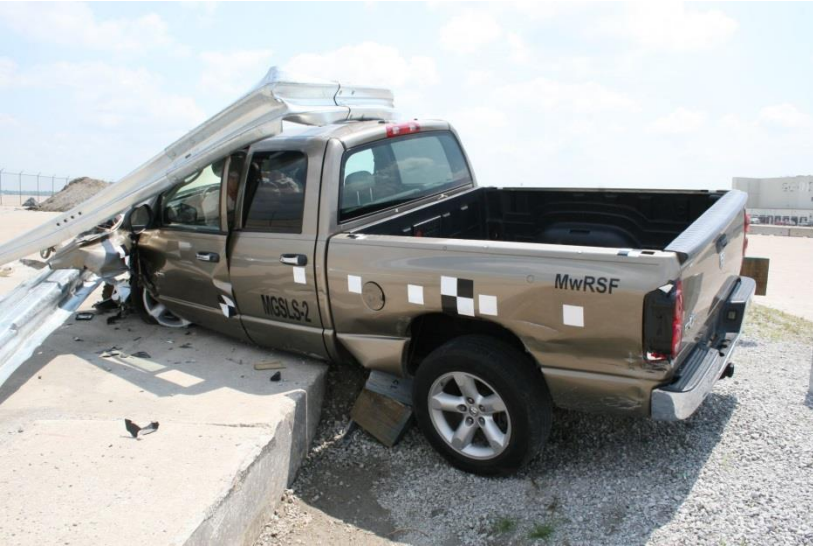
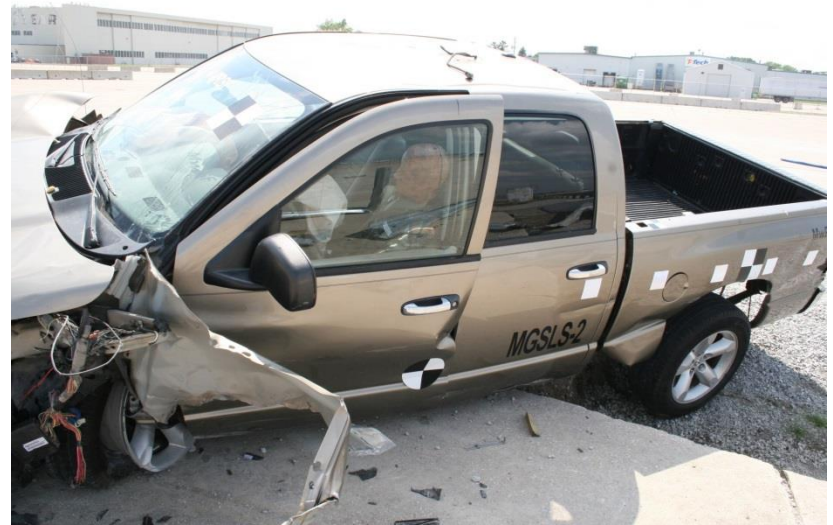
Figure 81. Vehicle Damage, Test No. MGSL-2

The damage to the vehicle was moderate, as shown in Figures 81 through 85. The maximum occupant compartment deformations are listed in Table 9 along with the deformation limits established in MASH for various areas of the occupant compartment. Note that none of the MASH-established deformation limits were violated. Complete occupant compartment and vehicle deformations and the corresponding locations are provided in Appendix D.
