# High Performance Concrete Bridge Deck Investigation

November 2009

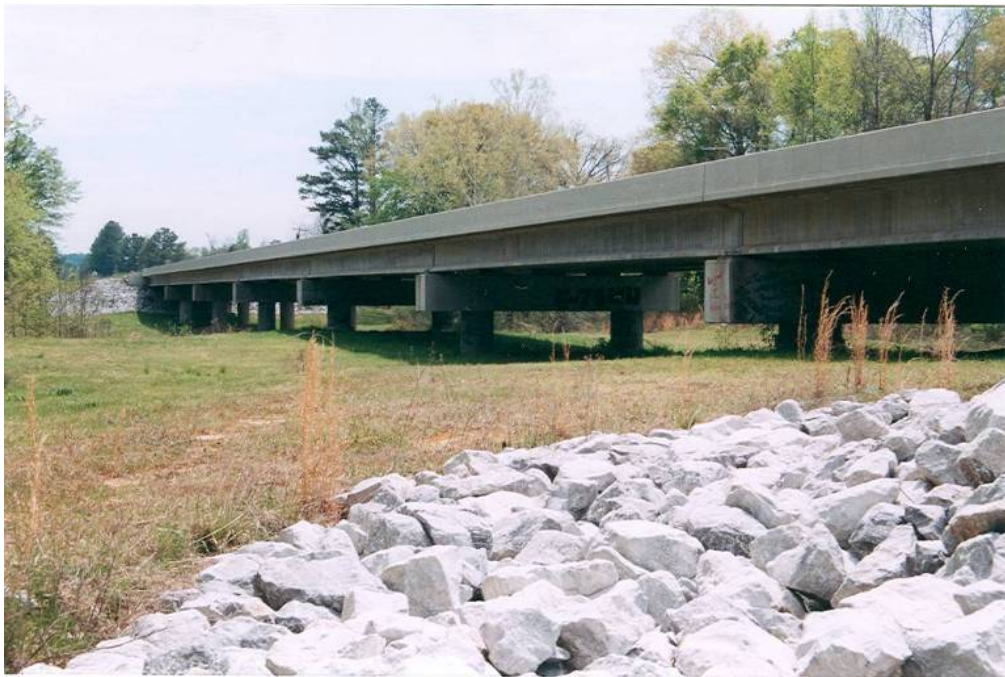
**Figure 1. Photo. Uphapee Creek Bridge, Alabama Highway 199 (Macon County, Alabama).**

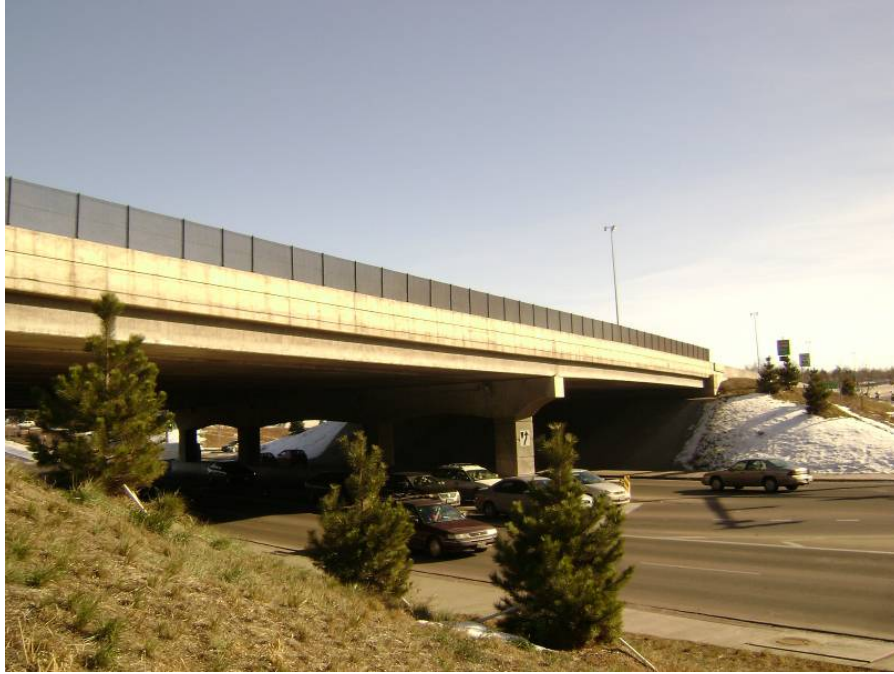
**Figure 2. Photo. Interstate 25 Bridge over East Yale Avenue (Denver, Colorado).**

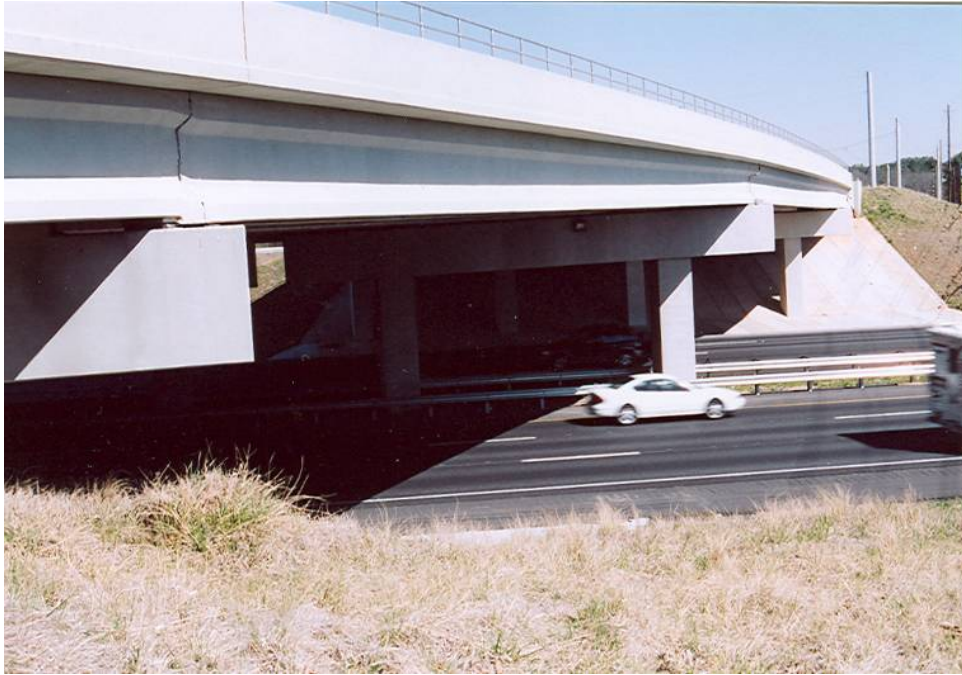
**Figure 3. Photo. Jonesboro Road Bridge over Interstate 75 (Atlanta, Georgia).**

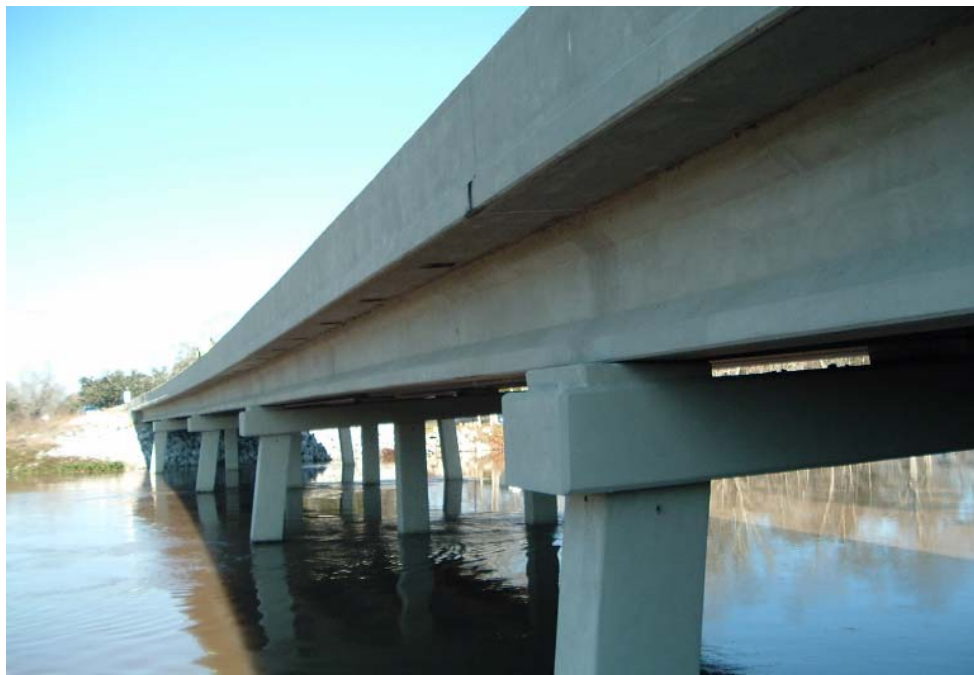
**Figure 4. Photo. Charenton Canal Bridge (Charenton, Louisiana).**

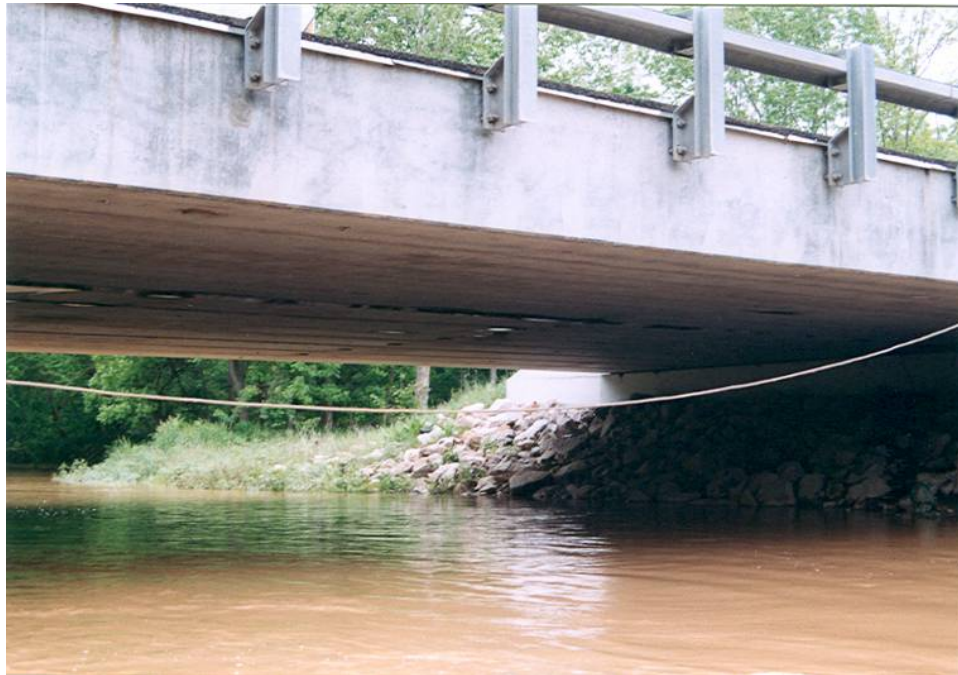
**Figure 10. Photo. State Route 22 Bridge at Milepost 6.57, Near Cambridge, Guernsey County, Ohio.**

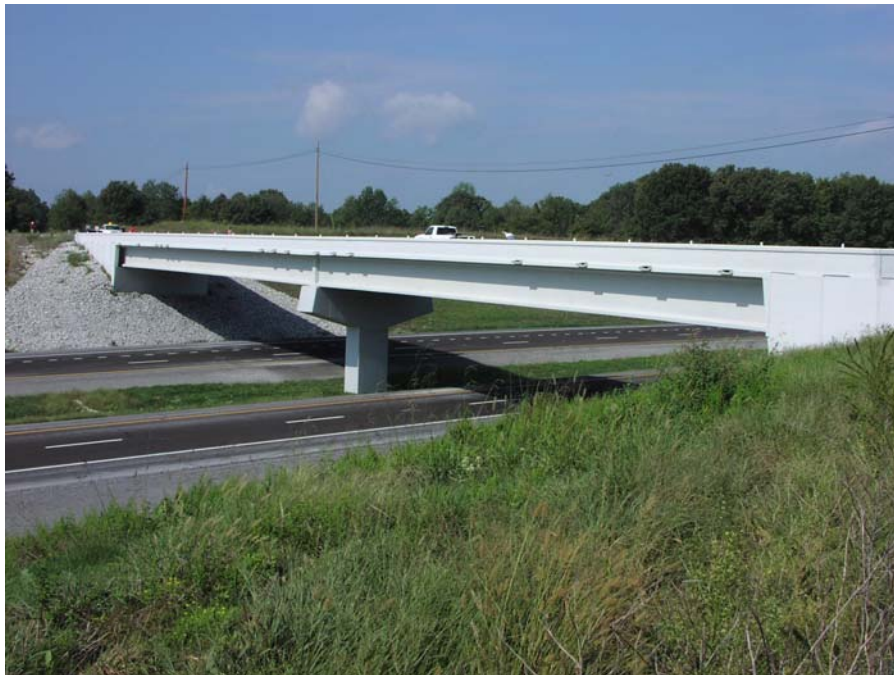
**Figure 14. Photo. Hickman Road (Dickson County, Tennessee).**

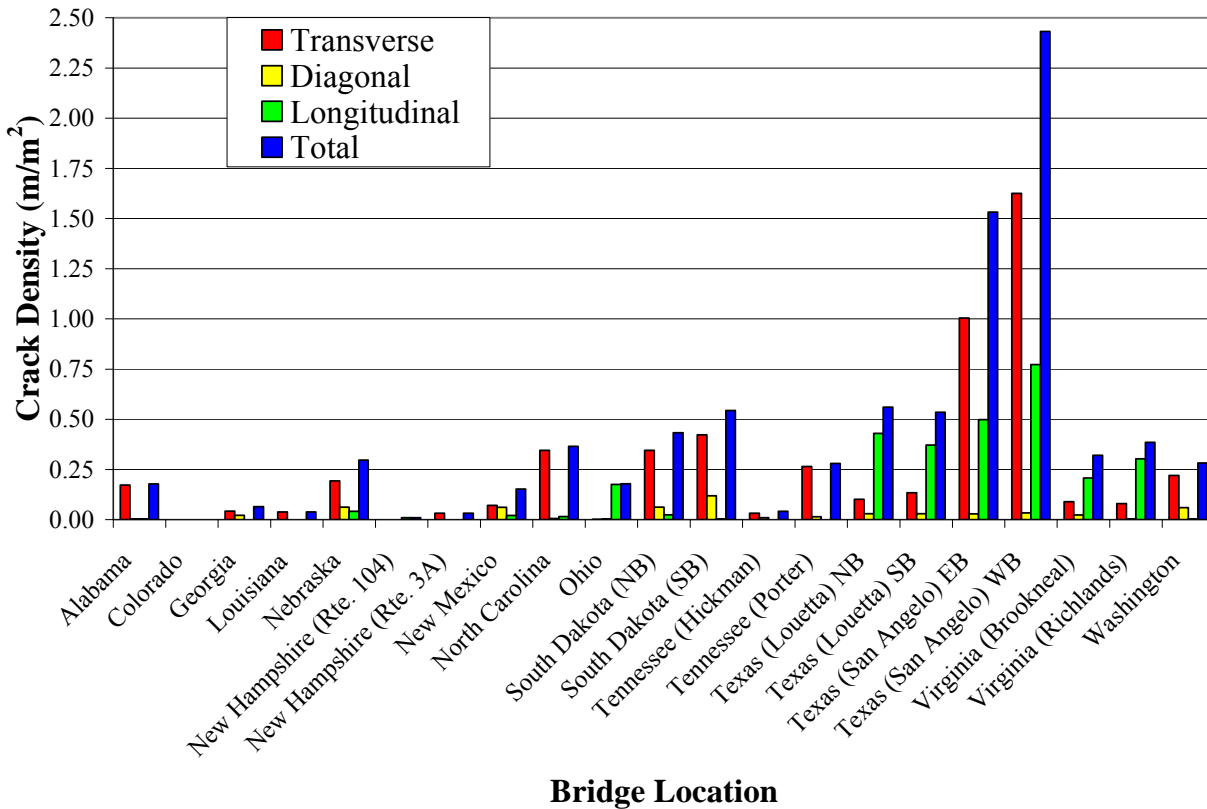
**Figure 20. Chart. Crack Densities for All Bridge Decks.**

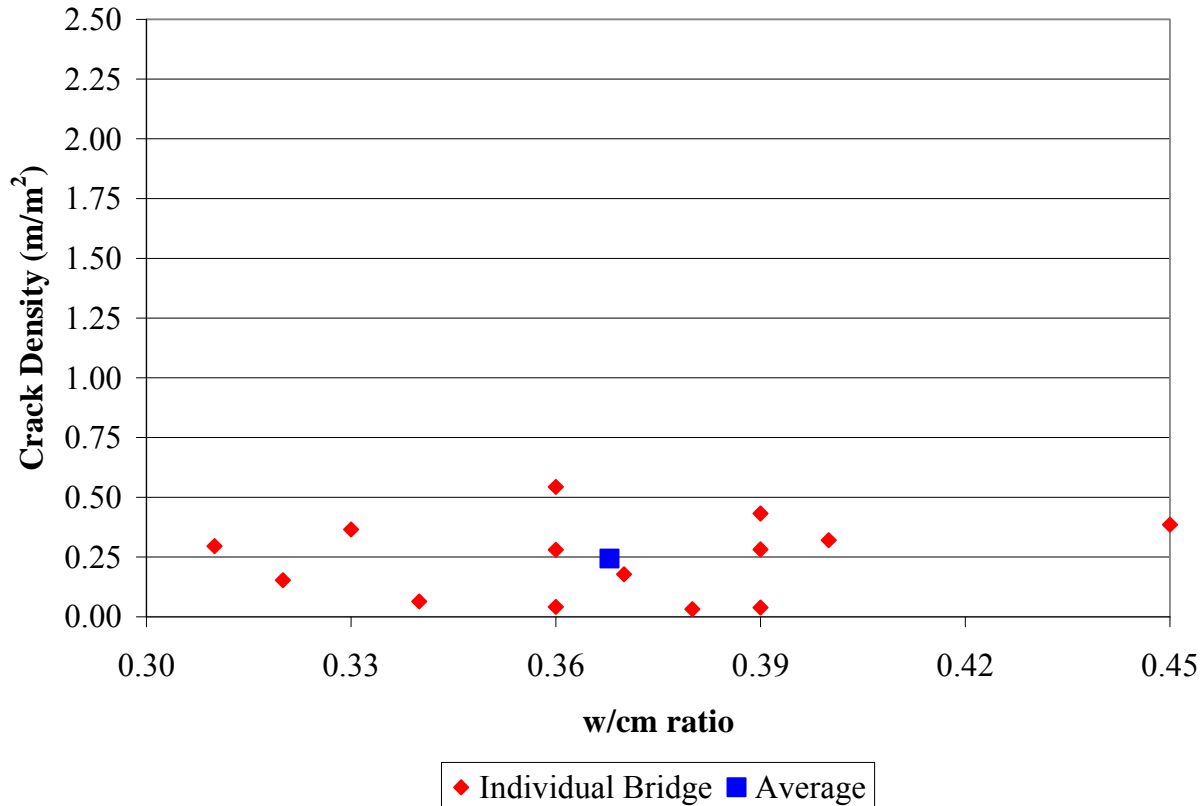
**Figure 21. Chart. Crack Density vs. w/cm ratio for all Bridge Decks.**

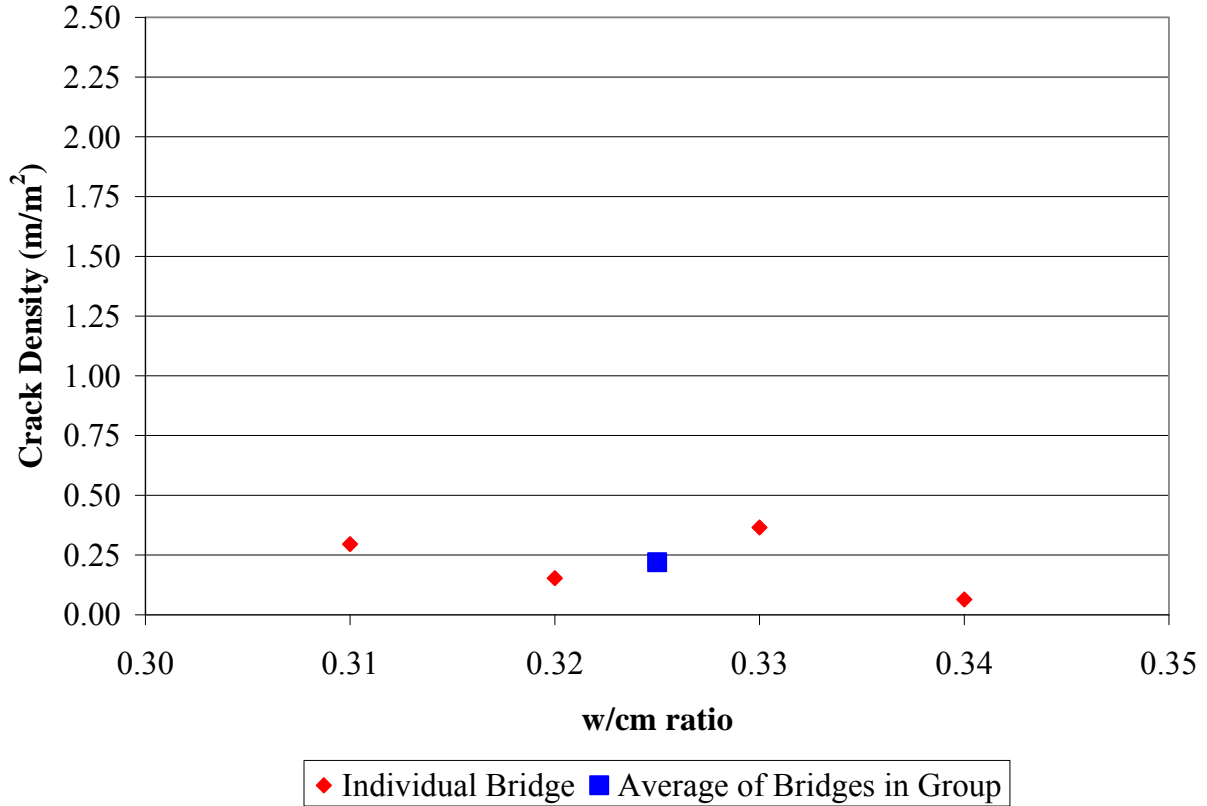
**Figure 22. Chart. Crack Densities for w/cm ratio 0.30 to 0.35.**

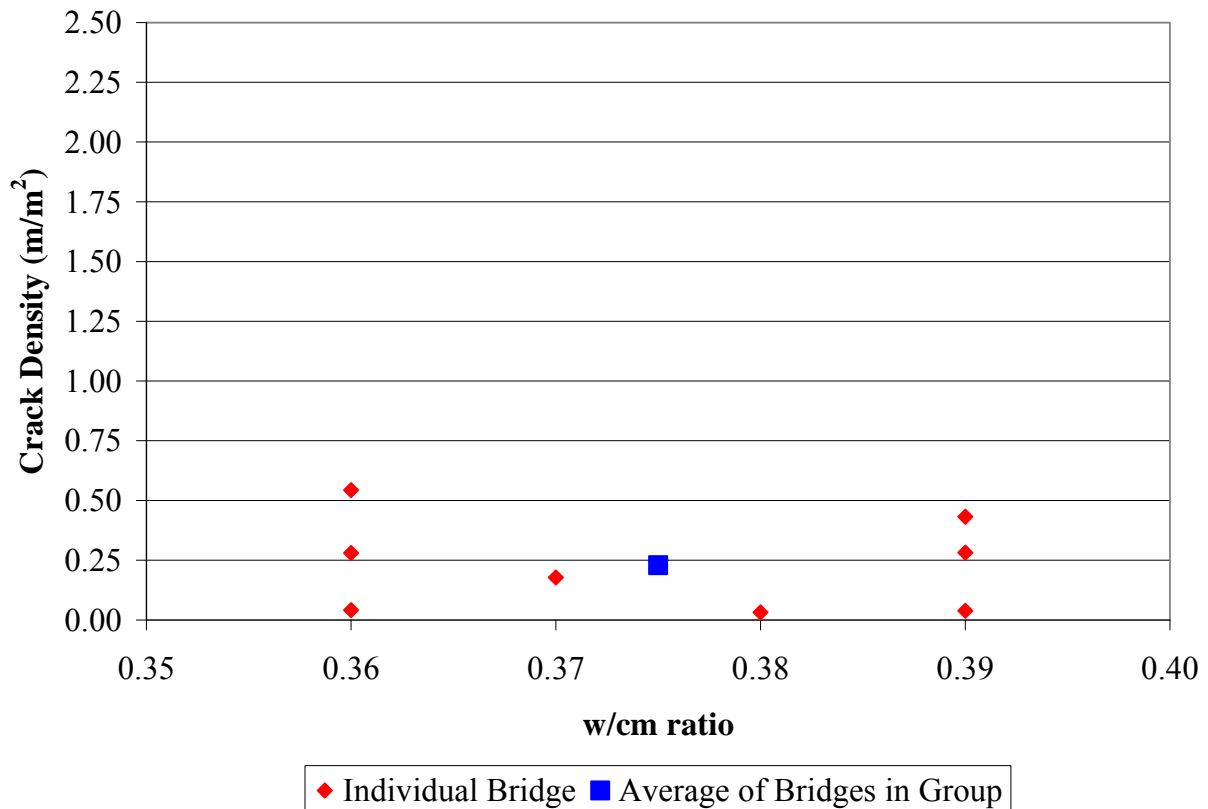
**Figure 23. Chart. Crack Densities for w/cm ratio 0.35 to 0.40.**

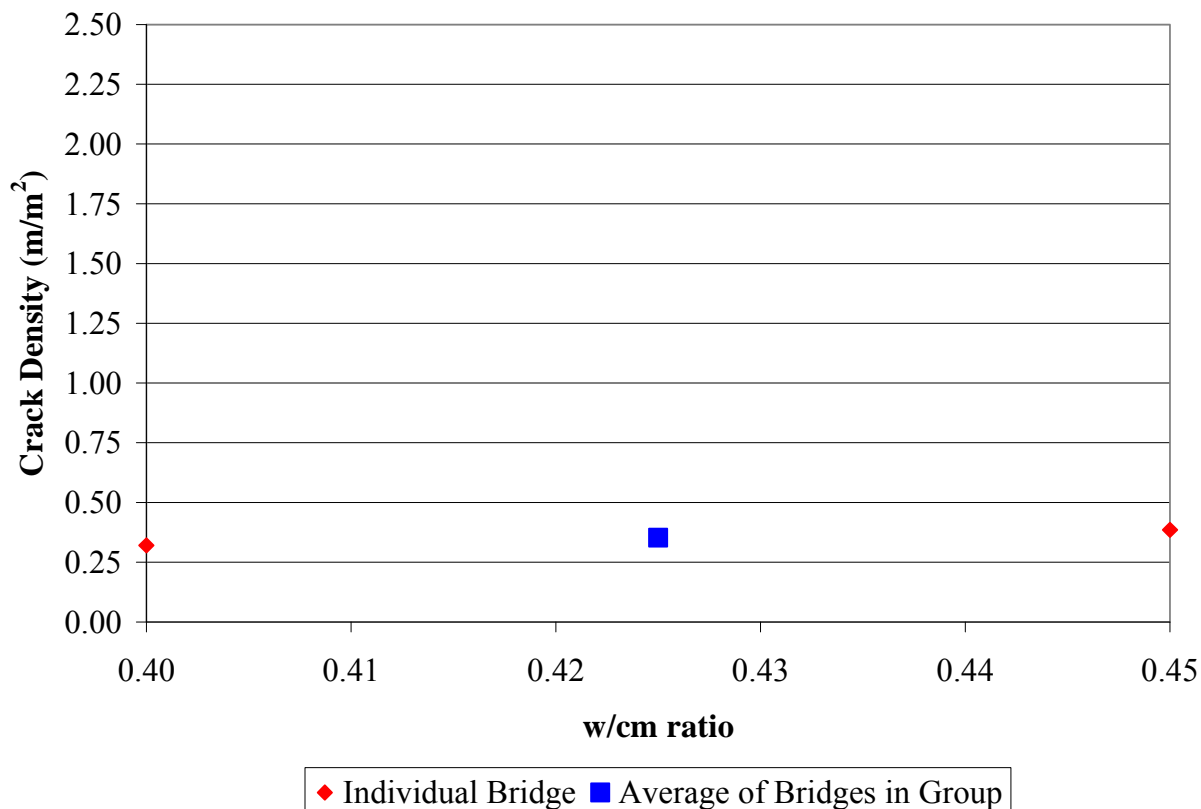
**Figure 24. Chart. Crack Densities for w/cm ratio 0.40 to 0.45.**

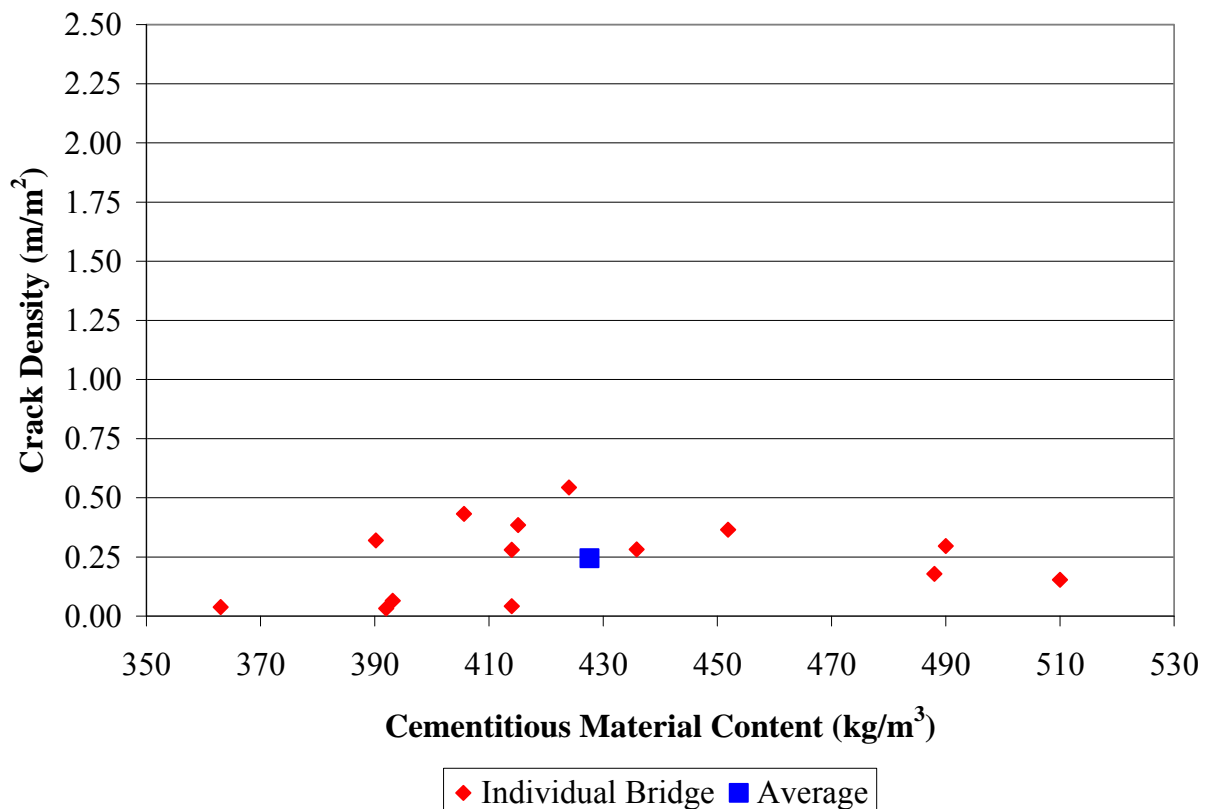
**Figure 25. Chart. Crack Density vs. Cementitious Material Content for all Bridge Decks.**

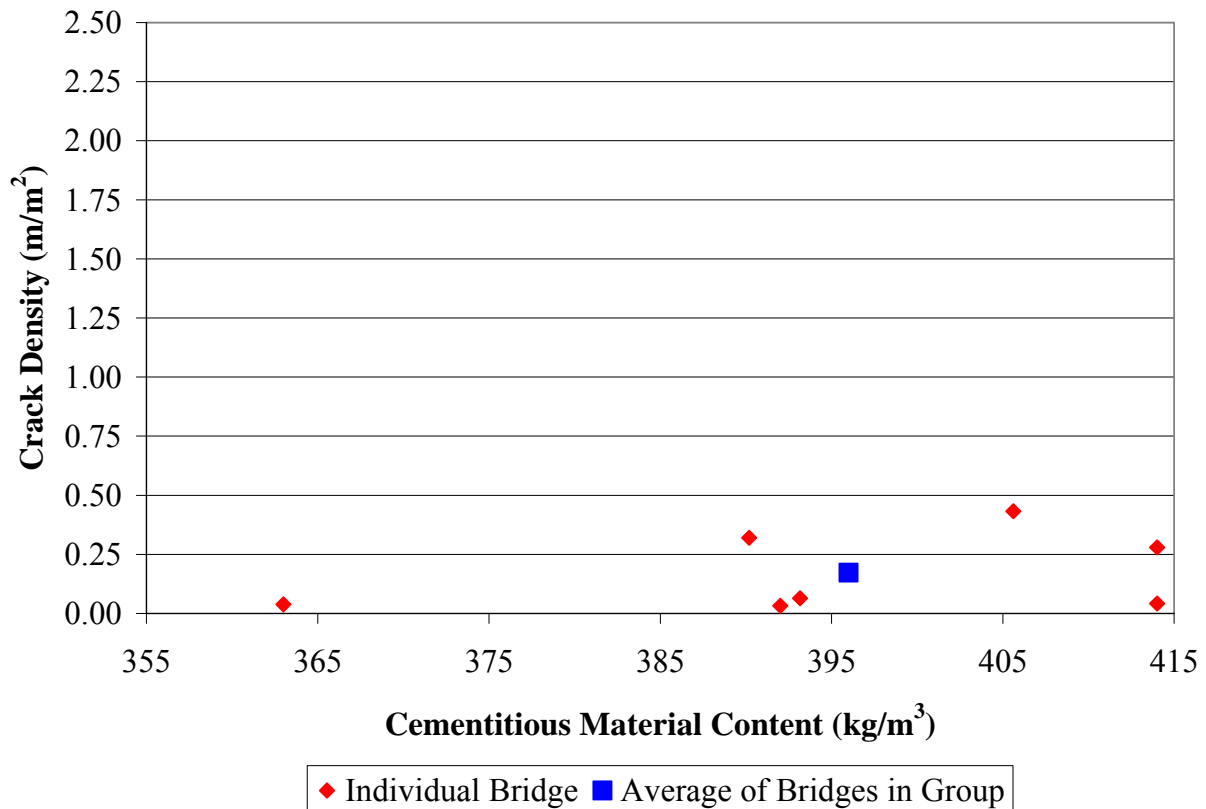
**Figure 26. Chart. Crack Densities for Cementitious Material Contents between 356 and 415 kg/m<sup>3</sup> (600 and 700 lb/yd<sup>3</sup>).**

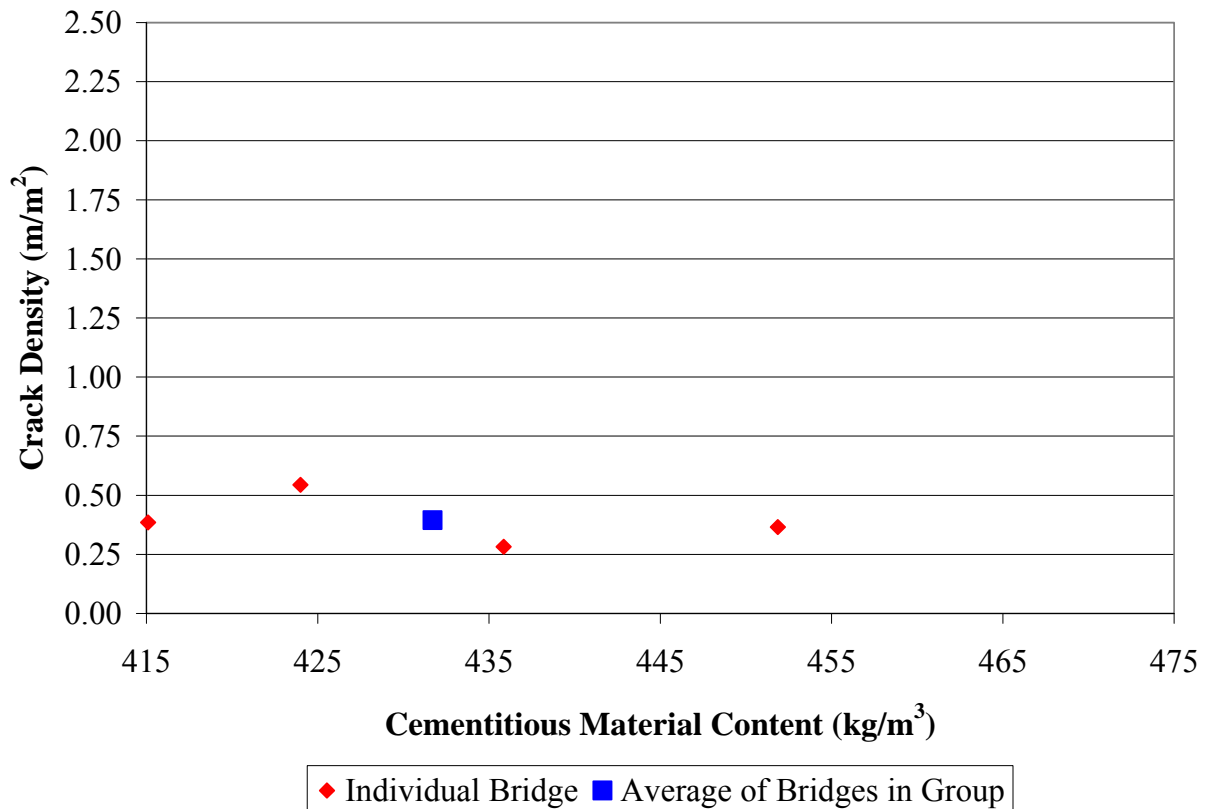
**Figure 27. Chart. Crack Densities for Cementitious Material Contents between 415 and 475 kg/m<sup>3</sup> (700 and 800 lb/yd<sup>3</sup>).**

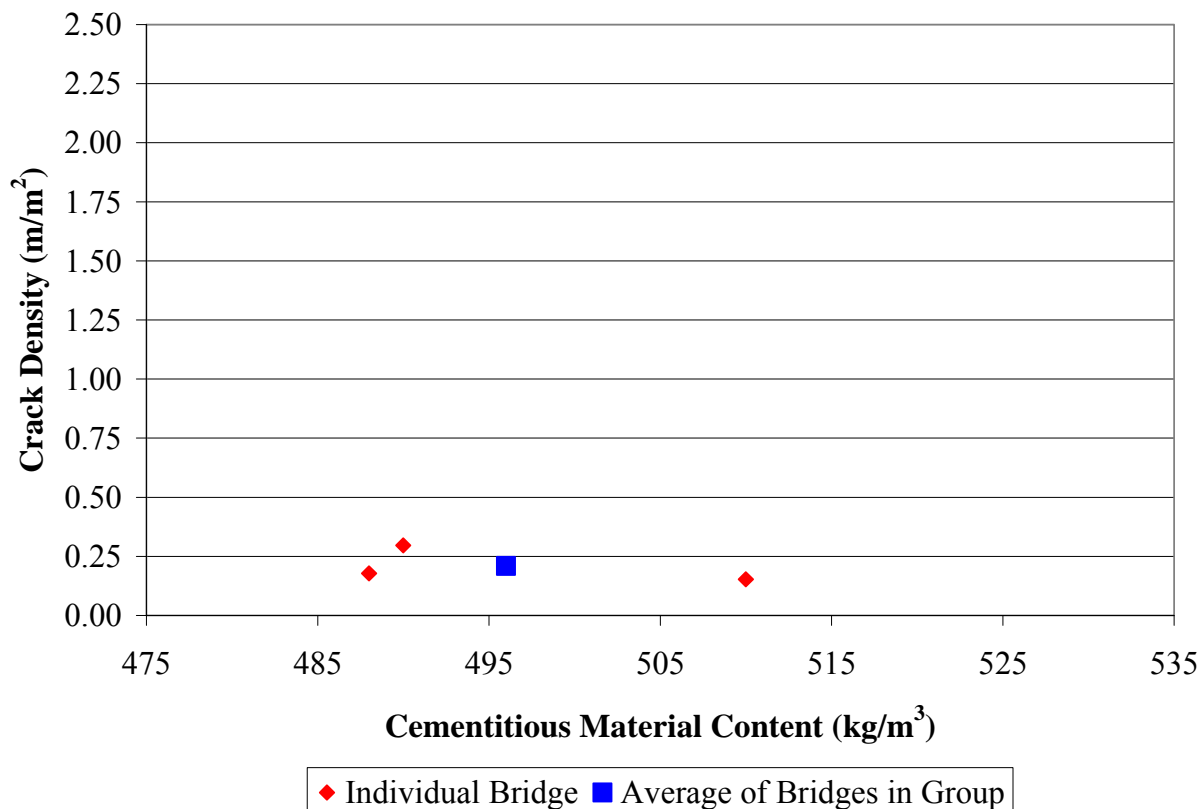
**Figure 28. Chart. Crack Densities for Cementitious Material Contents Greater than 475 kg/m<sup>3</sup> (800 lb/yd<sup>3</sup>).**

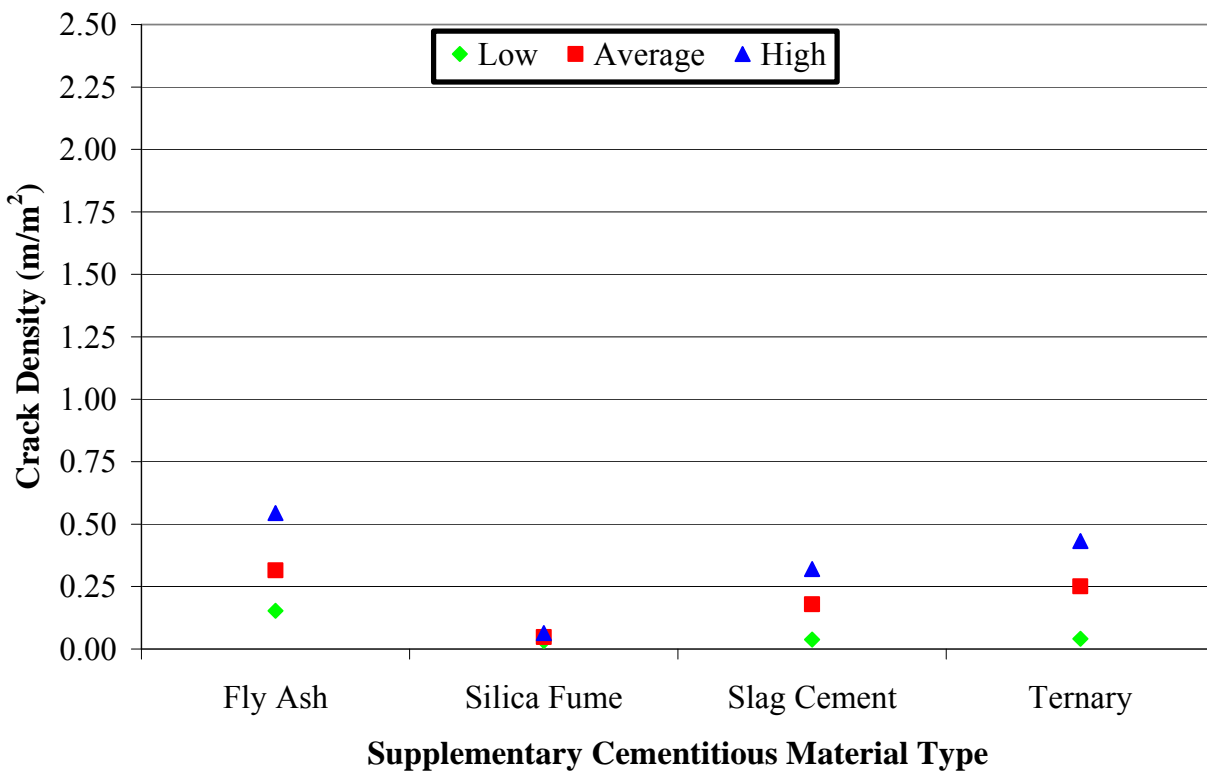
**Figure 29. Chart. Crack Density for Supplementary Cementitious Materials.**

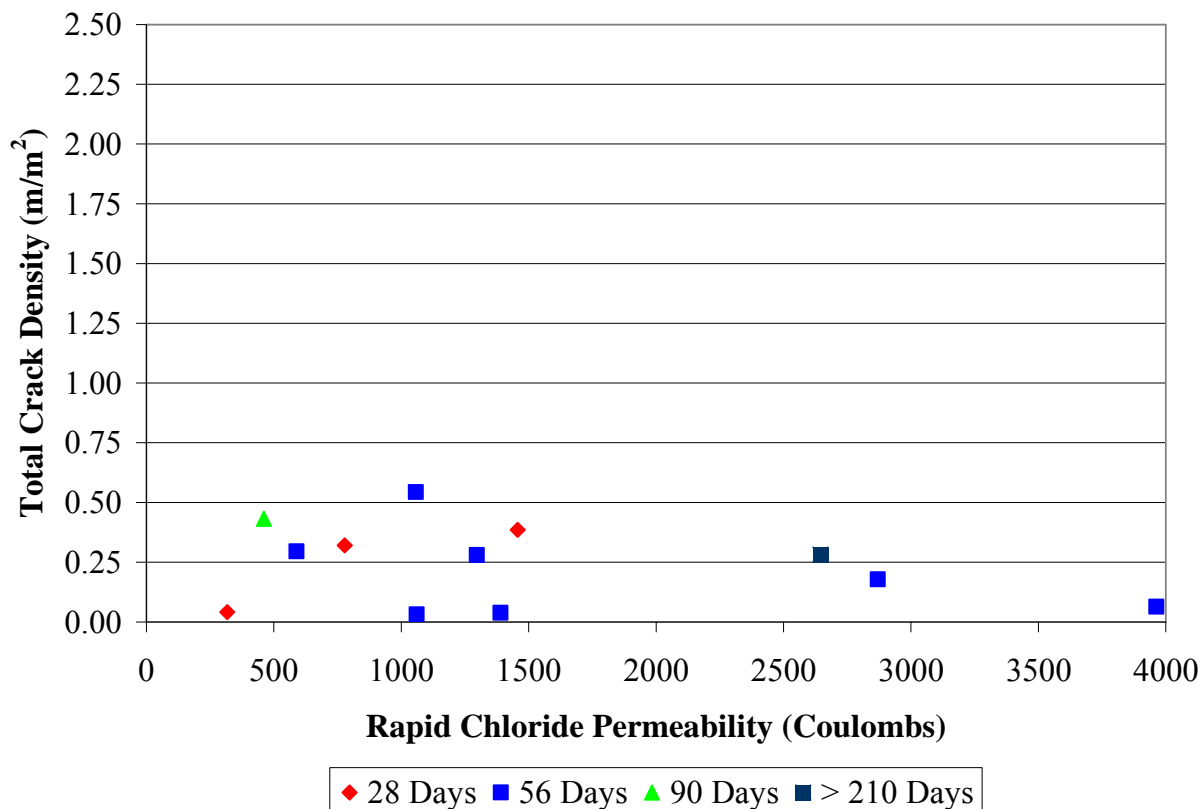
**Figure 30. Total Crack Density (m/m<sup>2</sup>) versus Rapid Chloride Permeability (Coulombs).**

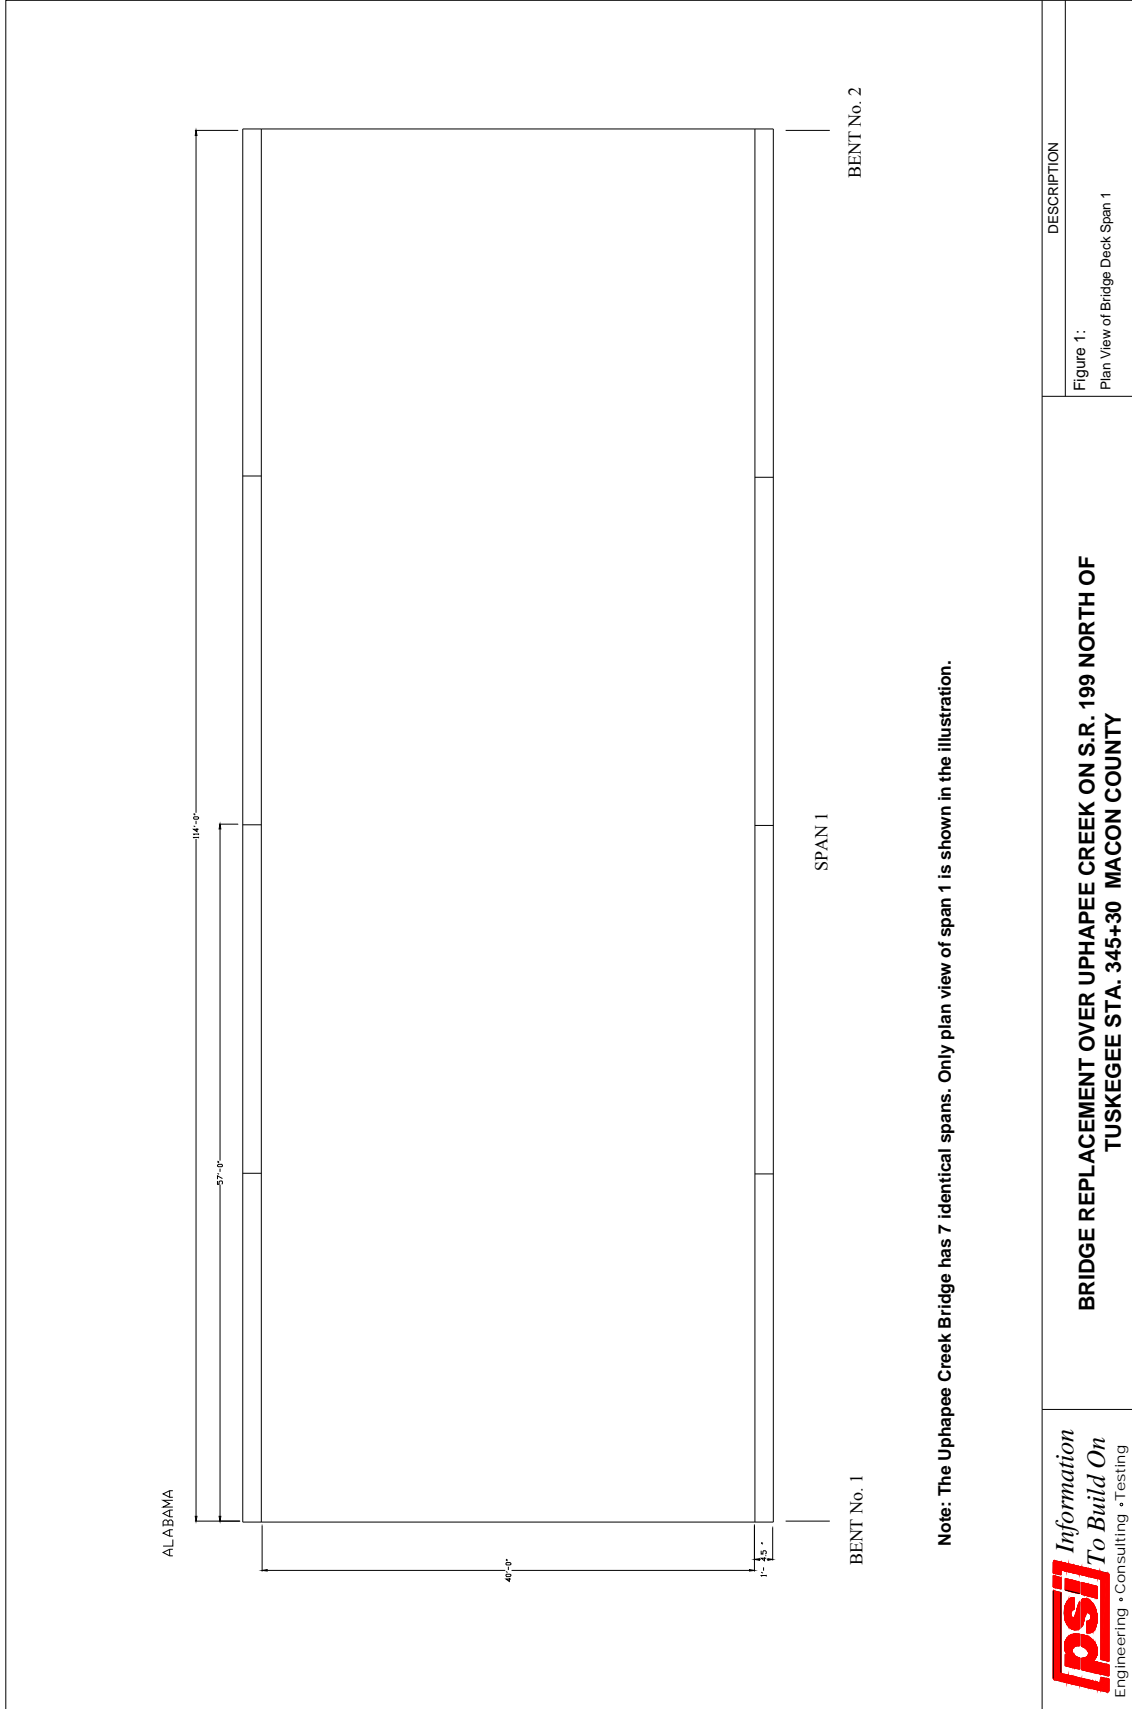
*Respectfully Submitted,*  
***Professional Service Industries, Inc.***  
*Structural Investigation and Petrography Department*

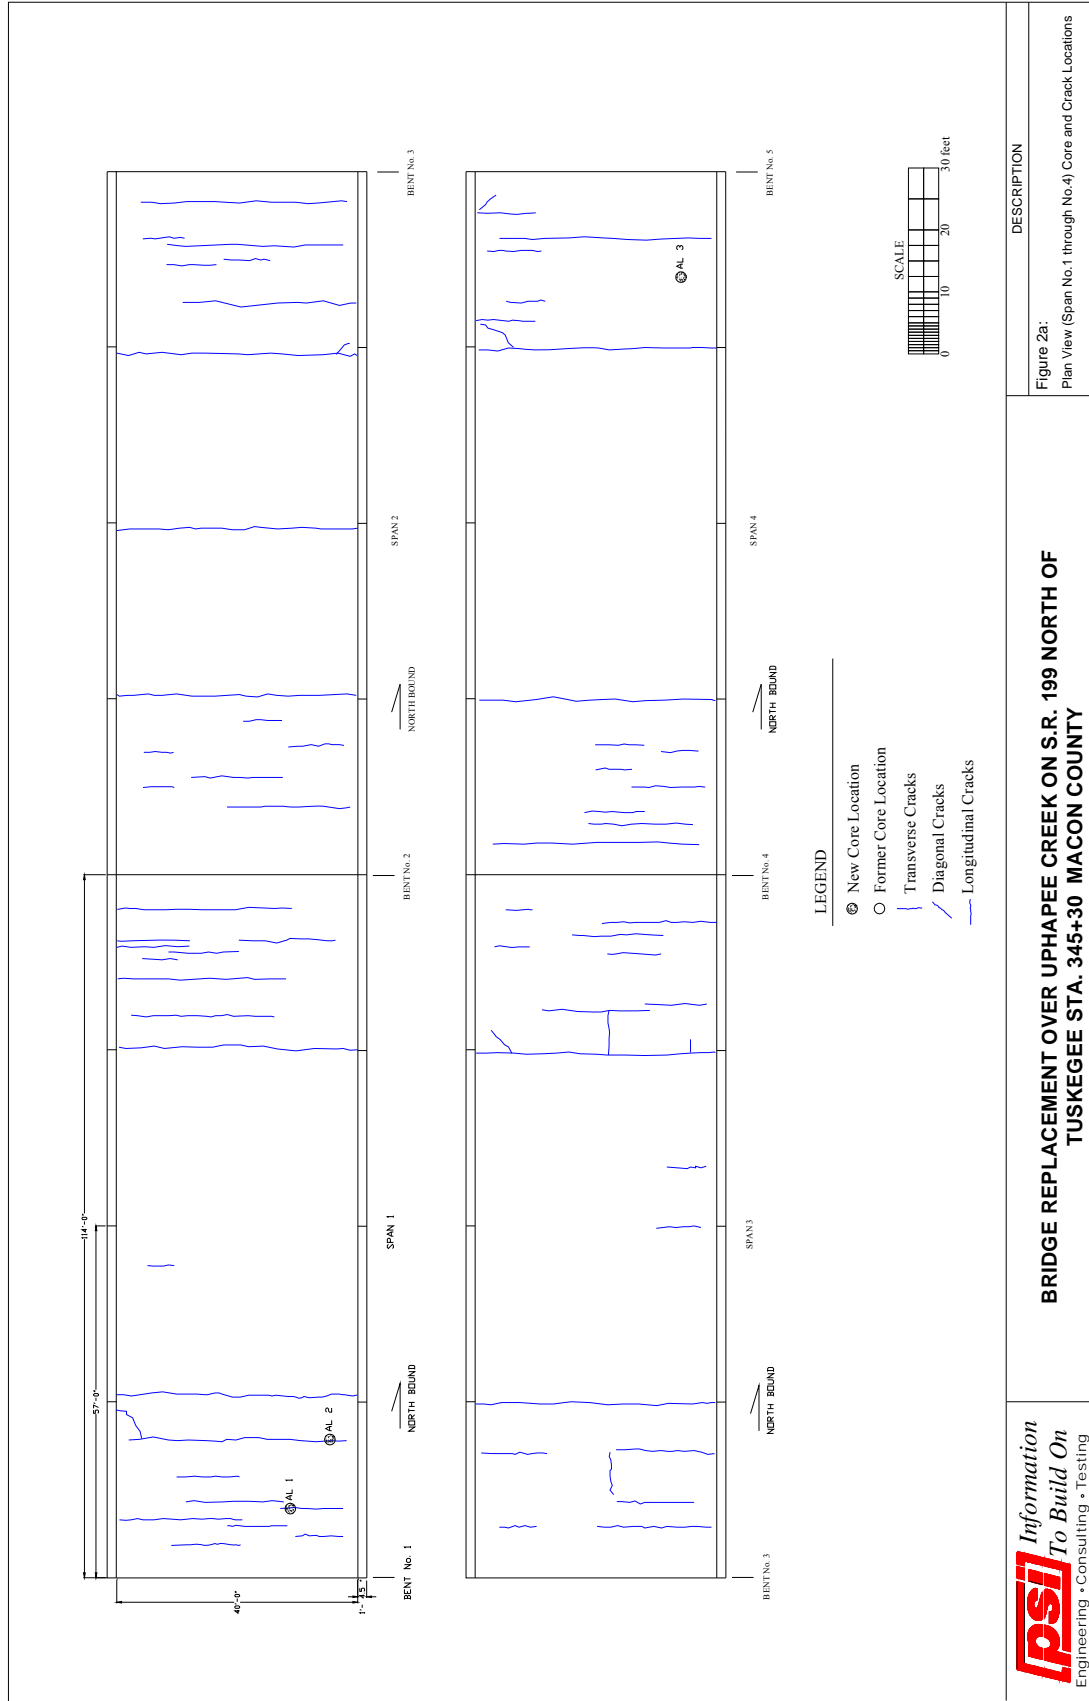
**BRIDGE REPLACEMENT OVER UPHAPEE CREEK ON S.R. 199 NORTH OF TUSKEGEE STA. 345+30 MACON COUNTY**

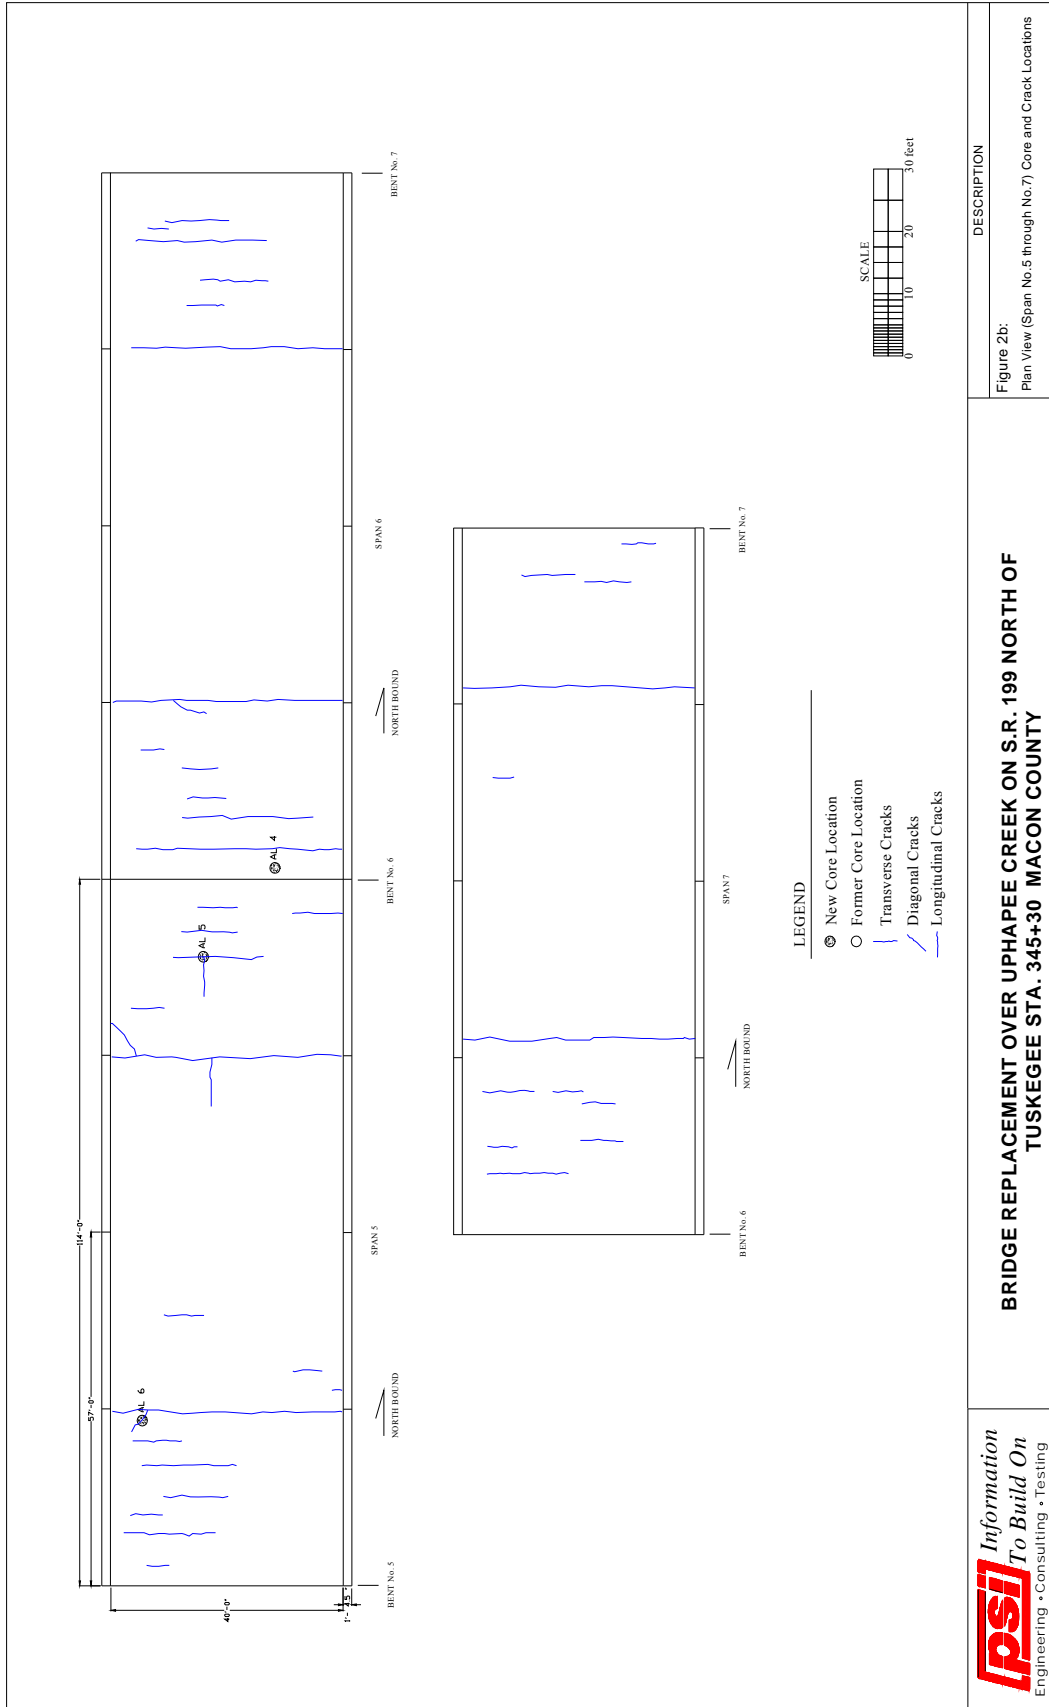
**BRIDGE REPLACEMENT OVER UPHAPEE CREEK ON S.R. 199 NORTH OF TUSKEGEE STA. 345+30 MACON COUNTY**

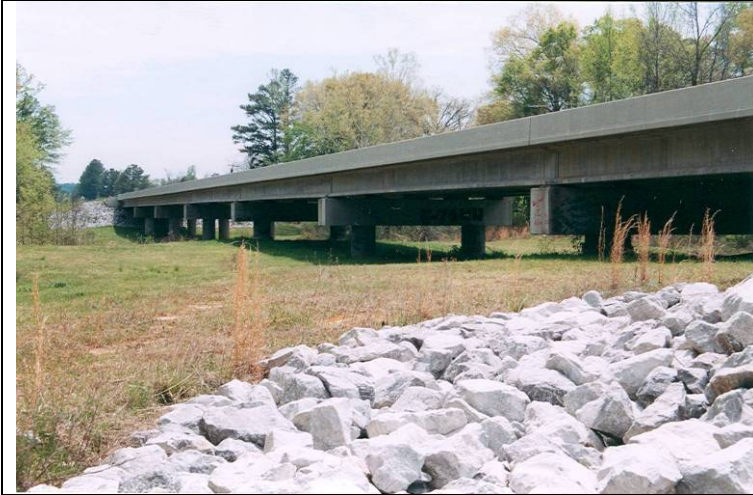
Photo 1: View looking south from the northern end of west facing bridge.

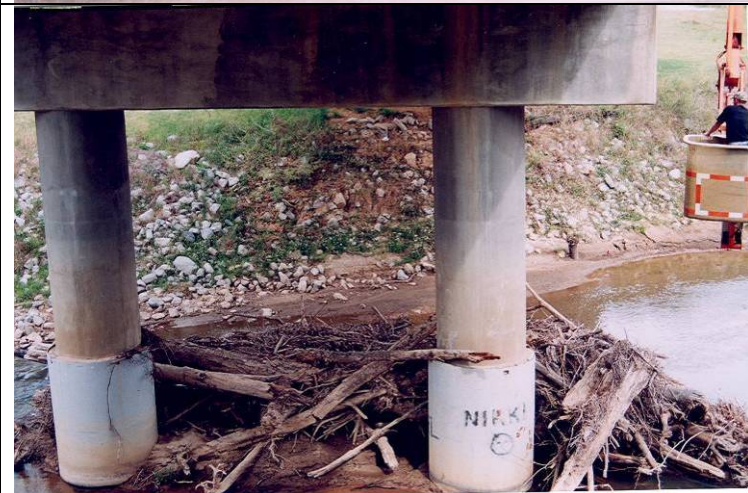
Photo 6: General condition of the piles at Span 2 east facing bridge. Accumulation of debris observed near the pile.

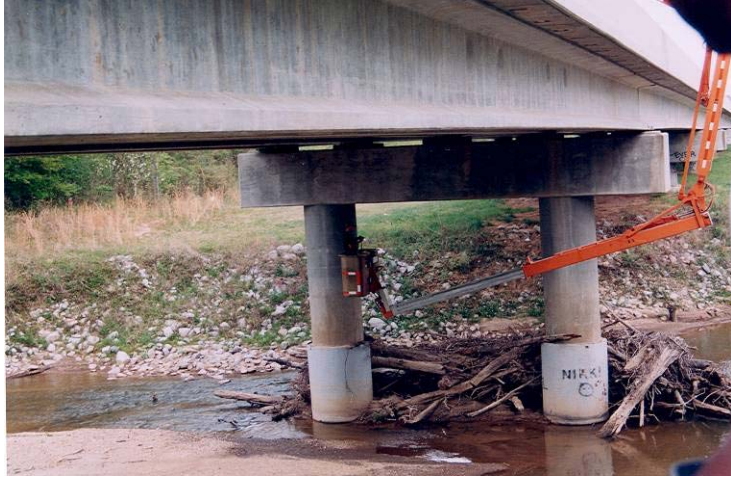
Photo 7: Close up view of bridge deck underside inspection using a snooper.

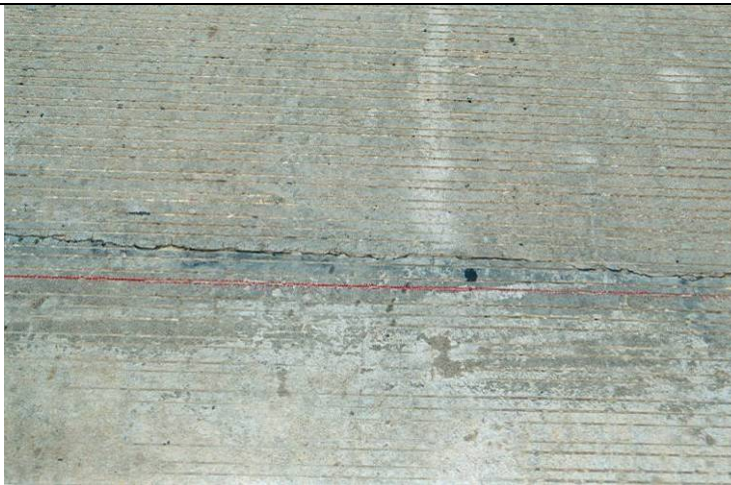
Photo 8: Close up view of typical transverse crack at deck joints.

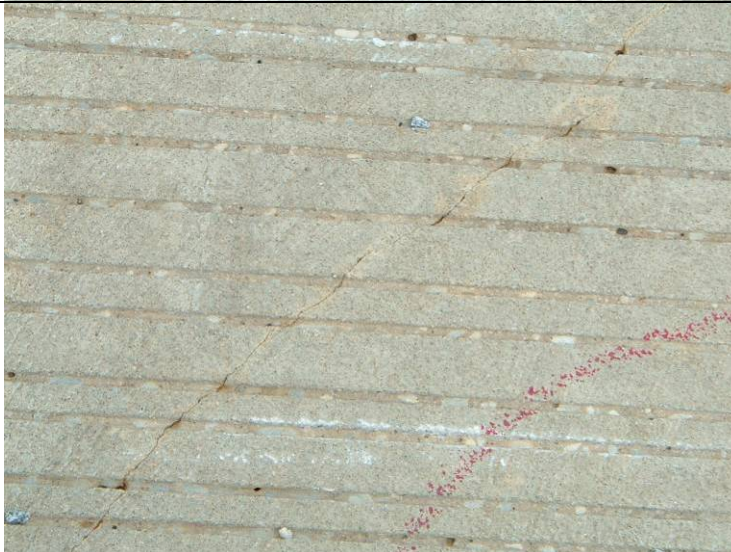
Photo 9: Close up view of typical longitudinal crack.

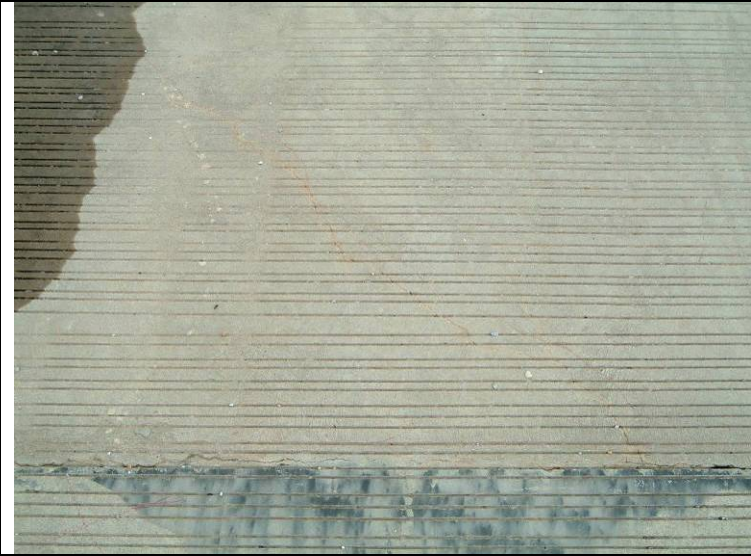
Photo 10: Close up view of typical diagonal crack.
