# High Performance Concrete Bridge Deck Investigation

November 2009

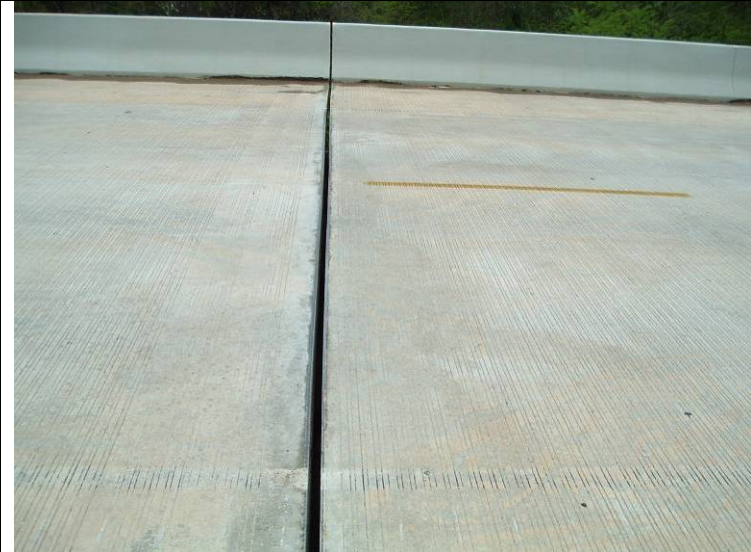
Photo 11: Unsealed gaps in between adjacent spans.

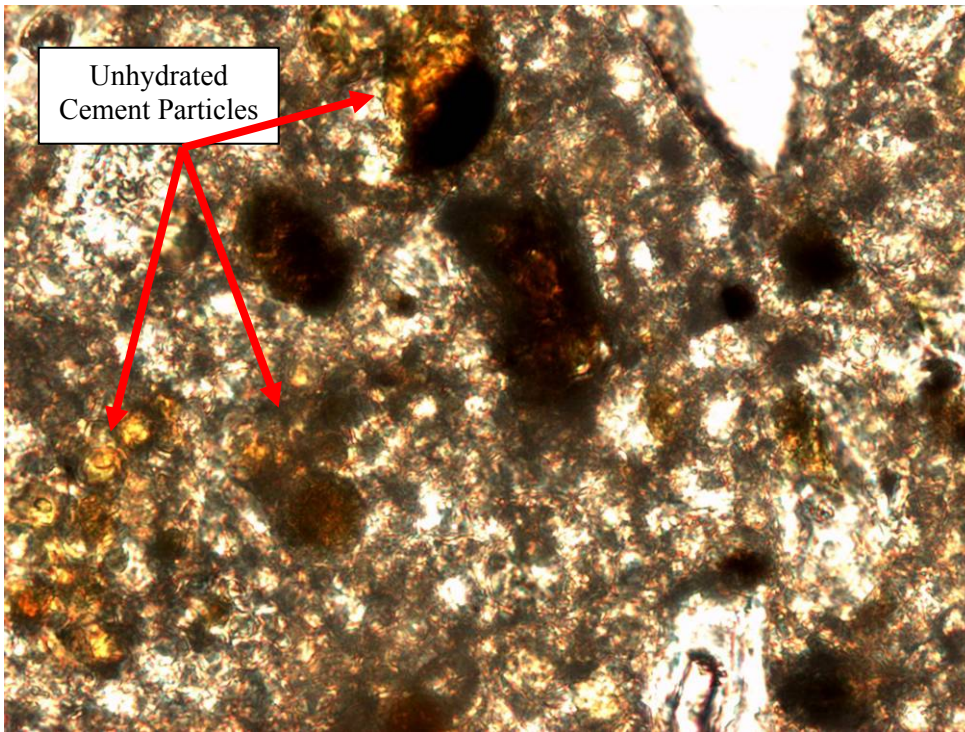
Figure A1-1: Unhydrated cement particles in paste. Width of field is 0.165 mm. Thin section image.

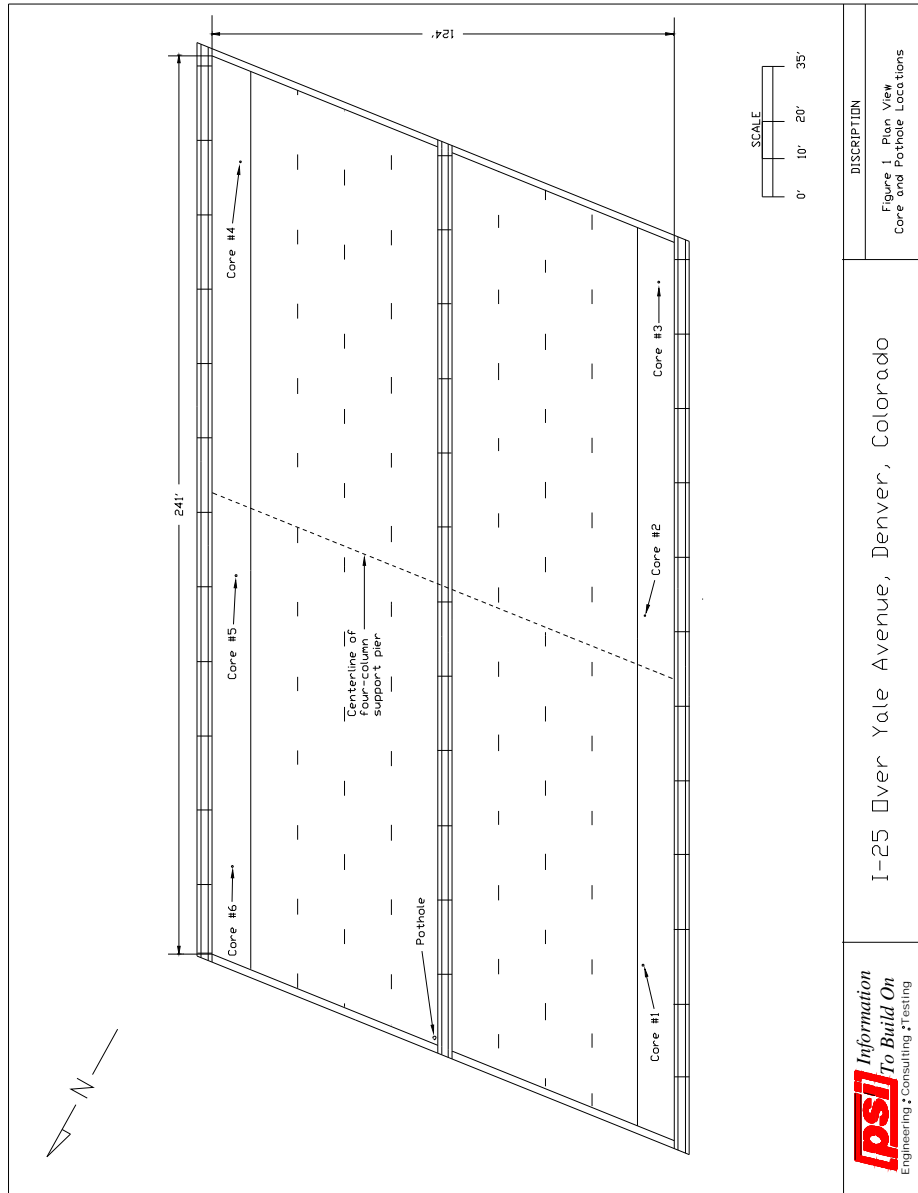
**[psj] Information To Build On**  
 Engineering • Consulting • Testing

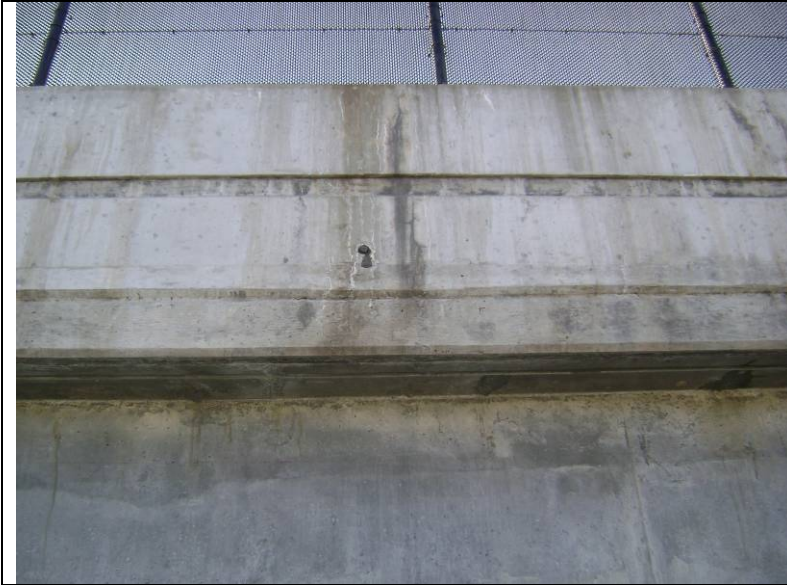
Photo 7: View showing typical cracks on the bridge parapet. Crack width is less than 1/32 in. and is categorized as hairline.

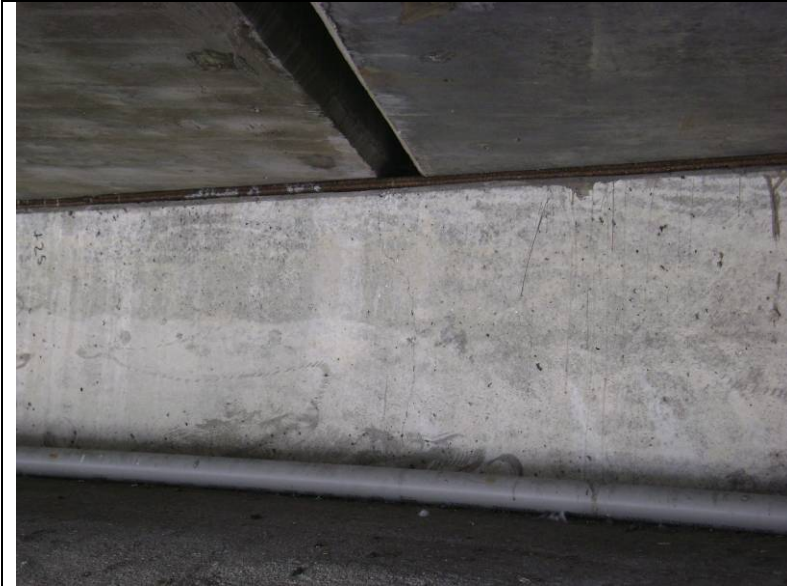
Photo 8: View showing cracks on the abutment at span ends.

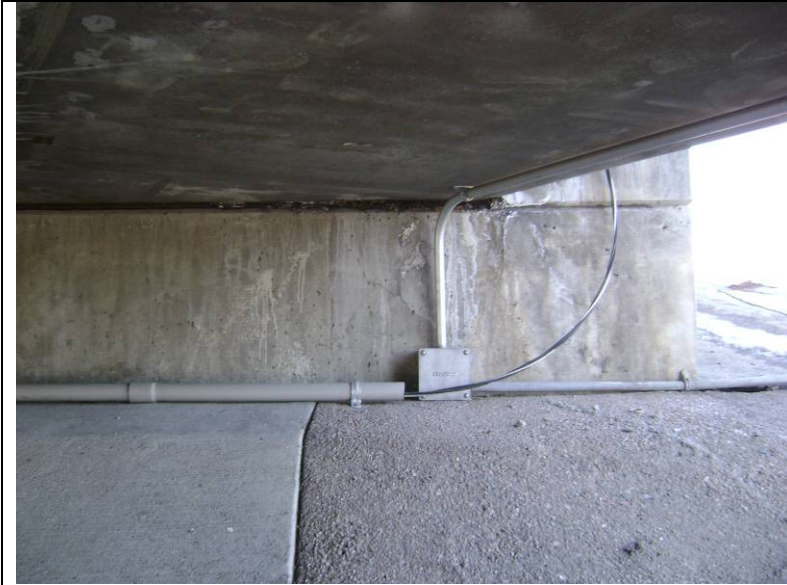
Photo 9: View showing underside of bridge at span end.

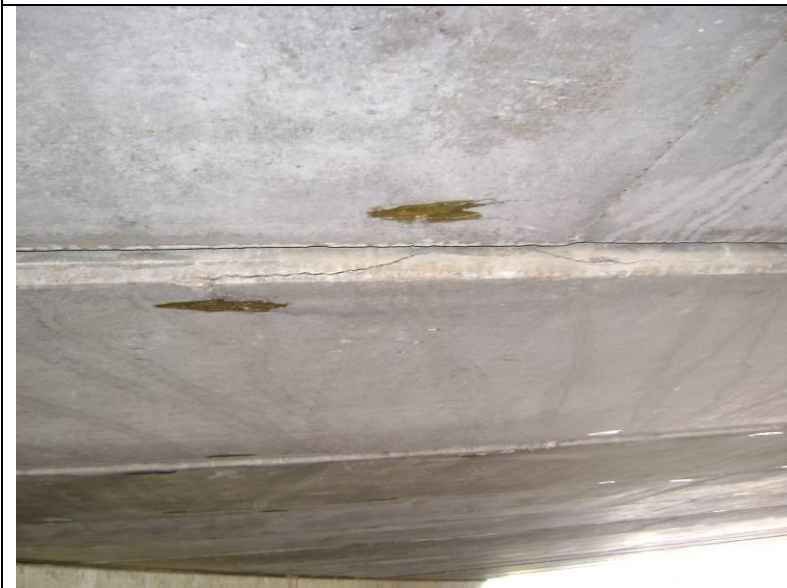
Photo 10: View showing the impact crack in the 16<sup>th</sup> girder.

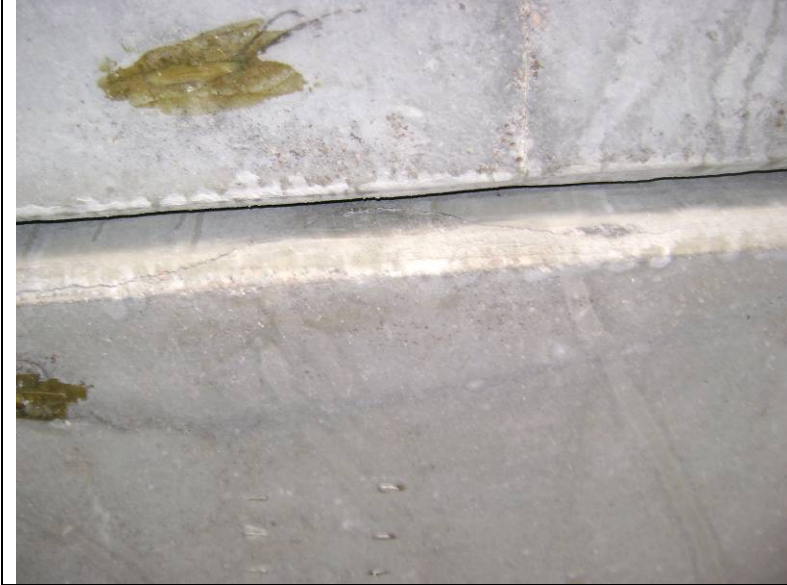
Photo 11: Close-up view showing of the impact crack in the 16<sup>th</sup> girder.

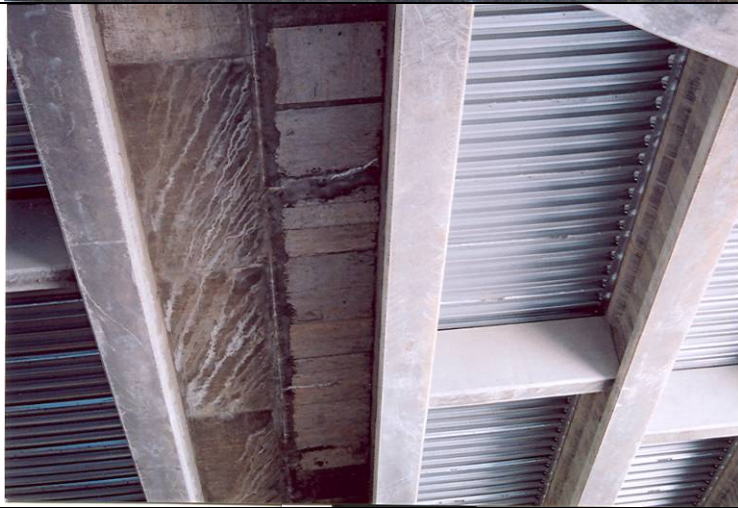
Photo 5: General condition of the girders at Span 2 facing west (southside). Cracks observed near efflorescence.

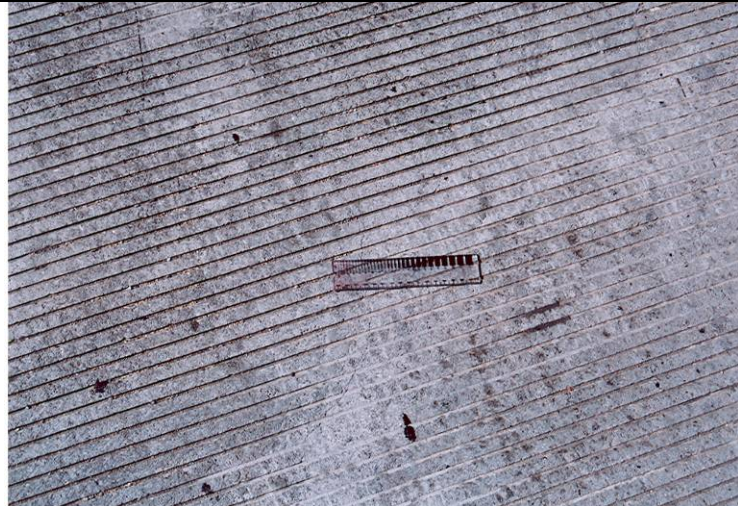
Photo 6: Close up view of diagonal crack at Span 1.

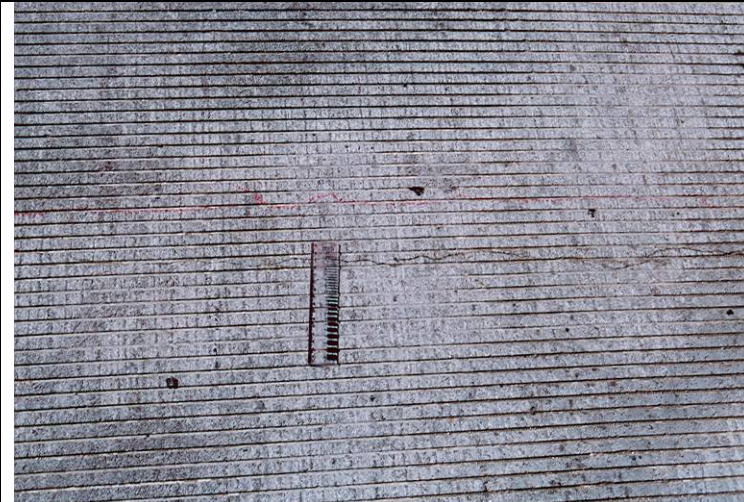
Photo 7: Close up view of transverse crack at Span 2. Crack width is 0.35 mm.

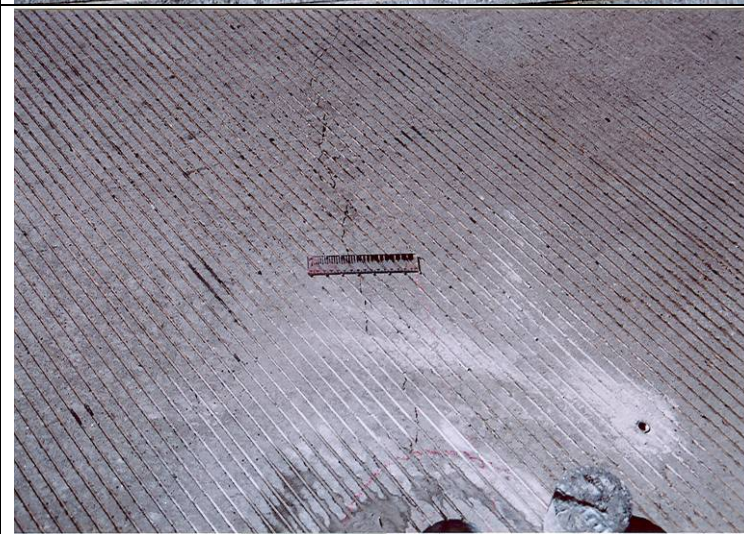
Photo 8: View of the diagonal crack extended through the core location.

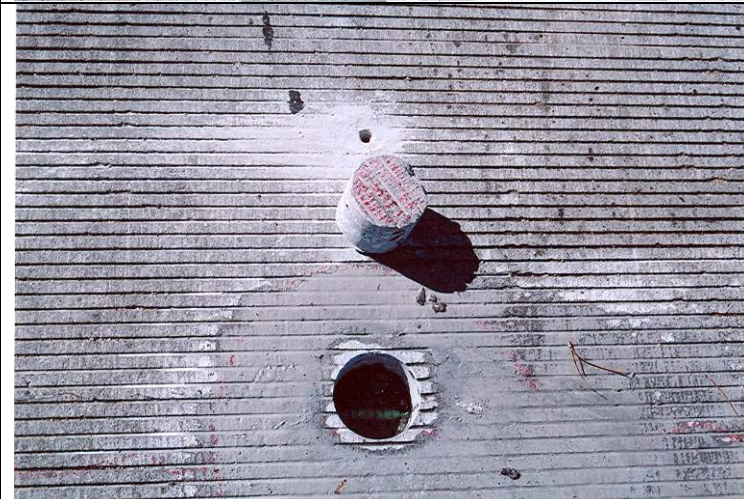
Photo 9: Broken tined edges core #6 at the shoulder of eastbound bridge Span 2.

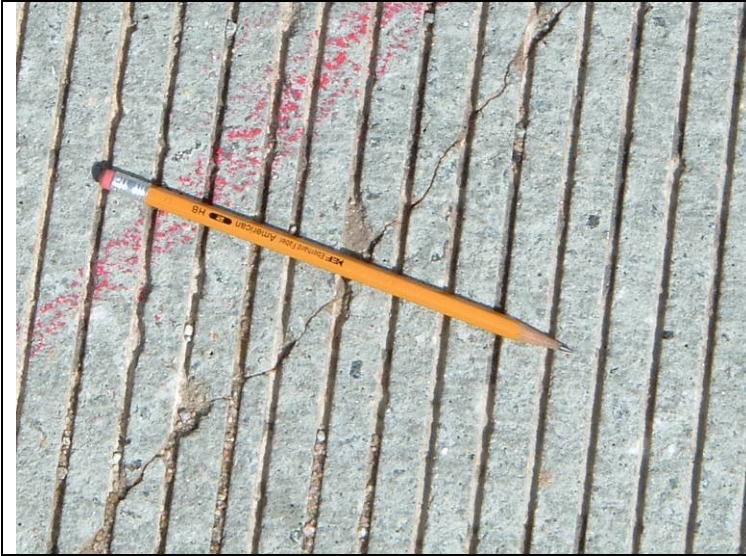
Photo 10: Close up view of the transverse crack at eastbound bridge Span 1.

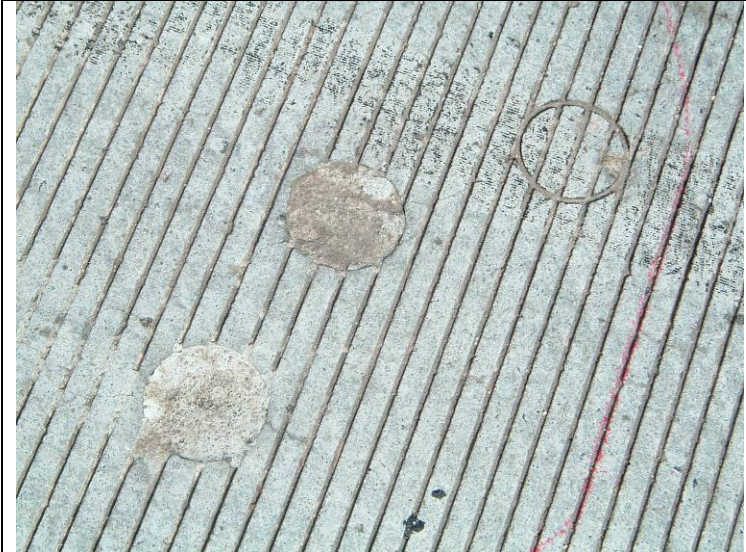
Photo 11: View of the existing drilled cores on Span 3 westbound bridge.

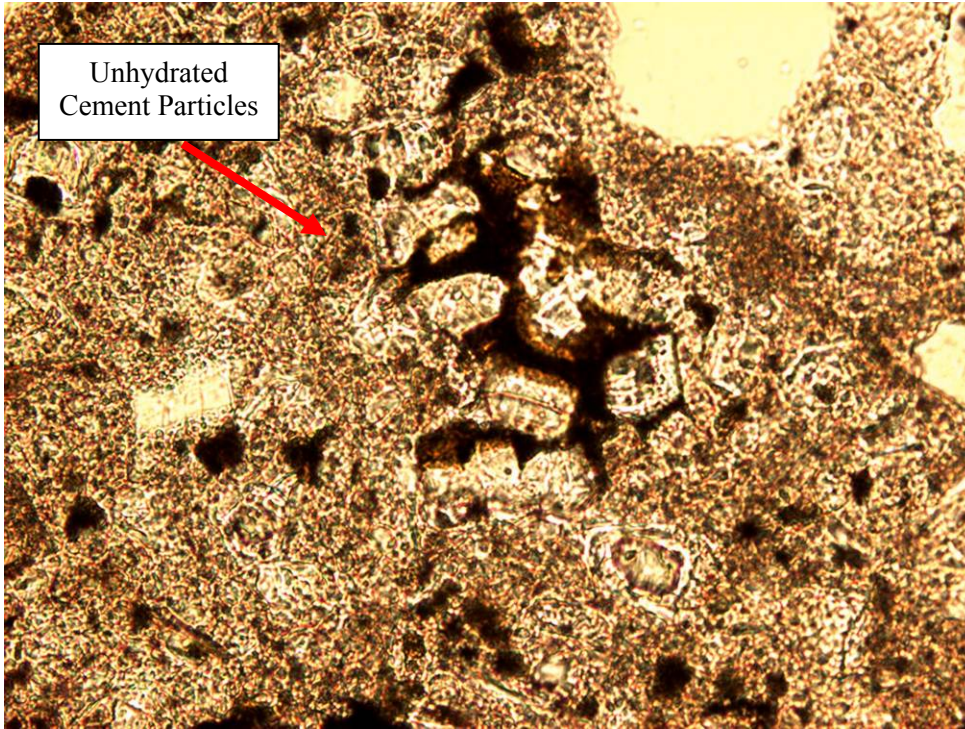
Figure C1-1: Unhydrated cement particles in paste. Width of field is 0.33 mm. Thin-section image.

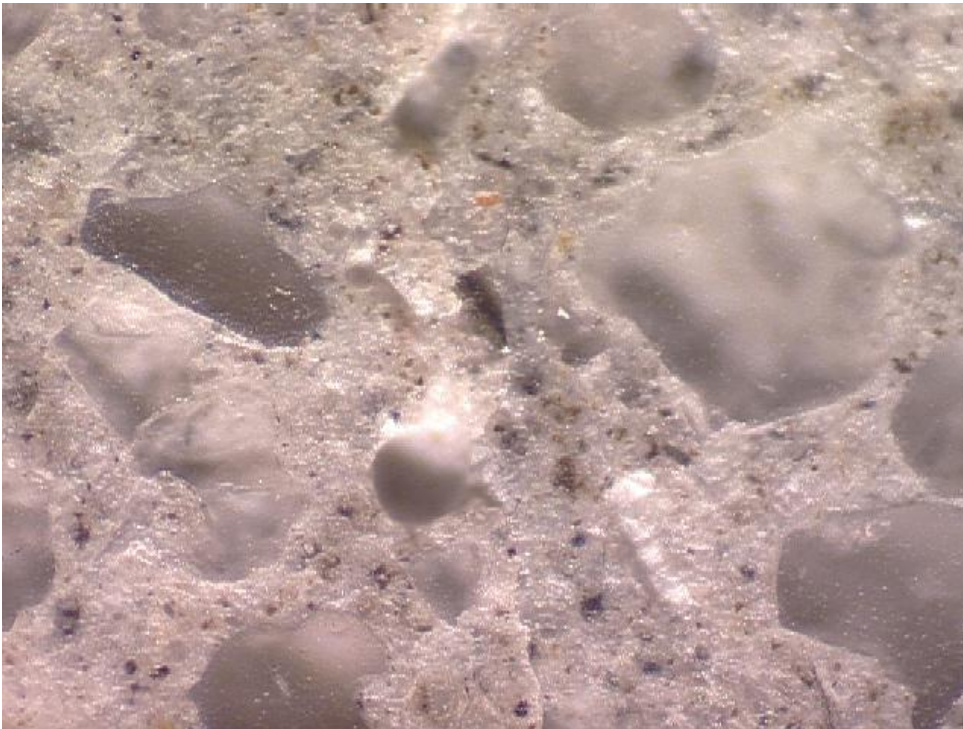
Figure C1-4: The bonding between aggregate and cement paste is moderate. Width of field is 2.0 mm. Polished surface image. Note a crack is at the center of the image.

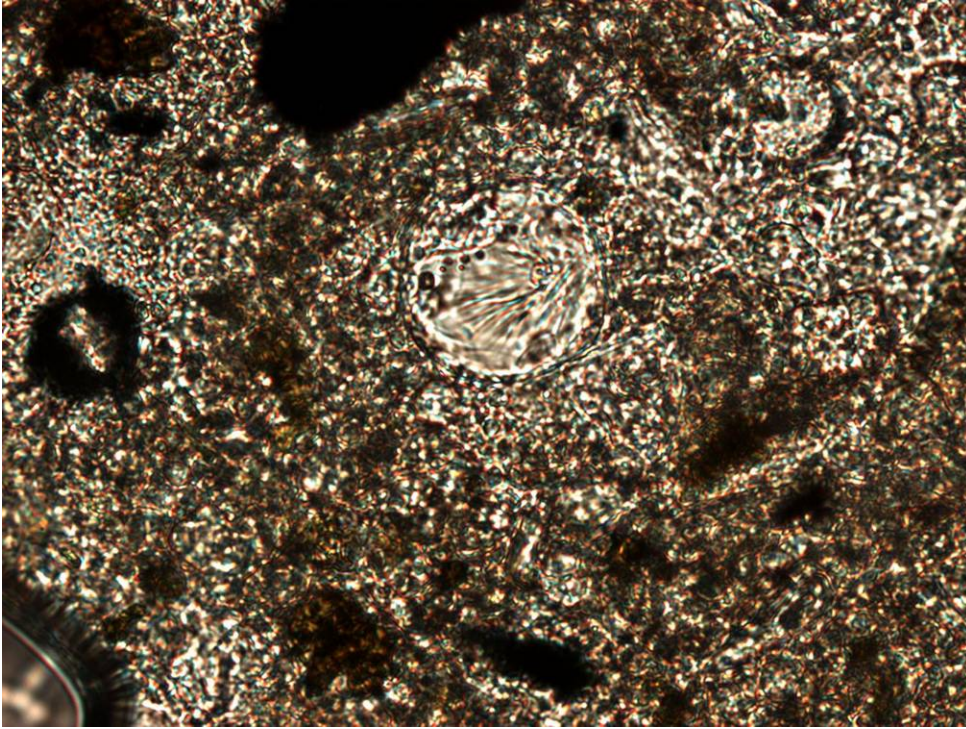
Figure C1-5: Image of ettringite in an air void. Width of field is 0.165 mm. Thin-section image 0.165 mm.

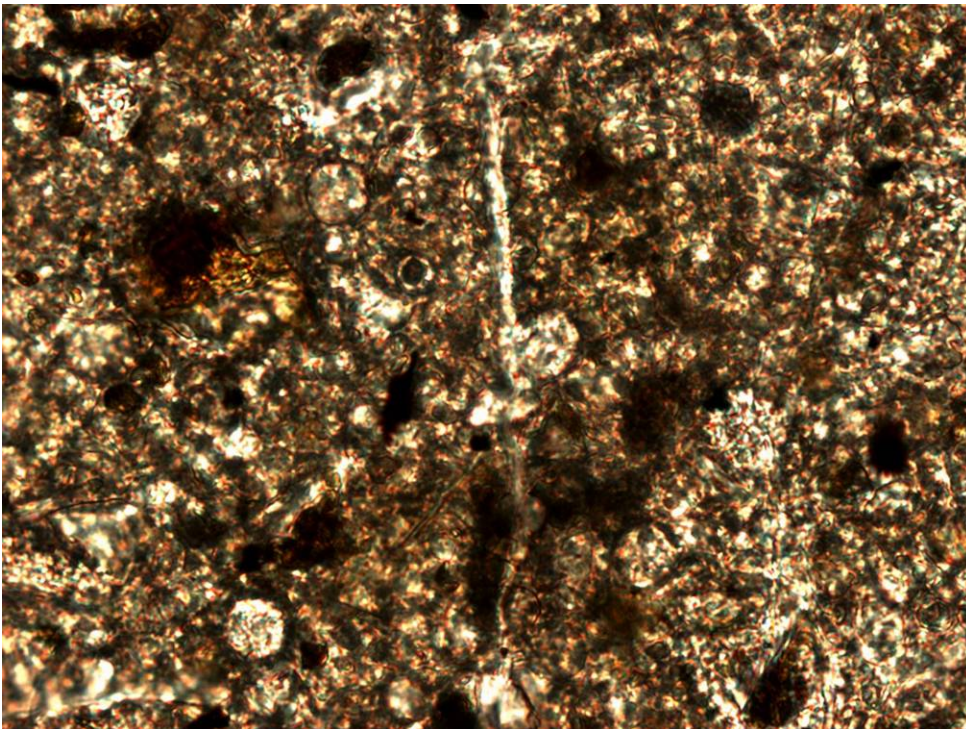
Figure C1-6: Crack in the cement paste. Width of field is 0.165 mm. Thin-section image.

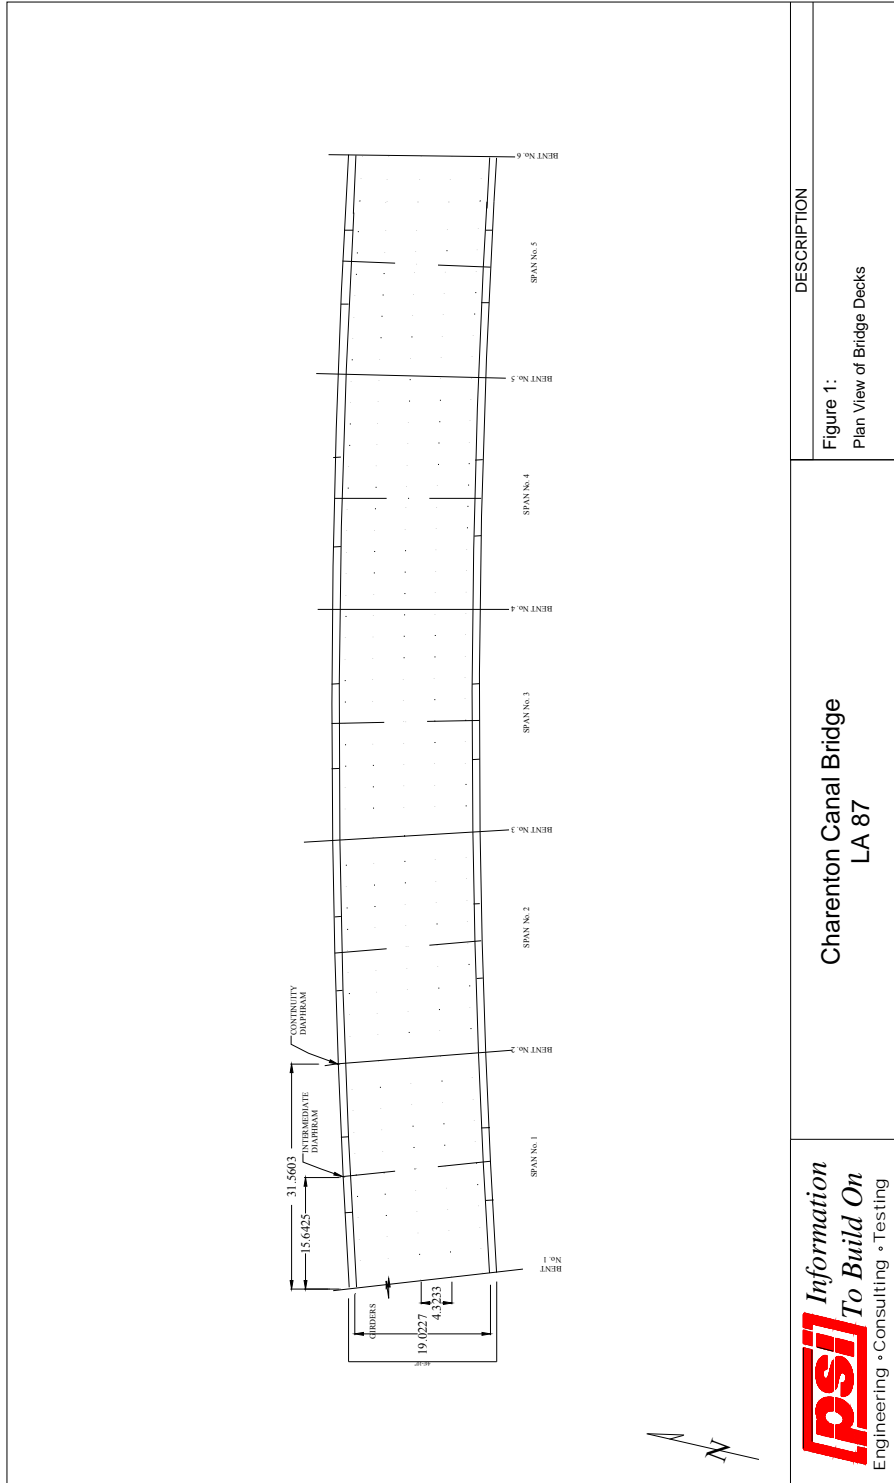
Figure 1:  
Plan View of Bridge Decks

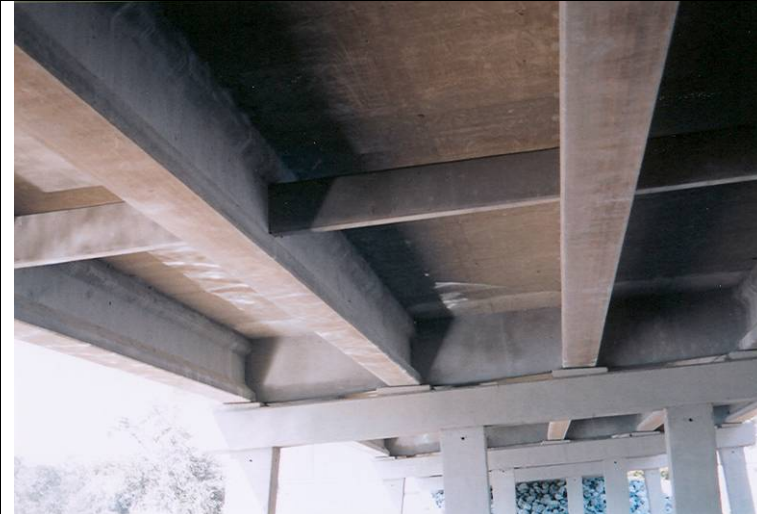
Photo 6: General condition of the girders at Span 2 facing west (southside).

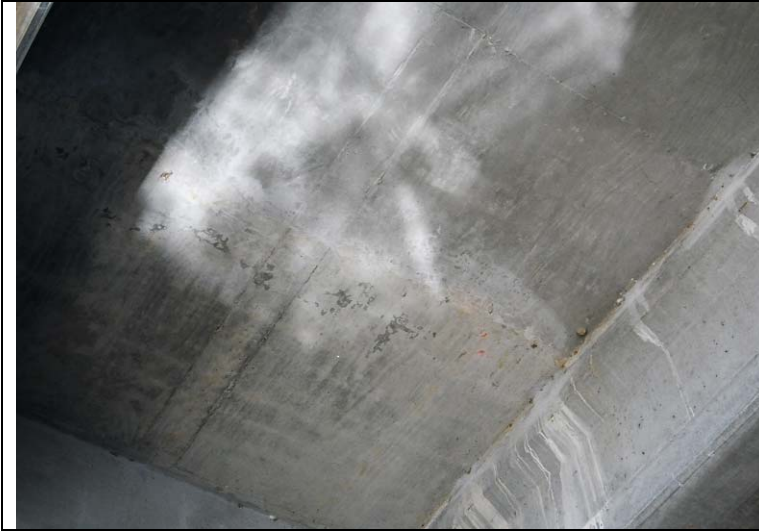
Photo 7: White precipitants along the overhang on the eastbound bridge.

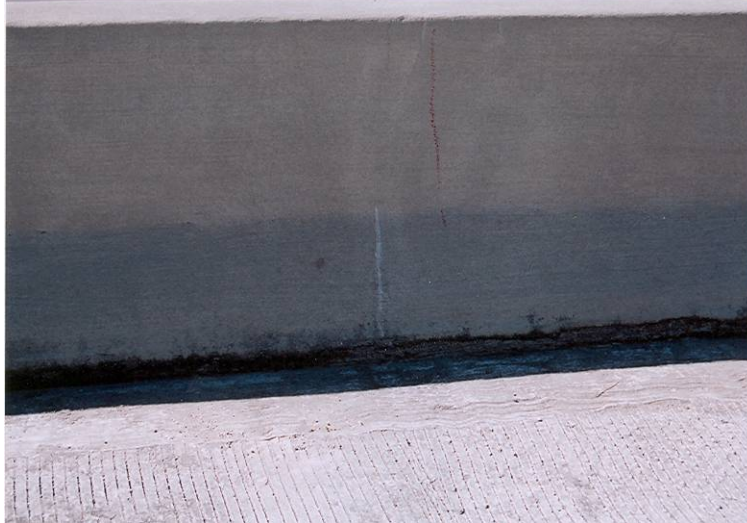
Photo 8: View of the concrete barrier at westbound bridge showing cracking and efflorescence.

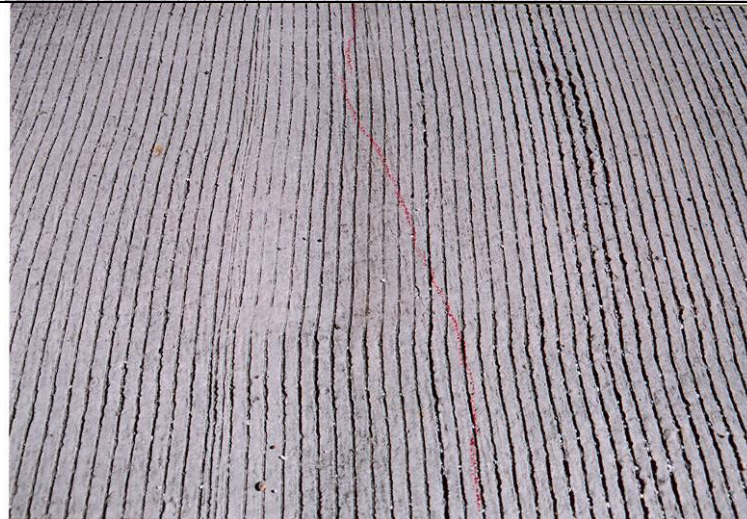
Photo 9: View of the transverse cracks at eastbound bridge Span 1 showing the transverse cracking pattern.

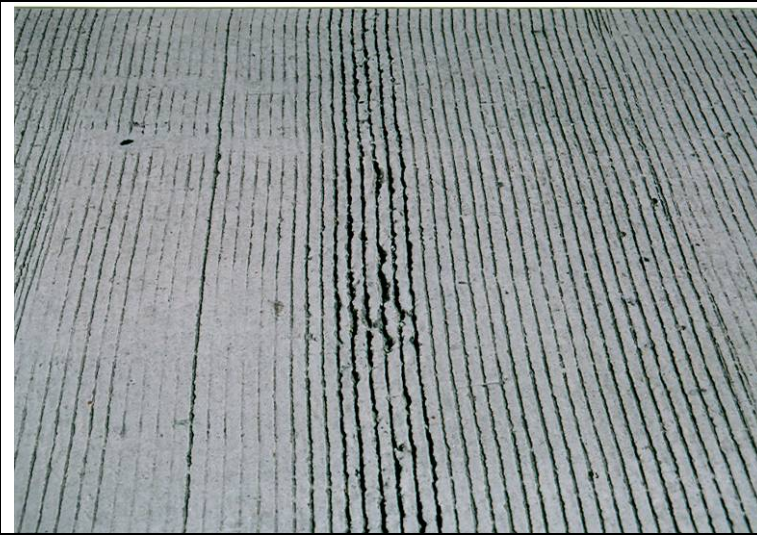
Photo 10: Broken tined edges at eastbound bridge Span 3.

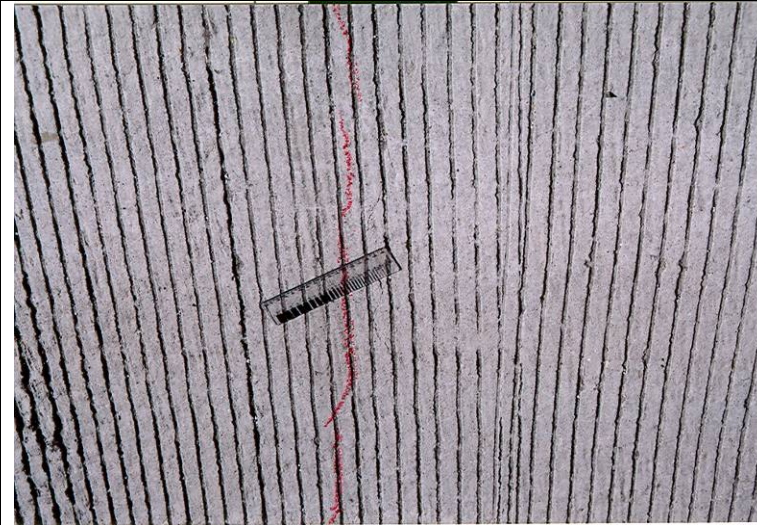
Photo 11: Close up view of the transverse crack at eastbound bridge Span 1.

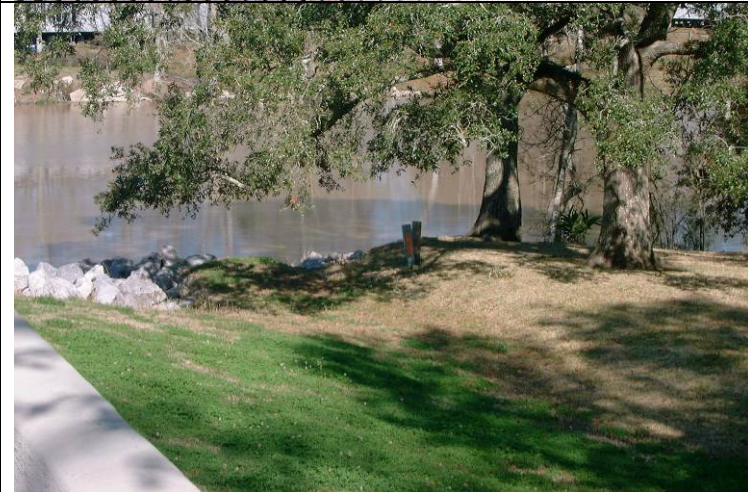
Photo 12: Close up view of the settlement at the eastern end of westbound bridge Span 5.

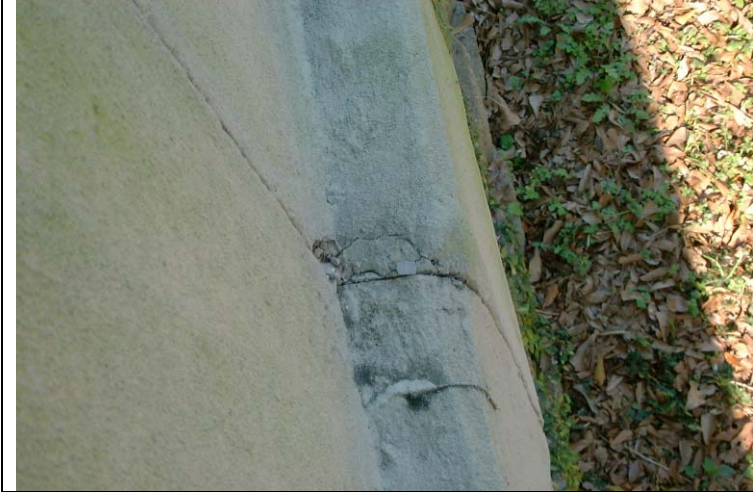
Photo 13: Close up view of the settlement related cracking at the eastern end of bridge Span 5.

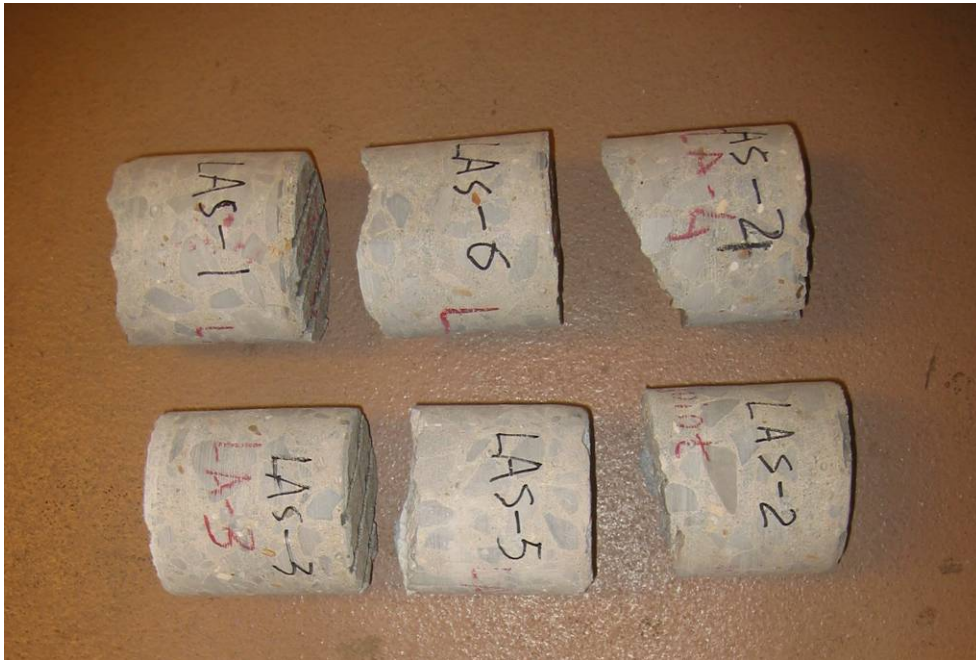
Figure D1-1: Six concrete cores as received.

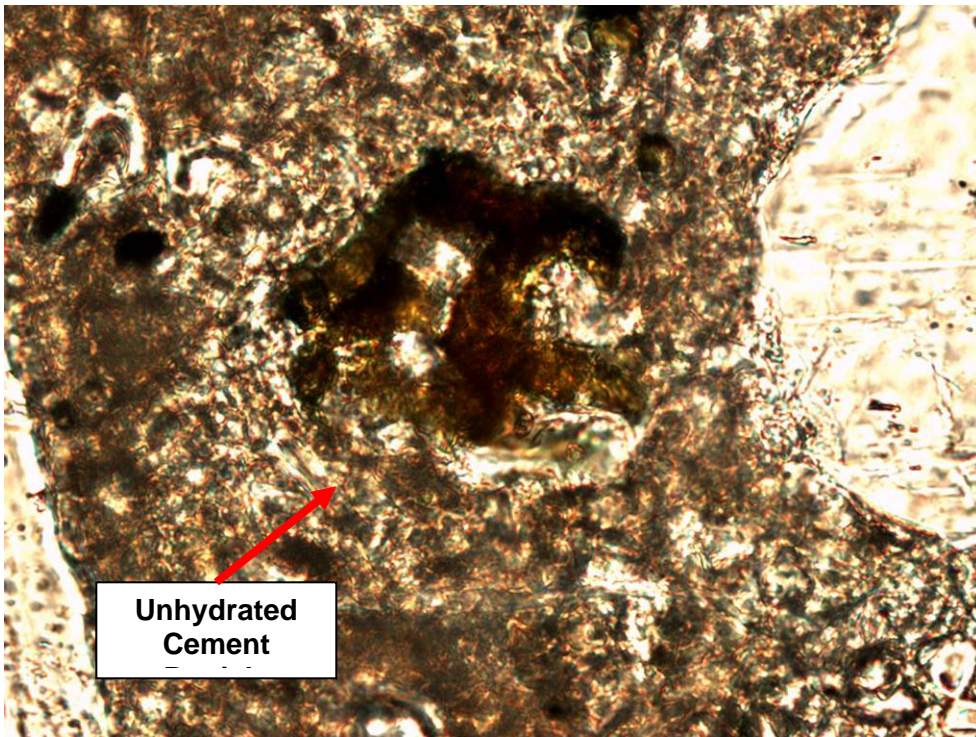
Figure D1-2: Unhydrated cement particle is observed in the concrete. Thin section photomicrograph. Width of field is 0.165 mm.

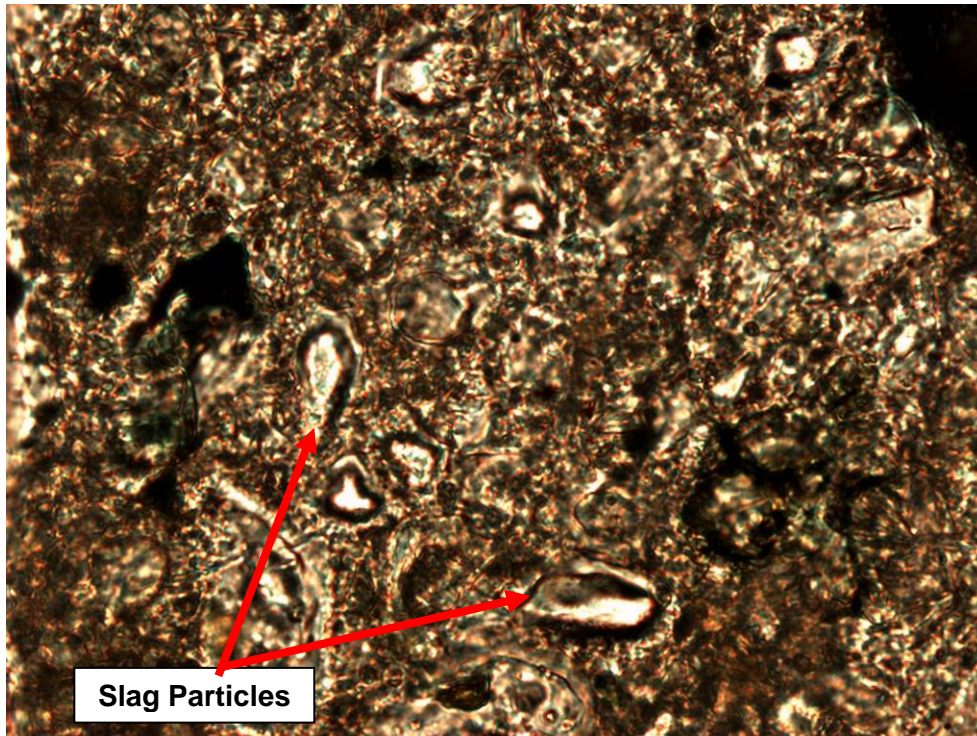
Figure D1-3: Ground granulated blast-furnace slag particles are present in the concrete, as shown in this thin section photomicrograph. Width of field is 0.165 mm.

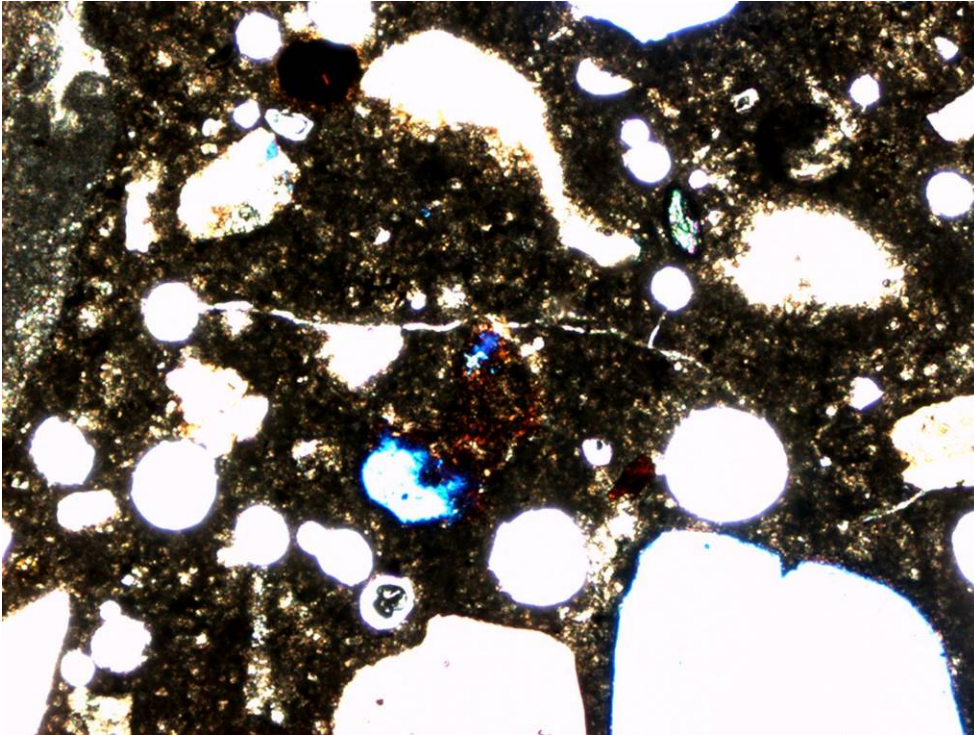
Figure D1-7: Cracks as seen in a thin section. Width of field is 1.6 mm.

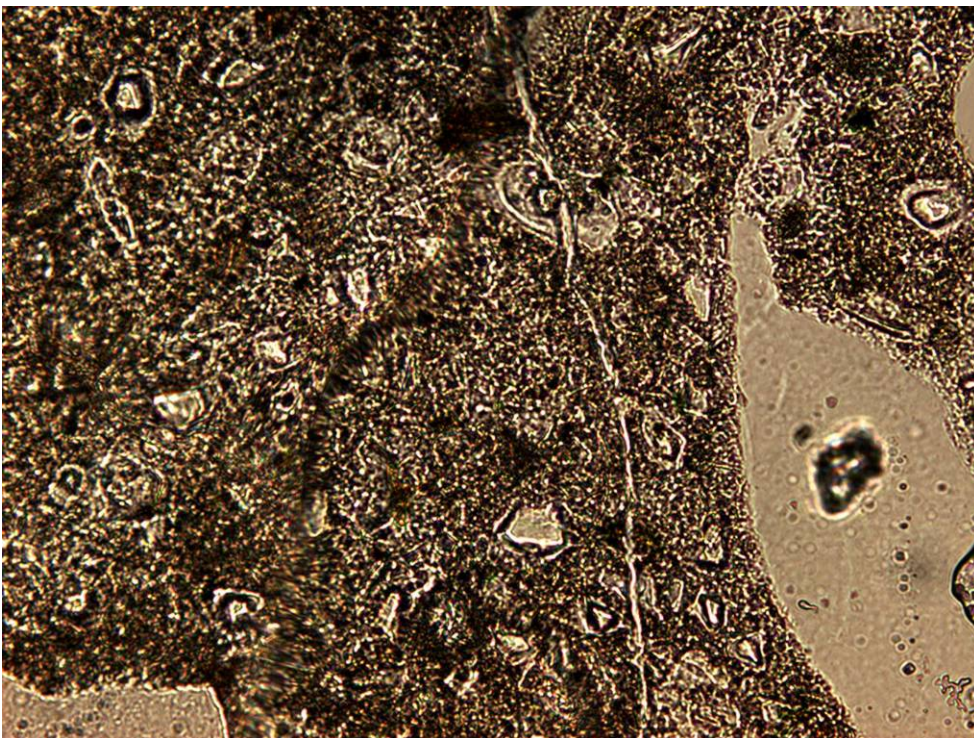
Figure D1-8: Cracks in paste. Width of field is 0.33 mm. Thin section photomicrograph.

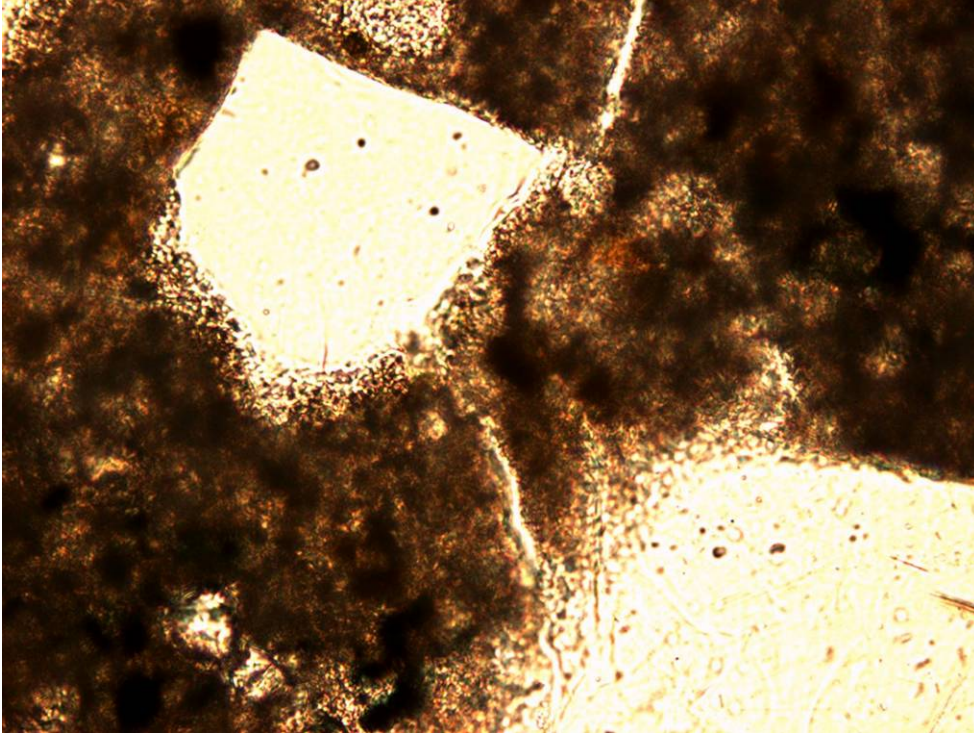
Figure D1-9: Crack along the fine aggregate/paste interface. Width of field is 0.33 mm. Thin section photomicrograph.

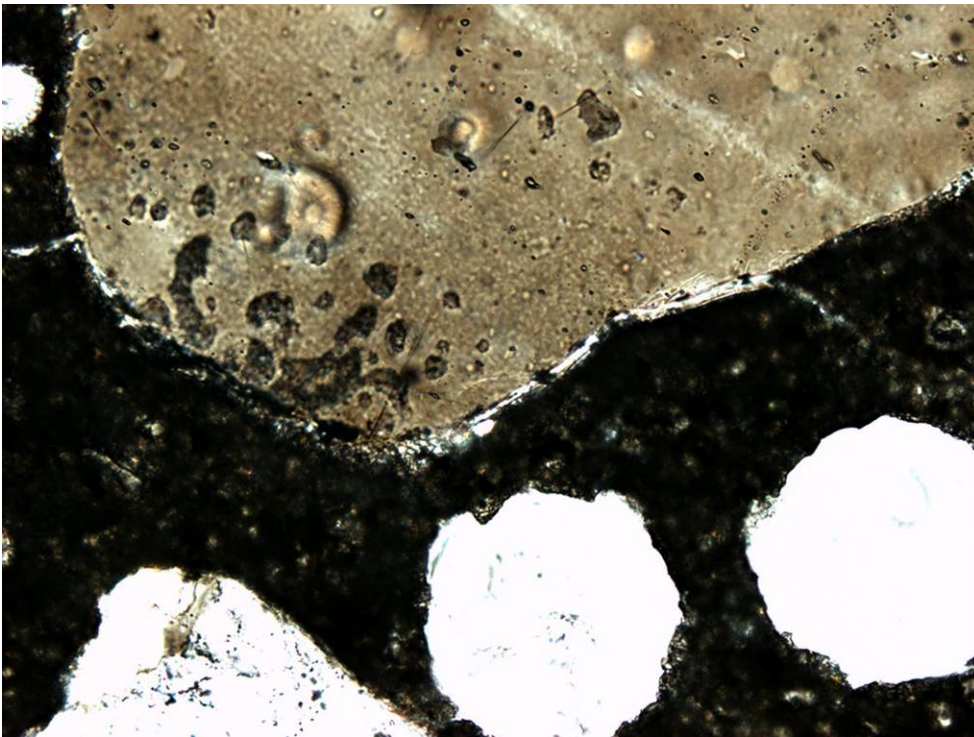
Figure D1-10: Another thin section photomicrograph showing crack along the fine aggregate/paste interface. Width of field is 0.65 mm.

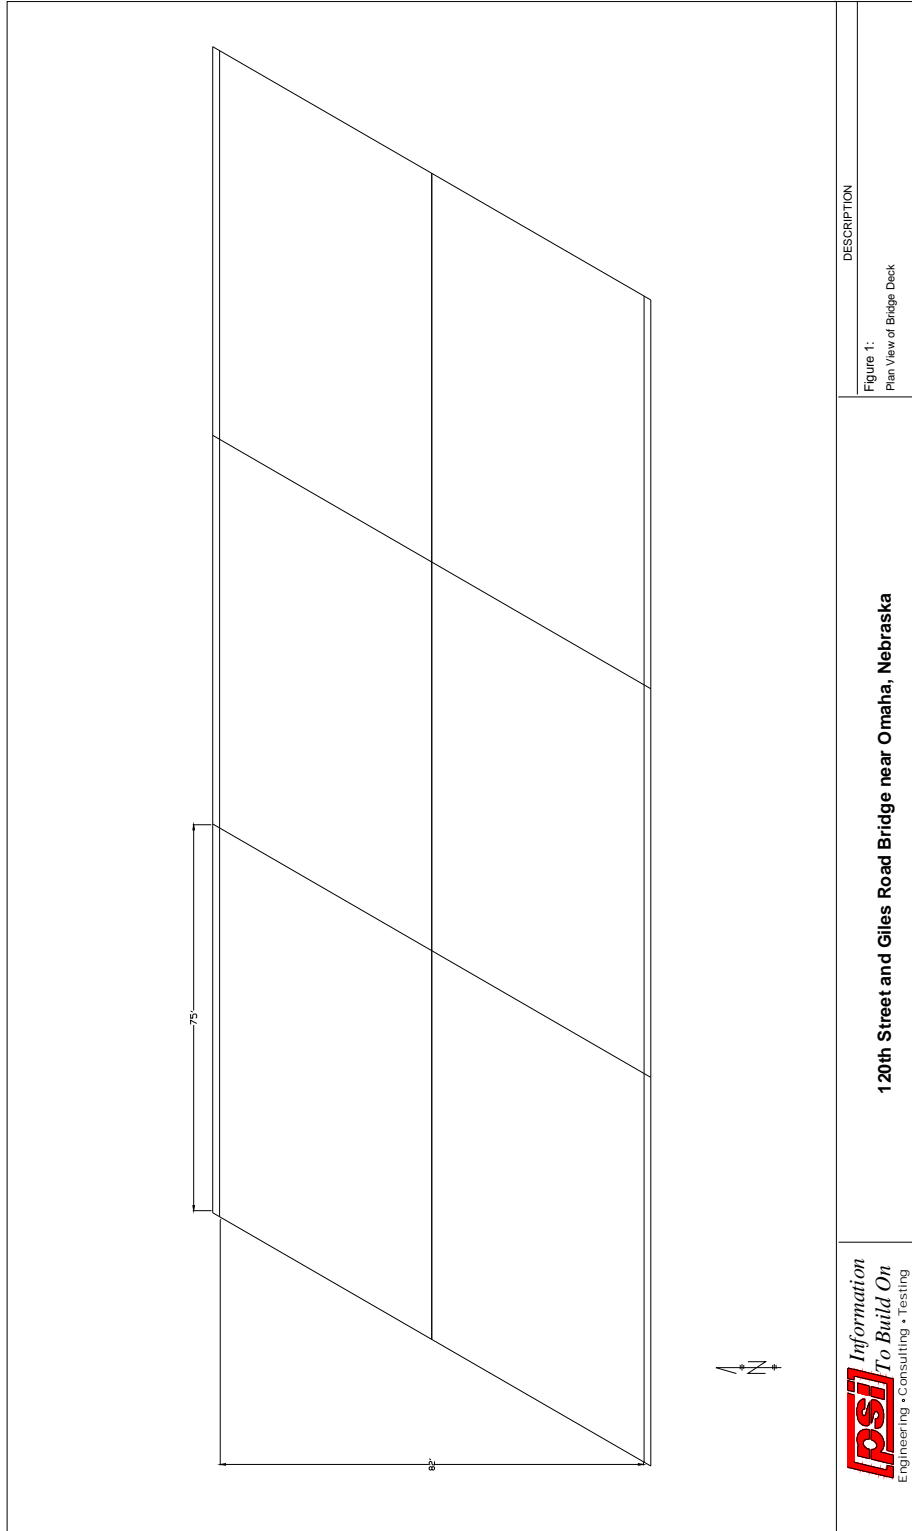
*Respectfully Submitted,*  
**Professional Service Industries, Inc.**  
*Structural Investigation & Petrography Department*

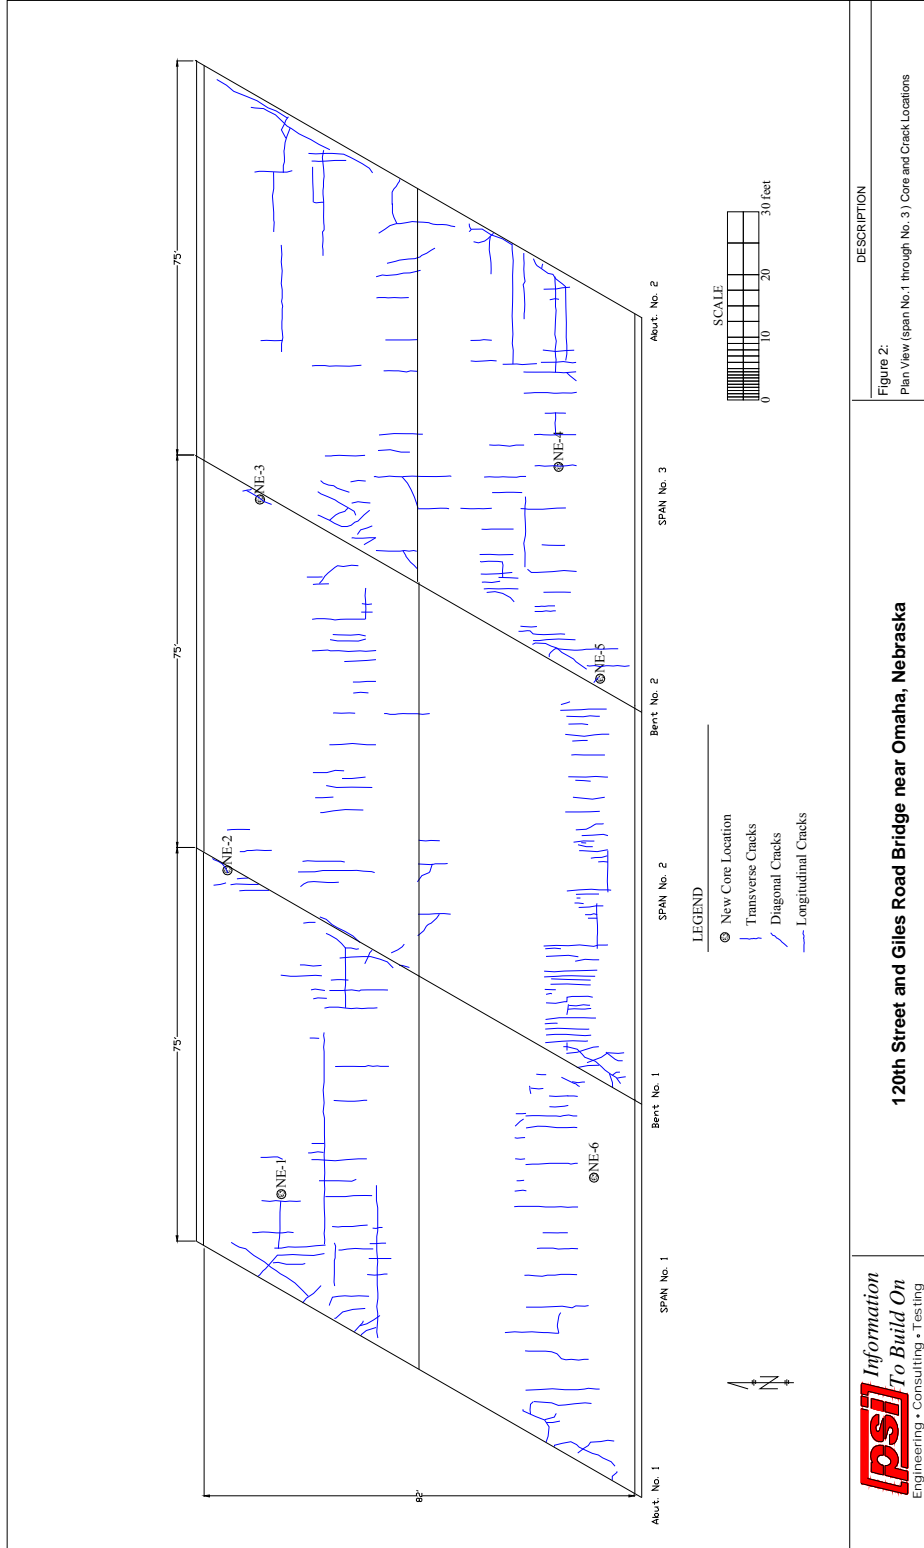
**120th Street and Giles Road Bridge near Omaha, Nebraska**
