# High Performance Concrete Bridge Deck Investigation

November 2009

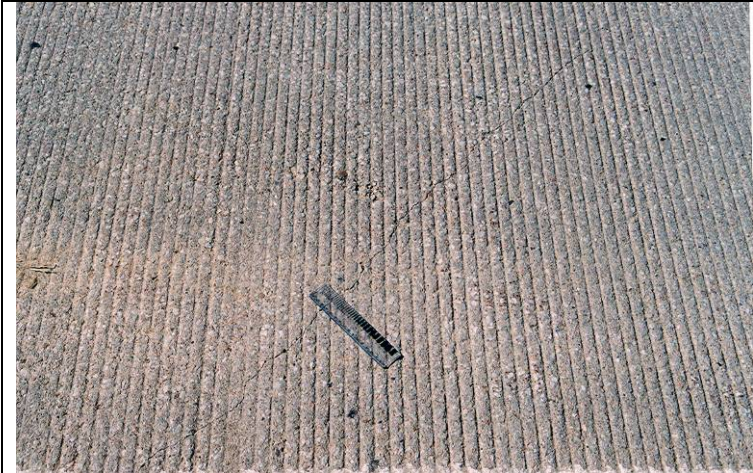
Photo 4: Close up view of typical diagonal crack.

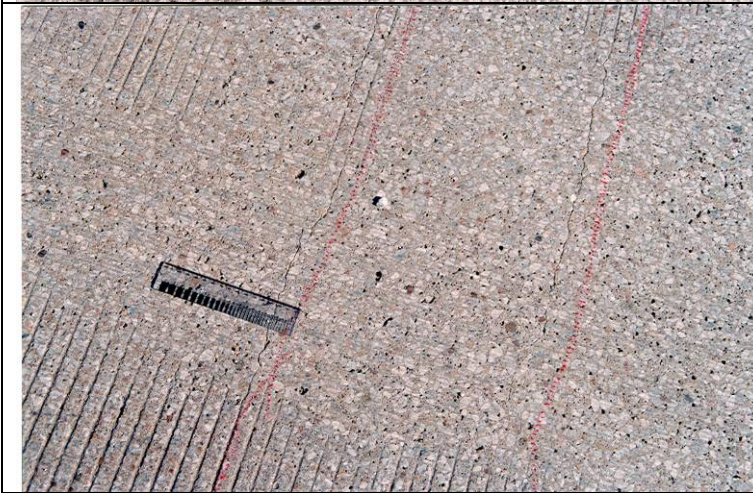
Photo 5: Close up view of typical transverse crack.

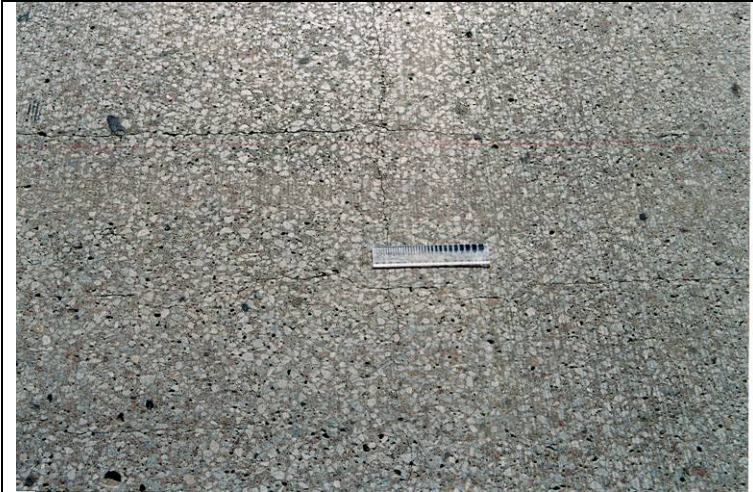
Photo 6: Close up view of typical longitudinal crack.

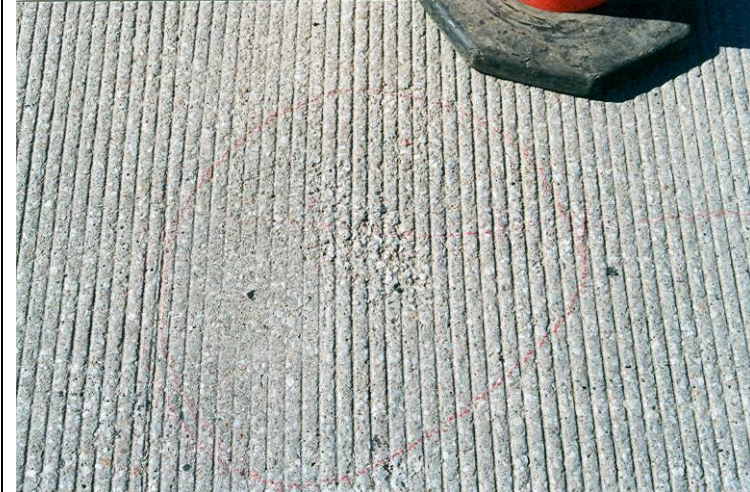
Photo 7: Close up view of broken tined surfaces.

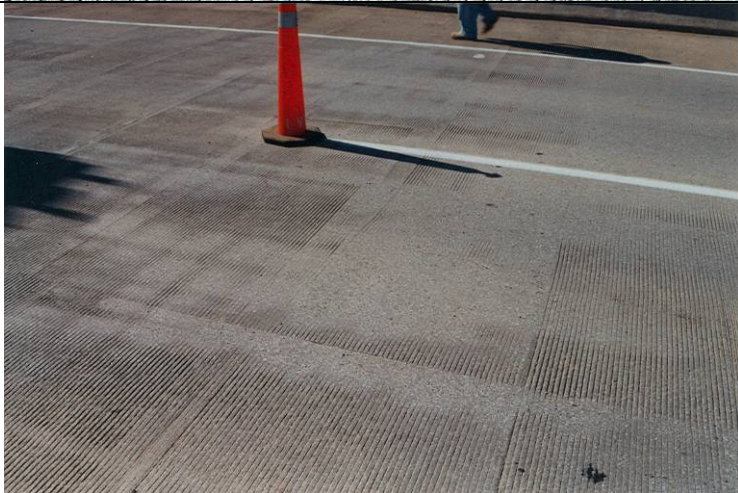
Photo 8: Close up view of polished deck surfaces.

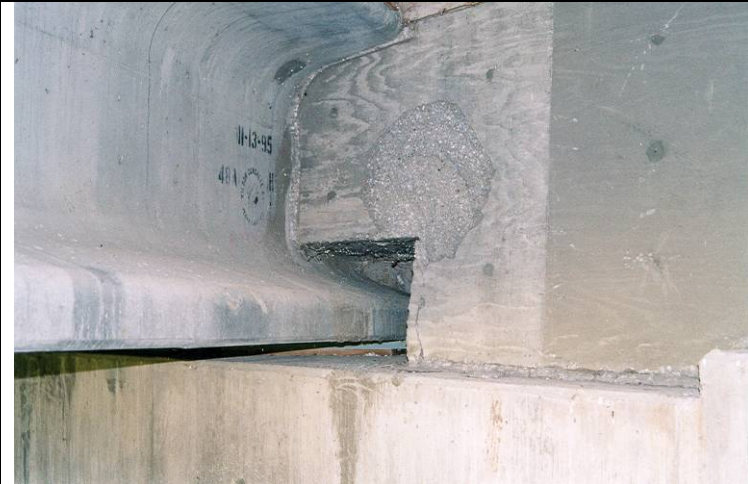
Photo 10: Spalling near the joints of second girder north side.

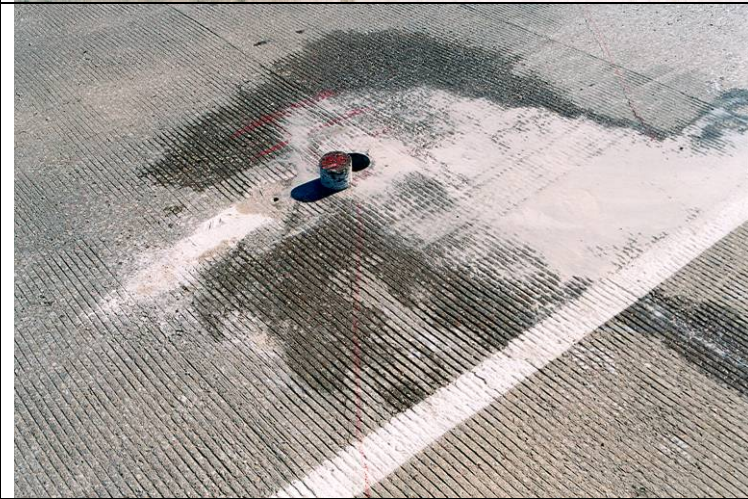
Photo 11: Taking core from a location over a transverse crack.

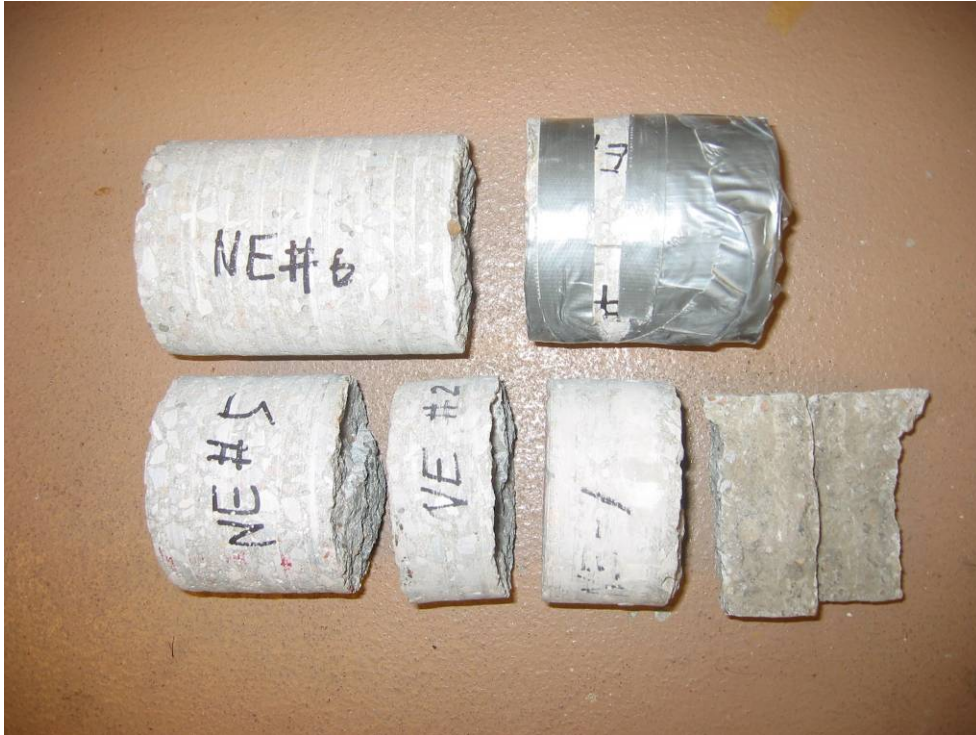
Figure E1-1: Six concrete cores as received.

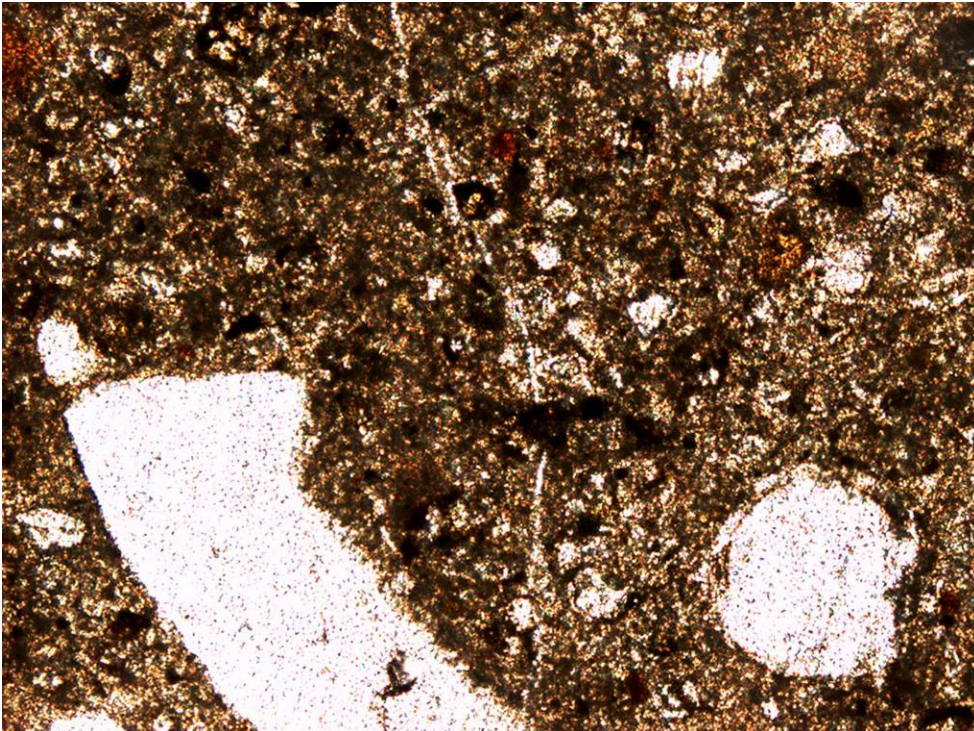
Figure E1-6: A crack in the cement paste. Width of field is 0.65 mm, thin section image.

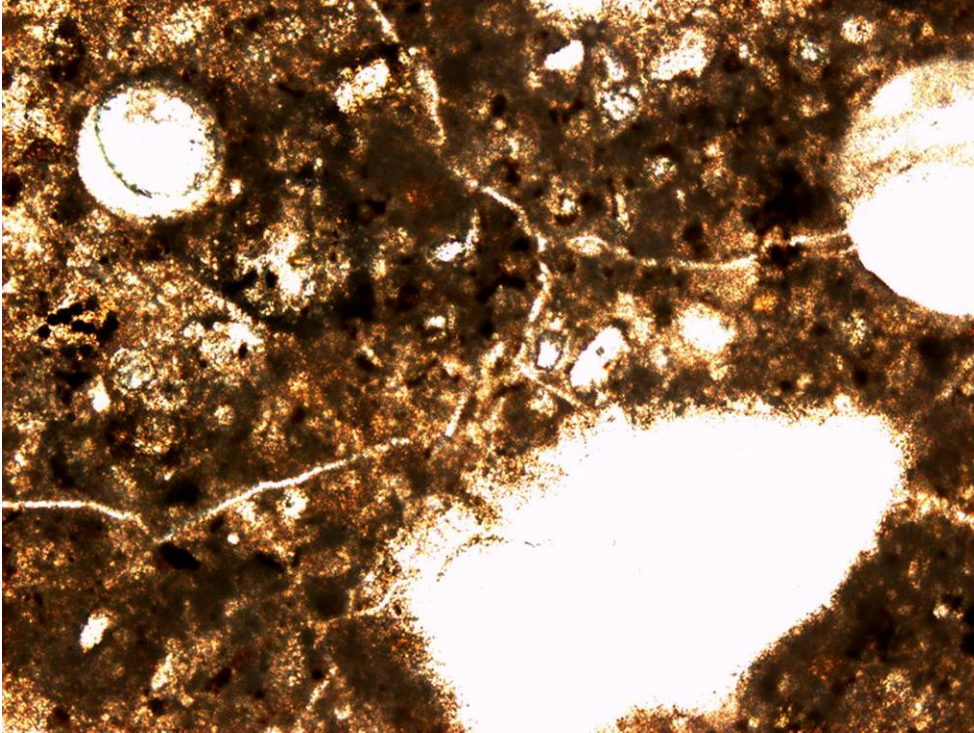
Figure E1-7: Cracks form a network. Width of field is 0.65 mm, thin section image.

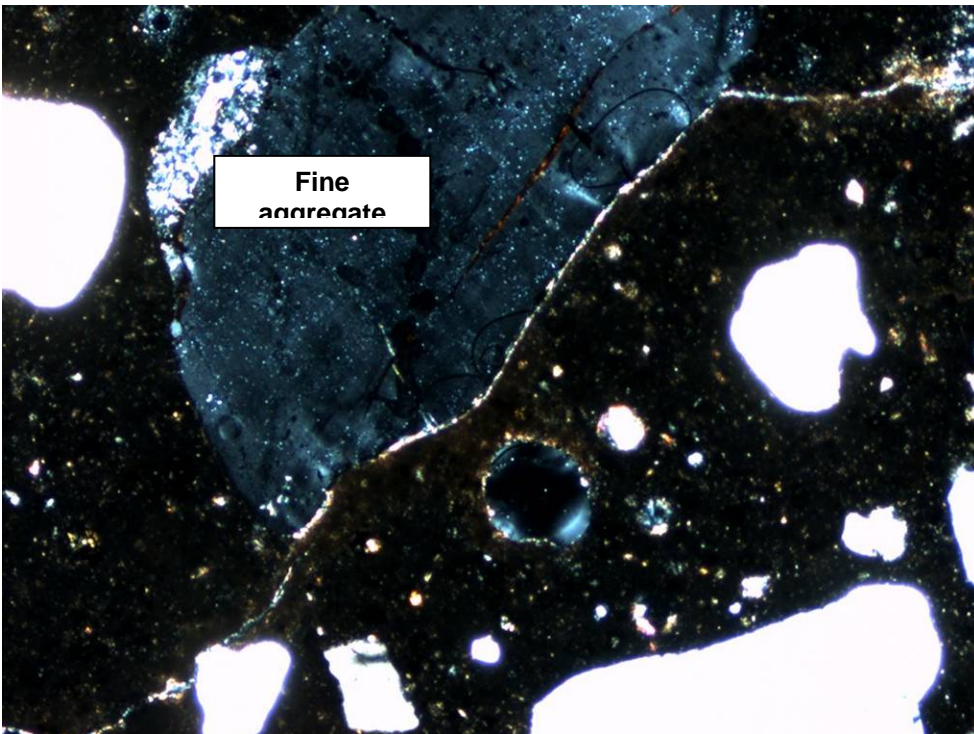
Figure E1-8: A crack at the interfacial region between a fine aggregate and the paste. Width of field is 1.6 mm, thin section image.

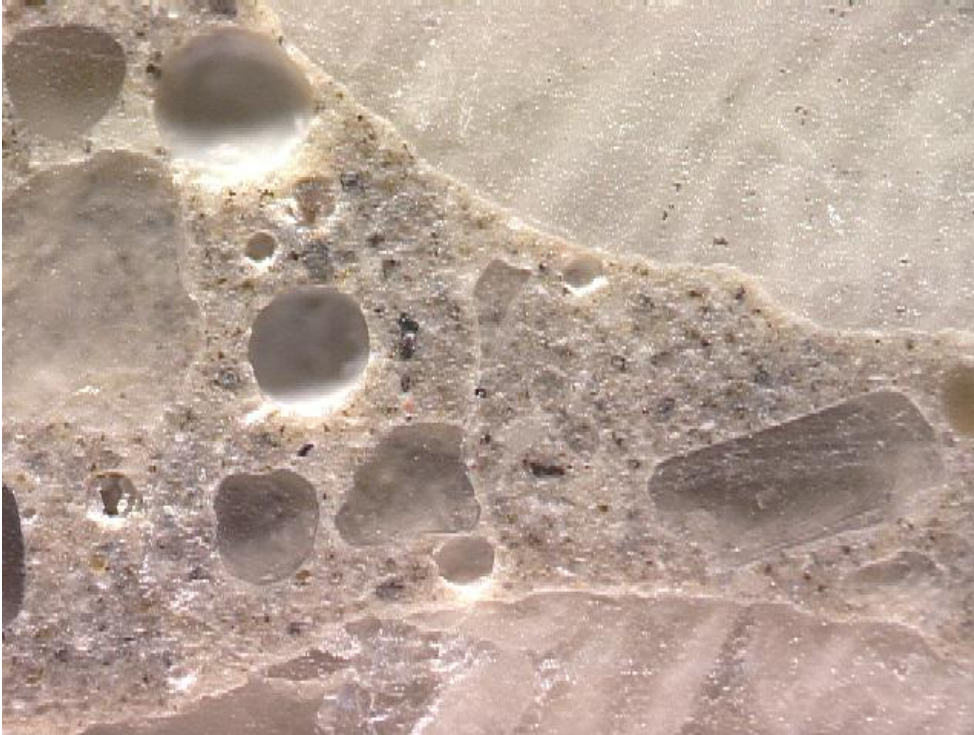
Figure E1-9: A crack in the paste between two aggregate particles. Width of field is 2.0 mm, polished surface image.

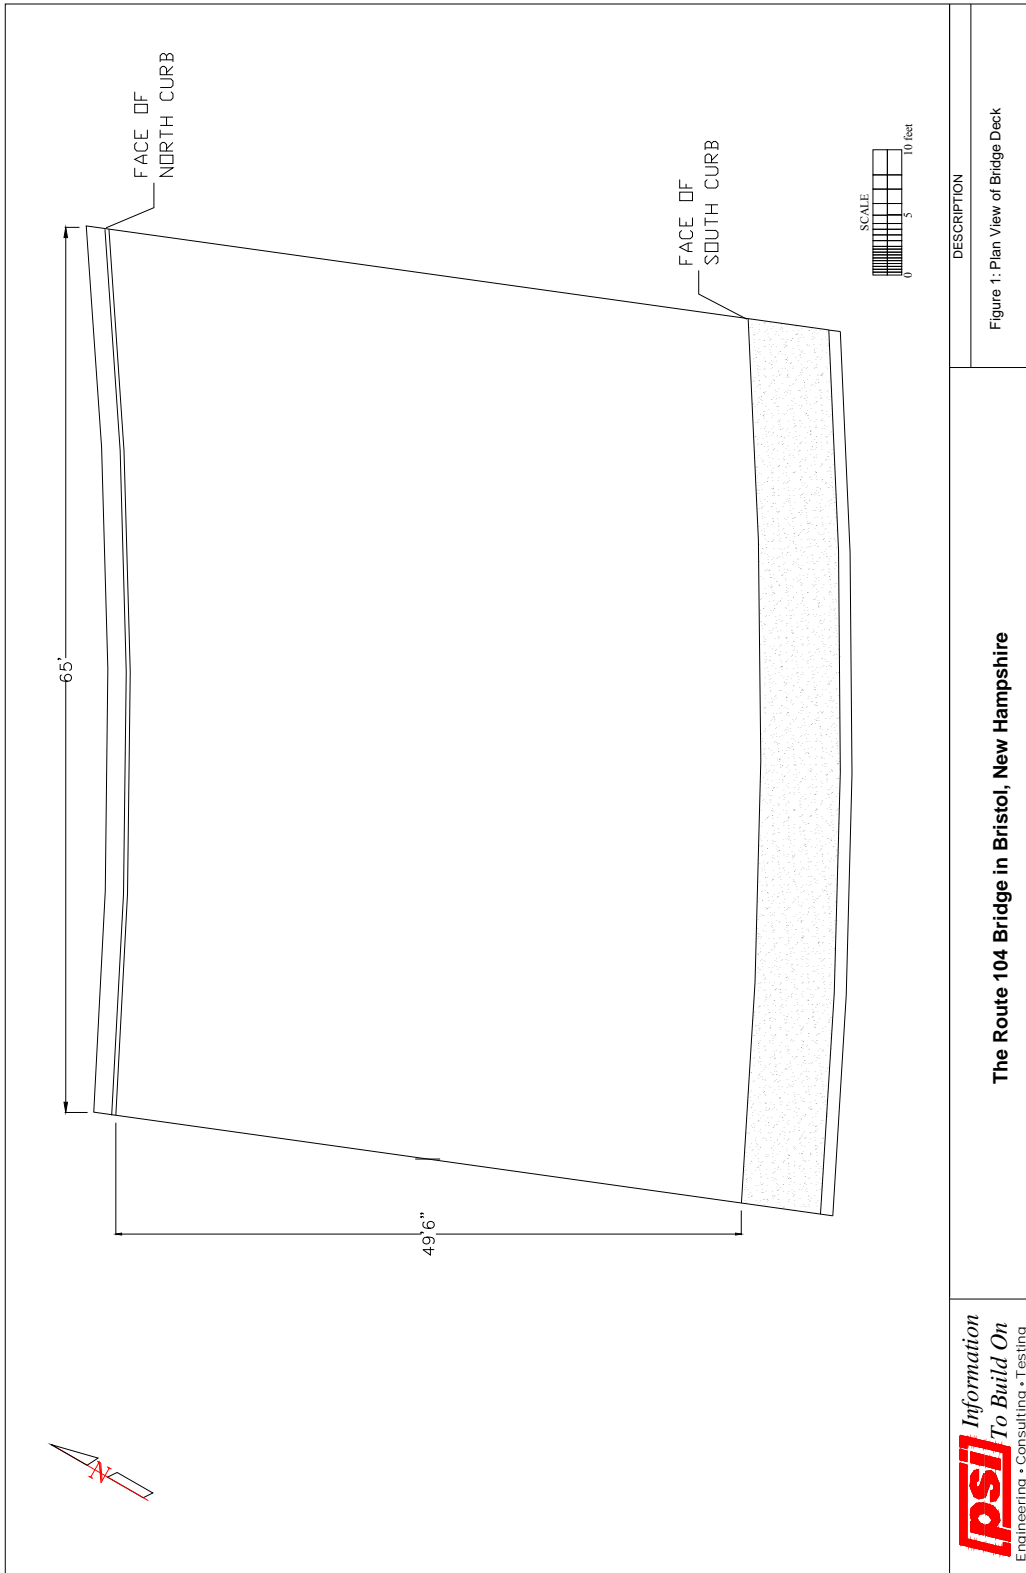
*Respectfully Submitted,*  
***Professional Service Industries, Inc.***  
*Structural Investigation & Petrography Department*

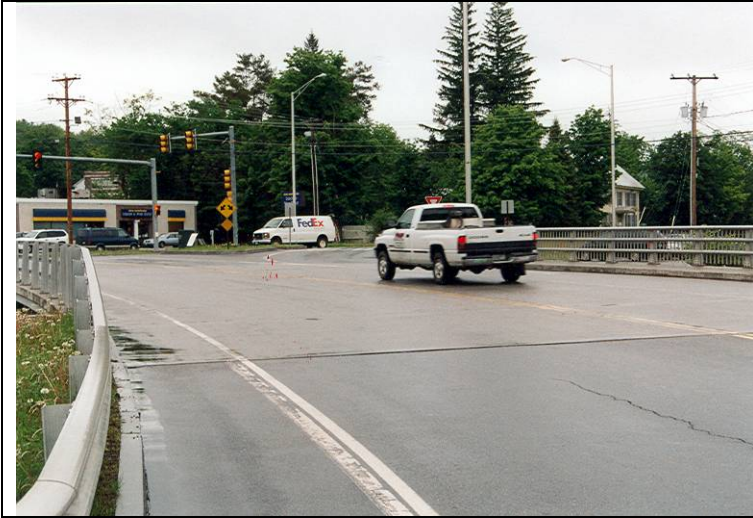
Photo 4: General view of longitudinal crack on bridge deck.

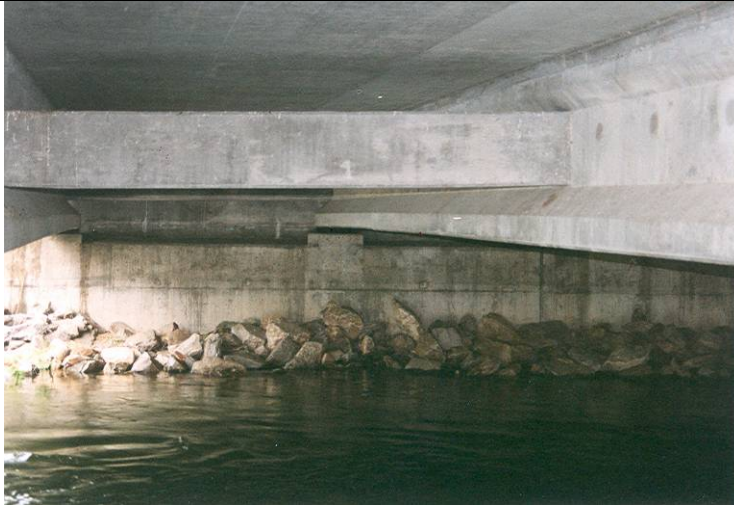
Photo 5: Close up view of bridge deck underside inspection using a boat.

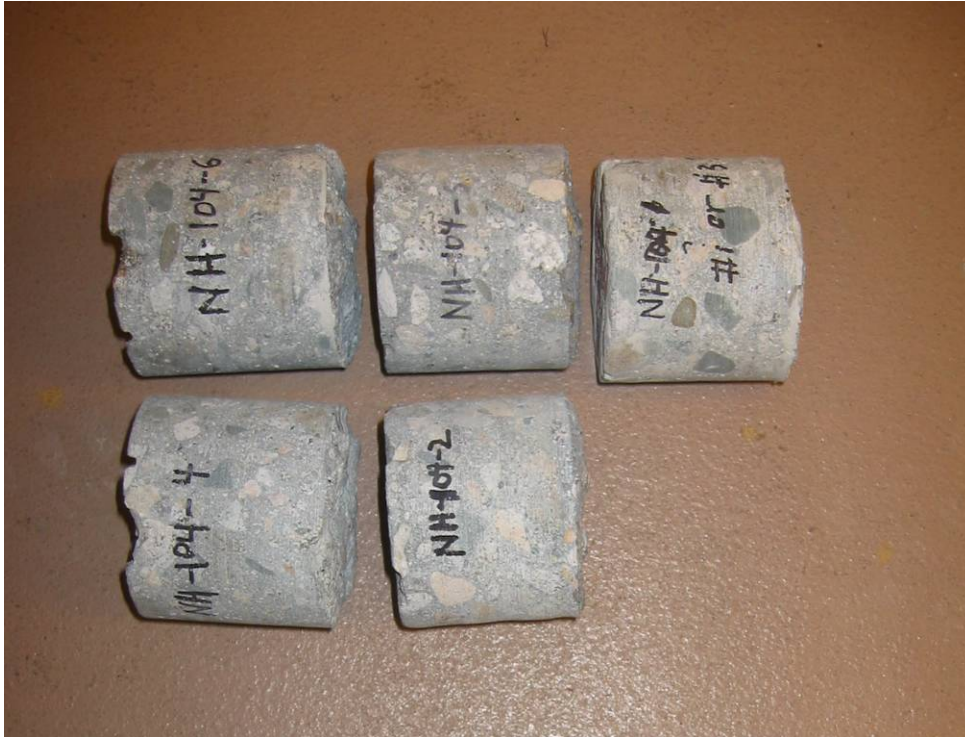
Figure F1-1: Five cores as received.

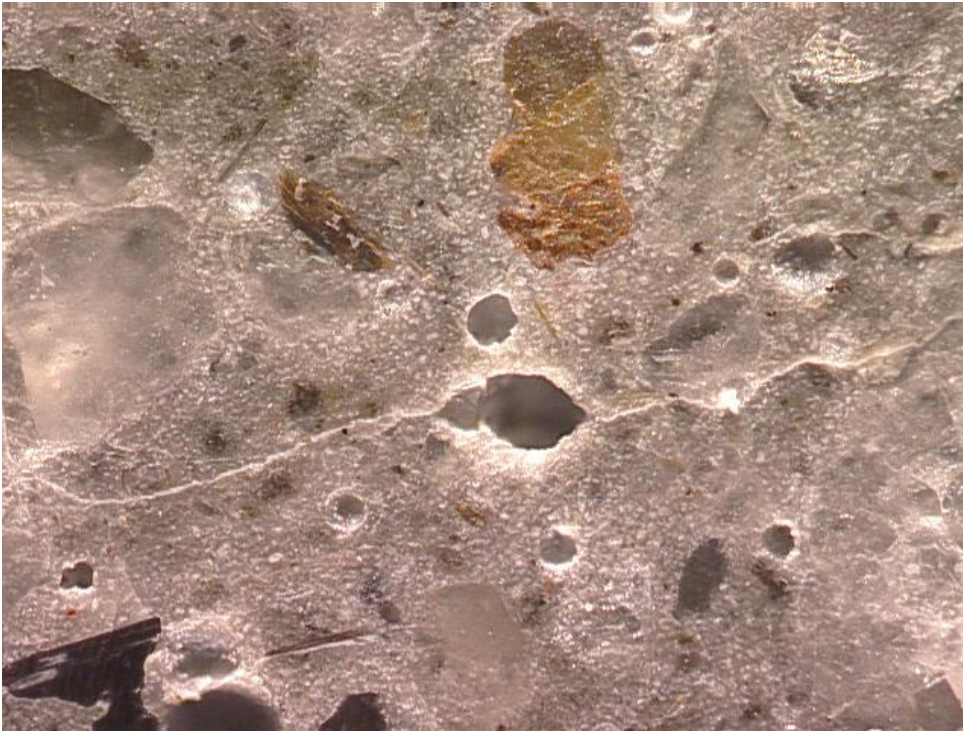
Figure F1-7: A crack in the paste. Width of field is 2.0 mm. Polished surface image.

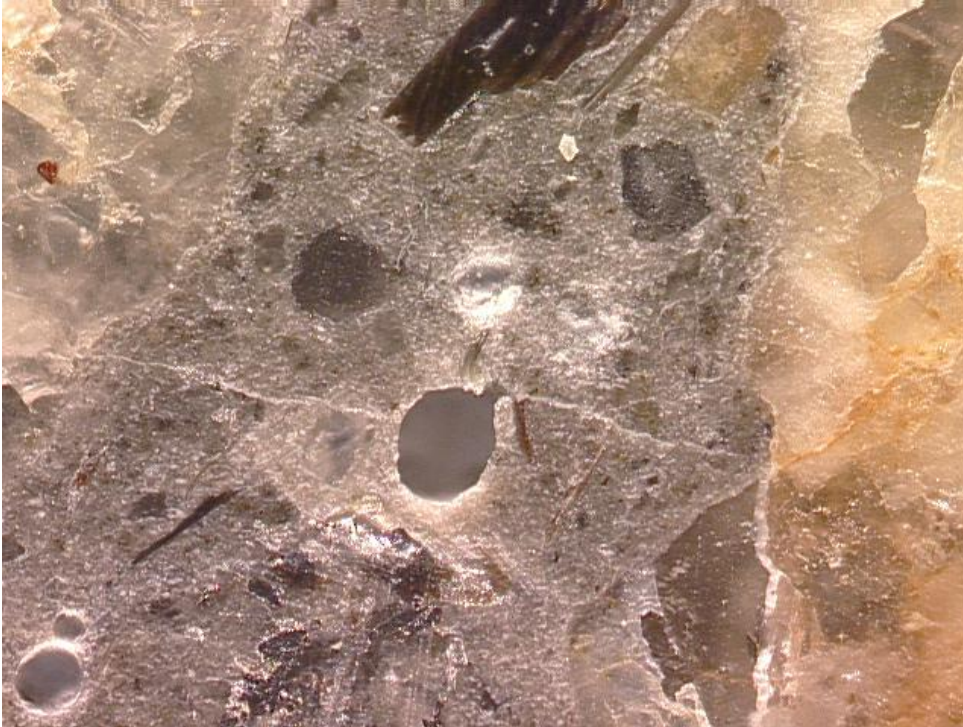
Figure F1-8: A crack connecting two aggregate pieces. Width of field is 2.0 mm. Polished surface image.

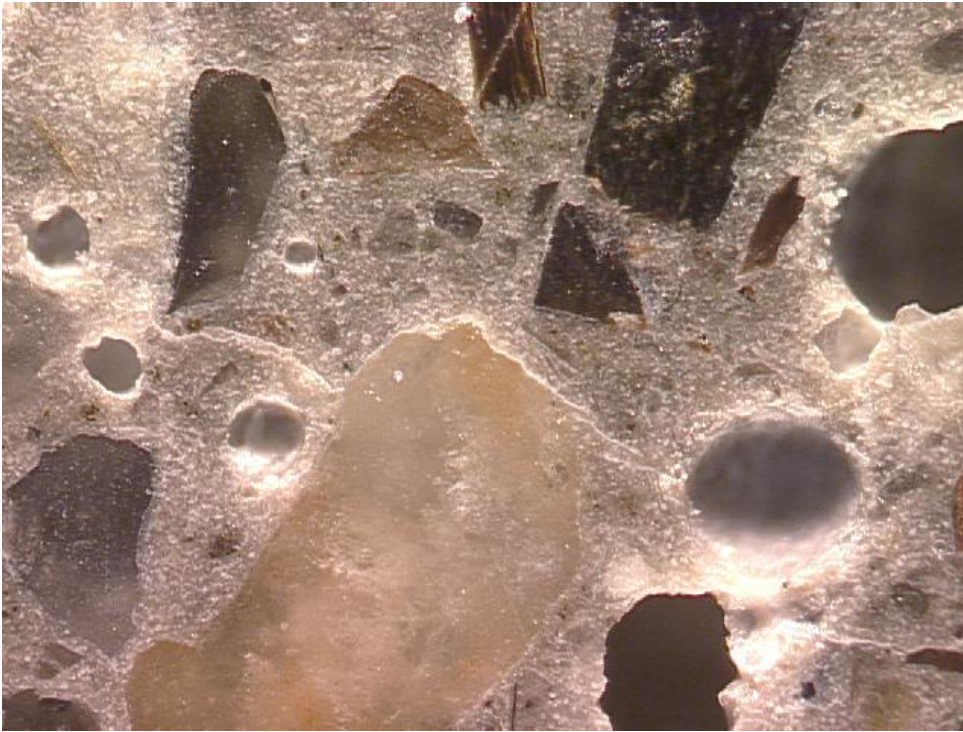
Figure F1-9: Cracks in the aggregate peripheral zone. Width of field is 2.0 mm. Polished surface image.

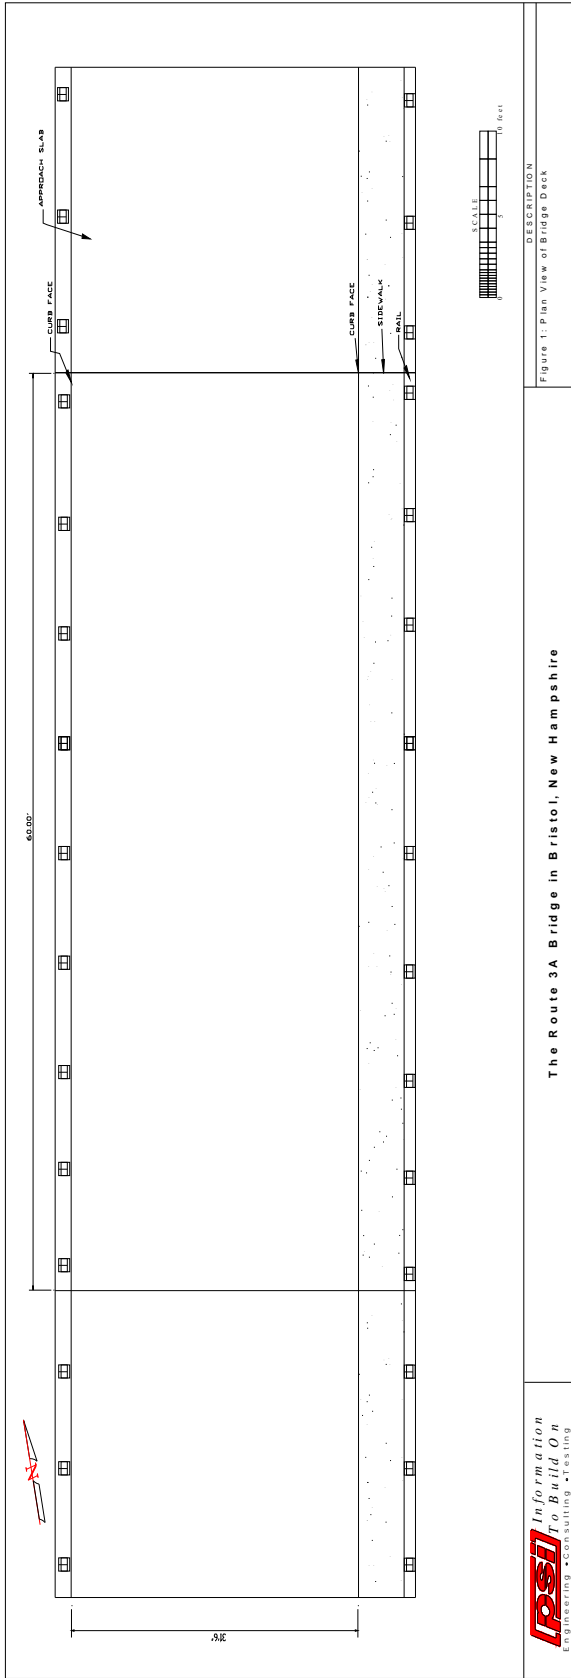
*Respectfully Submitted,*  
***Professional Service Industries, Inc.***  
*Structural Investigation & Petrography Department*

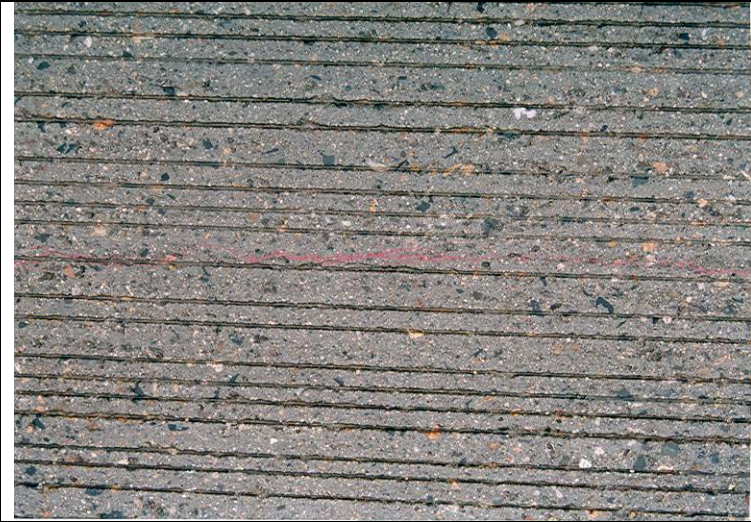
Photo 4: Close up view of transverse crack.

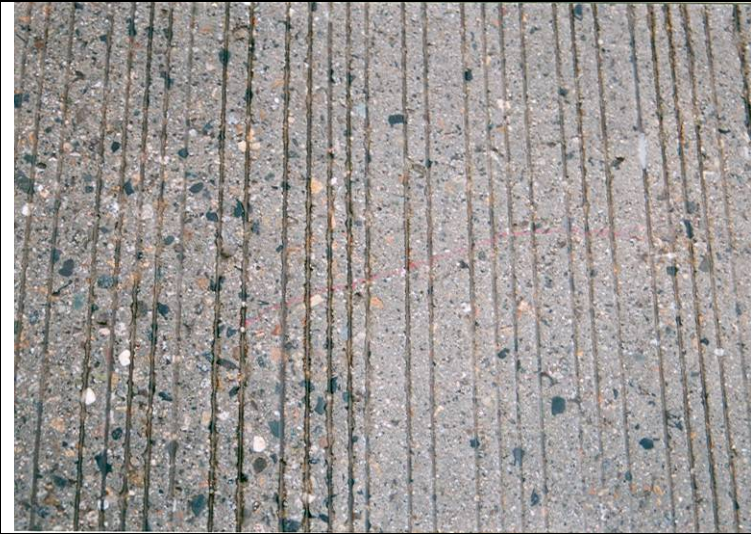
Photo 5: Close up view of longitudinal crack.

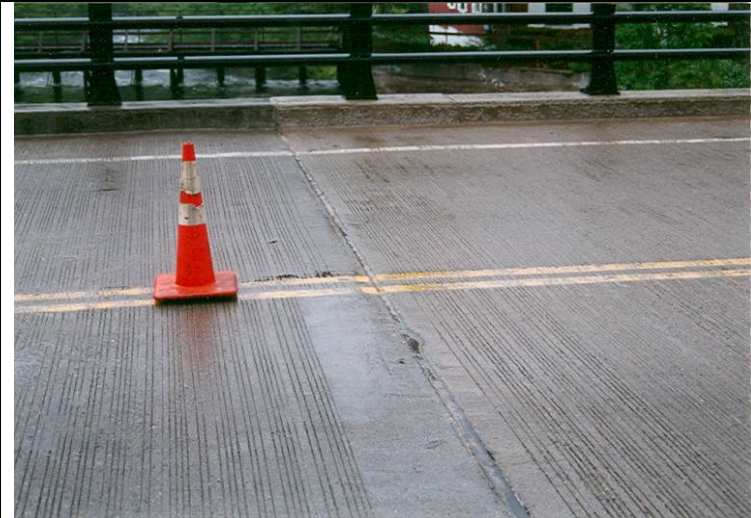
Photo 6: General condition of joint pattern.

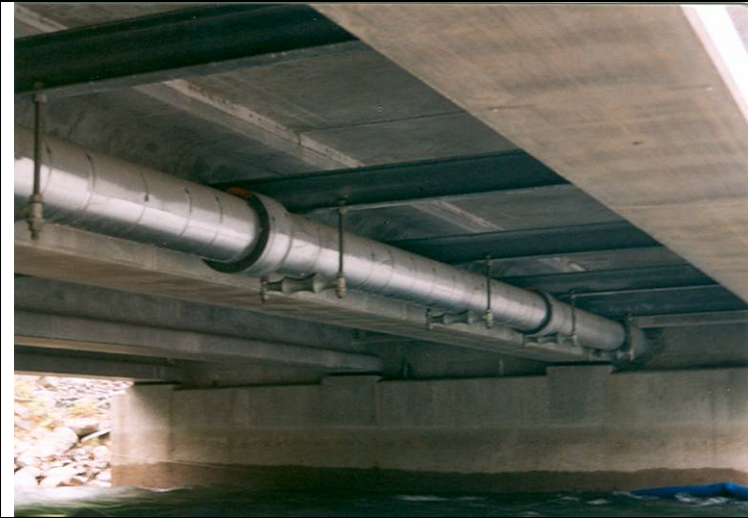
Photo7: Close up view of underside of the bridge.

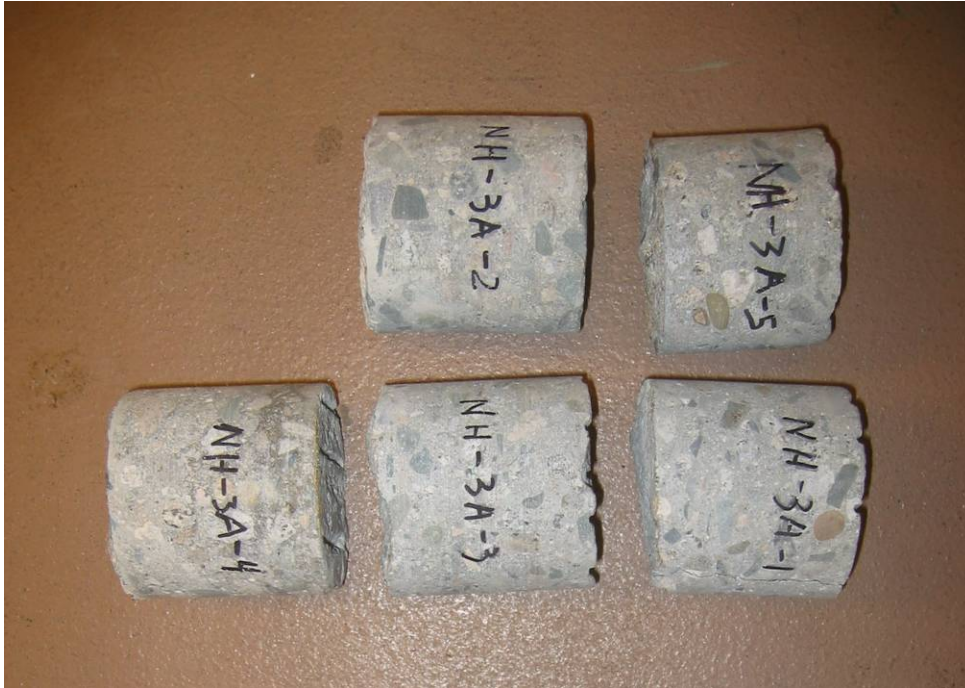
Figure G1-1: Five cores as received.

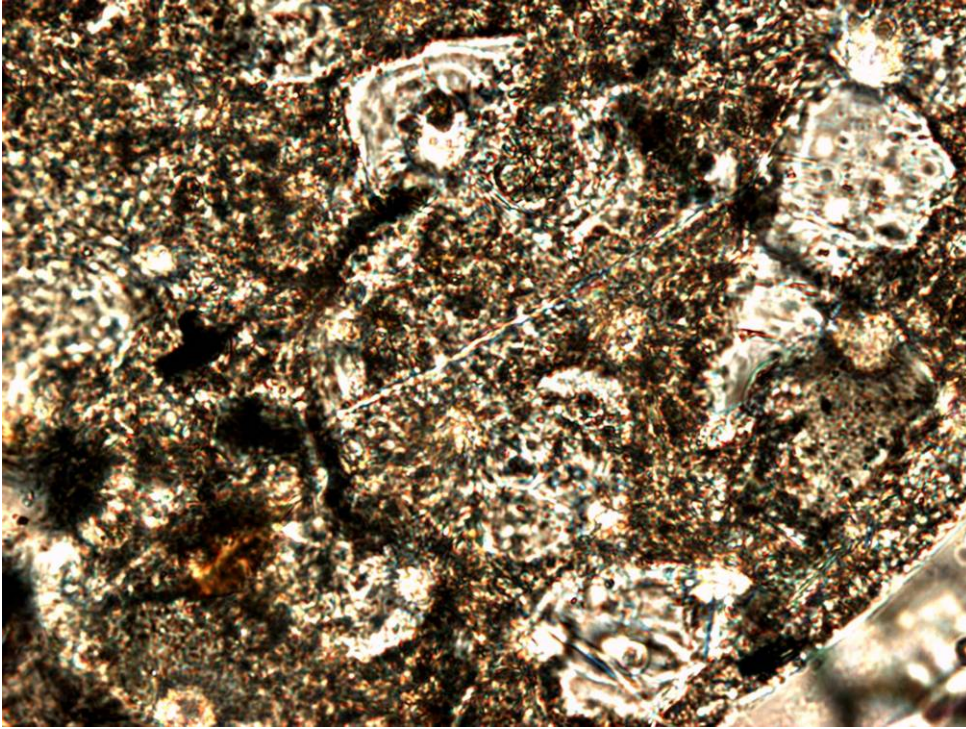
Figure G1-7: A crack in the paste. Width of field is 0.165 mm. Thin section image.

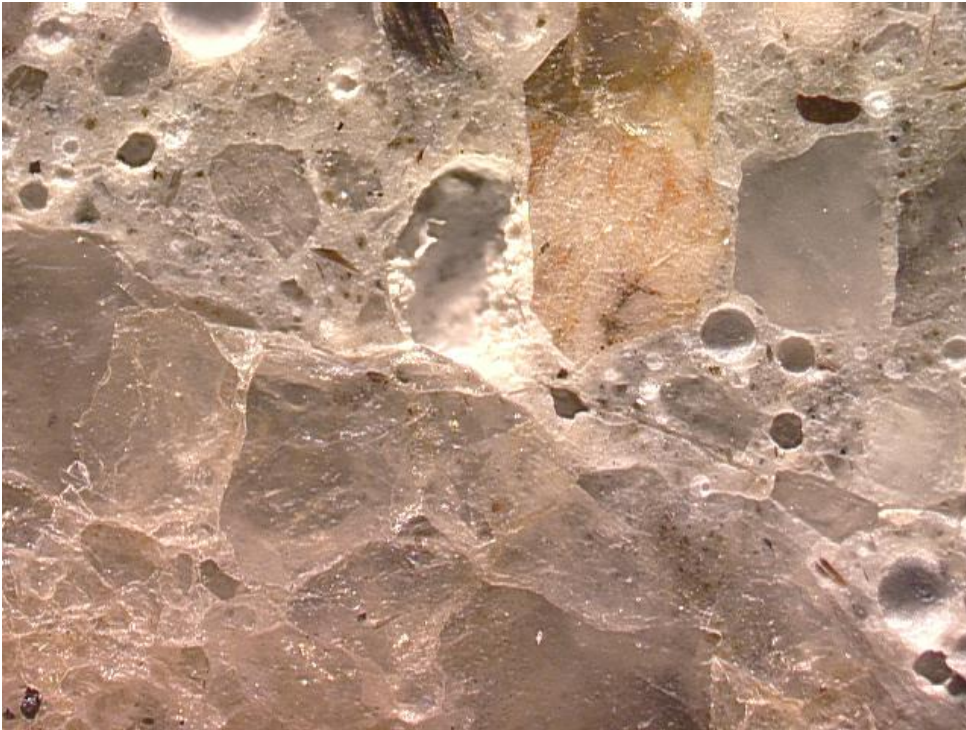
Figure G1-8: Crack in the aggregate-paste interfacial region. Width of field is 4.0 mm. Polished surface image.

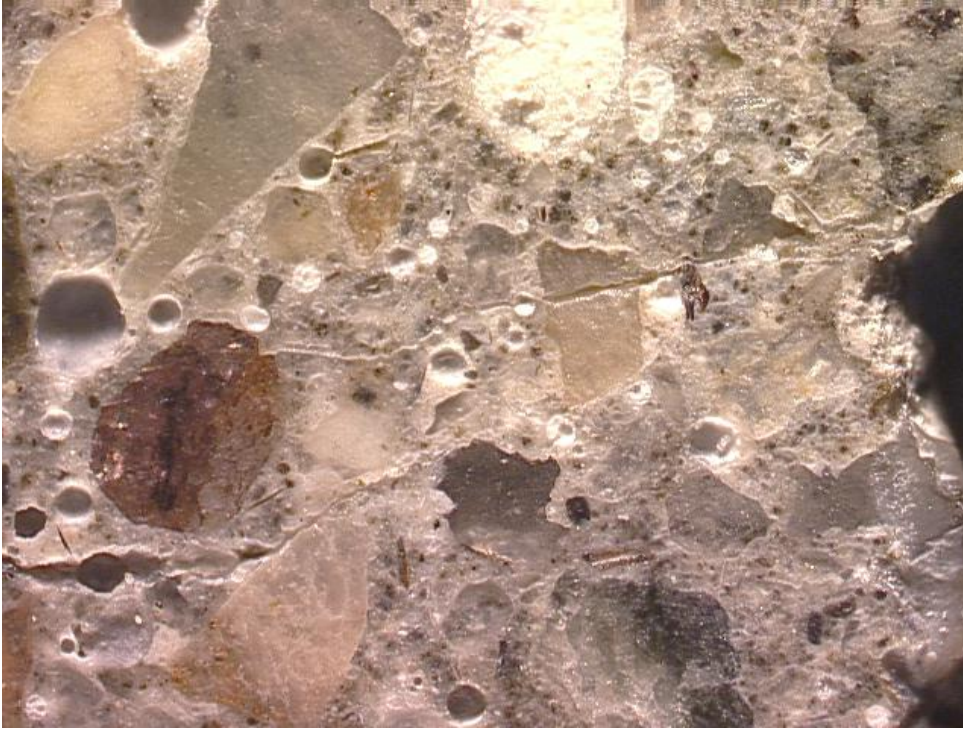
Figure G1-9: Cracks that are found just below the exposed surface. Width of field is 4.0 mm. Polished surface section image. The exposed surface is on the right side.

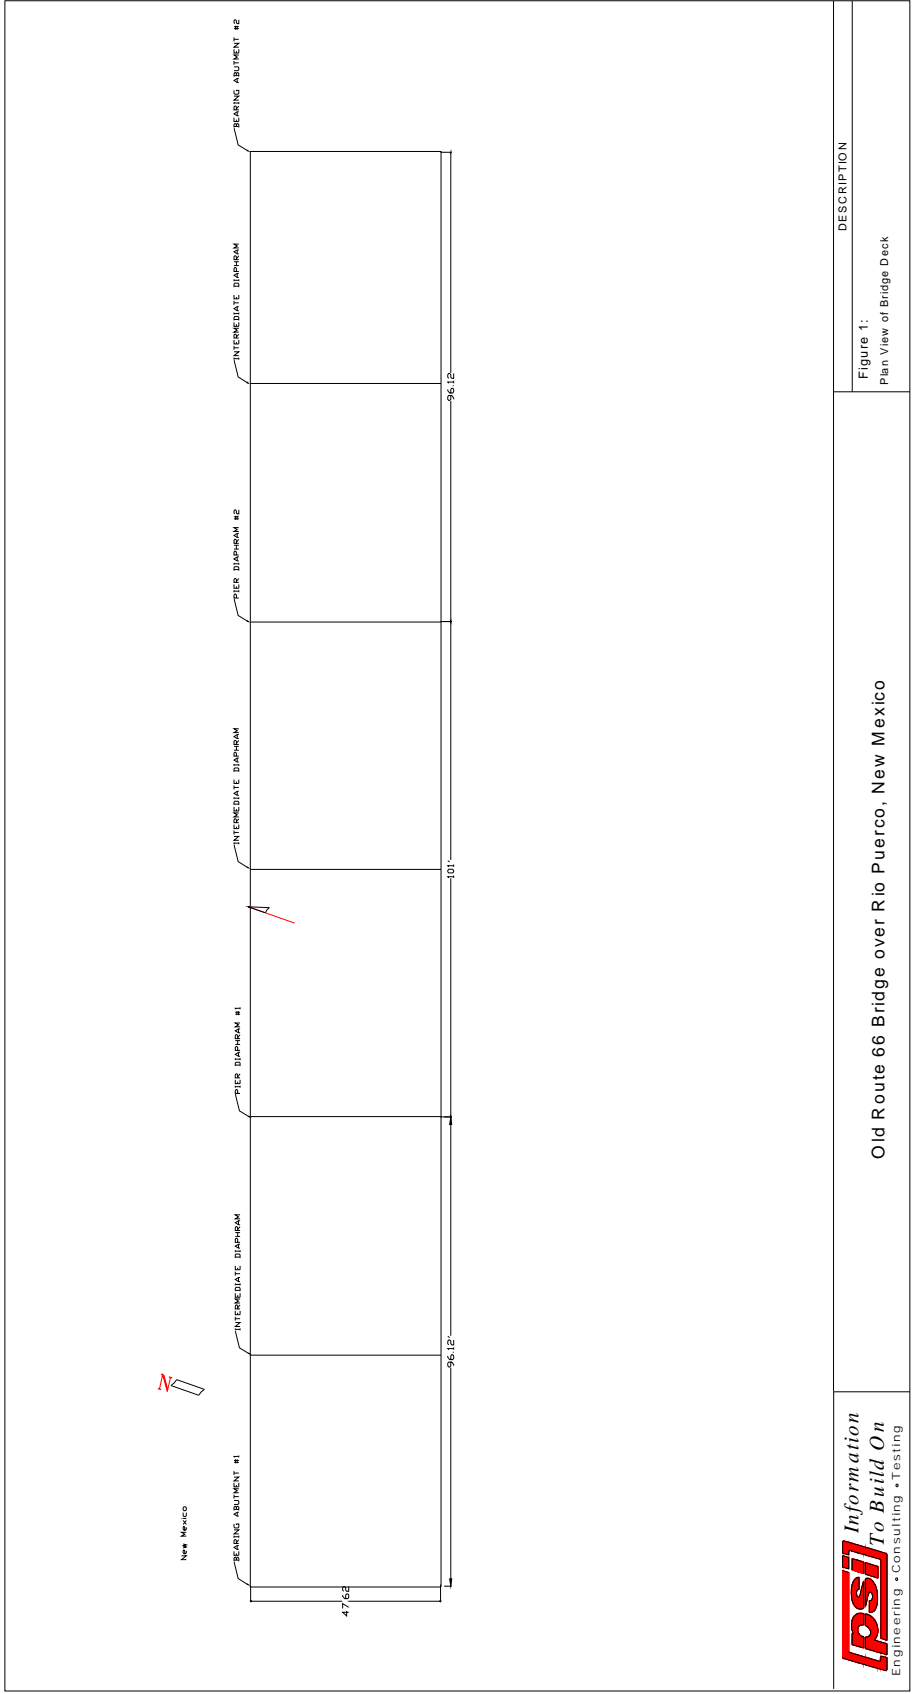
*Respectfully Submitted,  
Professional Service Industries, Inc.  
Structural Investigation & Petrography Department*

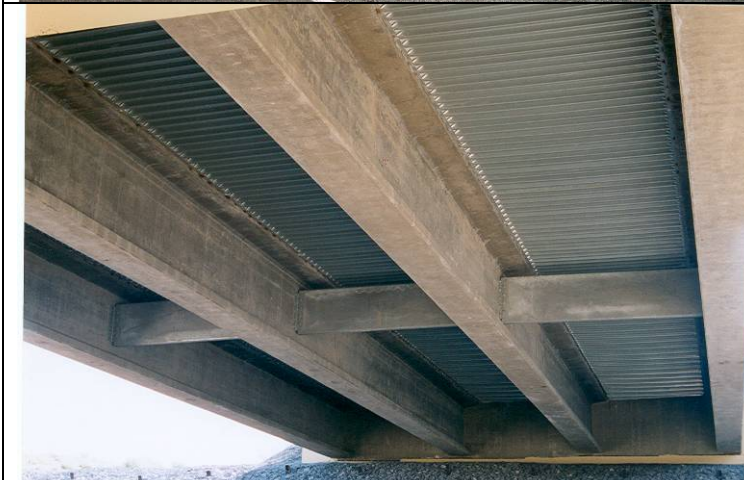
Photo 3: General condition of underside eastbound bridge.

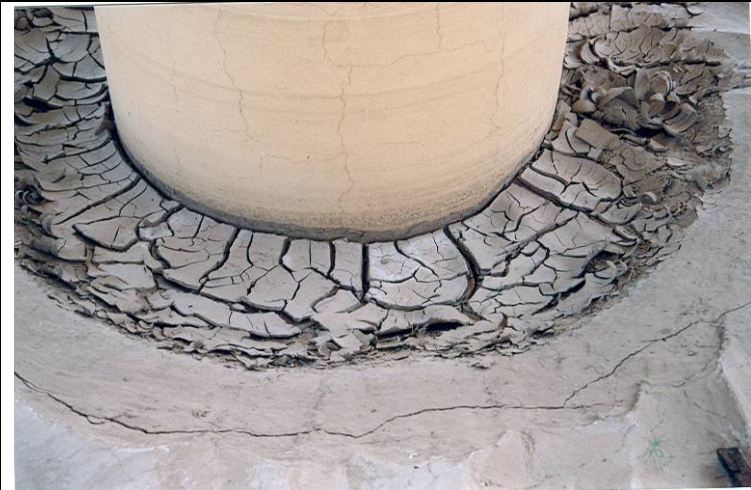
Photo 4: General condition of the piles at eastbound bridge. Cracks observed around the pile in the stucco.

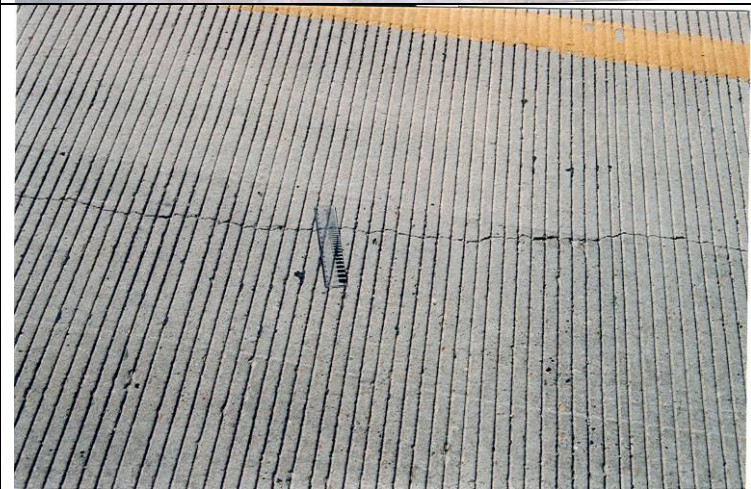
Photo 5: Close up view of longitudinal crack in the traffic lane.

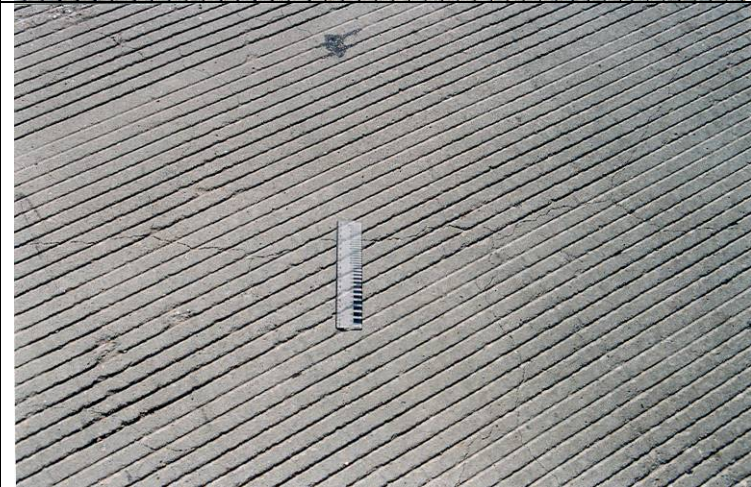
Photo 6: Close up view of typical diagonal cracks at bridge deck.

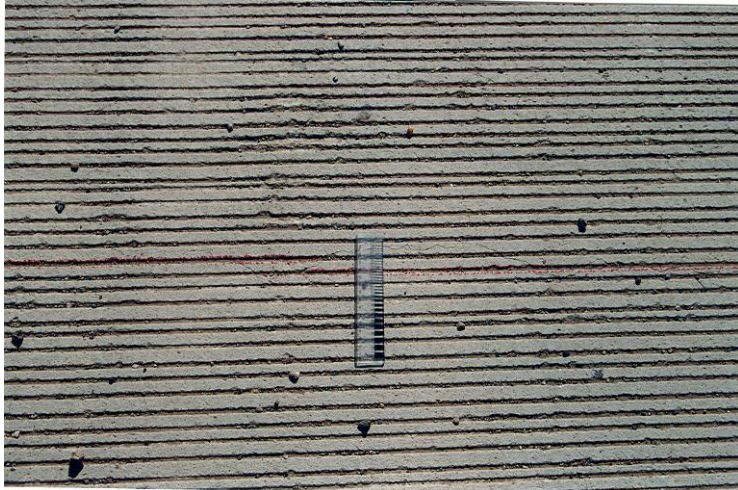
Photo 7: Close up view of typical transverse crack.

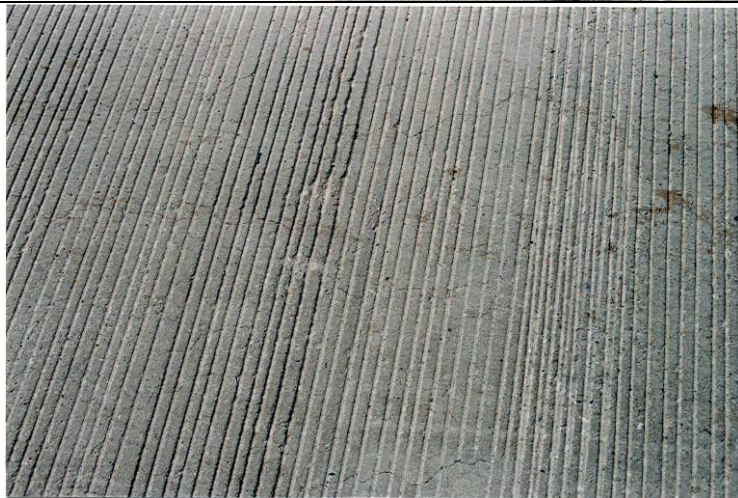
Photo 8: Close up view of broken tinned edges and polished surface.

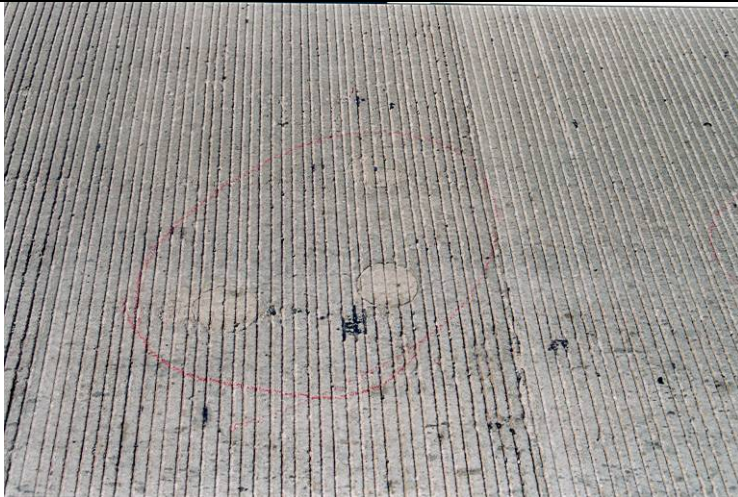
Photo 9: Cores taken by others and sign of broken tinned edges.

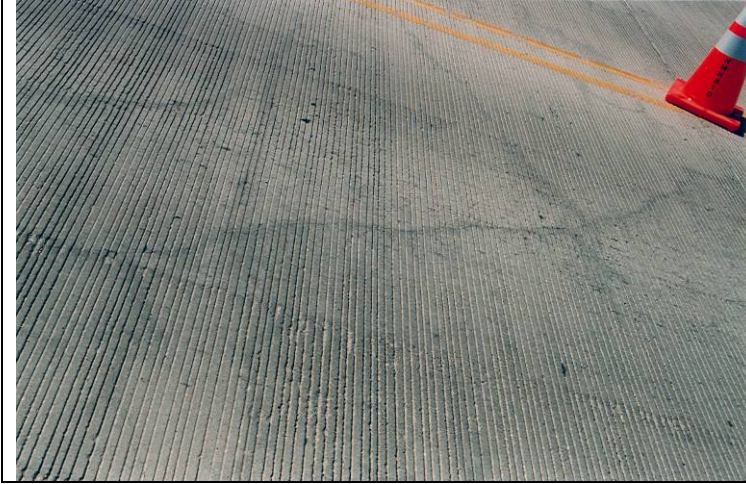
Photo 10: Close up view of the cracks at deck joints.
