# High Performance Concrete Bridge Deck Investigation

November 2009

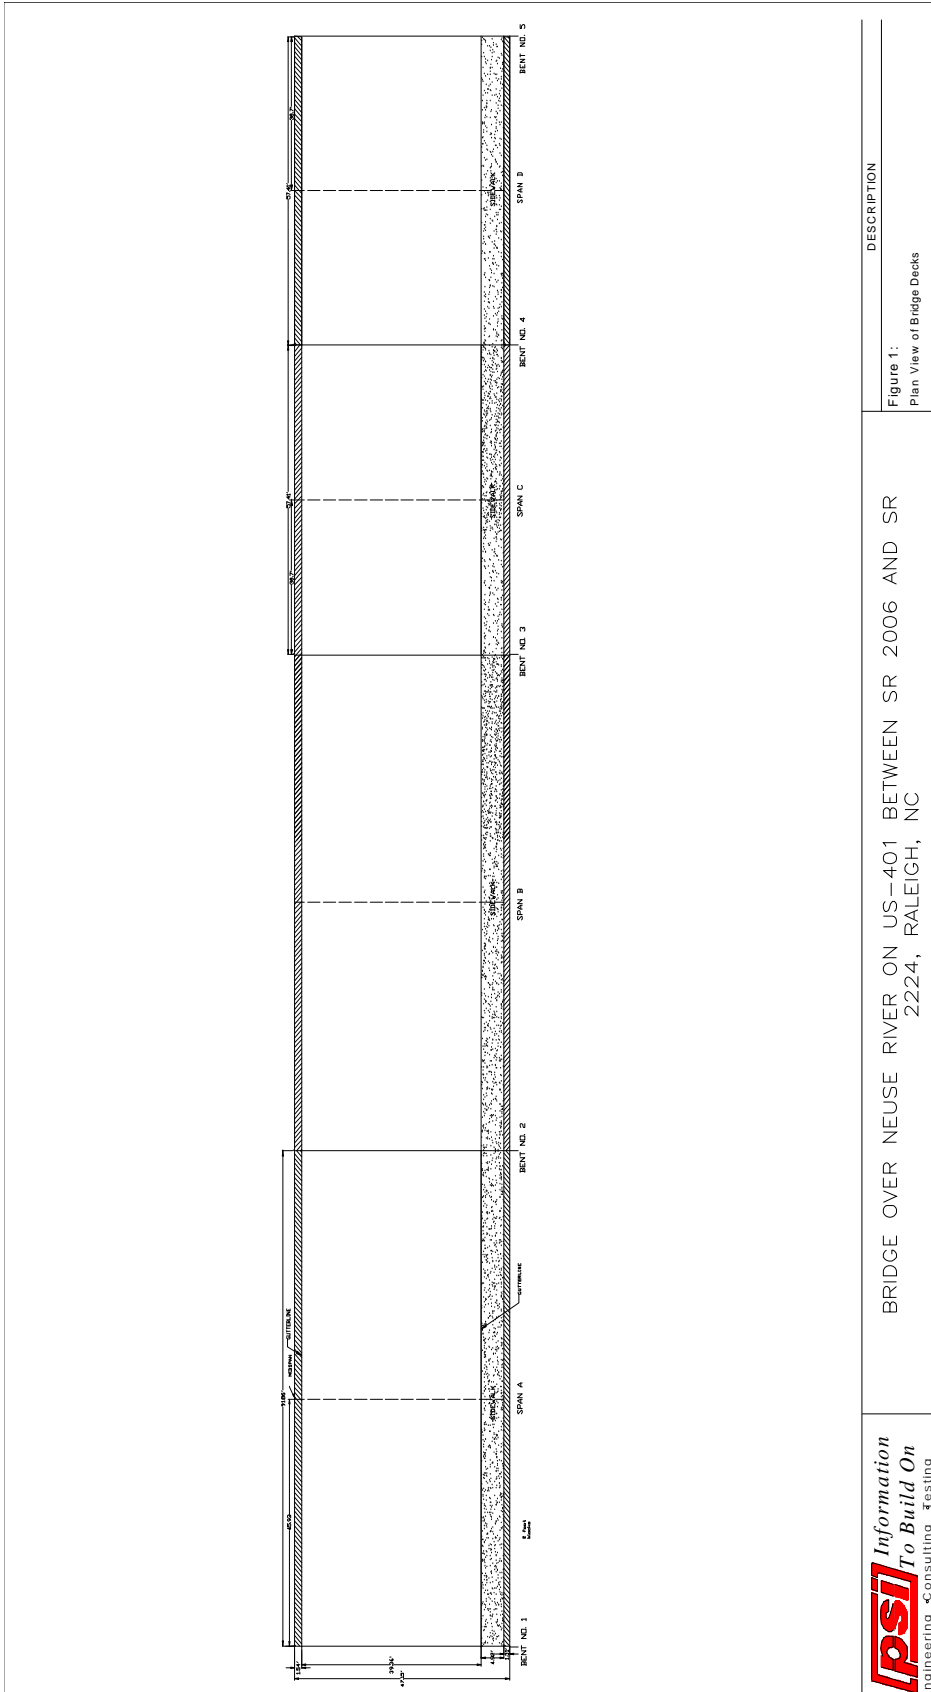
Figure 1:  
Plan View of Bridge Decks

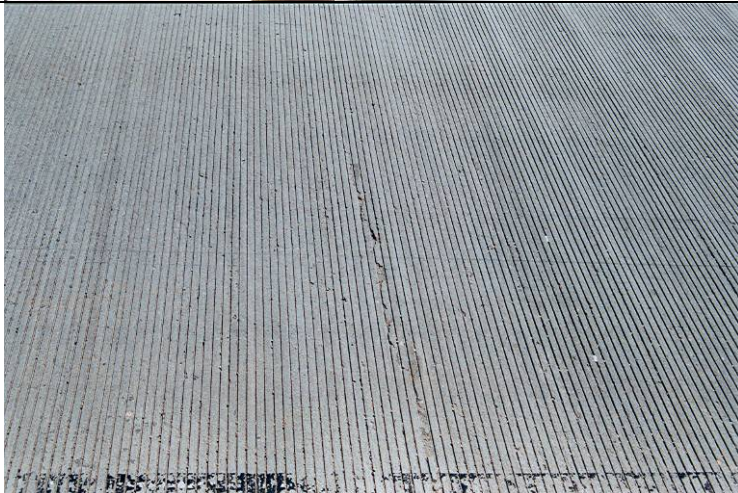
Photo 5: View of the transverse cracks on bridge deck.

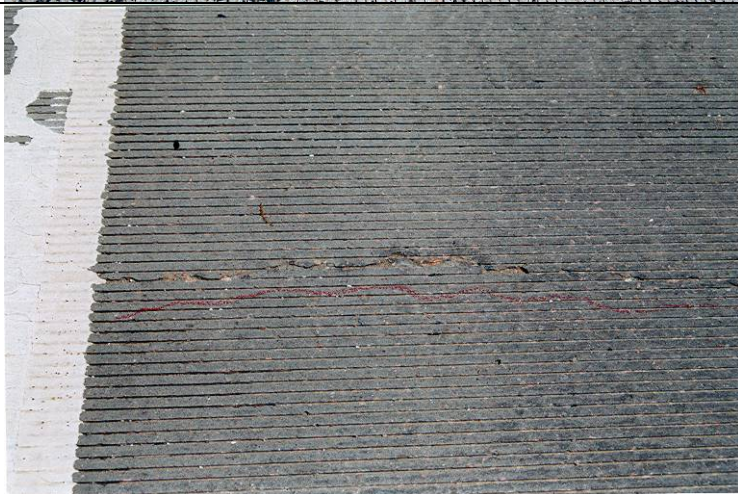
Photo 6: Close view of broken tinned edges along the transverse crack.

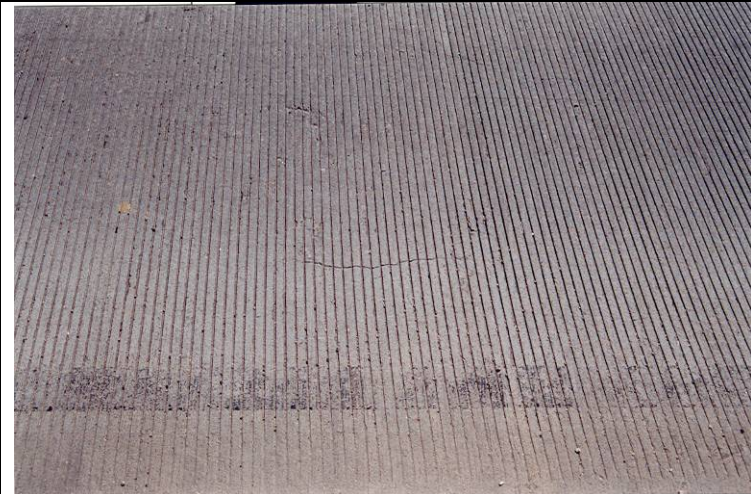
Photo 7: Close up view of longitudinal cracks on bridge deck.

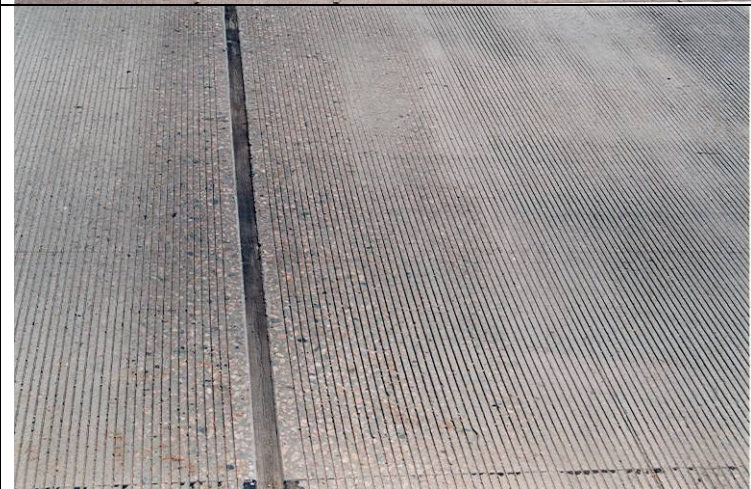
Photo 8: Close up view of typical polished surface near the joints.

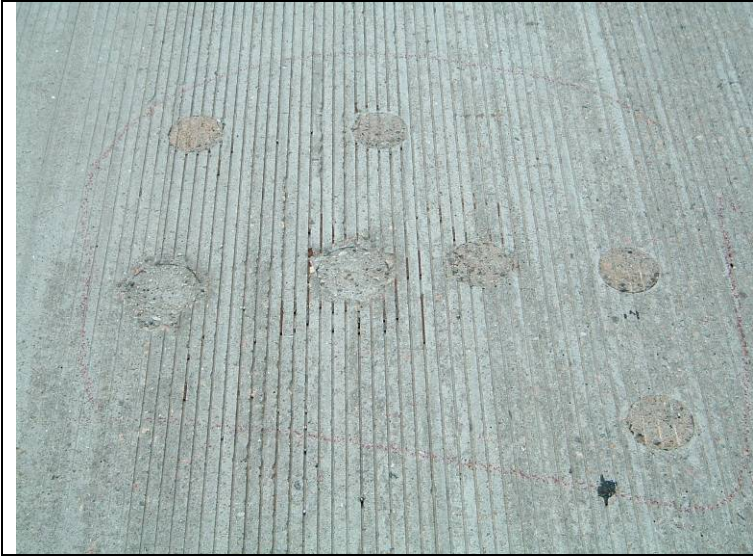
Photo 10: Failed patching work on bridge deck.

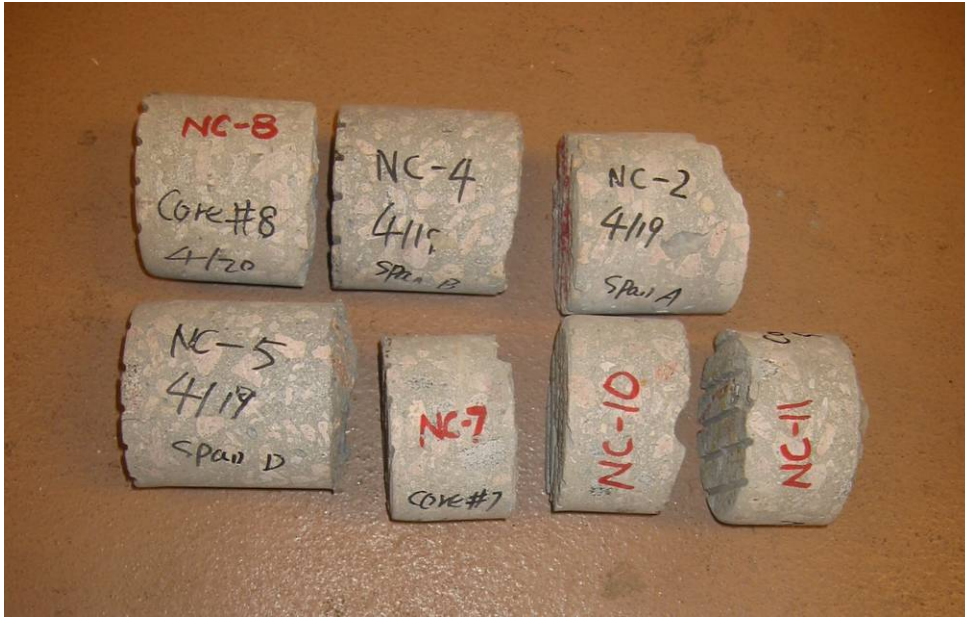
Figure I1-1: Seven concrete cores as received.

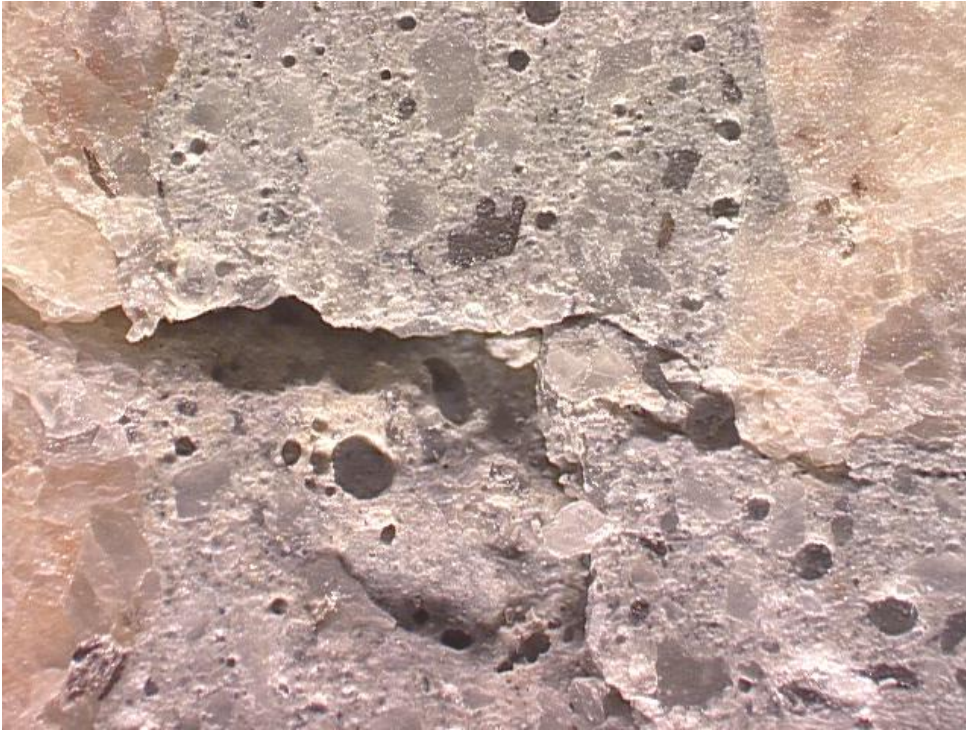
Figure I1-8. Another image of the major crack in core NC-5. Width of field is 6.5 mm.

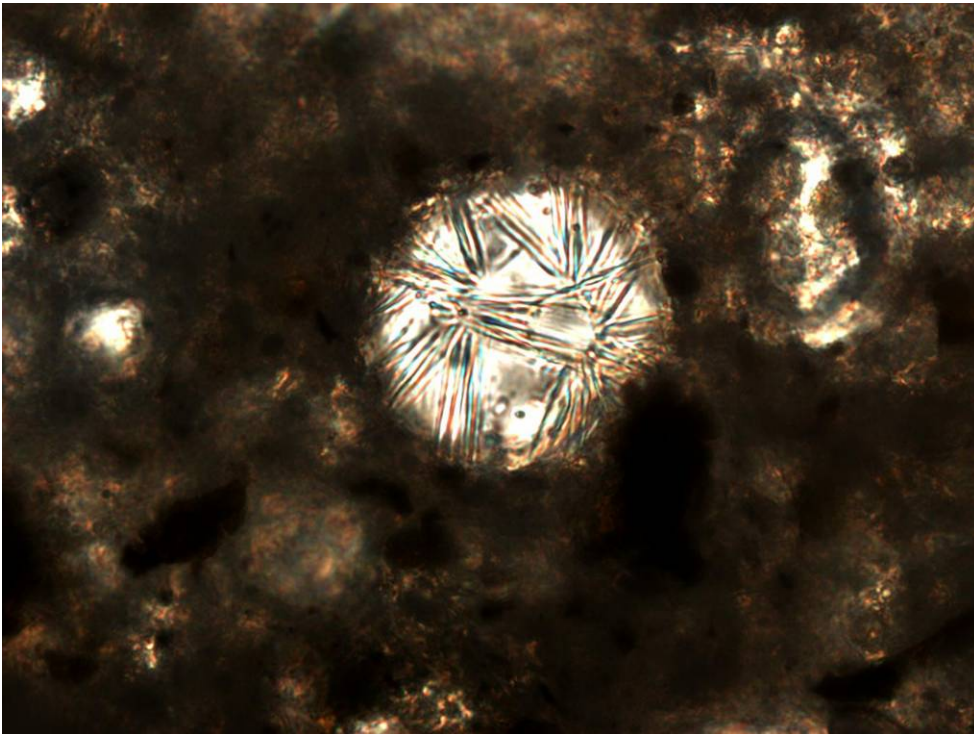
Figure I1-9: Ettringite in an air void. Width of field is 0.165 mm. Thin section image.

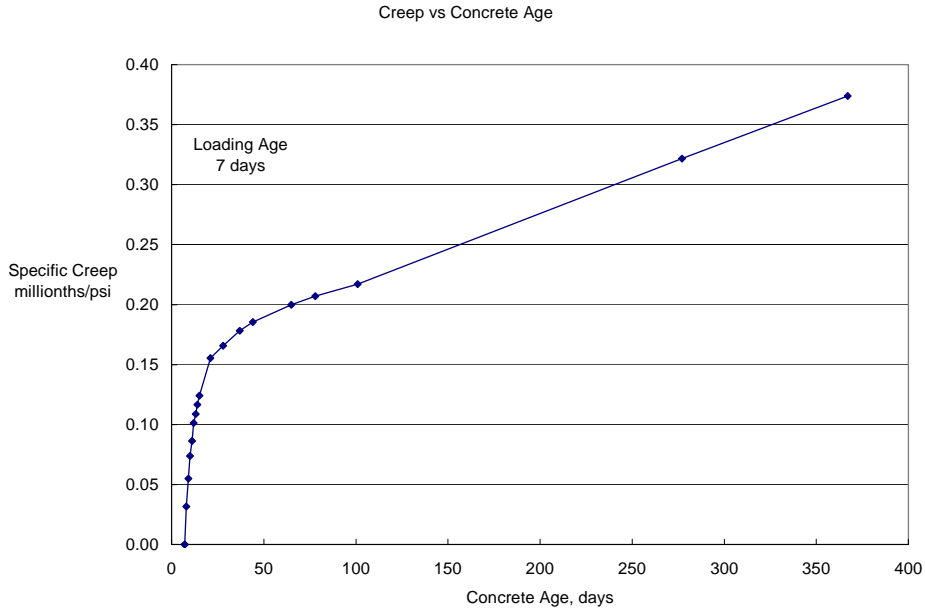
Figure 1. Creep measurements (ASTM C 512) for research tests of production concrete for girders.

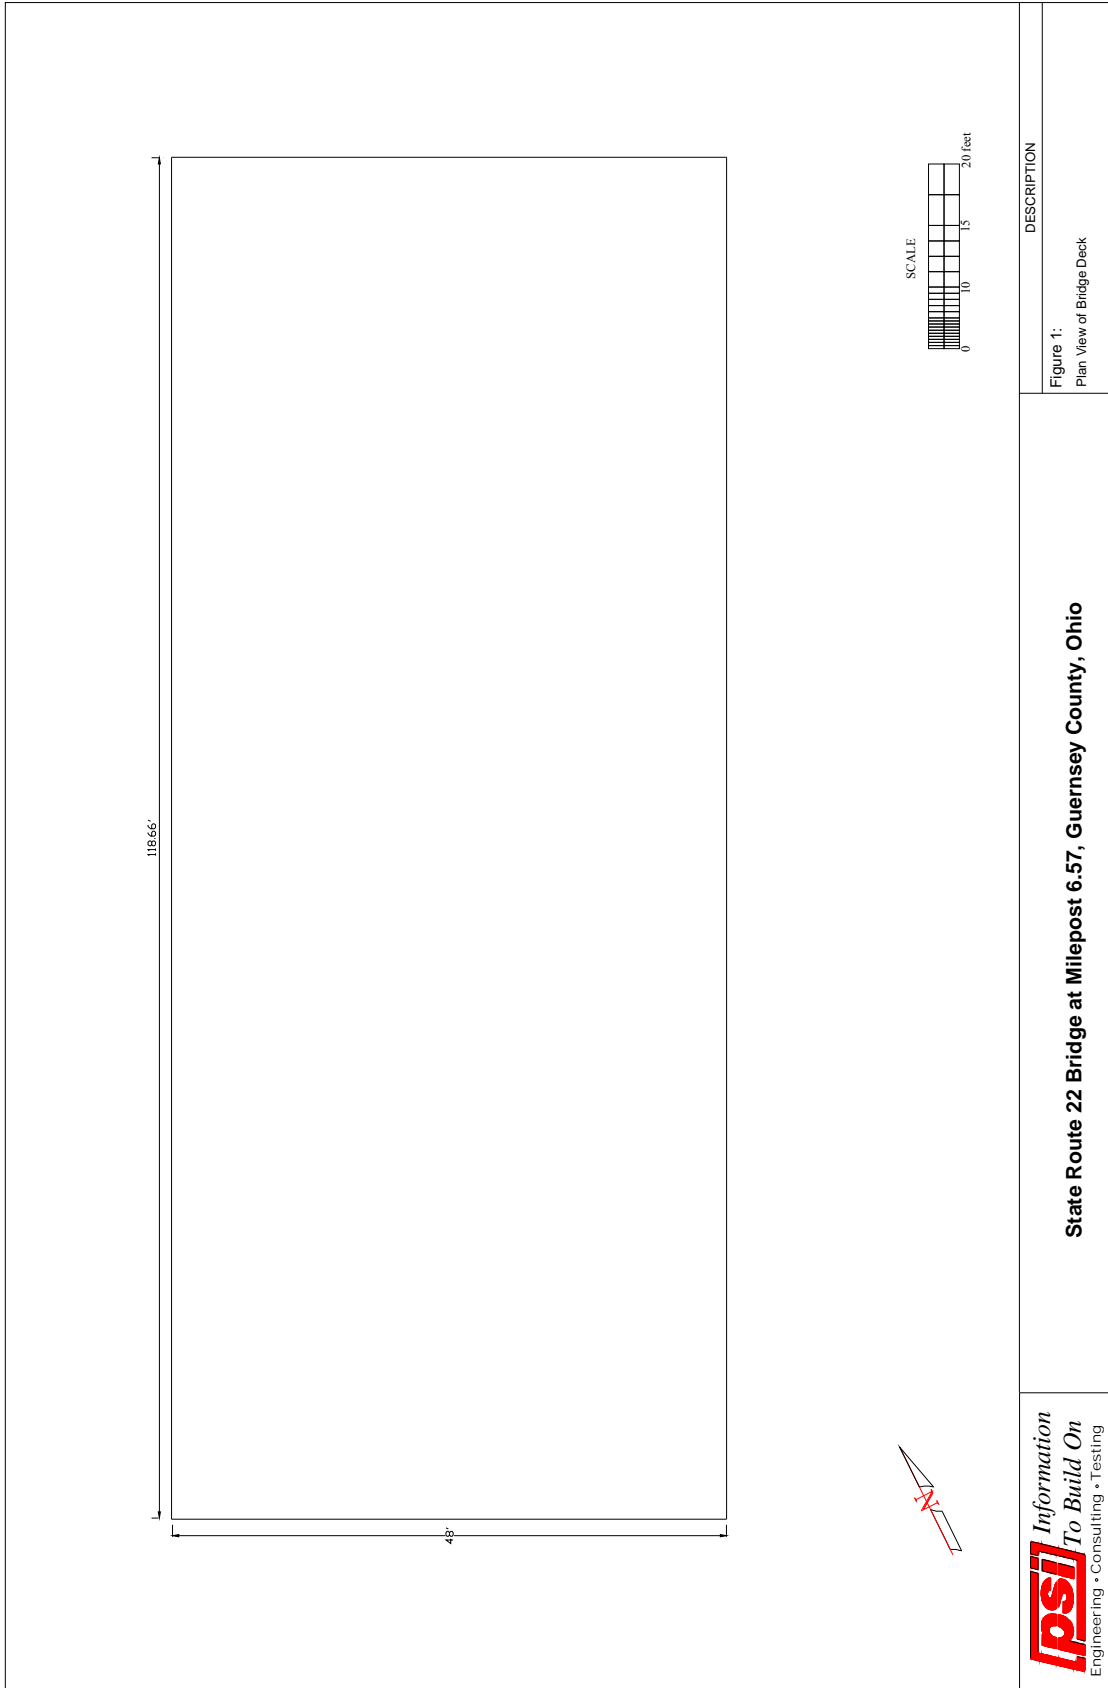
*Structural Investigation & Petrography Department*

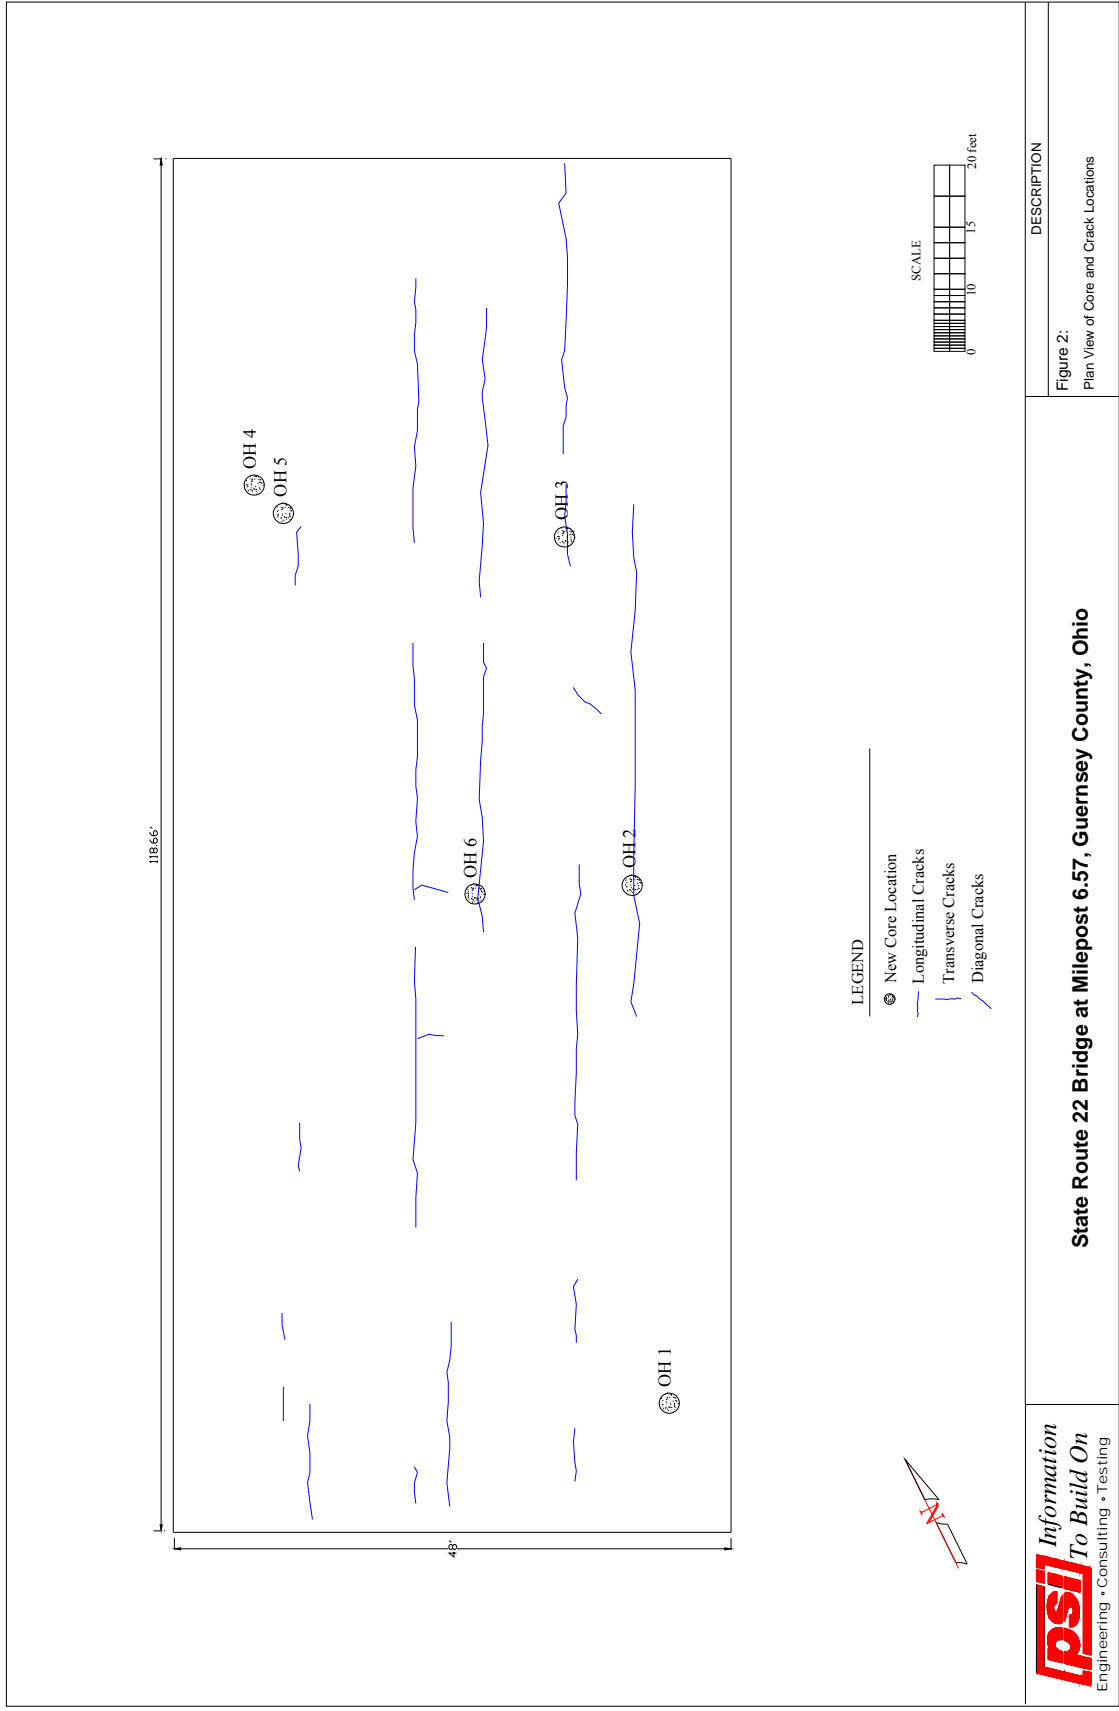
Figure 2:  
Plan View of Core and Crack Locations

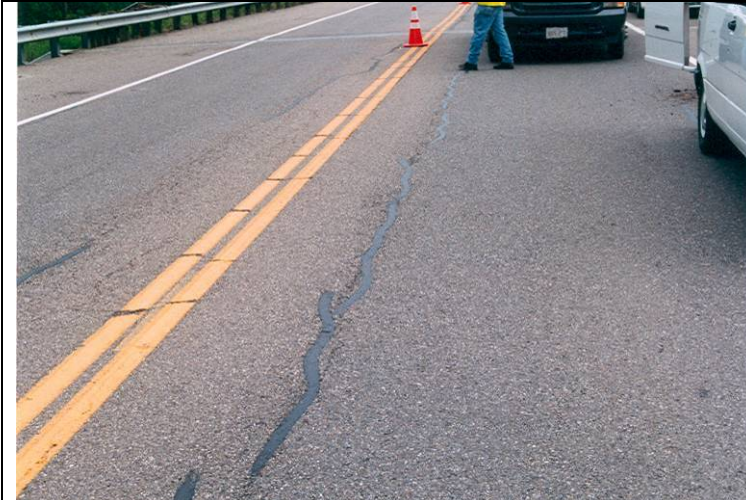
Photo 4: General overall view of the sealed cracks on asphalt wearing surface.

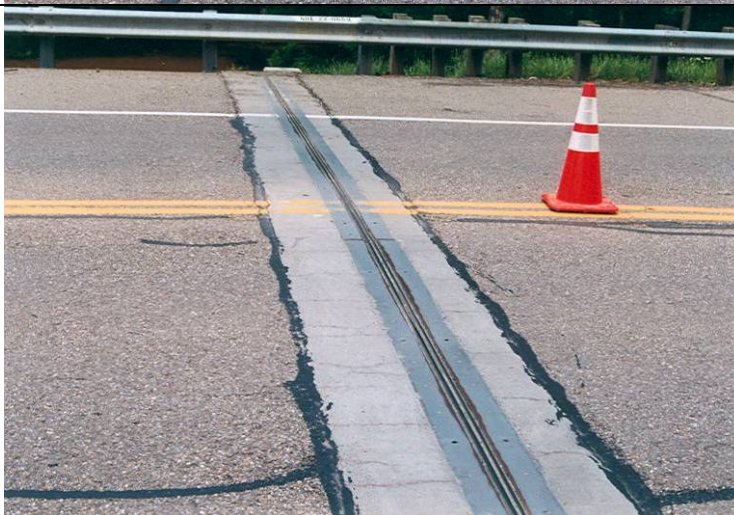
Photo 5: Transverse expansion joint at the end of the bridge.

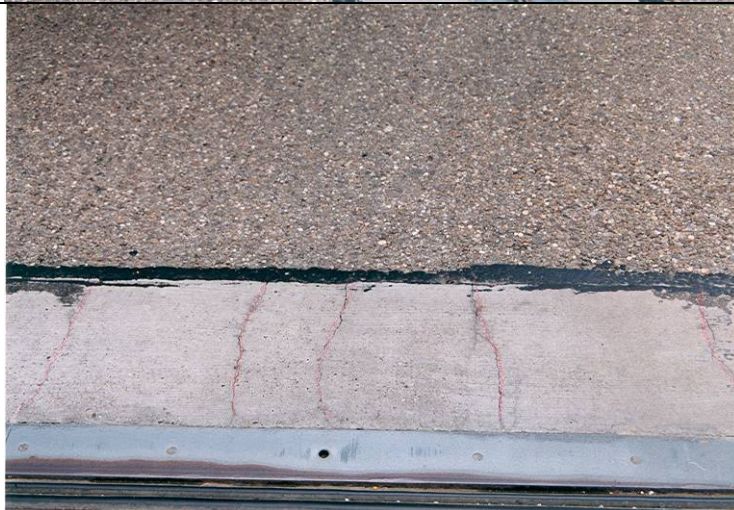
Photo 6: Close up view of the cracks at the joints.

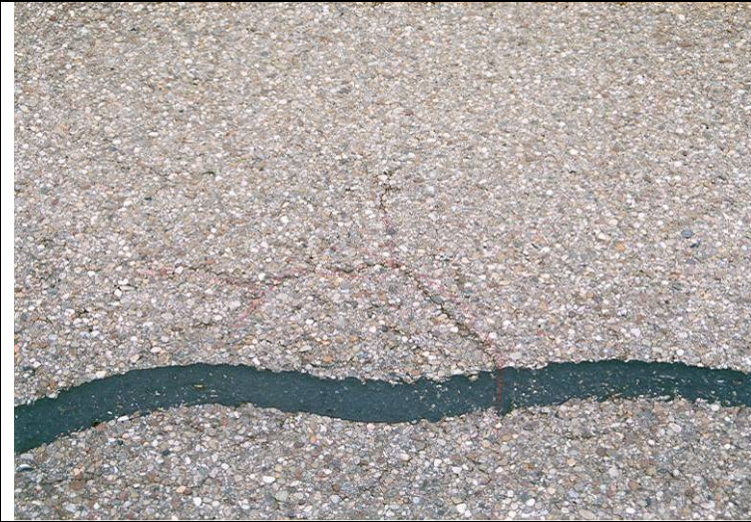
Photo 7: Sealed longitudinal cracks on asphalt overlay.

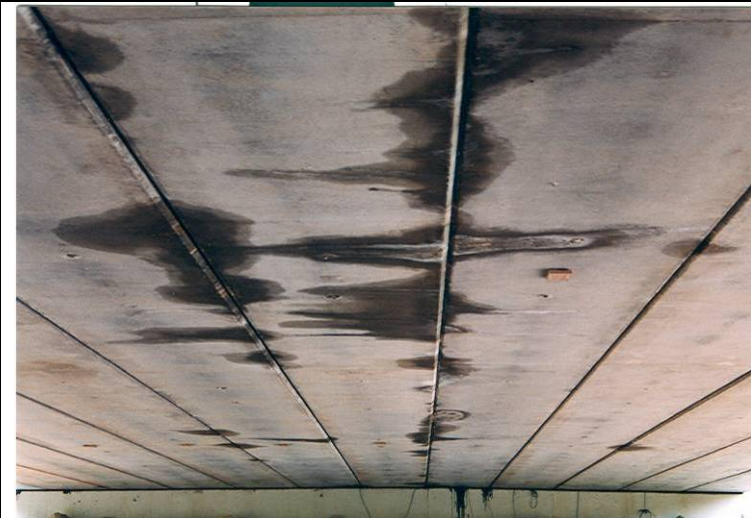
Photo 8: View of the underside of bridge.

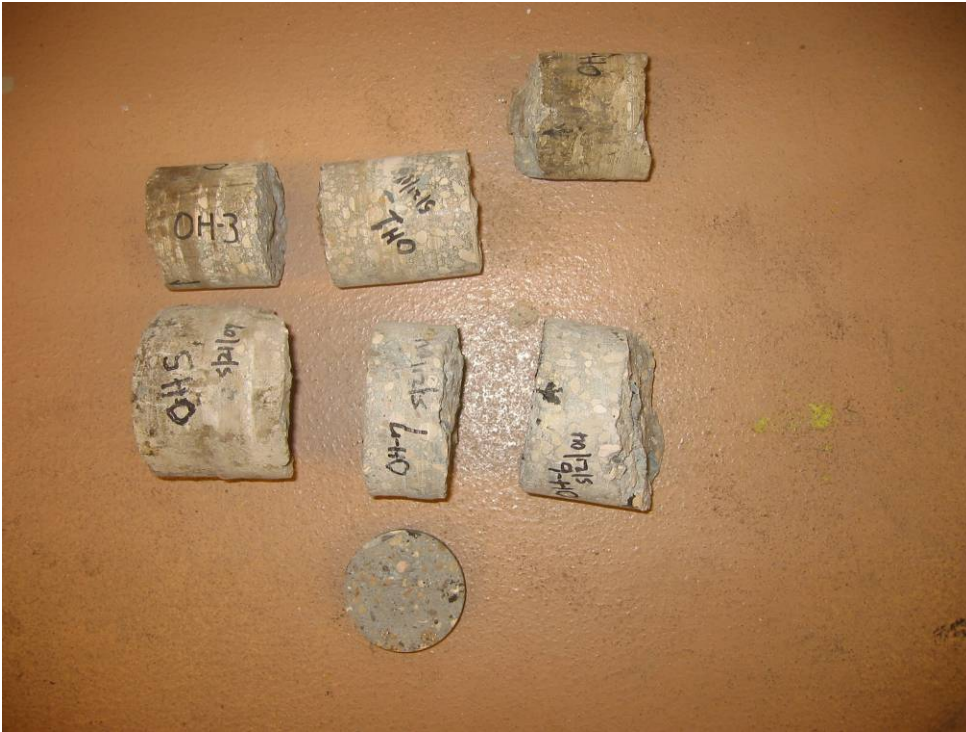
Figure J1-1: Seven cores as received. Notice that the small piece at the bottom (OH-4) is a 7/8-in. thick disc.

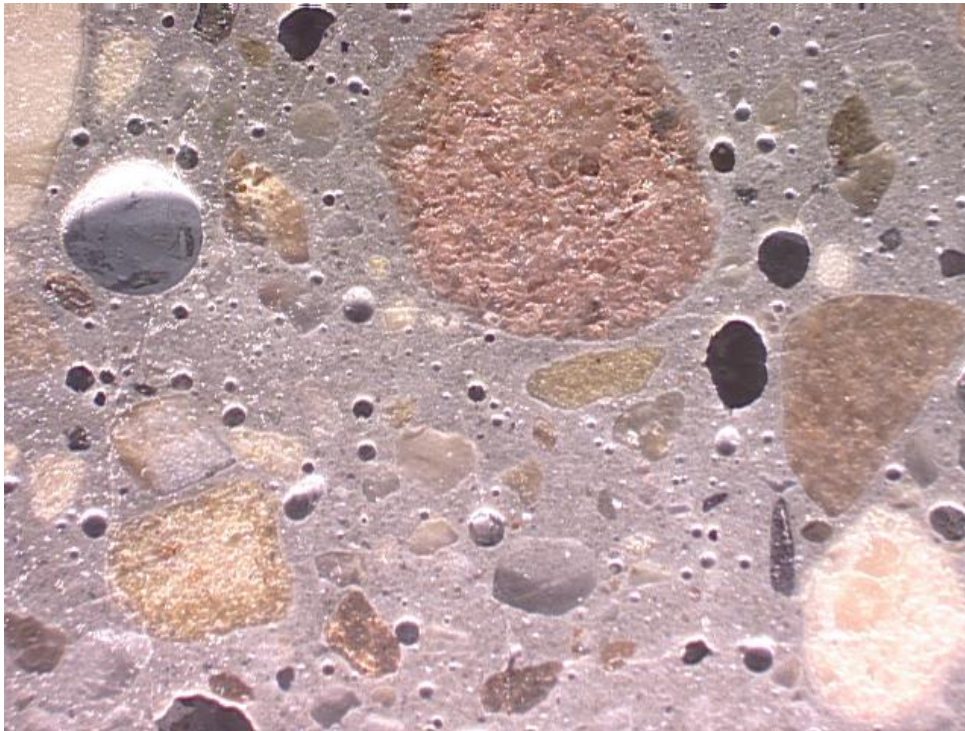
Figure J1-4: Entrained air voids in the concrete. Width of field is 4.0 mm. Polished surface image. Many cracks are also noticeable in this image.

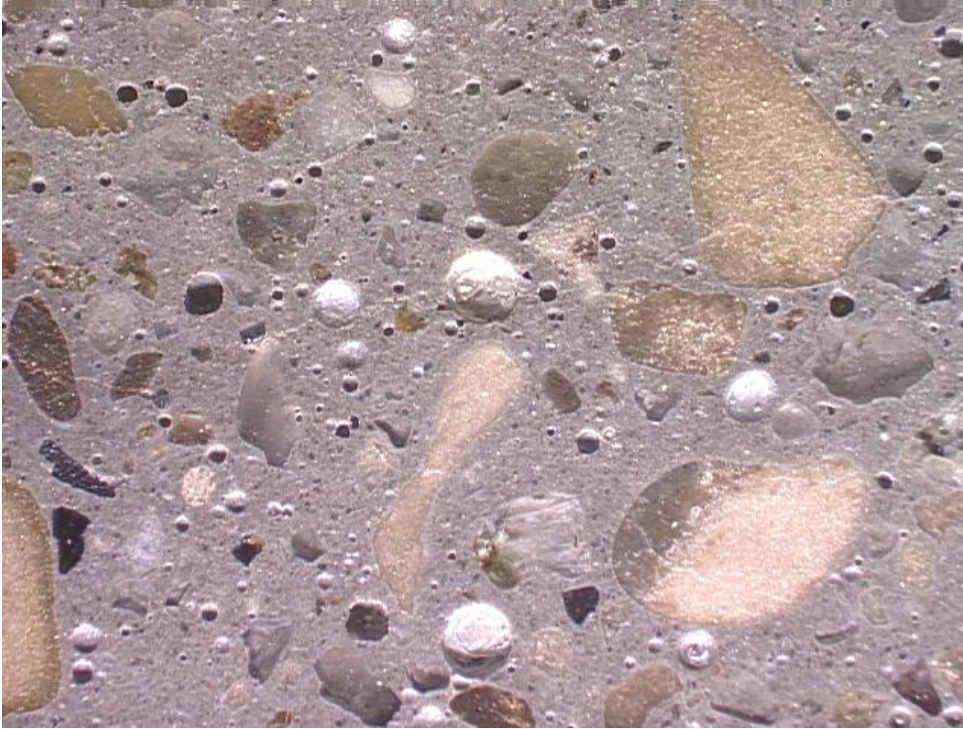
Figure J1-5: The bonding between aggregate and cement paste is moderate to poor. Width of field is 6.5 mm. Polished surface image.

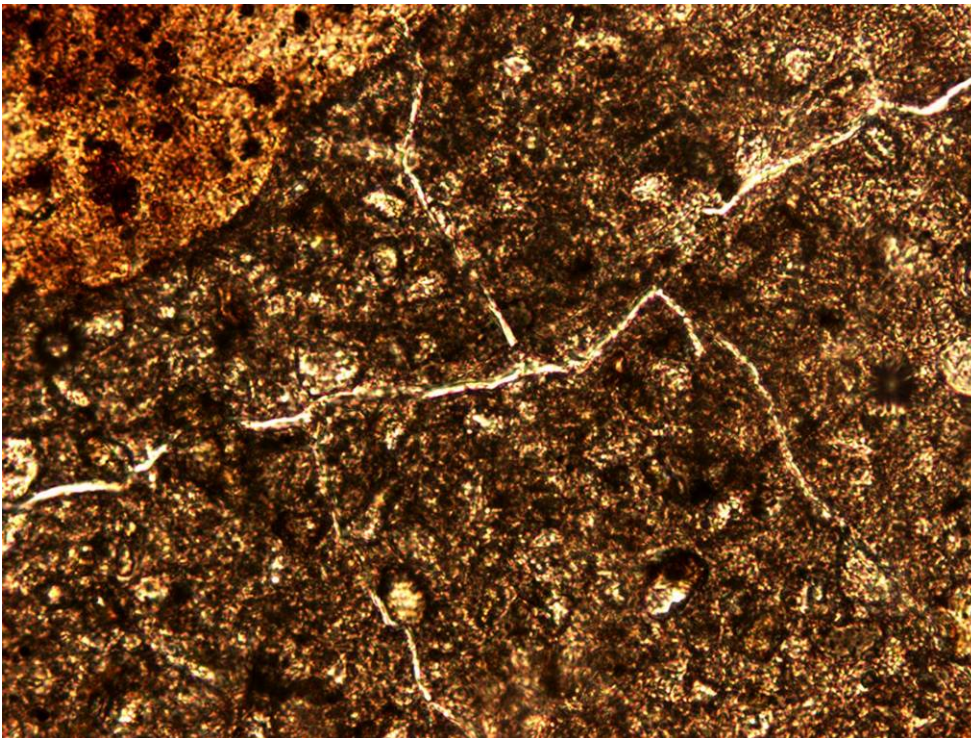
Figure J1-6: Cracks in the paste form network. Width of field is 0.33 mm. Thin section image.

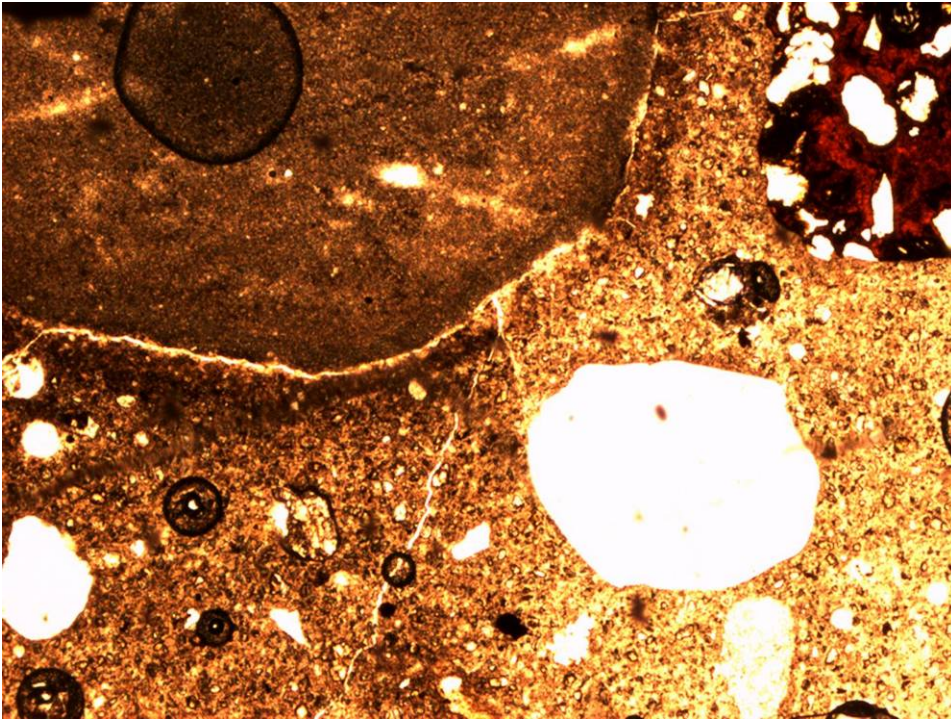
Figure J1-7: Cracks around aggregate as well as in paste. Width of field is 0.16 mm. Thin section image.

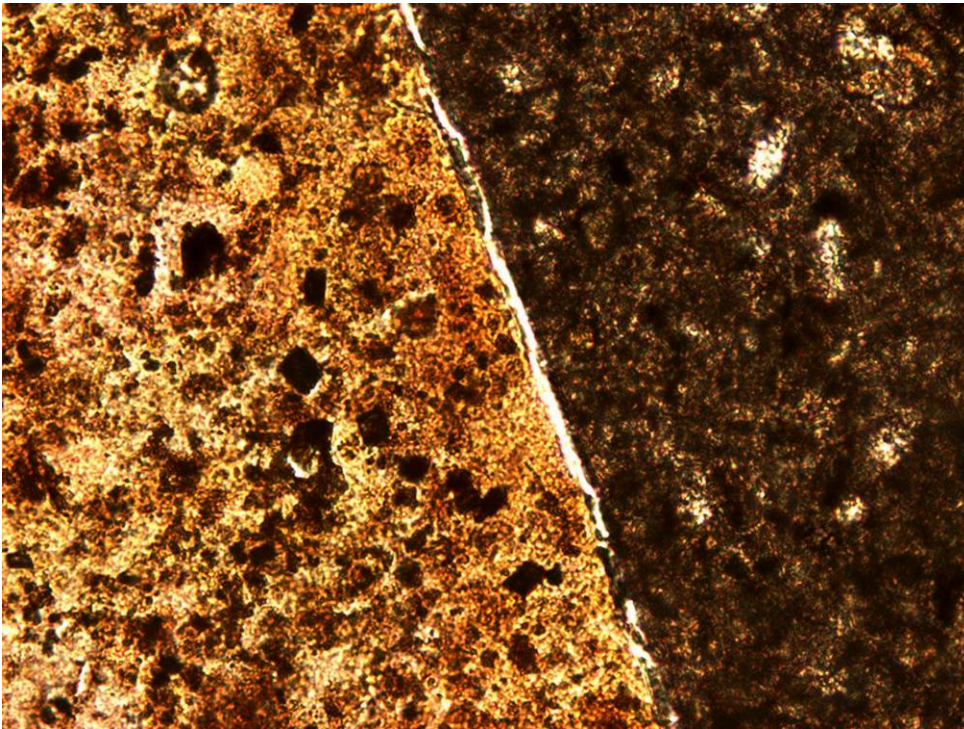
Figure J1-8: Crack along the aggregate/paste interface. Width of field is 0.33 mm. Thin section image.

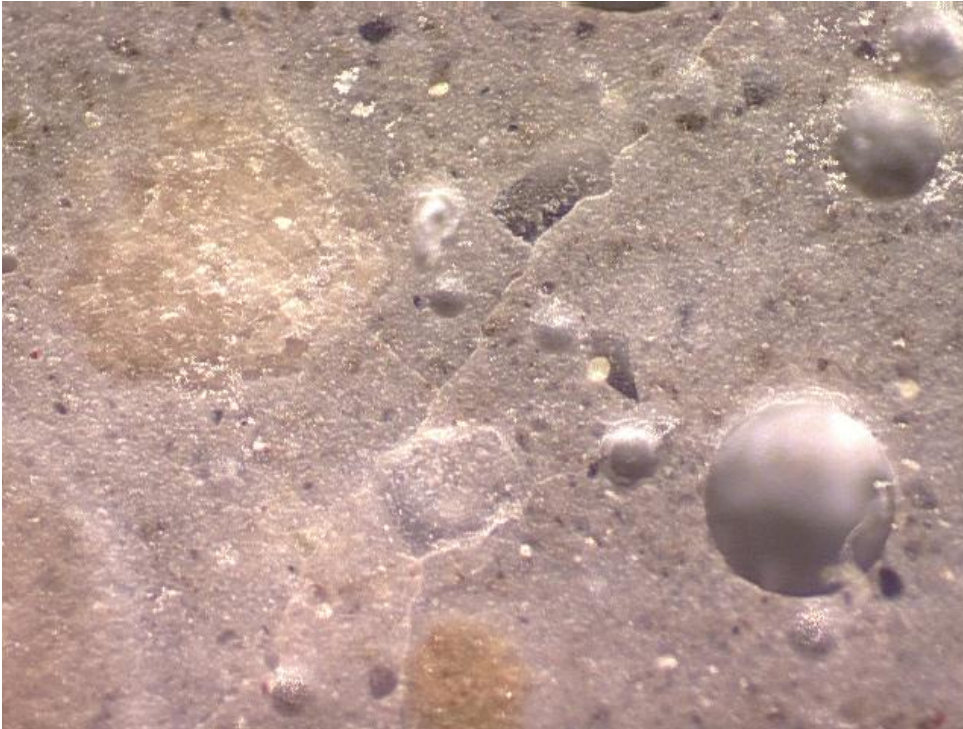
Figure J1-9: Cracks as seen in the polished slab. Width of field is 1.1 mm.

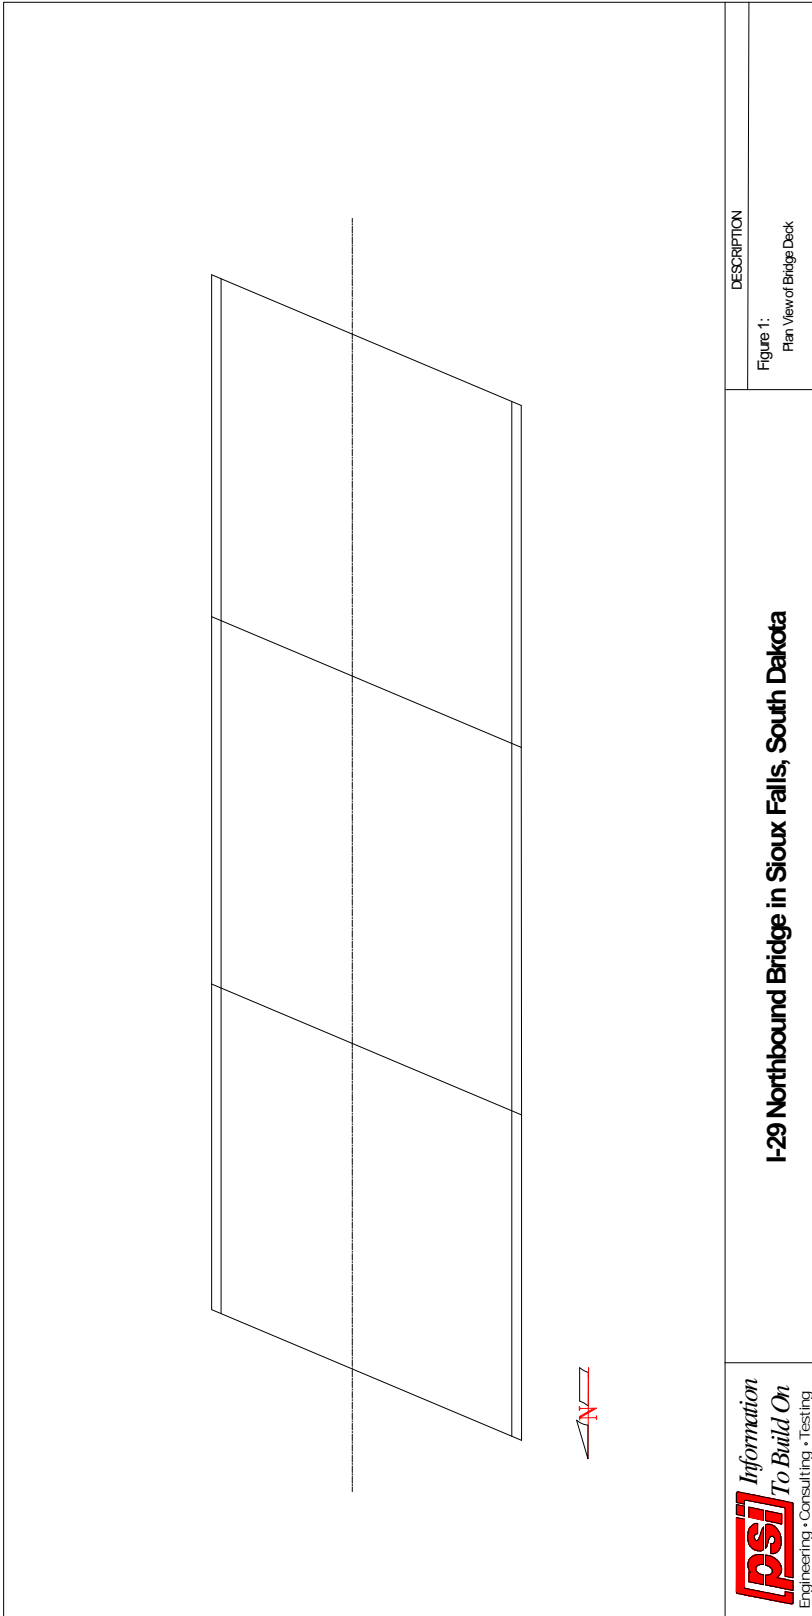
*Respectfully Submitted,*  
***Professional Service Industries, Inc.***  
*Structural Investigation & Petrography Department*

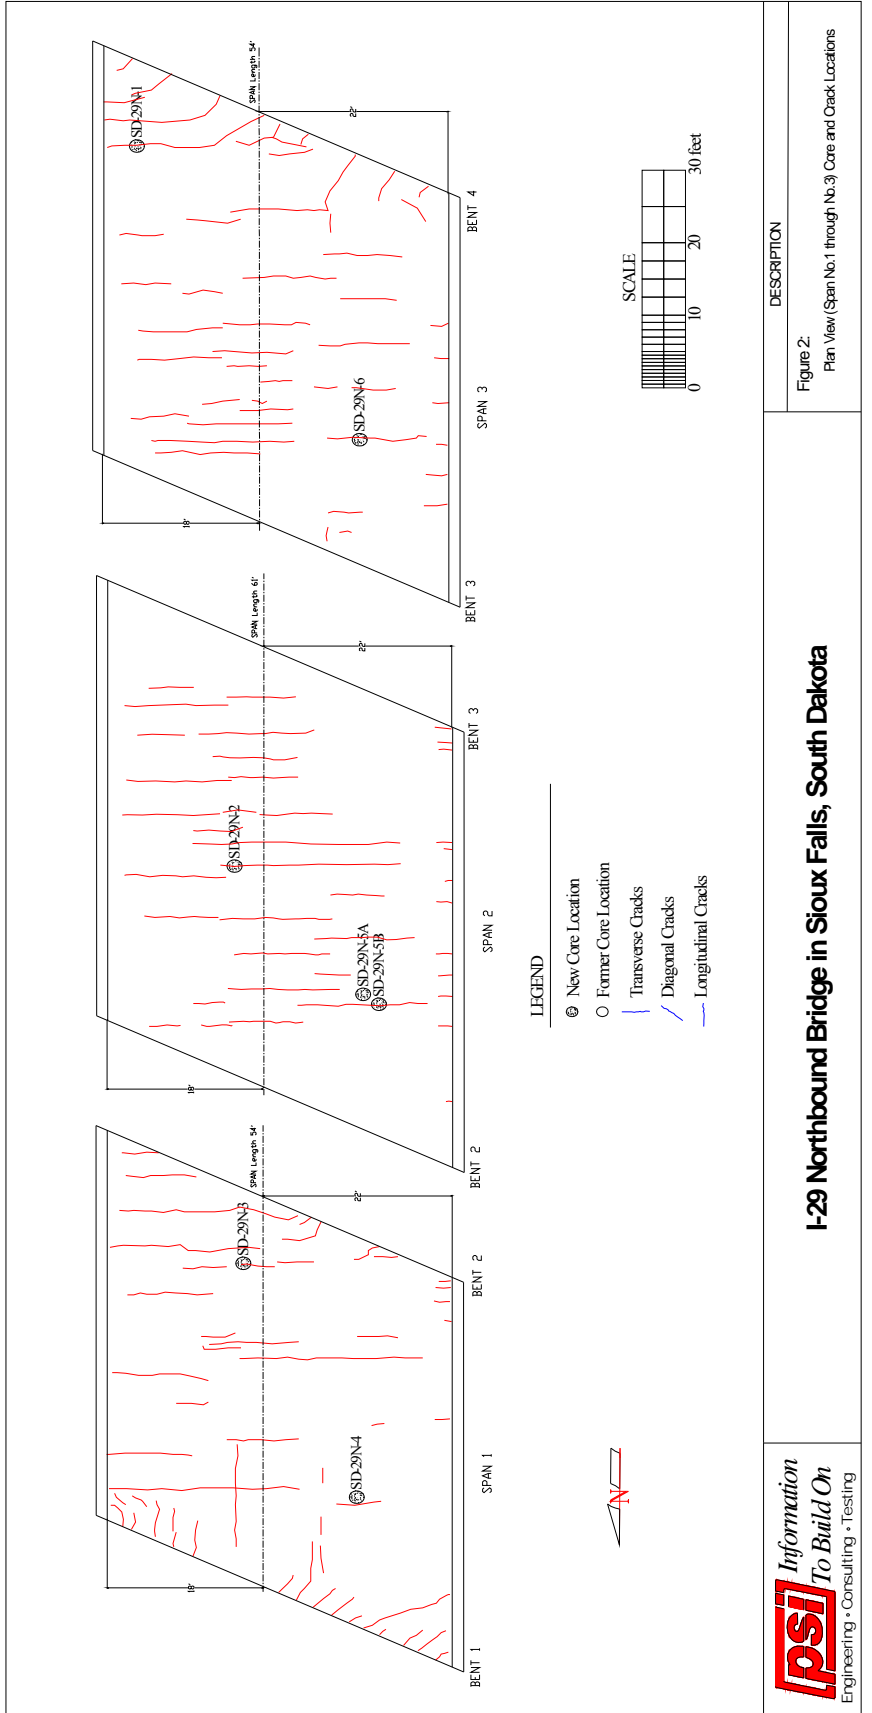
**I-29 Northbound Bridge in Sioux Falls, South Dakota**

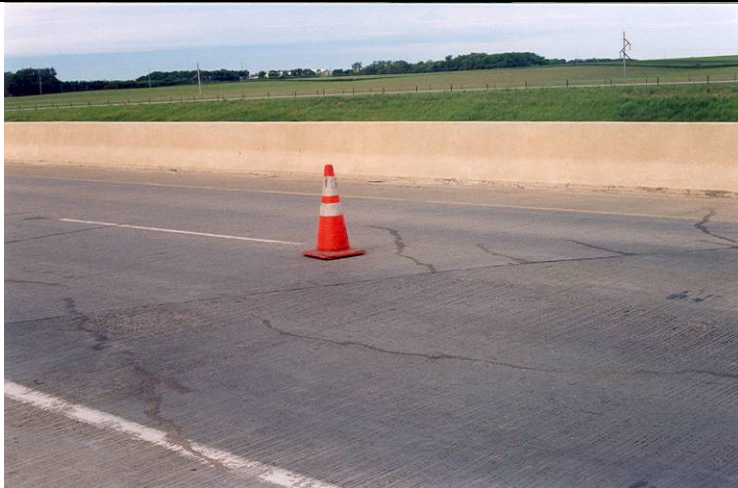
Photo 3: Cracks on the north side approach slab on the I-29 Northbound Bridge.

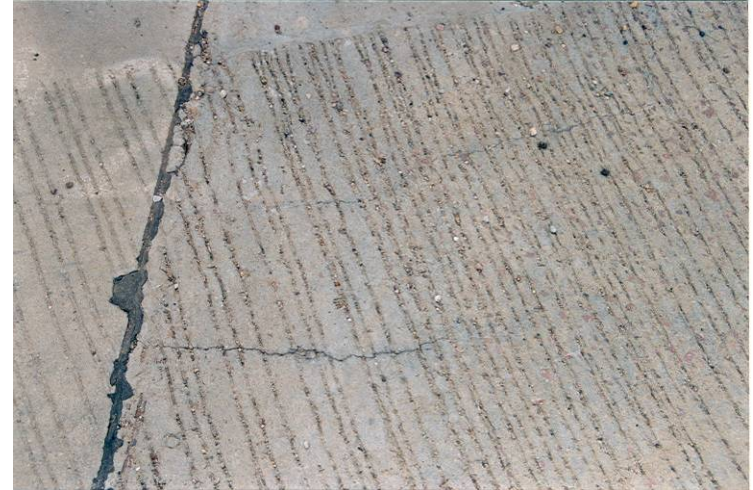
A close-up photograph of a concrete bridge deck surface. The surface has a ribbed texture. A prominent, dark, diagonal crack runs from the upper left towards the center. A horizontal crack is also visible, intersecting the diagonal one near the center.	<p>Photo 4: Close up view of diagonal crack near the joint.</p>

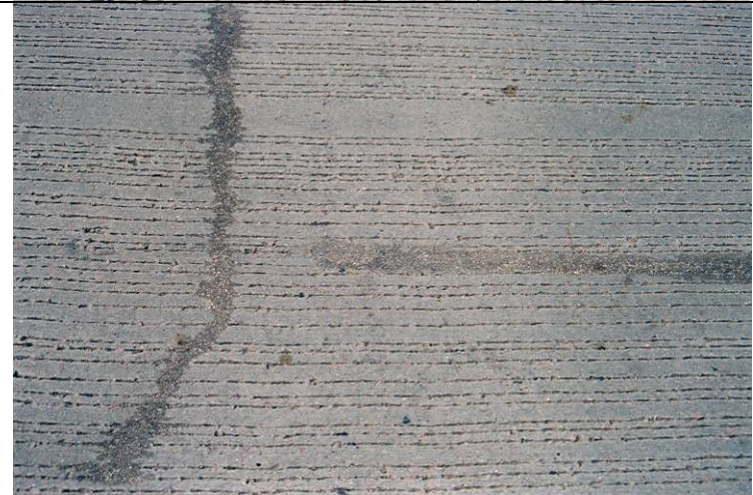
A close-up photograph of a concrete bridge deck surface with a ribbed texture. A vertical, transverse crack runs down the center of the frame. The crack is filled with a dark, possibly sealant or debris.	<p>Photo 5: Close up view of transverse crack.</p>

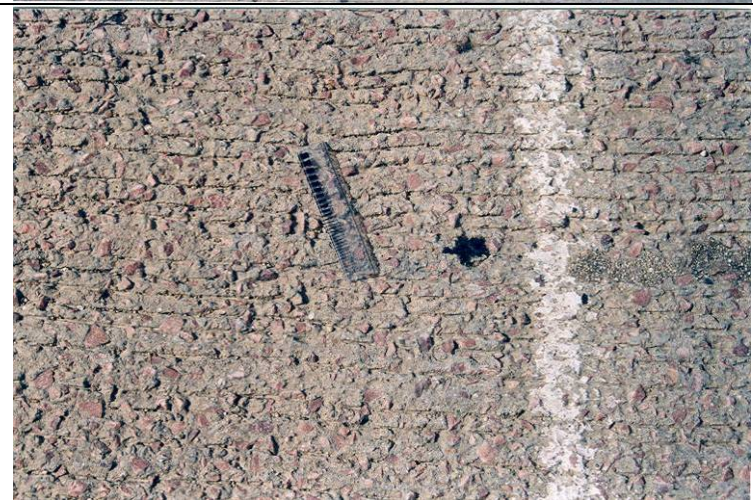
A close-up photograph of a concrete bridge deck surface showing a rough, aggregate-rich texture. A small, dark, irregular chip is visible. A ruler is placed horizontally on the surface to the left of the chip for scale.	<p>Photo 6: small chips observed near the saw-cut grooves.</p>

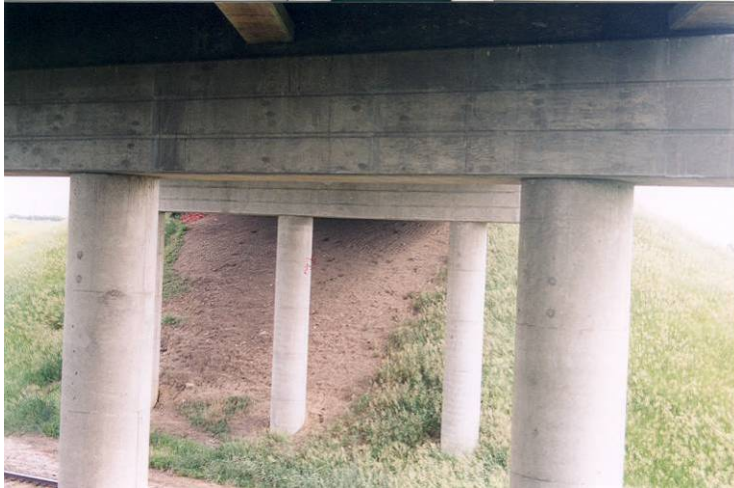
Photo 7: General overview of underside of the bridge.

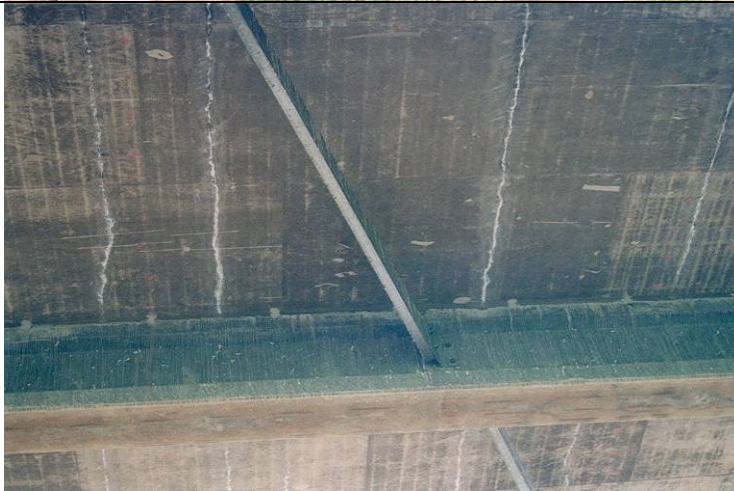
Photo 8: Close up view of underside of the bridge. Note the crack and efflorescence.

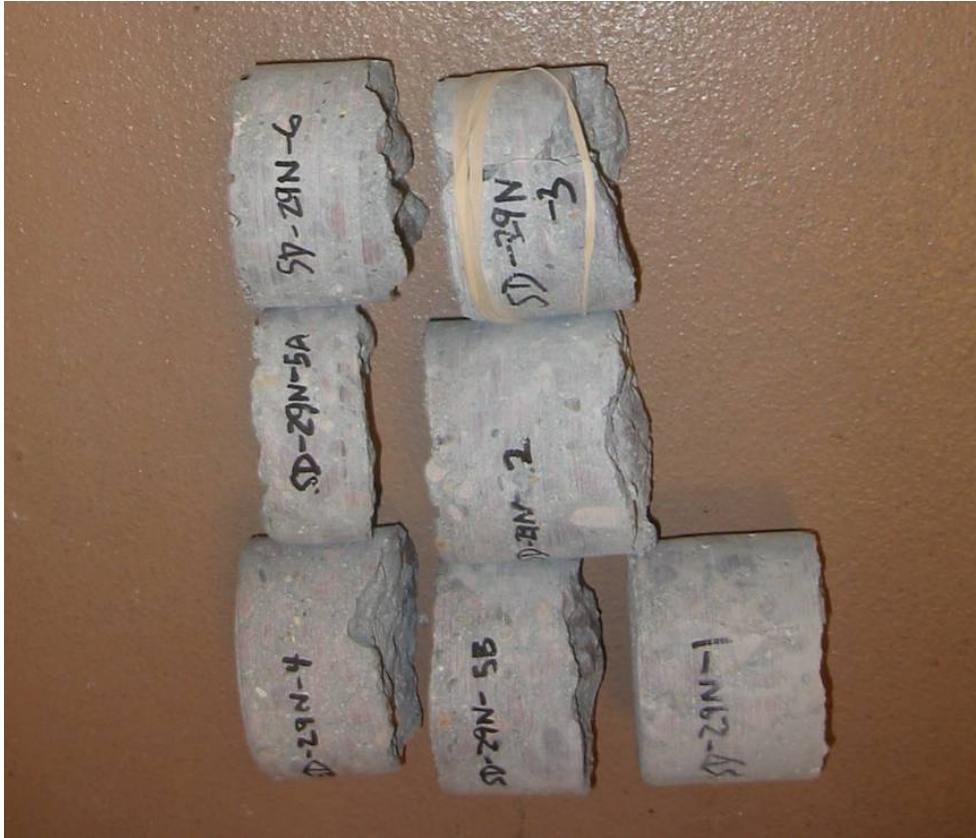
Figure K1-1: Seven concrete cores as received.
