# High Performance Concrete Bridge Deck Investigation

November 2009

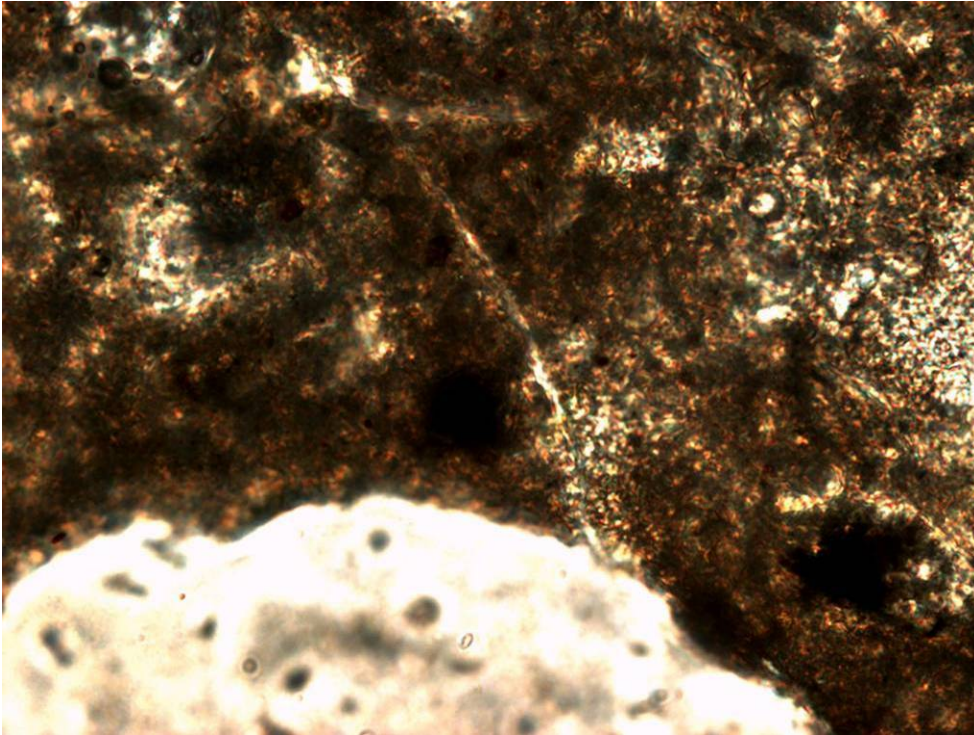
Figure K1-7: A crack in cement paste. Width of field is 0.165 mm. Thin section image.

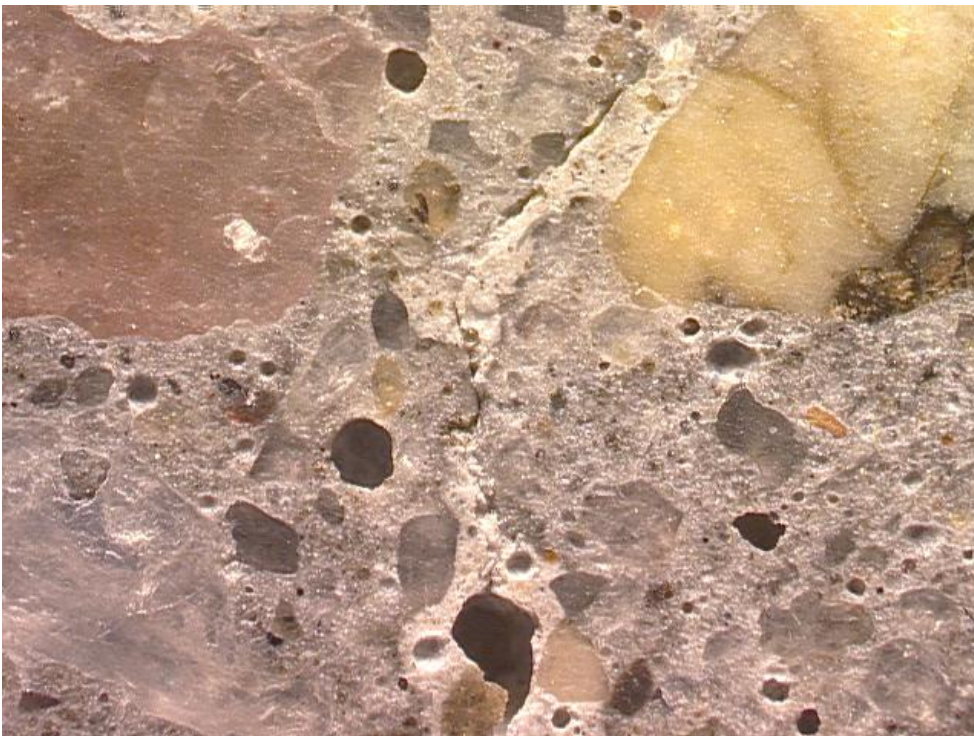
Figure K1-8: A crack located about  $\frac{1}{2}$  in. below the exposed surface. Width of field is 4.0 mm. Polished surface image.

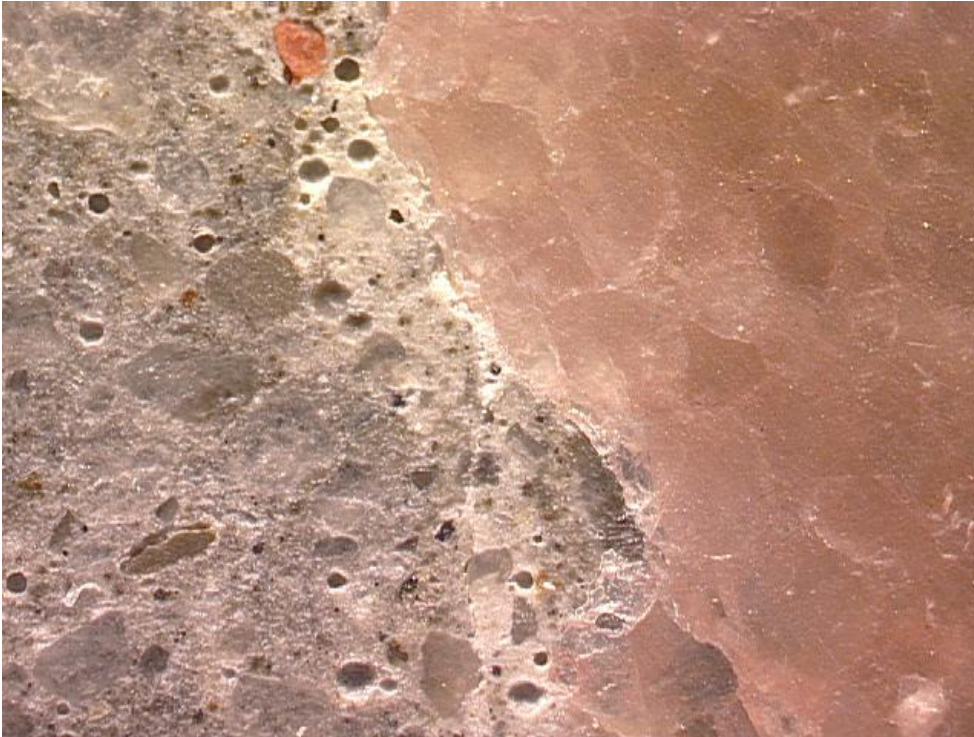
Figure K1-9: Cracks at the interfacial region between a coarse aggregate particle and paste. Width of field is 4.0 mm. Polished section image.

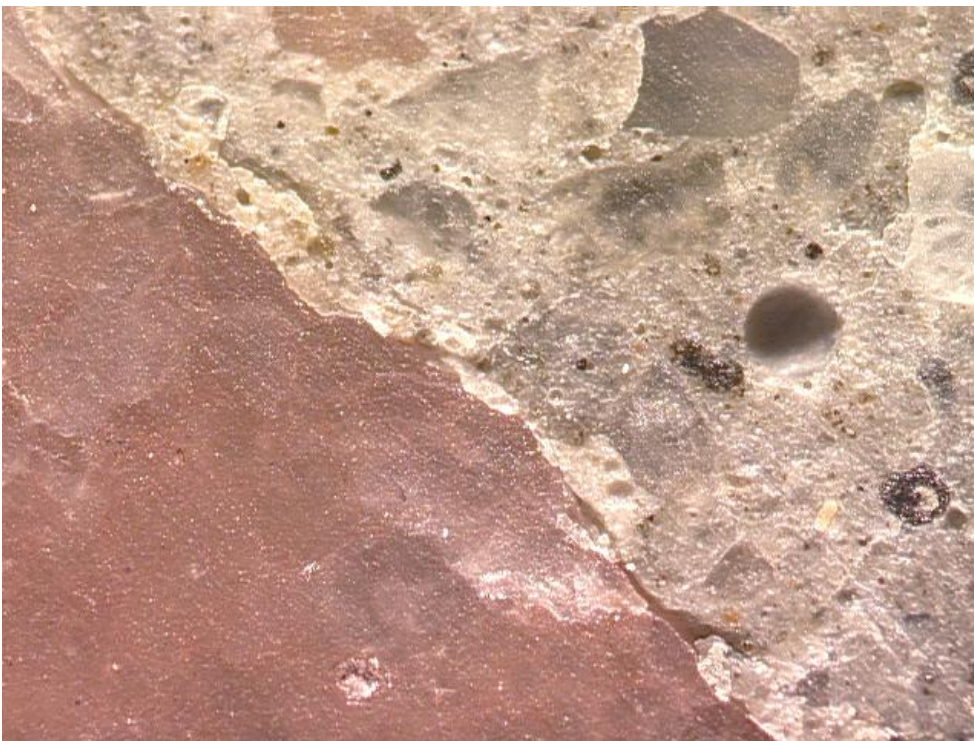
Figure K1-10: Another image showing cracking at the interfacial region between a coarse aggregate particle and the paste. Width of field is 2.0 mm. Polished section image.

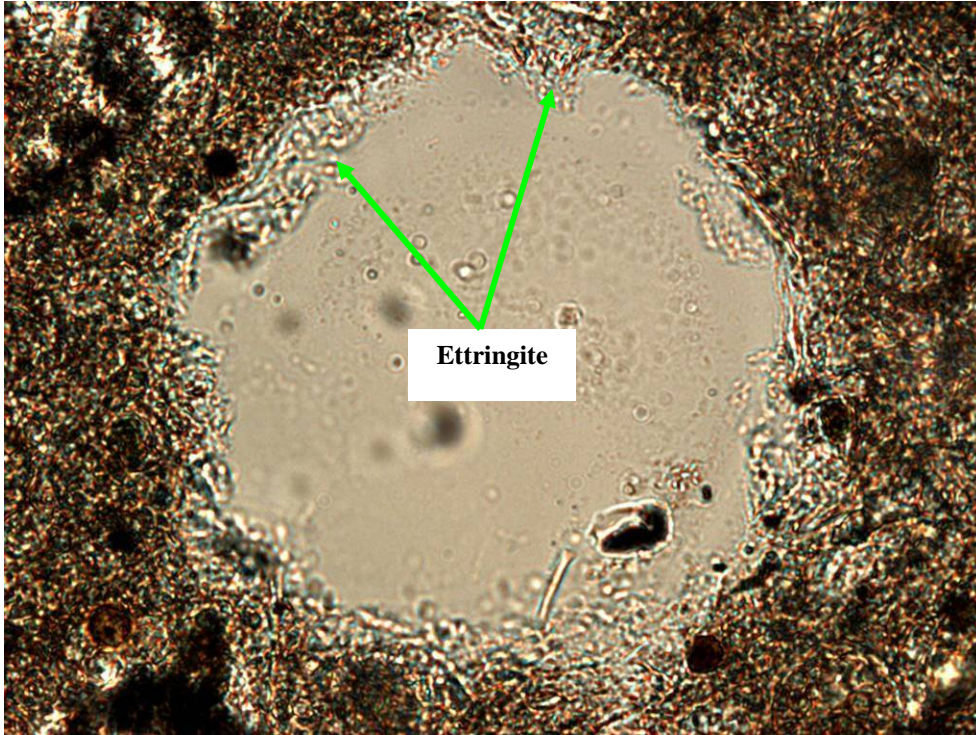
Figure K1-11: Ettringite in a void. Width of field is 0.165 mm. Thin section image.

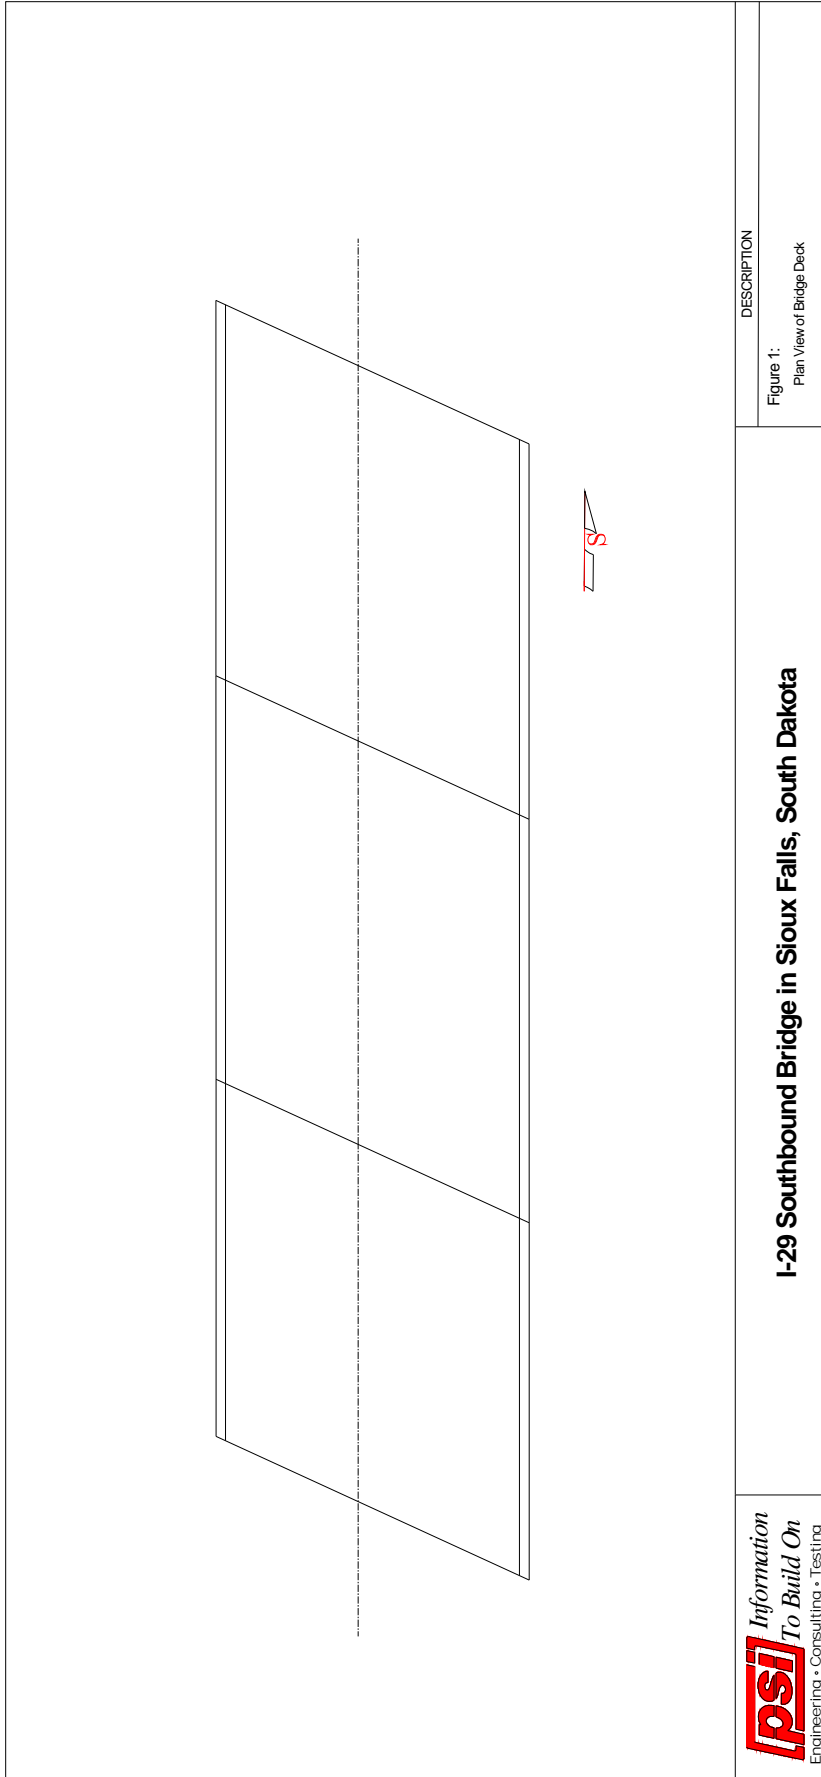
*Respectfully Submitted,*  
***Professional Service Industries, Inc.***  
*Structural Investigation & Petrography Department*

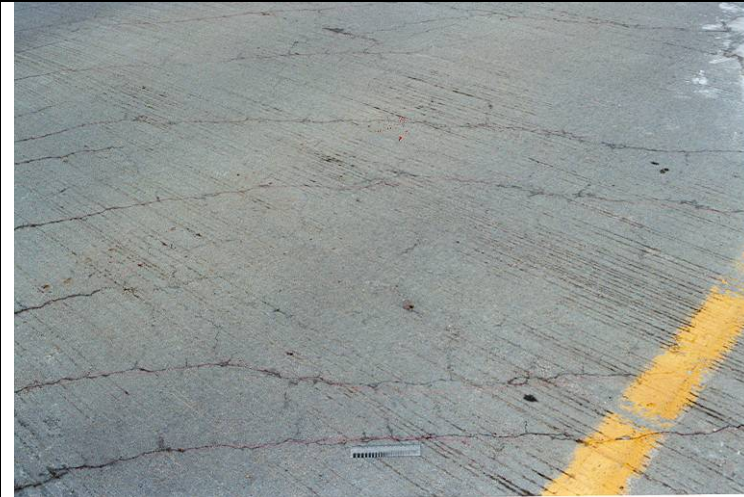
Photo 3: Crack patterns on the Southbound Bridge.

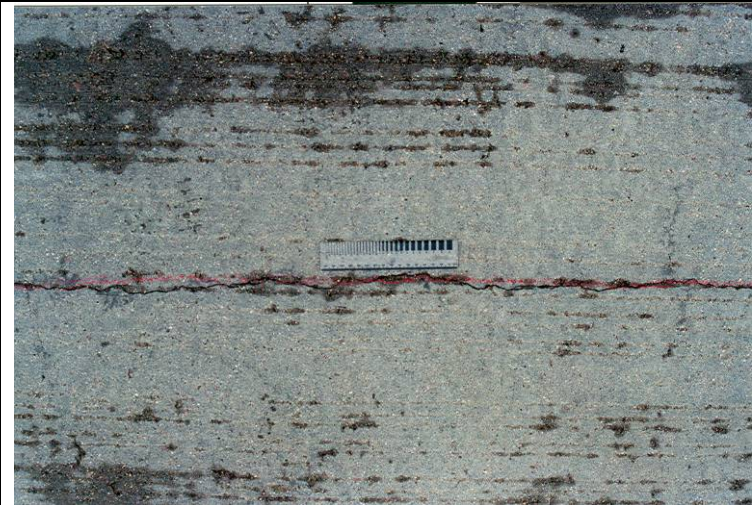
A close-up photograph of a concrete bridge deck. A prominent, dark, diagonal crack runs horizontally across the center of the frame. Above the crack, a small white ruler is placed for scale. The concrete surface is textured and shows some discoloration and minor surface wear.	<p>Photo 4: Close up view of diagonal crack near the joint.</p>

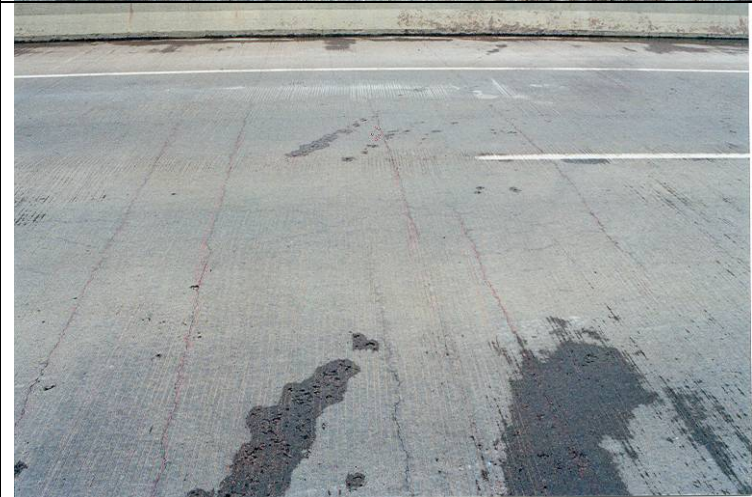
A photograph showing a wider view of the bridge deck. Several parallel transverse cracks are visible, running across the width of the deck. The surface is light-colored with some darker patches and a white painted line is visible in the distance.	<p>Photo 5: Close up view of transverse cracks.</p>

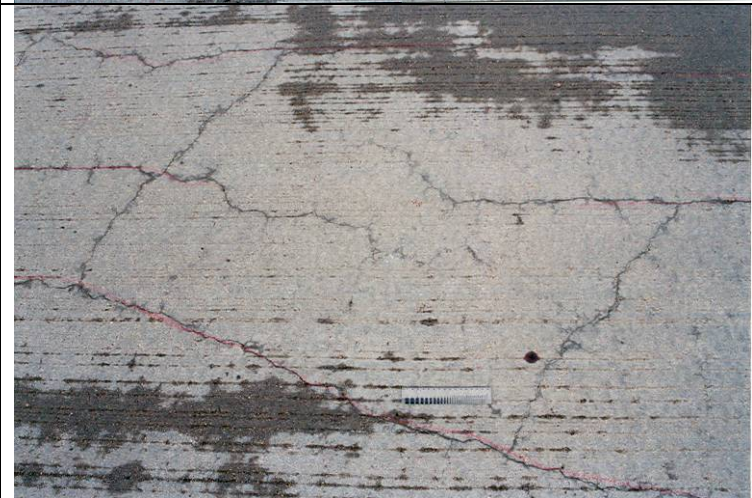
A close-up photograph of a complex crack pattern on the bridge deck. Multiple cracks of varying lengths and orientations are visible, creating a network of fractures. A small white ruler is placed at the bottom center for scale. The concrete appears aged and weathered.	<p>Photo 6: Close up view of crack pattern on Span 2 of Southbound Bridge.</p>

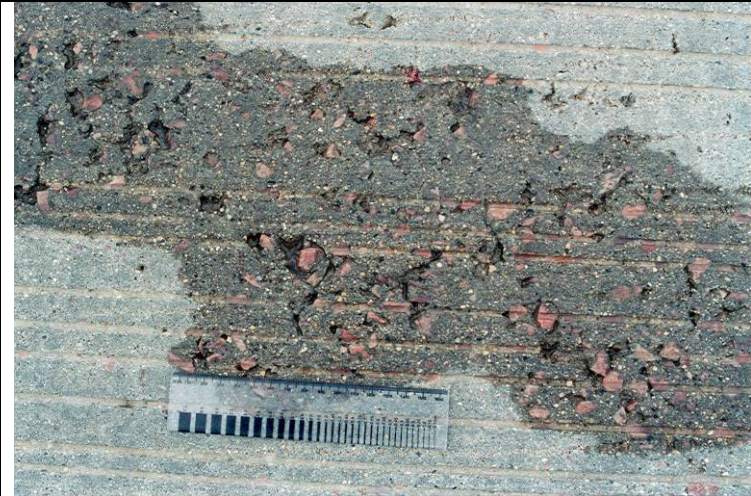
Photo 7: Honeycomb defects observed on Span 2 of Southbound Bridge.

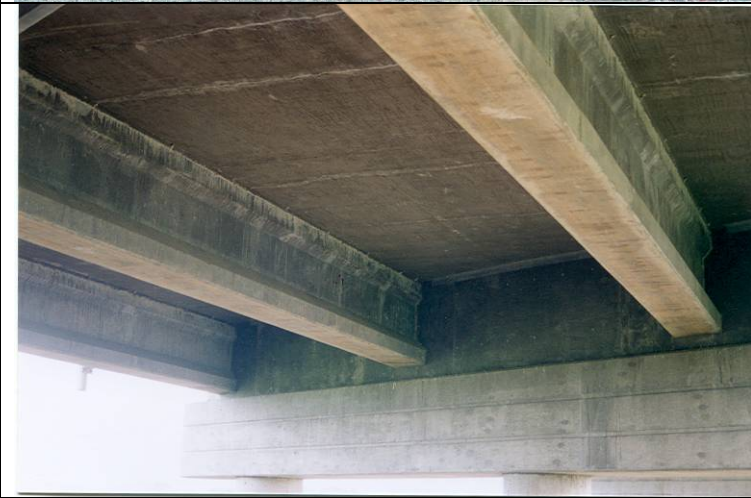
Photo 8: General overview of underside of the bridge.

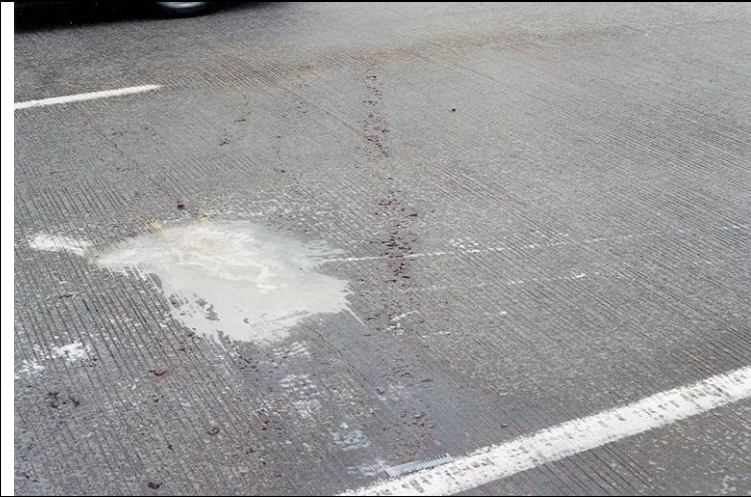
Photo 9: Close up view of patched core location on Southbound Bridge. Note the crack over the core.

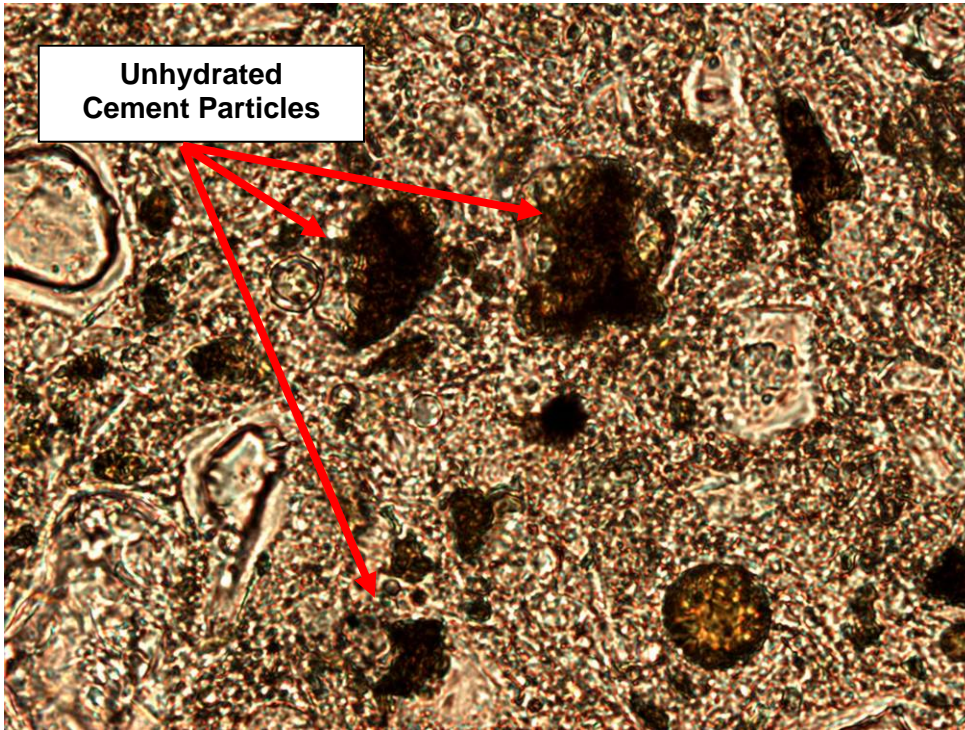
Figure L1-1: Unhydrated cement particles in paste. Width of field is 0.33 mm. Thin section image.

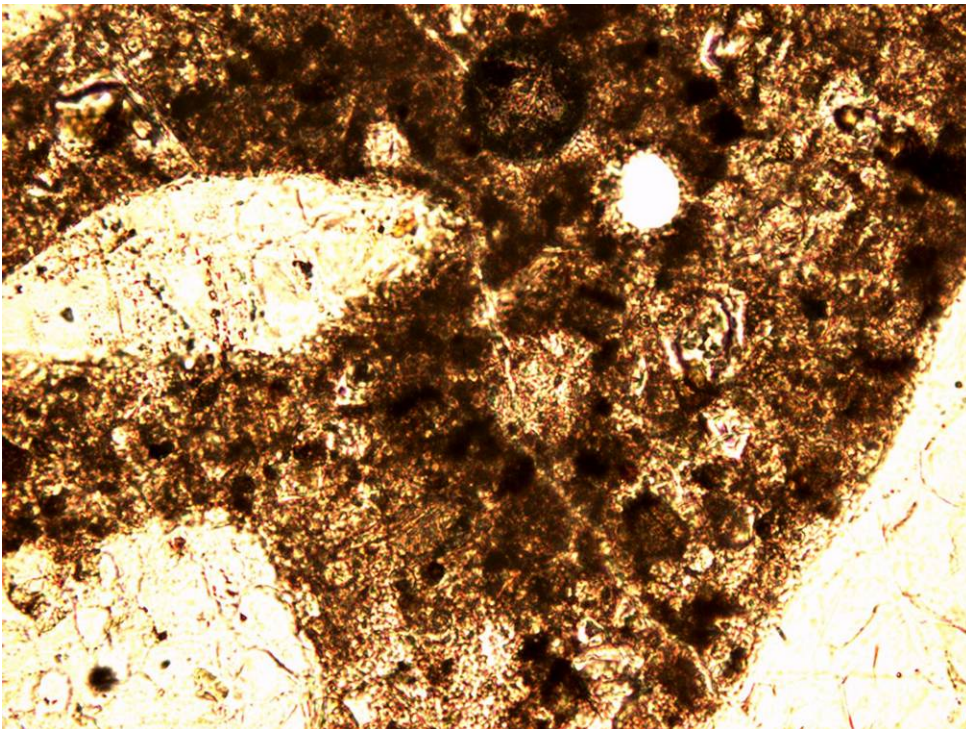
Figure L1-8: Crack in the cement paste matrix. Width of field is 0.33 mm. Thin section image.

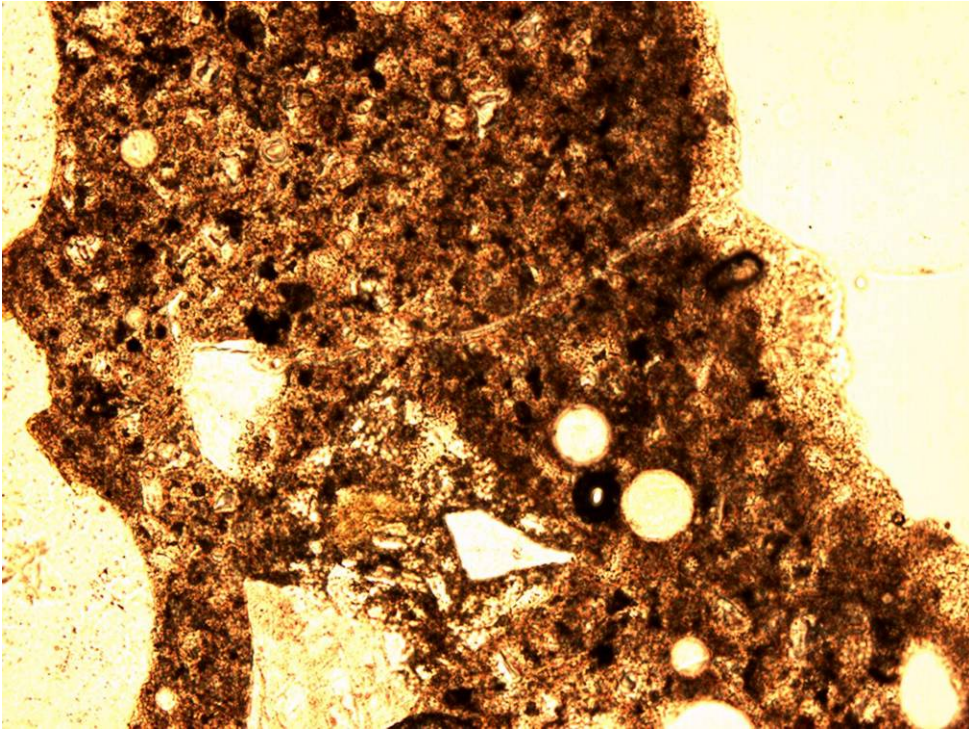
Figure L1-9: Another crack in the cement paste matrix. Width of field is 0.33 mm. Thin section image.

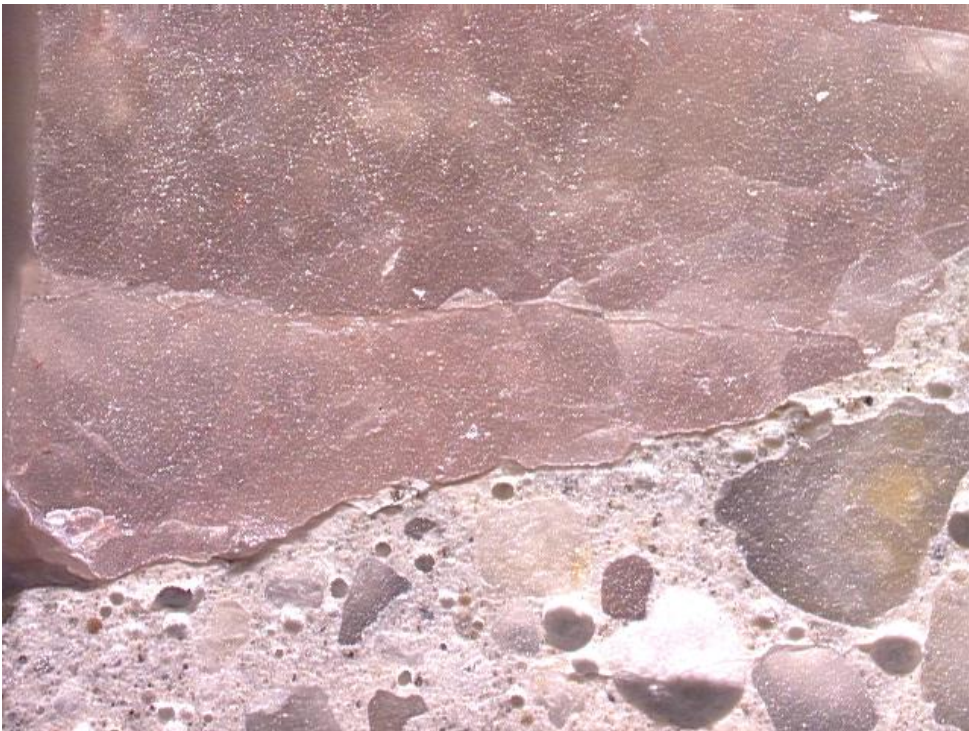
Figure L1-10: Crack at the aggregate-paste interface. Width of field is 4.0 mm. Polished surface image.

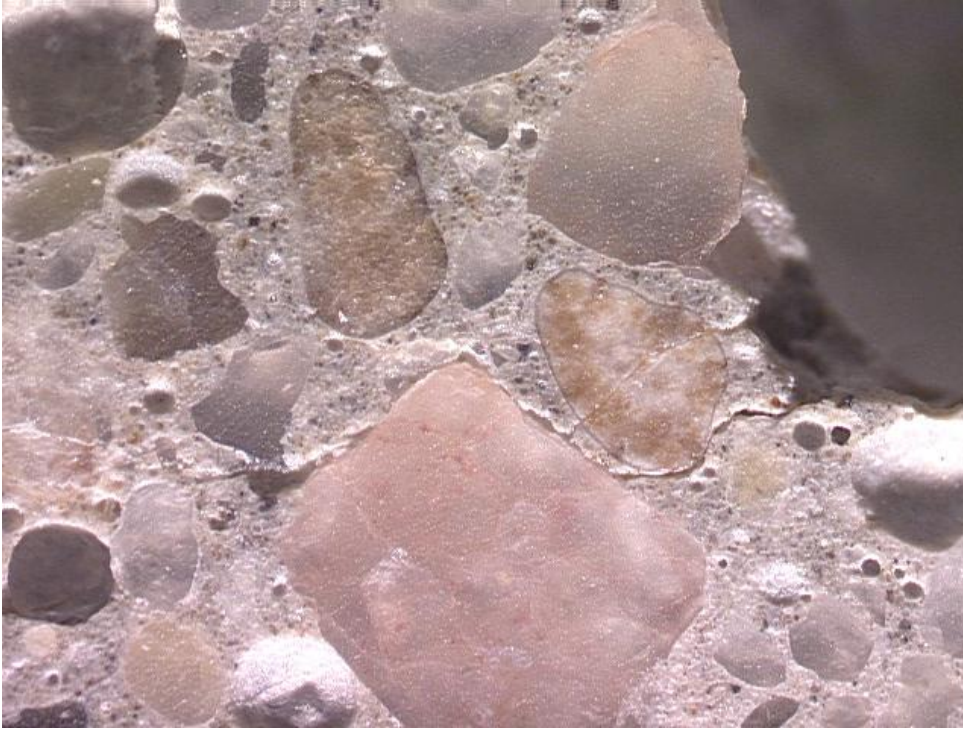
Figure L1-11: Crack at the aggregate-paste interface (crushed pink quartzite). Width of field is 4.0 mm. Polished surface image. Also a crack through an aggregate particle (a rounded natural sand particle with a weathering rim).

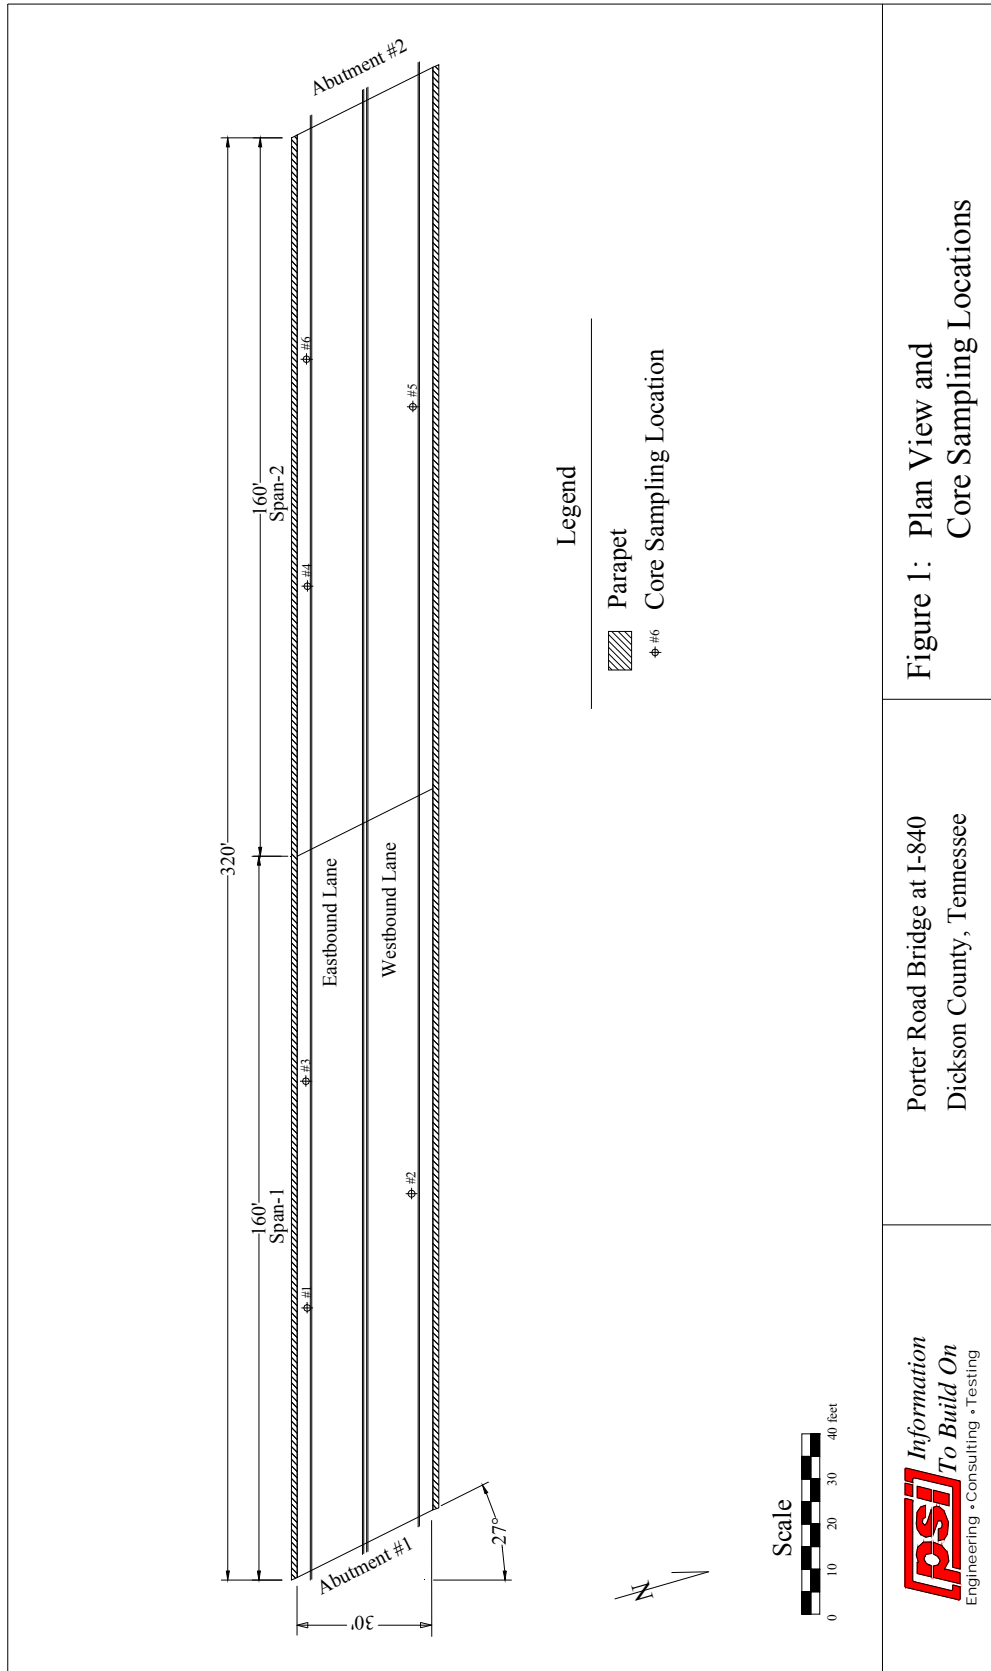
Figure 1: Plan View and Core Sampling Locations

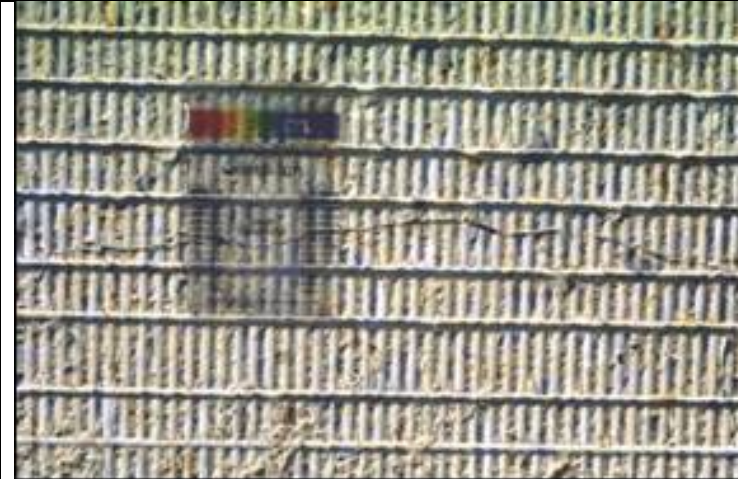
Photo 4. Typical Transverse Crack (0.020 in. width).

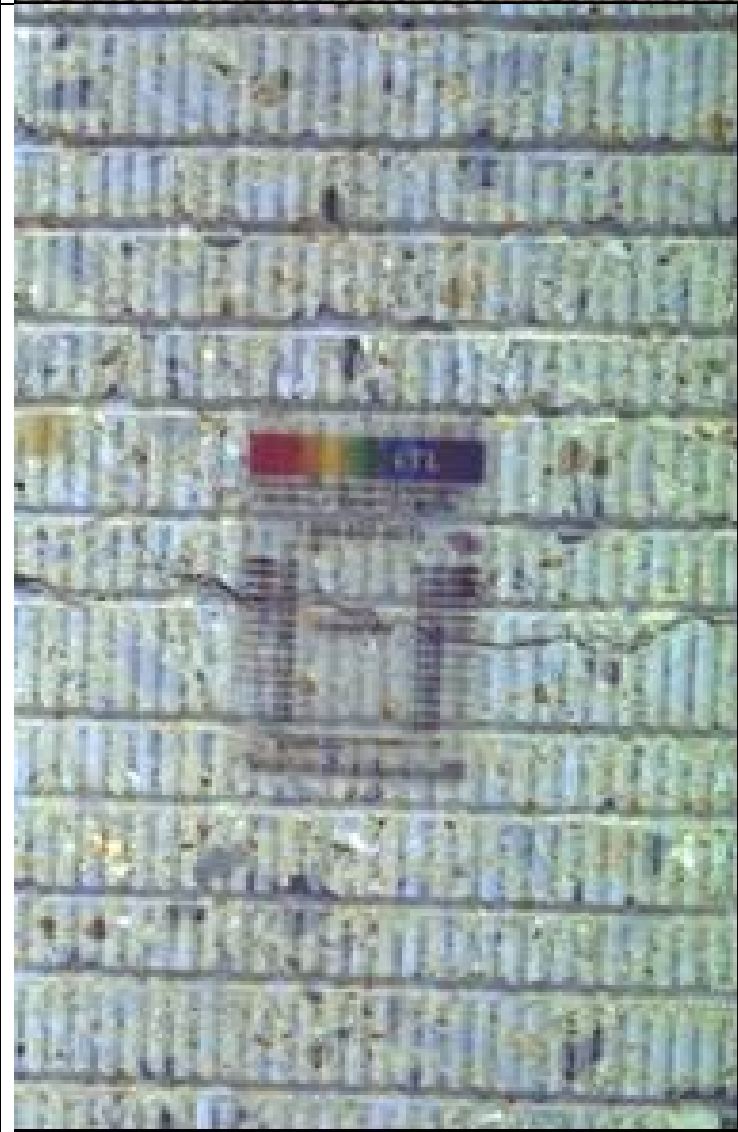
Photo 5. Typical Transverse Crack (0.016 in. width).

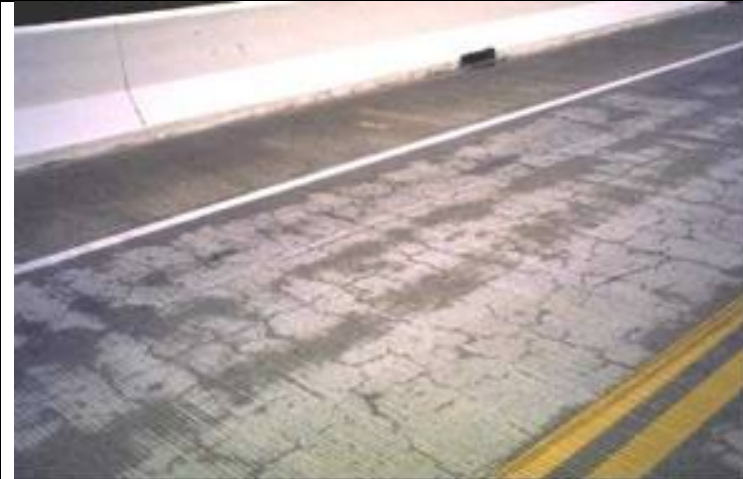
Photo 6. Typical Map Crack  
General view.

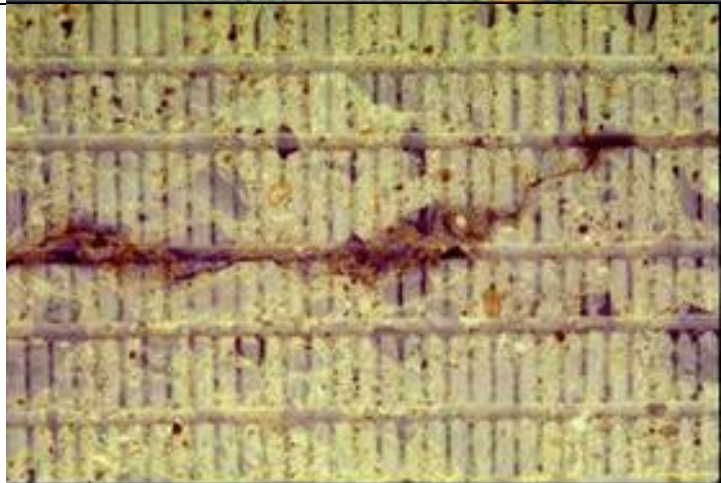
Photo 7. Typical Map Crack  
(Detail view 0.010 in).

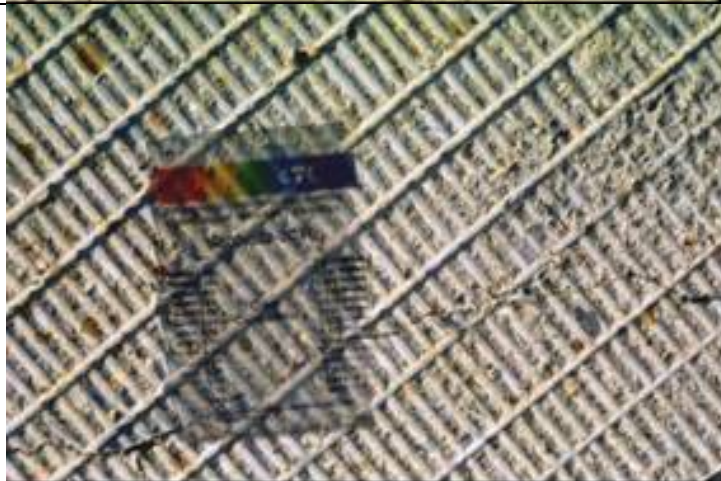
Photo 8. Typical Diagonal Crack  
(Detail view 0.010 in).

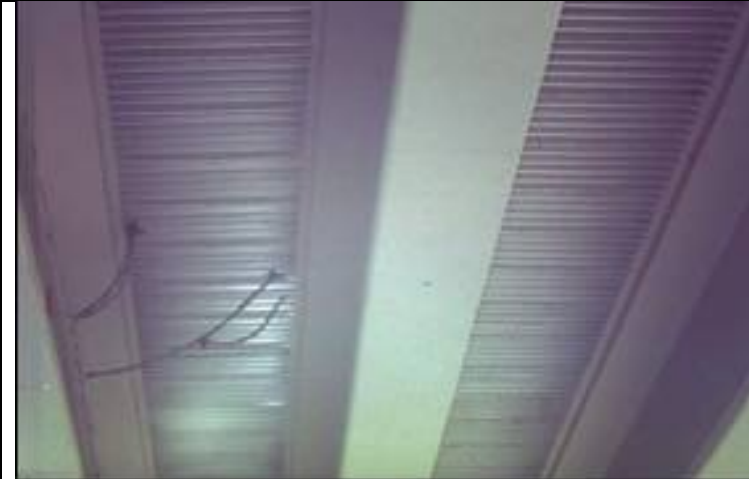
Photo 9. Underside of Deck (Note Stay-in-Place Forms and Connections for Instrumentation.

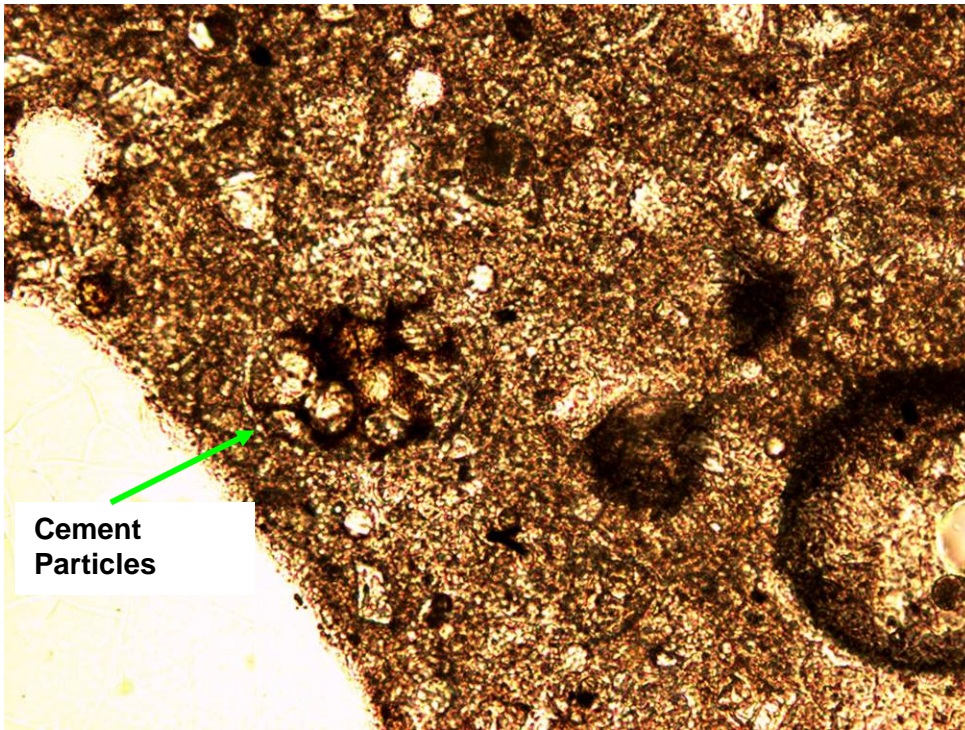
Figure M1-1: Unhydrated cement particles in paste. Width of field is 0.33 mm. Thin section image.

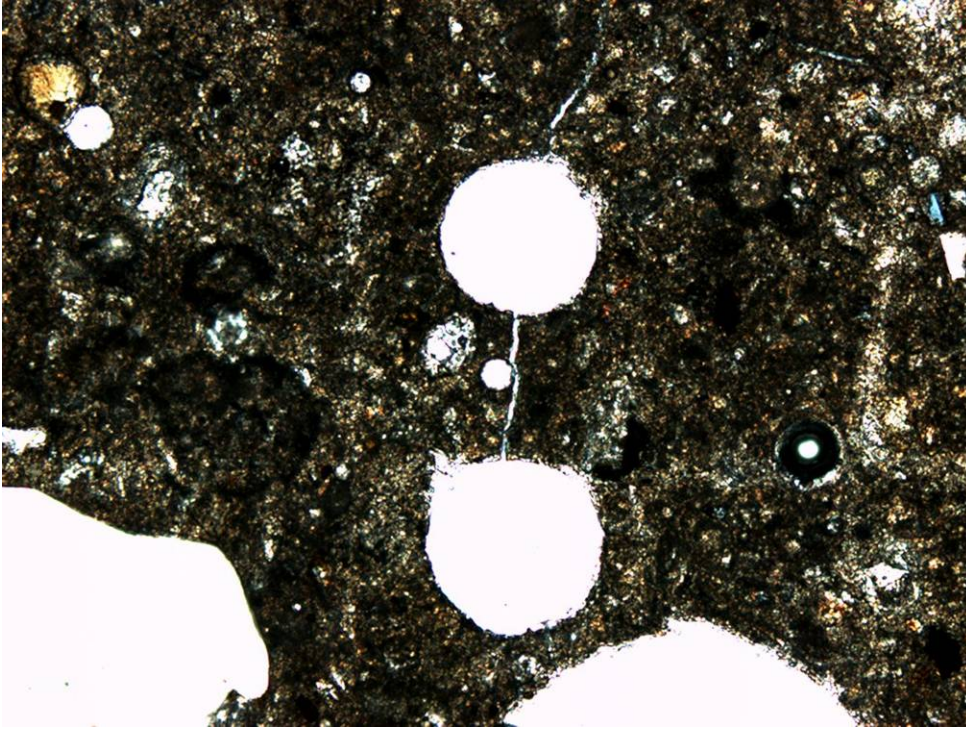
Figure M1-3: A crack connecting air voids. Width of field is 0.65 mm. Thin section image.

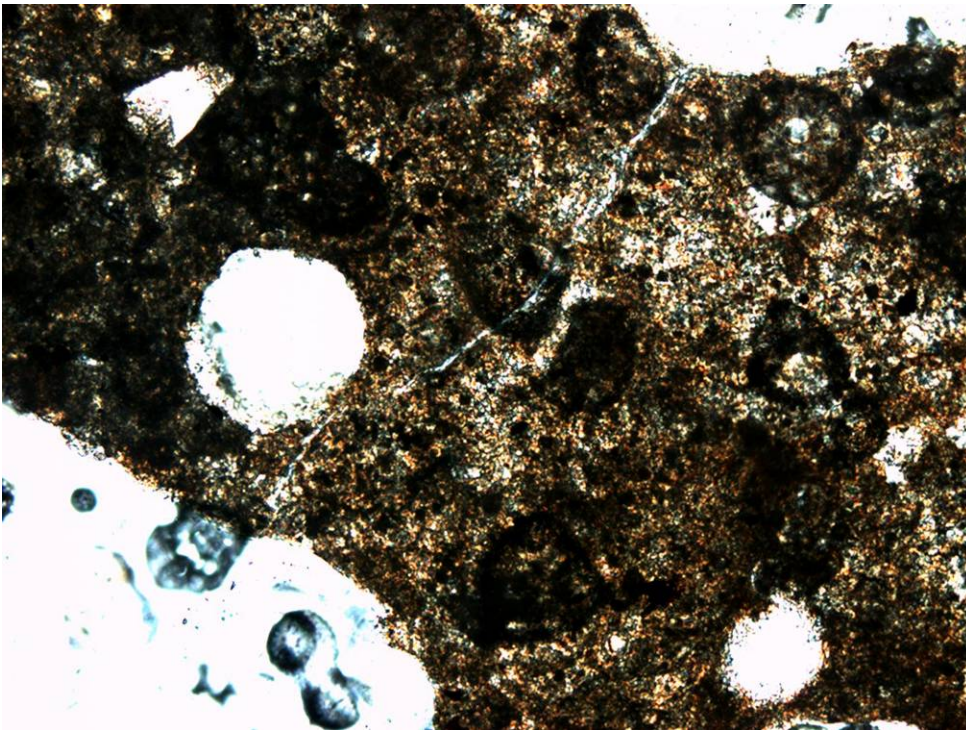
Figure M1-4: A crack connecting two fine aggregate particles. Width of field is 0.65 mm. Thin section image.

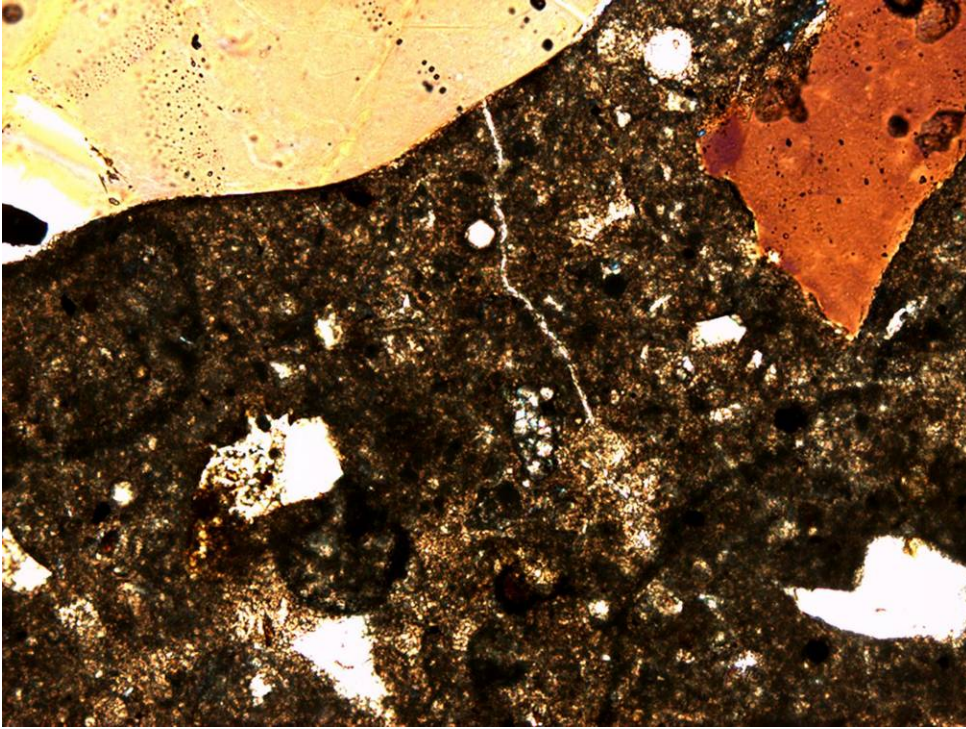
Figure M1-5: A crack close to a coarse aggregate particle. Width of field is 0.65 mm. Thin section image.

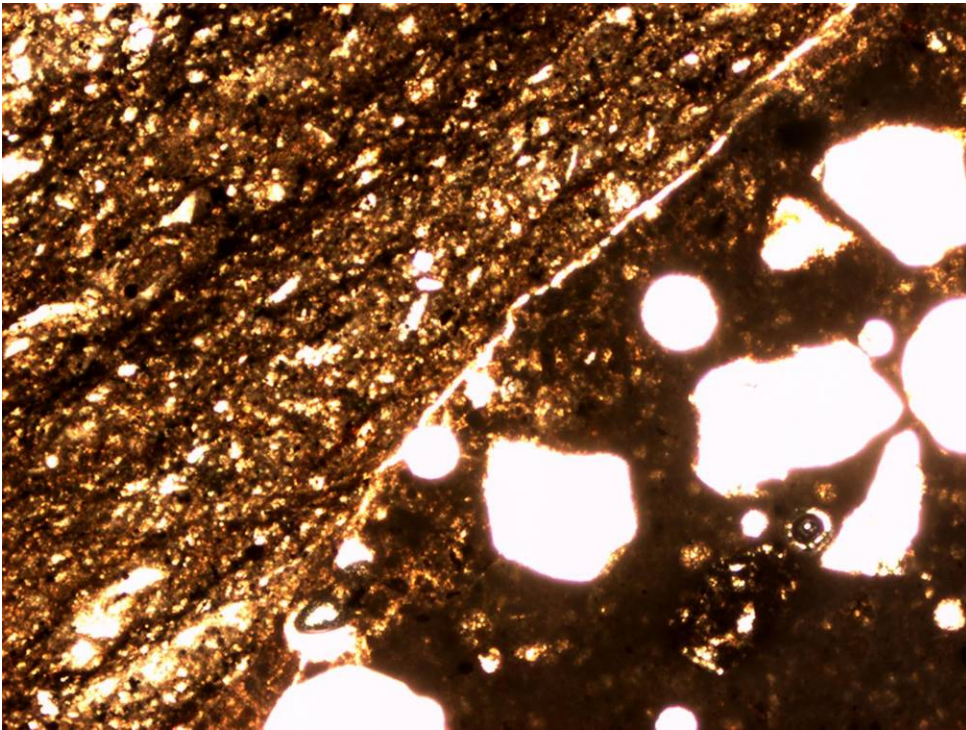
Figure M1-6: Crack in the coarse aggregate/paste interface. Width of field is 0.65 mm. Thin section image.

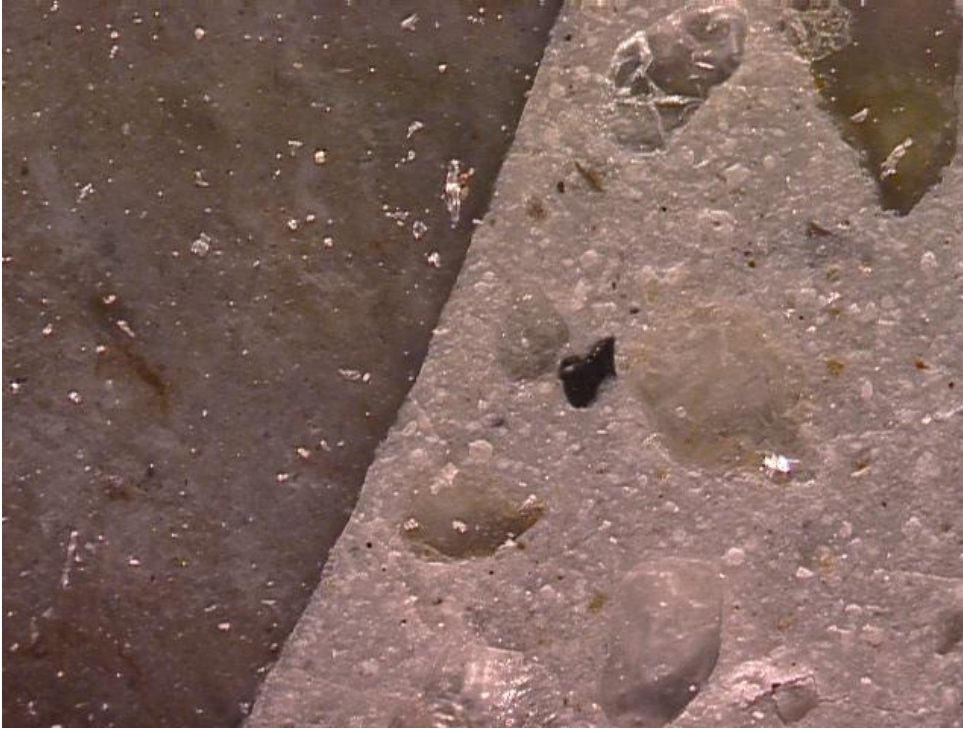
Figure M1-7: An image of aggregate/paste interface. Width of field is 2.0 mm. Polished surface image.

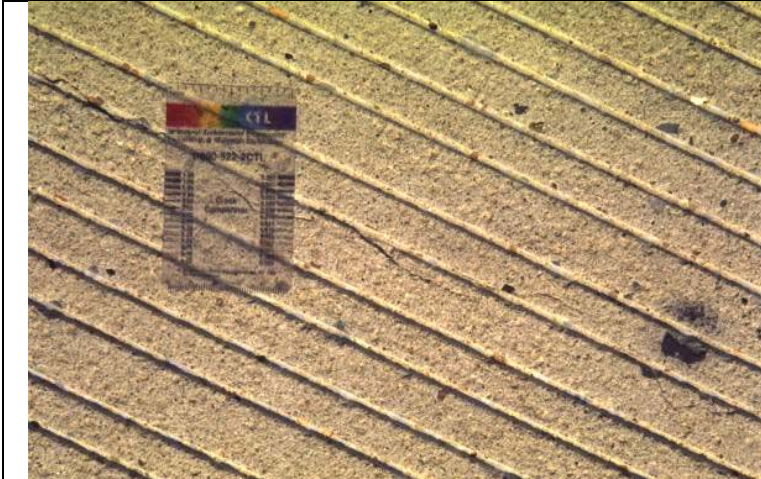
Photo 4: Typical transverse crack, 0.020 in. width.

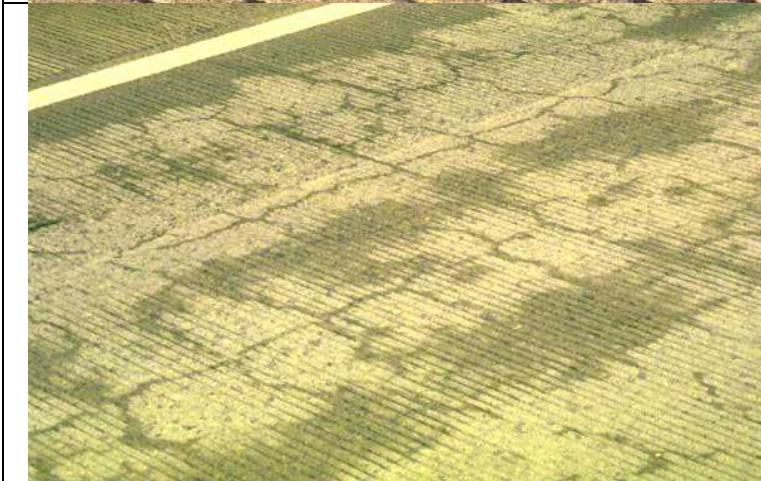
Photo 5: General view of the typical map cracking.

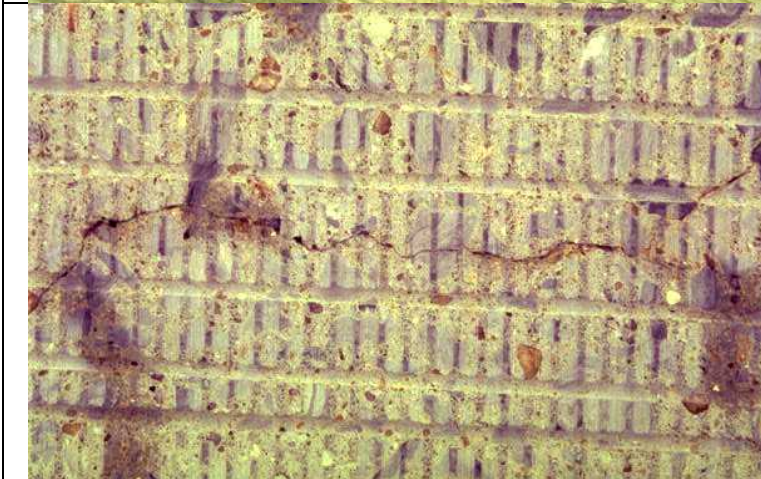
Photo 6: Close-up view of the typical map cracking. Crack width 0.010 in.

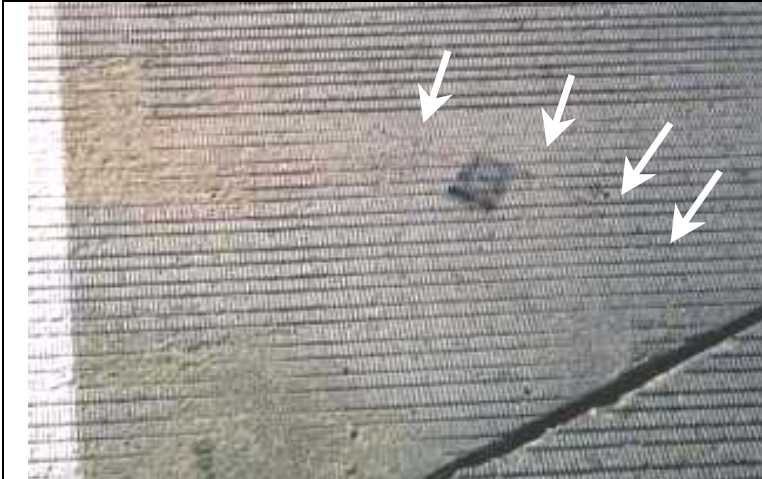
Photo 7: General view of the typical diagonal crack.

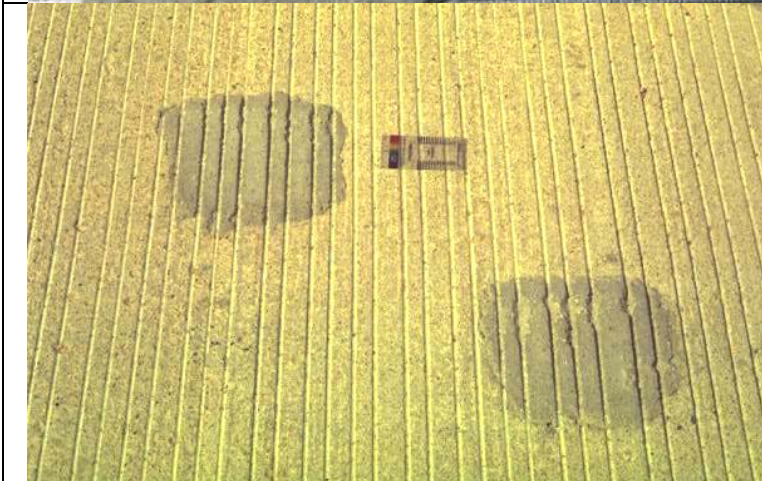
Photo 8: Typical patched area.

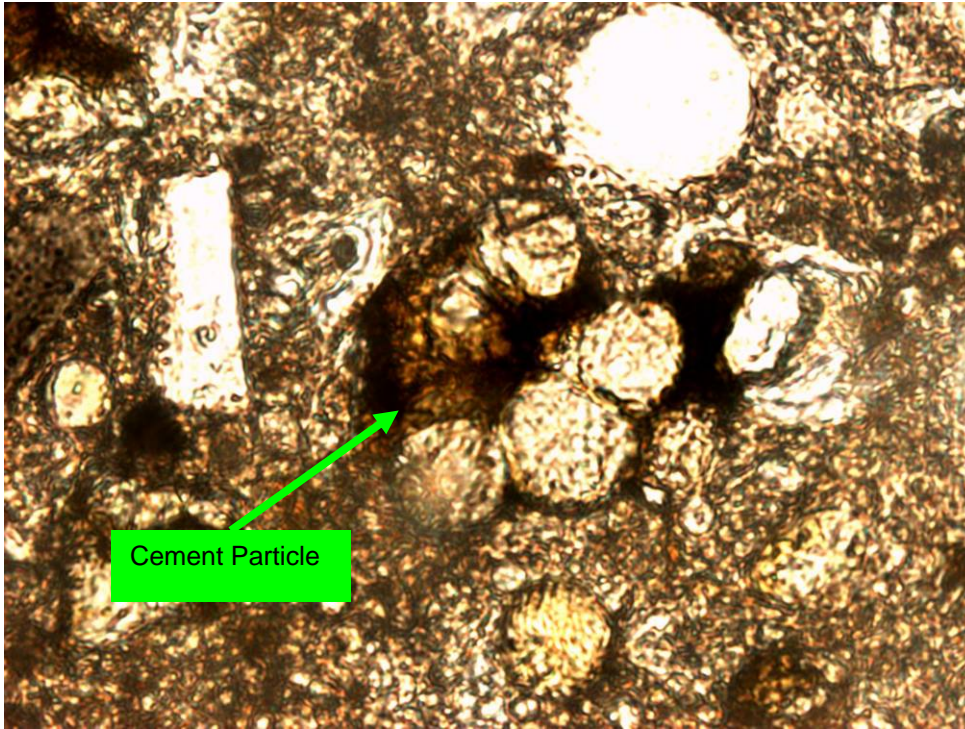
Figure N1-1: Unhydrated cement particles in paste. Width of field is 0.165 mm. Thin section image.
