# High Performance Concrete Bridge Deck Investigation

November 2009

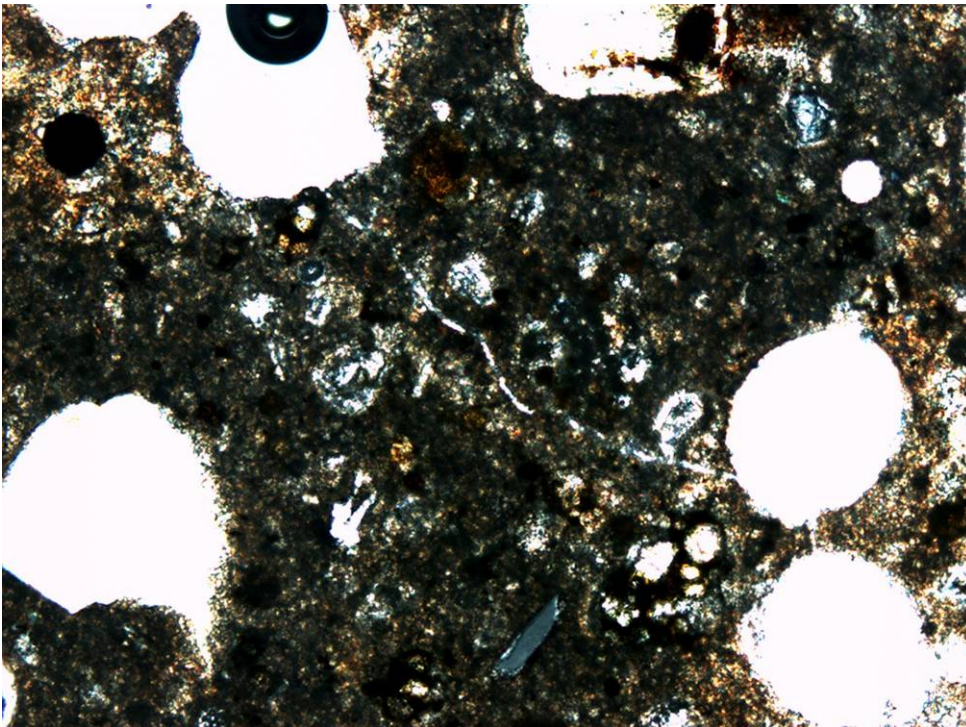
Figure N1-4: A crack connecting air voids. Width of field is 0.65 mm. Thin section image.

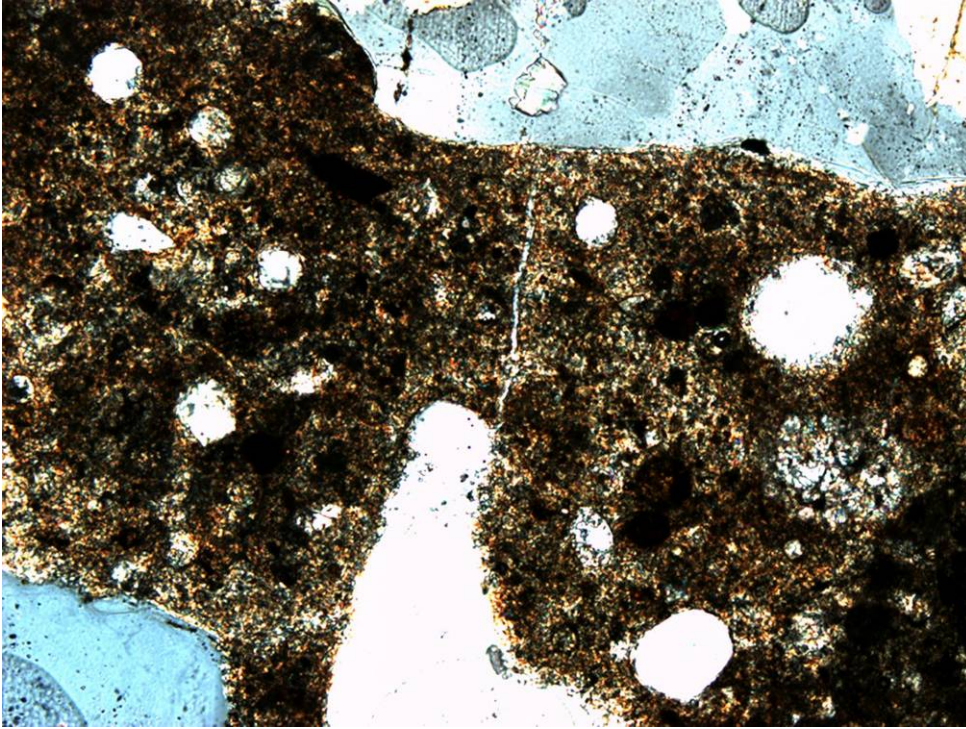
Figure N1-5: A crack connection two fine aggregate particles. Width of field is 0.65 mm. Thin section image.

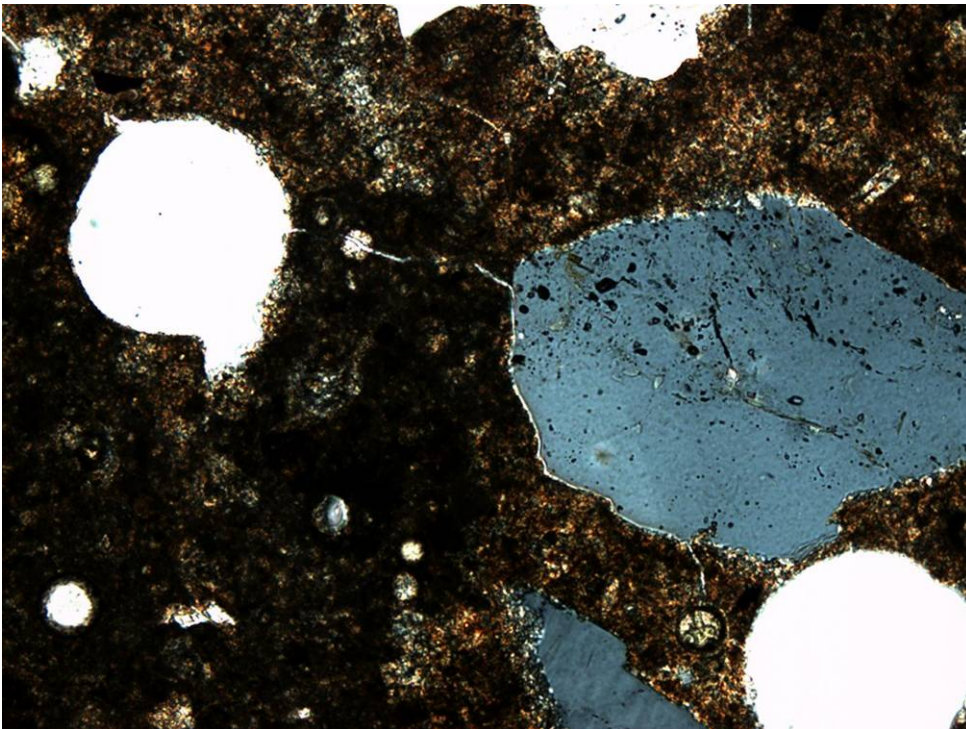
Figure N1-6: Cracking in the fine aggregate/paste interface. Width of field is 0.65 mm. Thin section image.

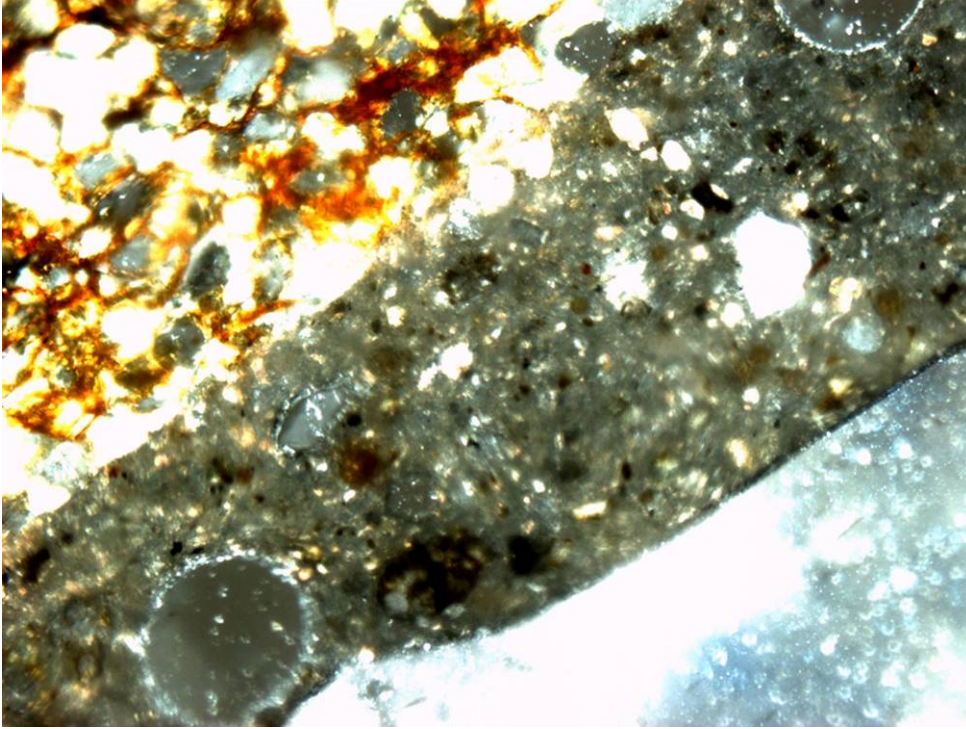
Figure N1-7: Coarse aggregate/paste interface. Width of field is 0.65 mm. Thin section image.

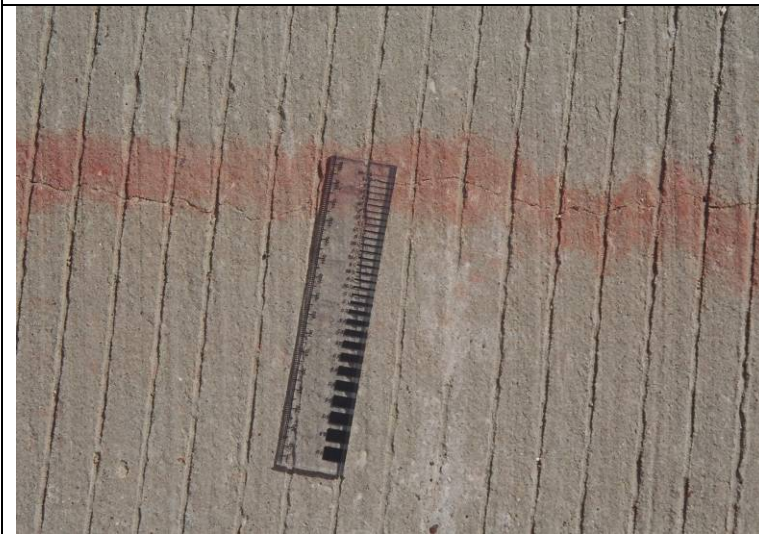
Photo 7: View showing typical crack in the bridge deck. Crack width is less than 1/32 in. and is categorized as hairline.

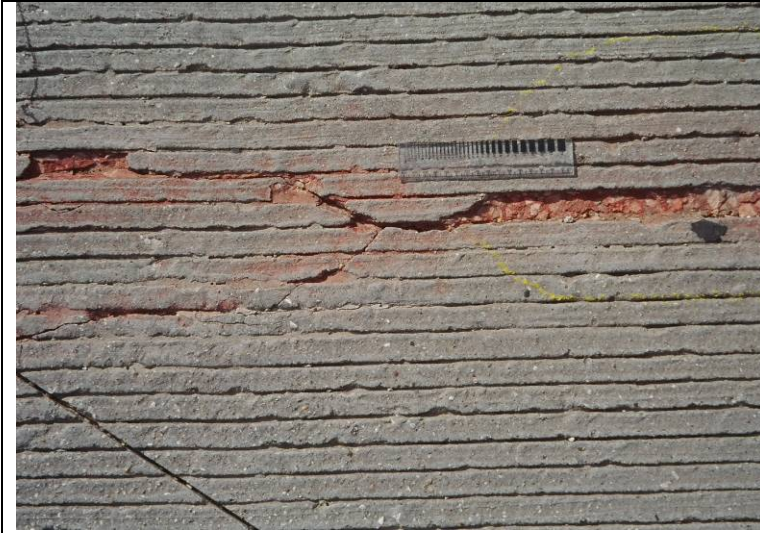
Photo 8: View showing spalling associated with cracks in the deck at span ends.

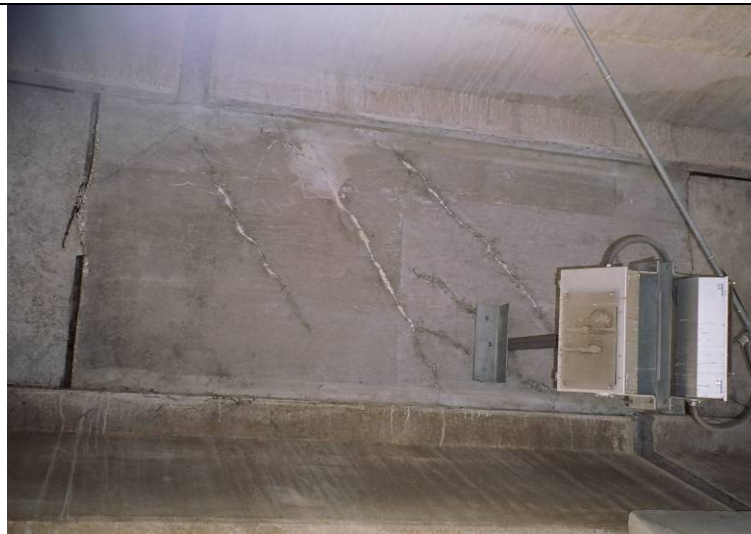
Photo 9: View showing underside of bridge at span end.

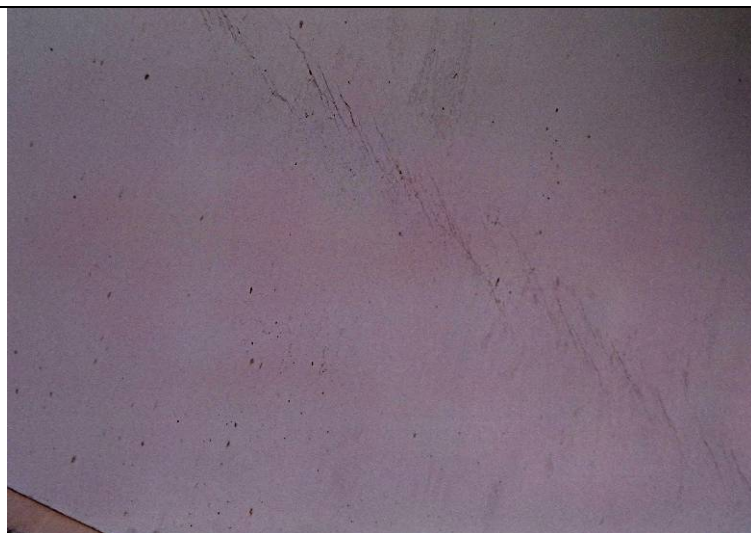
Photo 10: View showing close-up of fine cracks in the northeastern most girder of the northbound bridge.

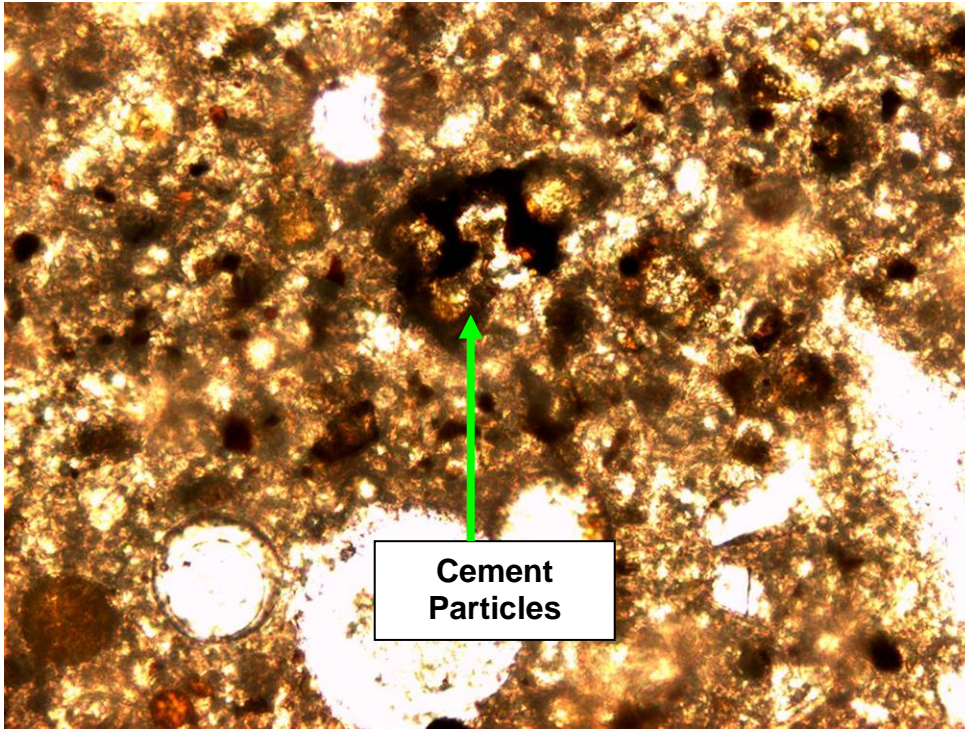
Figure O1-1: Unhydrated cement in paste. Width of field is 0.33 mm. Thin section image.

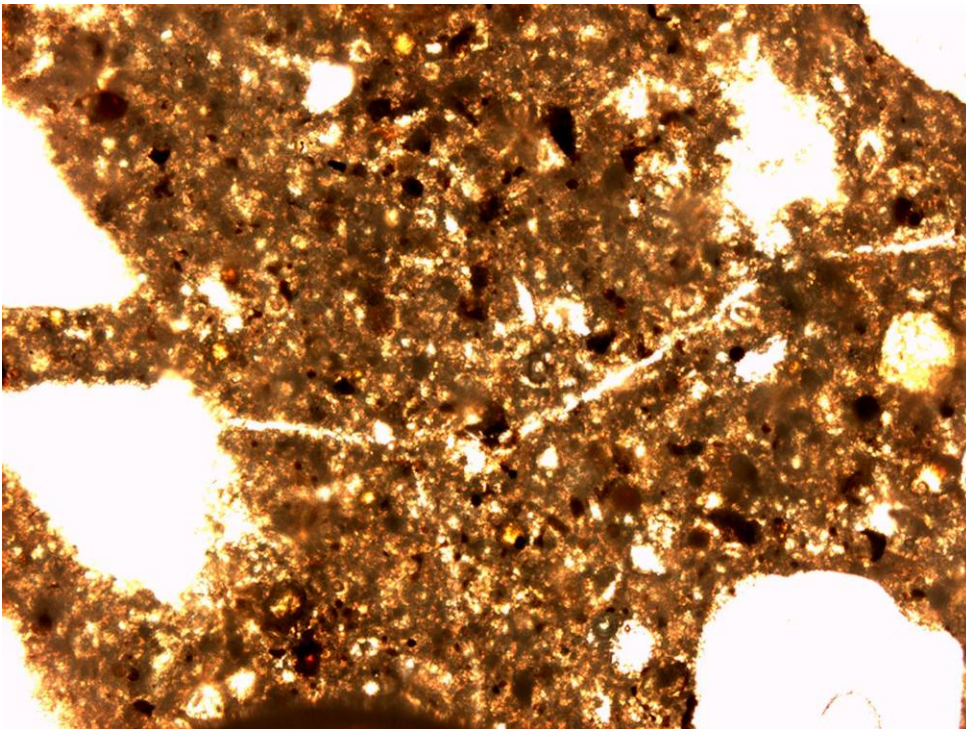
Figure O1-6: Micro-cracks in the concrete. Width of field is 0.65 mm. Thin section image.

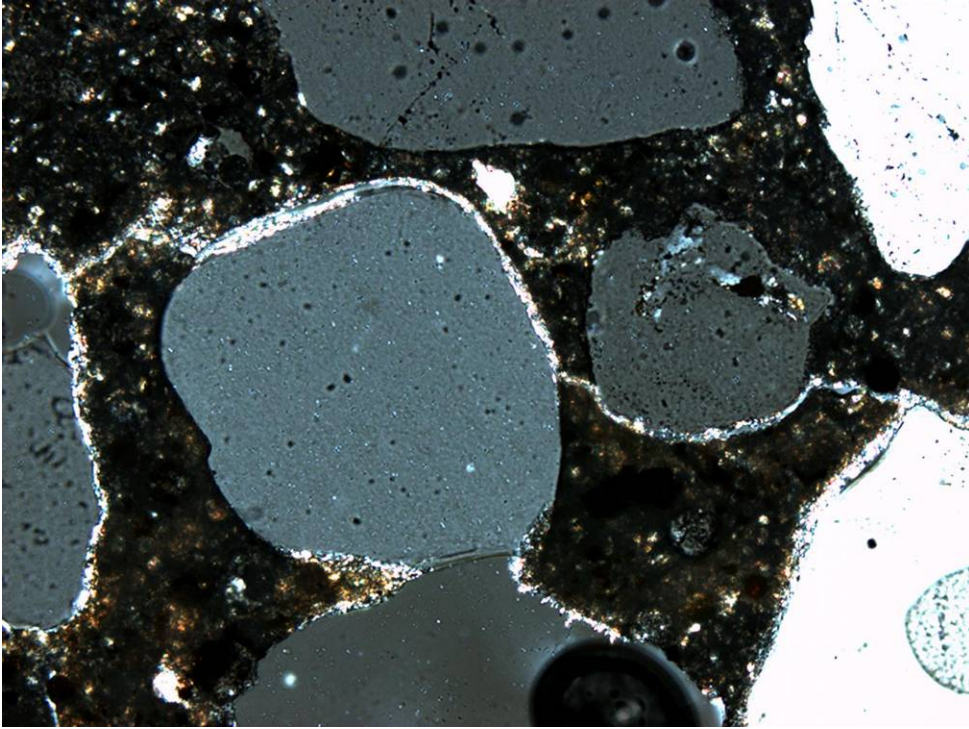
Figure O1-7 Cracks in the aggregate/paste interfacial region. Width of field is 0.65 mm. Thin section image.

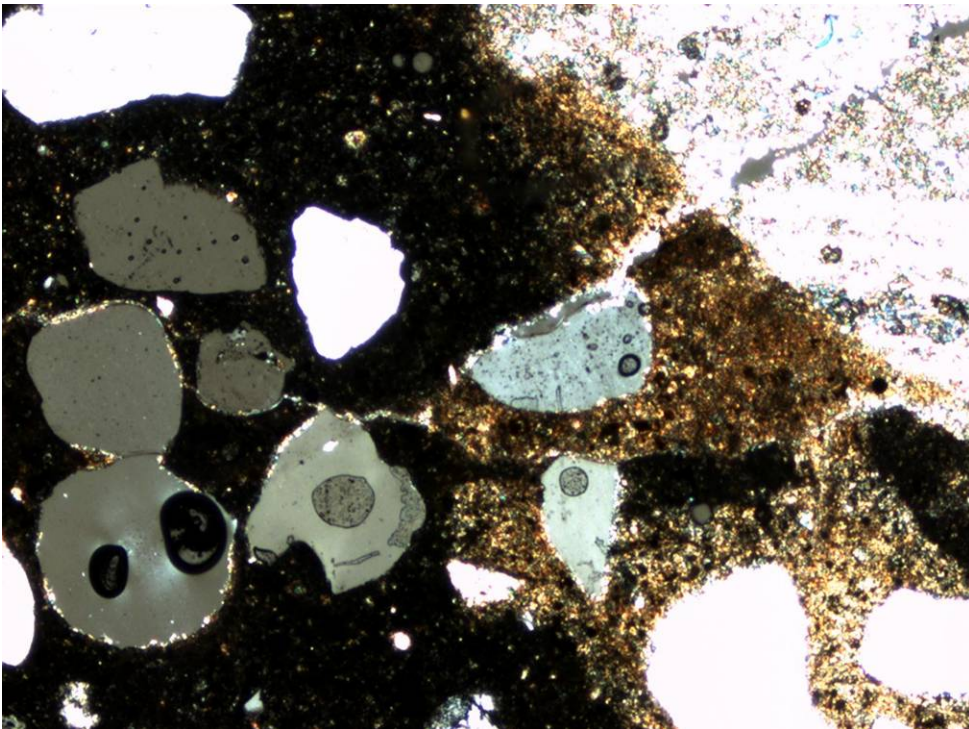
Figure O1-8: Another image showing cracking in the coarse aggregate, cement paste, and fine aggregate/paste interfacial region. Width of field is 1.6 mm. Thin section image.

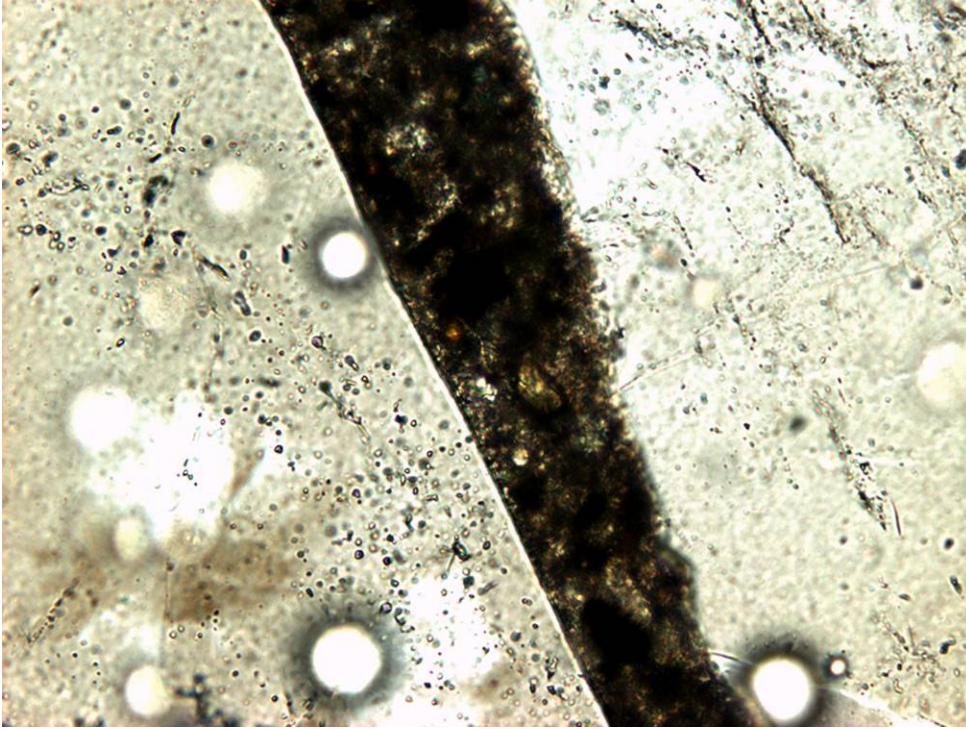
Figure O1-9: Paste/coarse aggregate interfacial region. Width of field is 0.33 mm. Polished surface image.

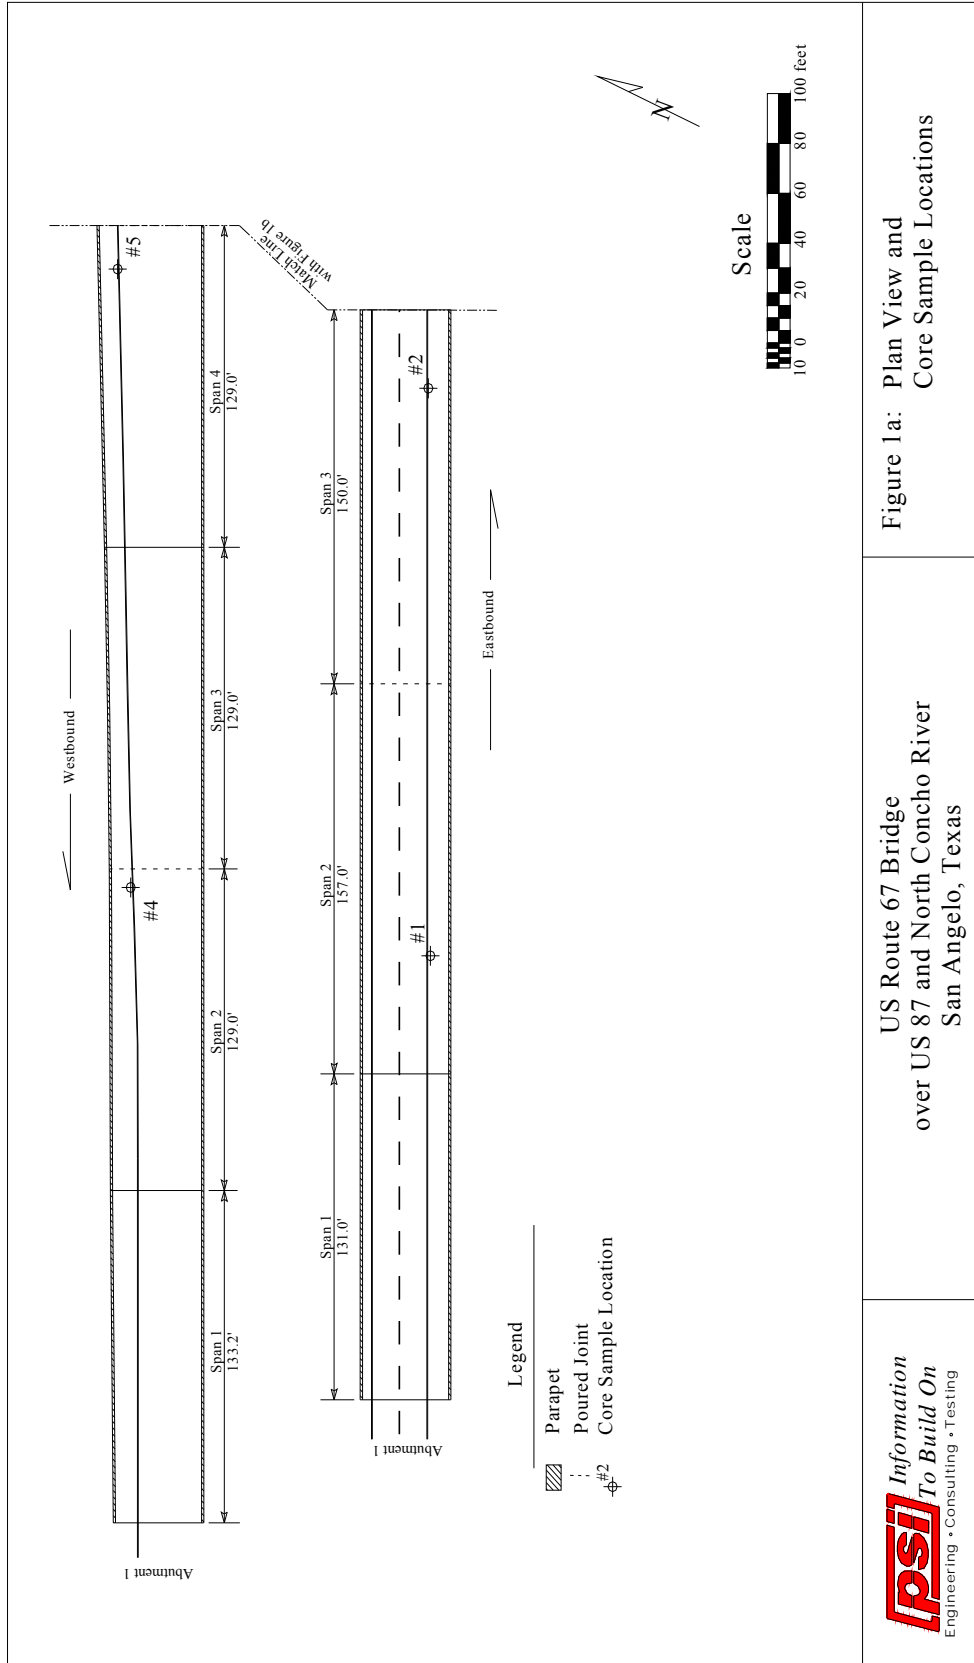
*Respectfully Submitted,*  
**Professional Service Industries, Inc.**  
*Structural Investigation and Petrography Department*

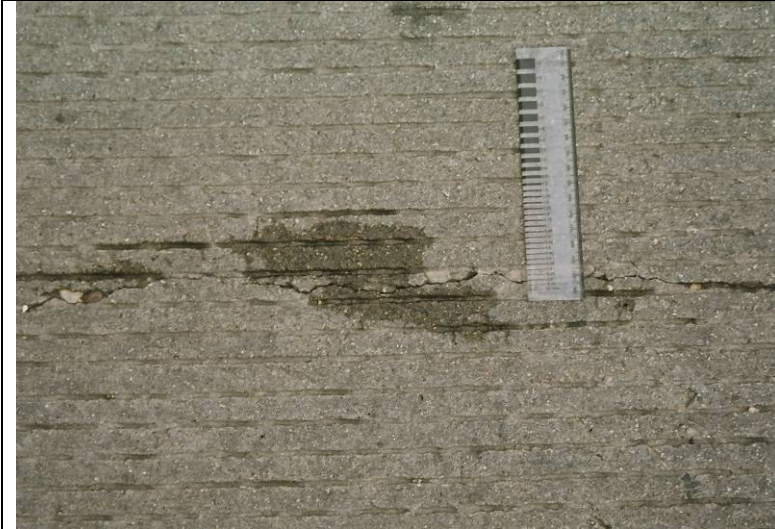
Photo 5: Closeup view of a transverse crack.

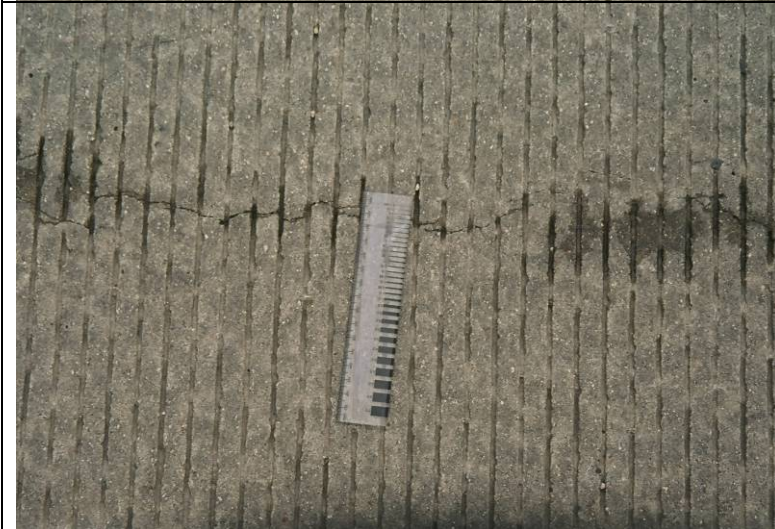
Photo 6: Closeup view of a longitudinal crack.

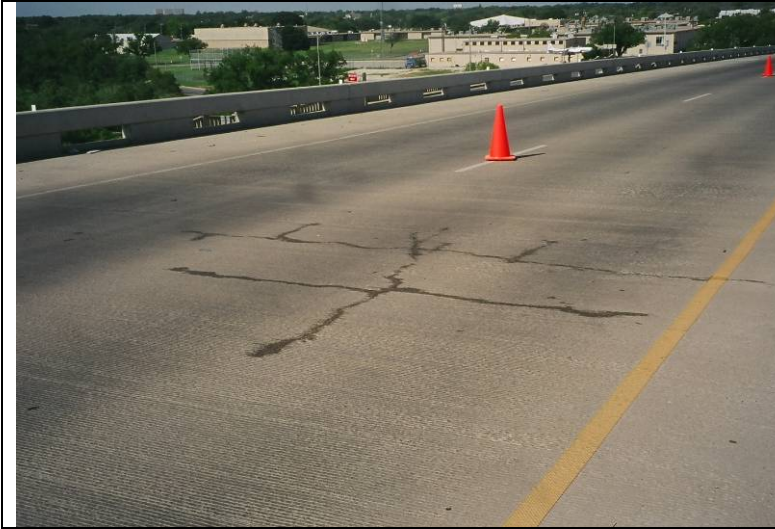
Photo 7: View of the eastbound bridge, the western end of Span 5, showing cracking pattern at the edge of span.

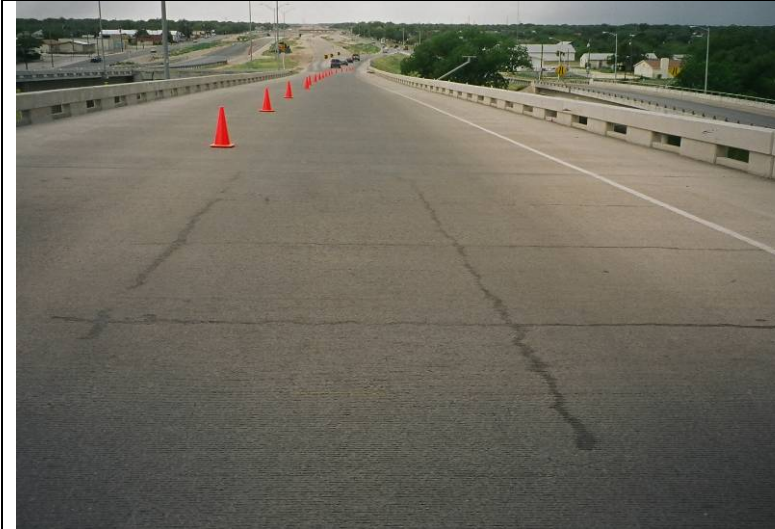
Photo 8: View of the westbound bridge, the western end of Span 4 showing the rectangular cracking pattern.

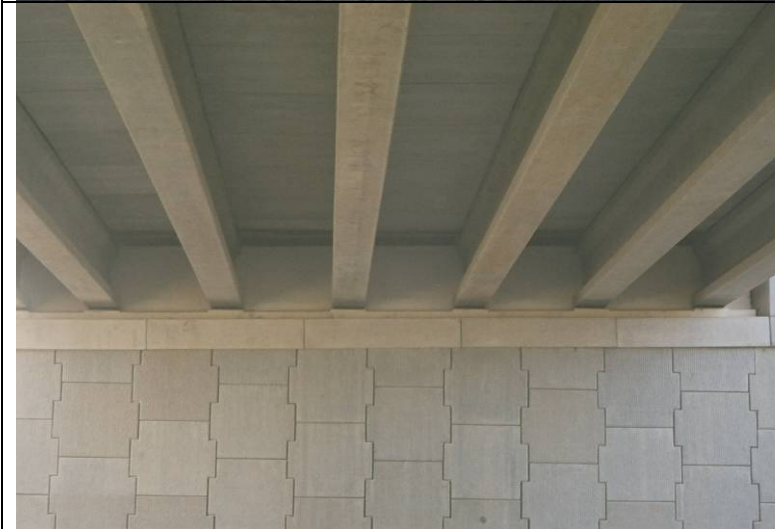
Photo 9: Typical condition of the underside of the deck.

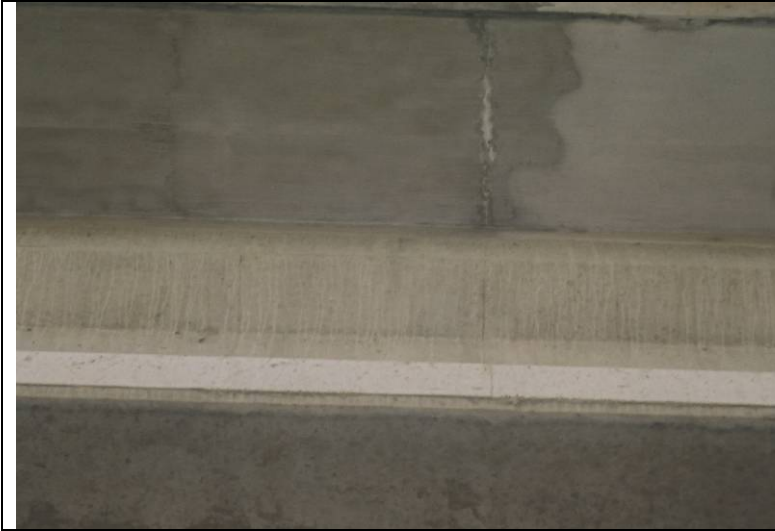
Photo 10: Cracks with efflorescence along the overhang on the westbound bridge.

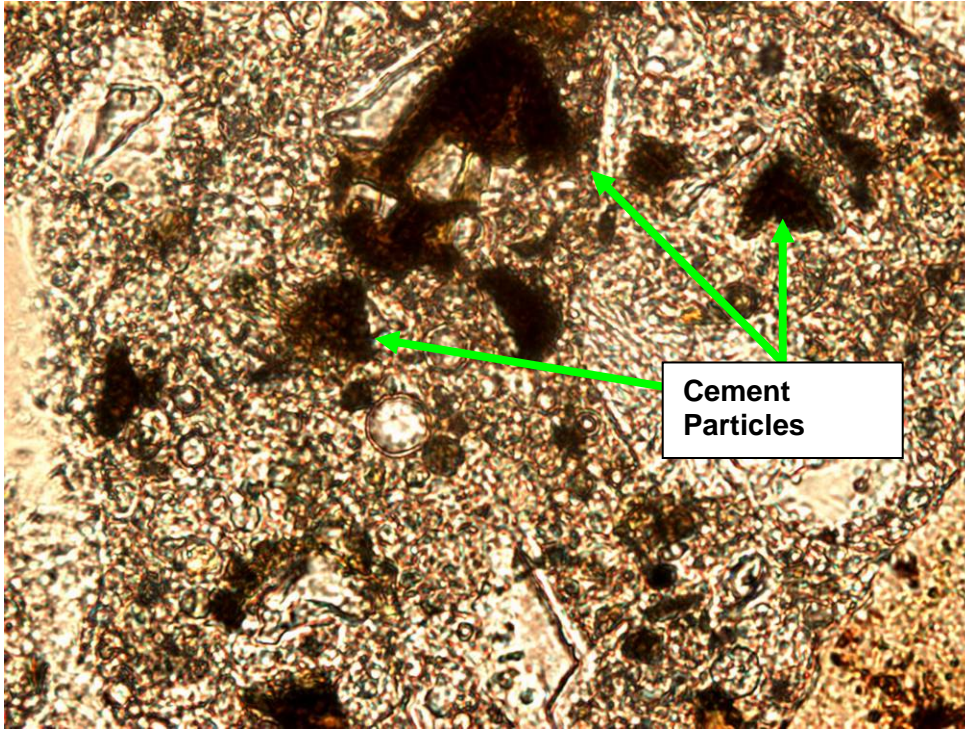
Figure P1-1. Unhydrated cement particles in paste. Width of field is 0.165 mm. Thin section image.

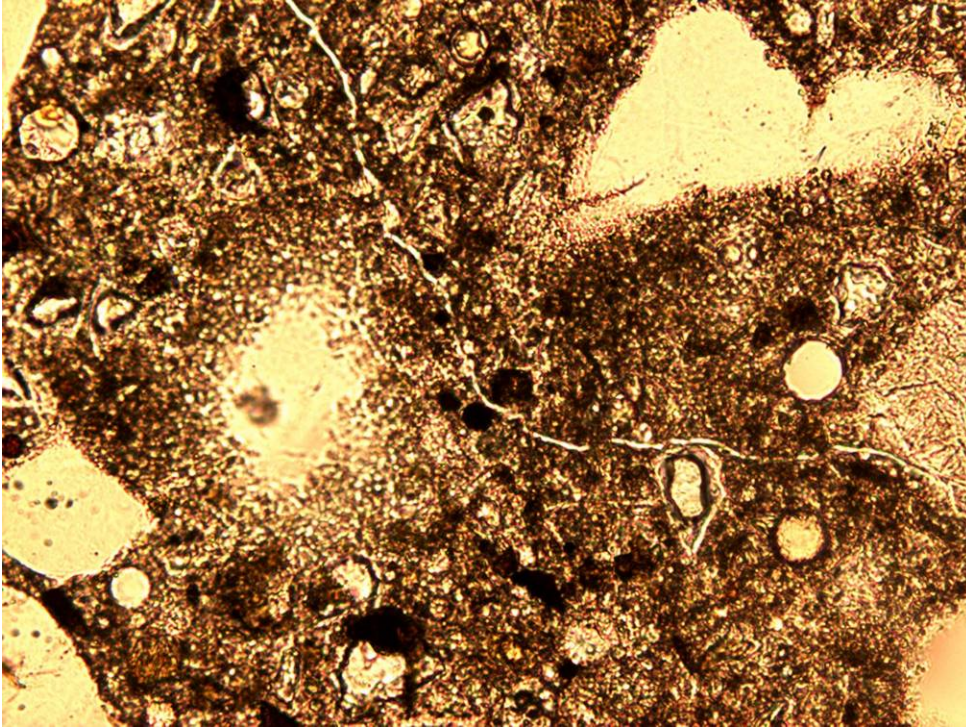
Figure P1-5. Crack in cement paste. Width of field is 0.33 mm. Thin section image.

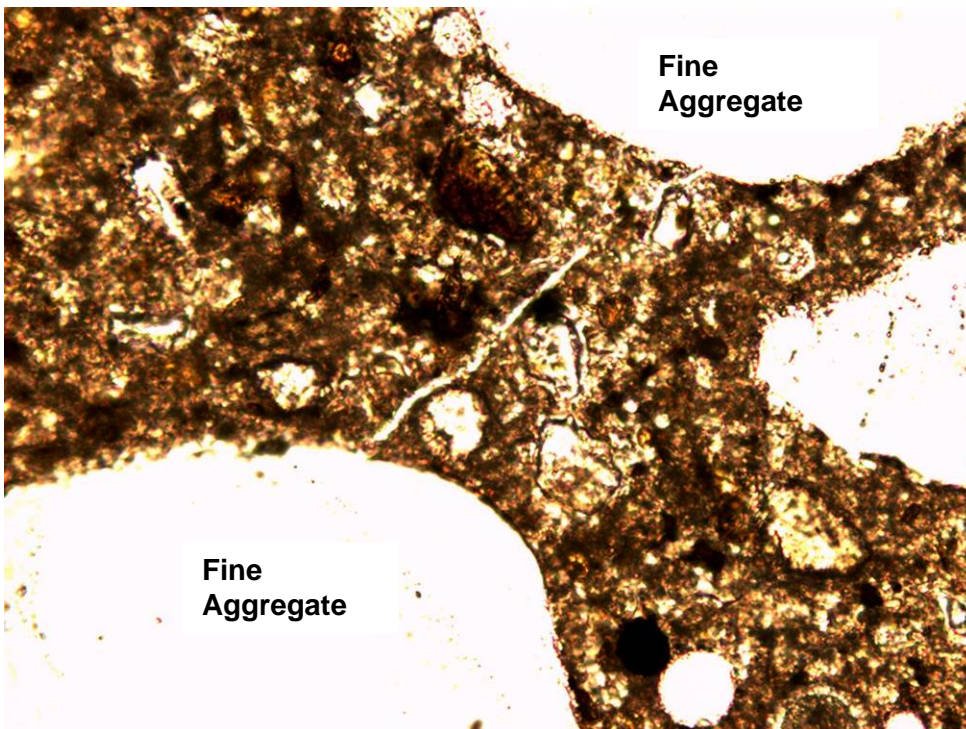
Figure P1-6. Crack connecting two fine aggregate particles. Width of field is 0.33 mm. Thin section image.

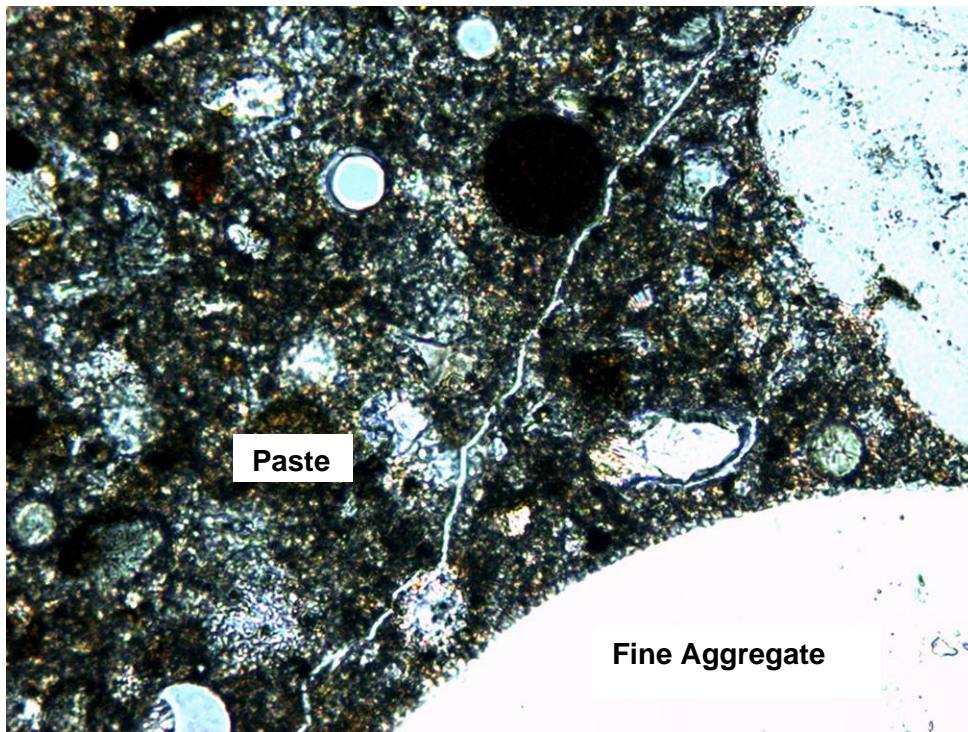
Figure P1-7. Crack in the cement paste and close to the aggregate/paste interface. Width of field is 0.33 mm. Thin section image.

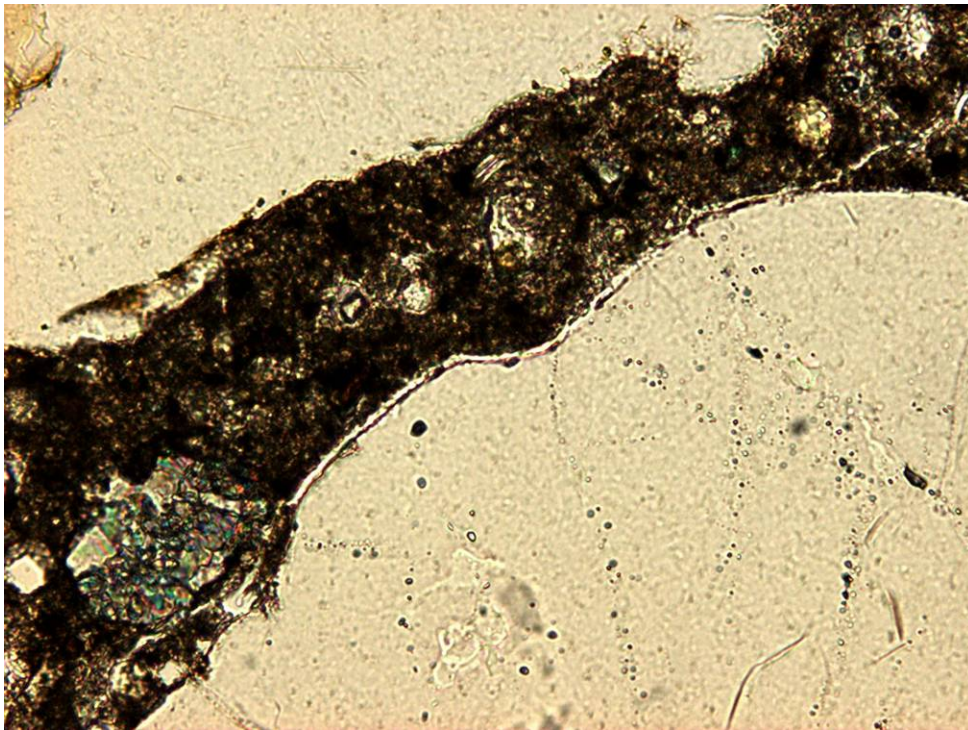
Figure P1-8. Crack in the paste/fine aggregate interfacial region. Width of field is 0.33 mm. Thin section image.

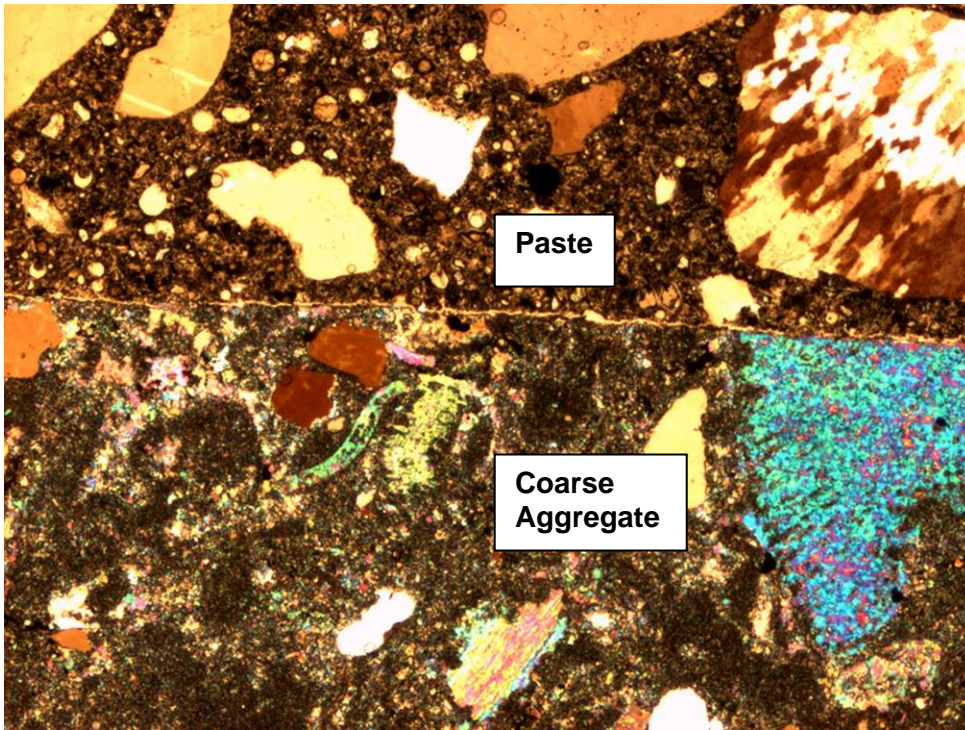
Figure P1-9. Crack in the paste/coarse aggregate interfacial region. Width of field is 1.60 mm. Thin section image.

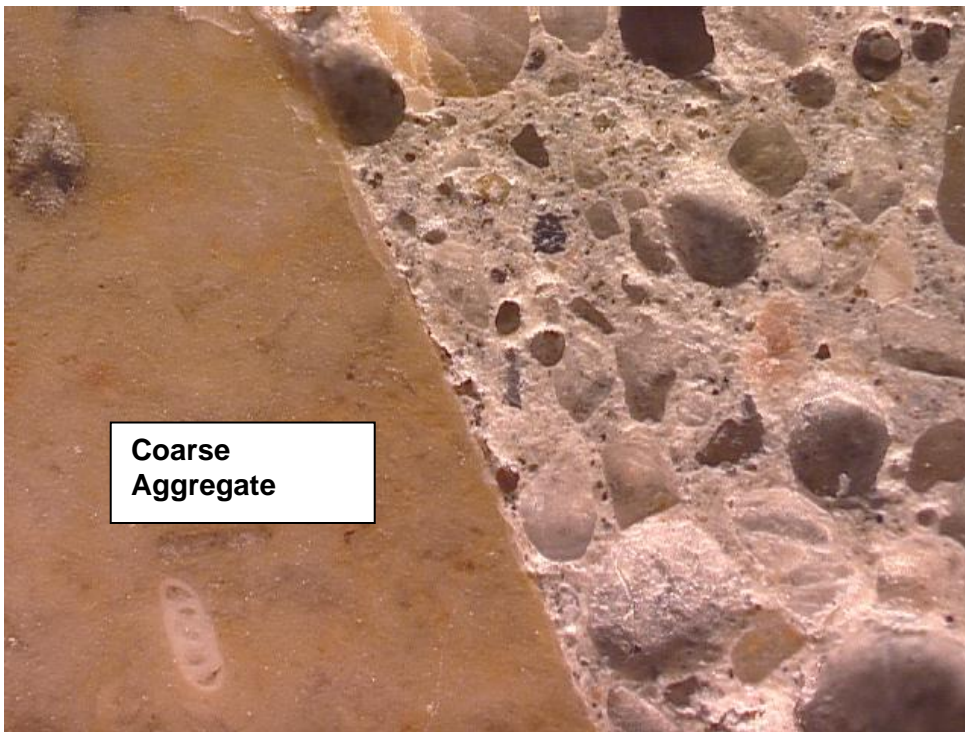
Figure P1-10. Gap between the coarse aggregate and the paste. Width of field is 4.0 mm. Polished surface image.

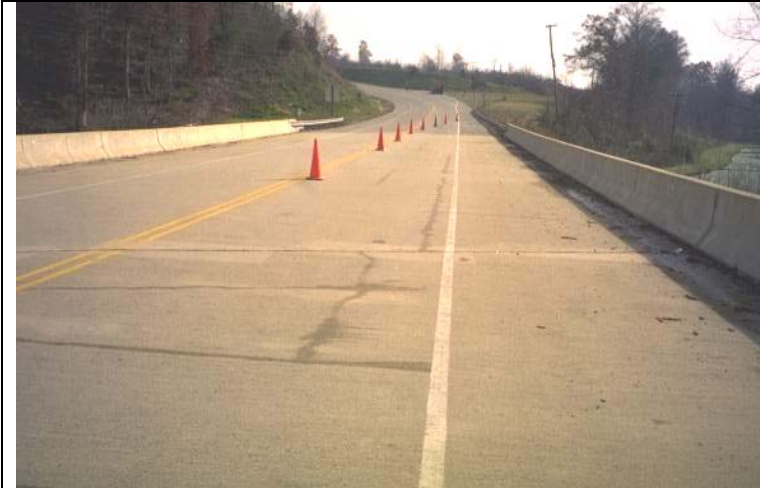
Photo 4: General view longitudinal cracks east bound.

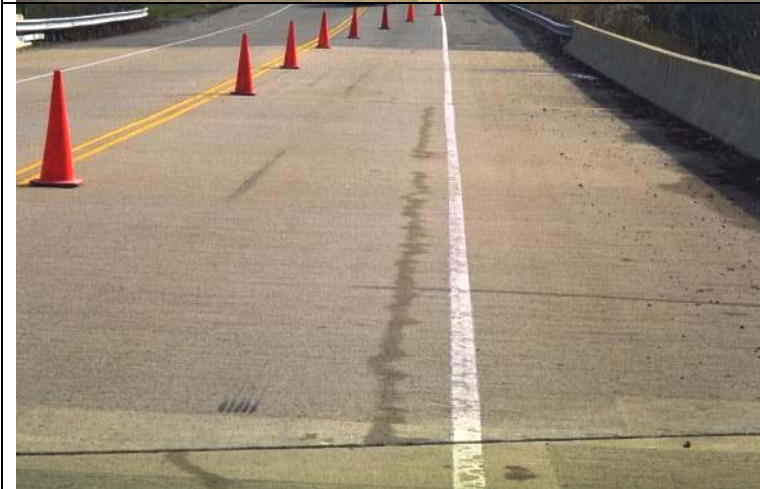
Photo 5: General view, longitudinal cracks, east bound.

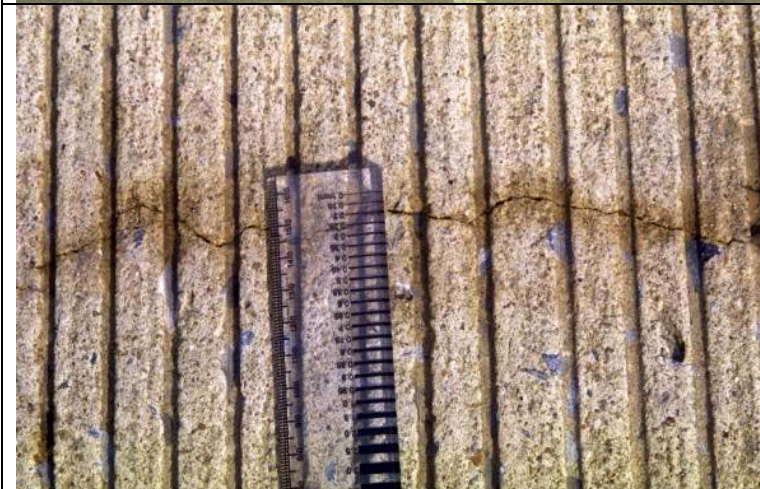
Photo 6: Detail view, longitudinal cracks, 0.008 in. width.

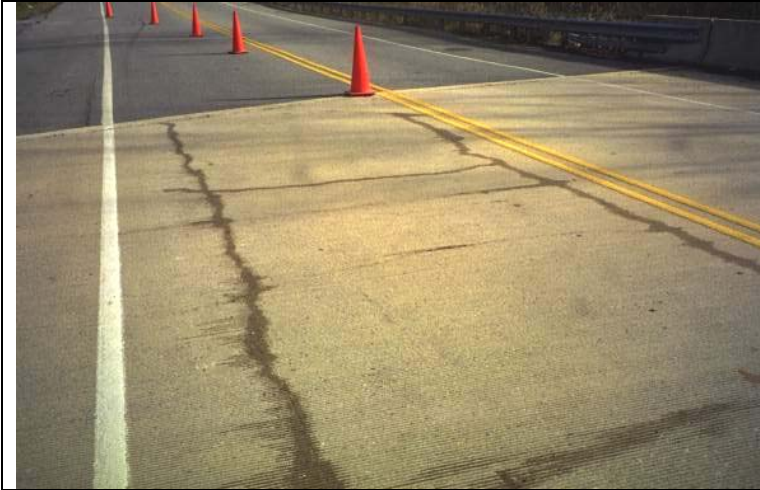
Photo 7: General view, longitudinal cracks, west bound

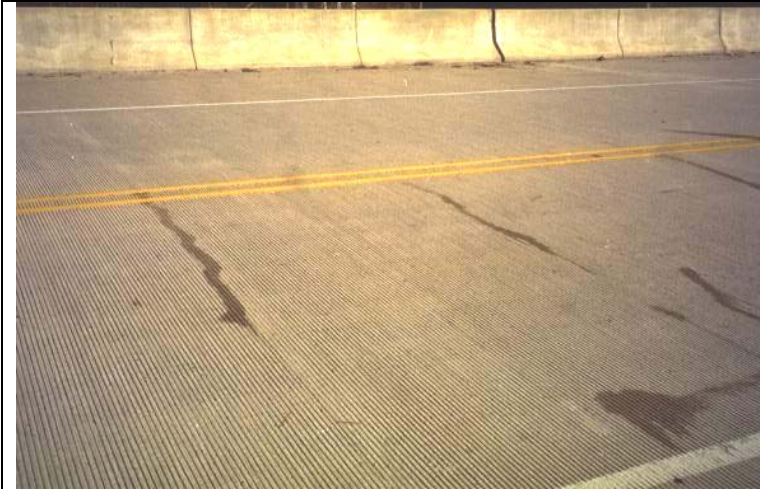
Photo 8: Transverse cracks.

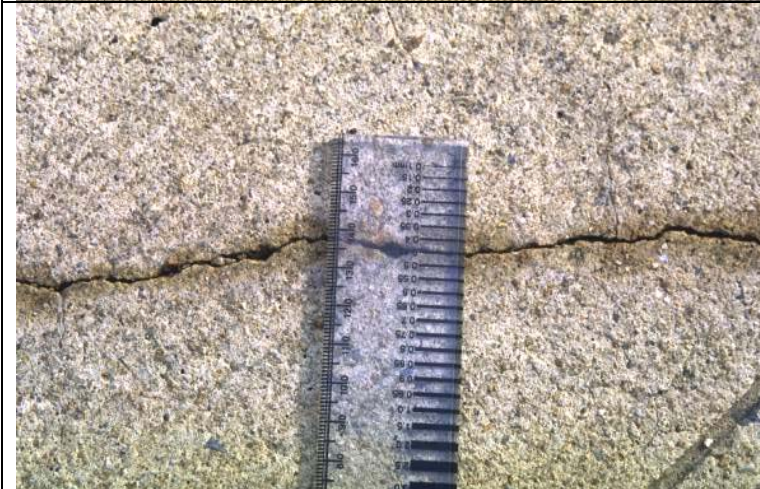
Photo 9: Typical diagonal crack, detail view, 0.018 in. width.

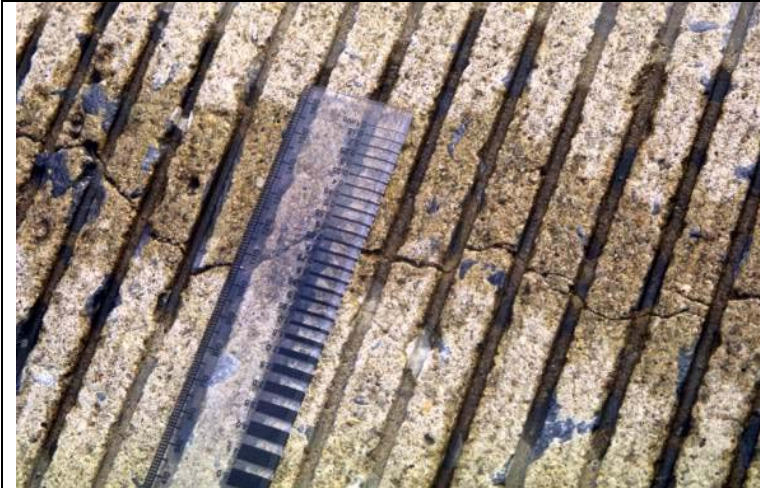
Photo 10: Typical diagonal crack, detail view, 0.025 in. width.

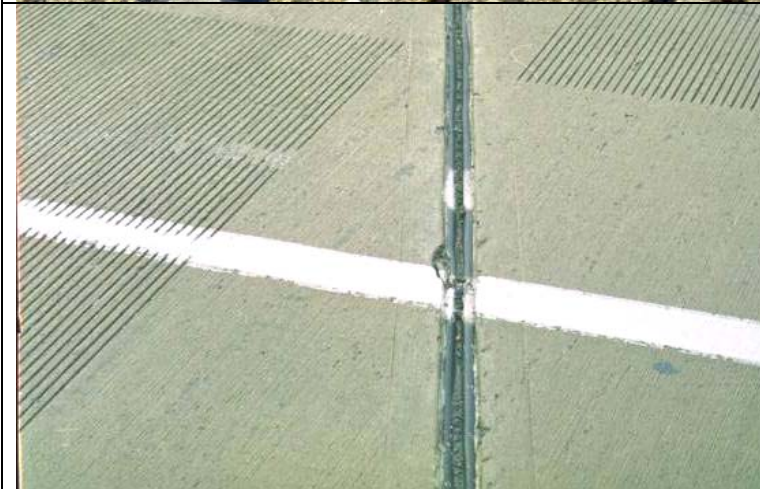
Photo 11: Typical D-Spall.

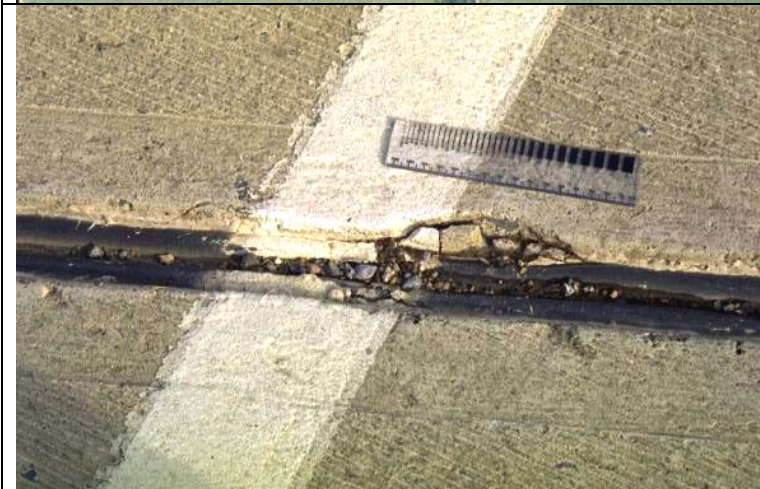
Photo 12: Typical D-Spall, detail view.

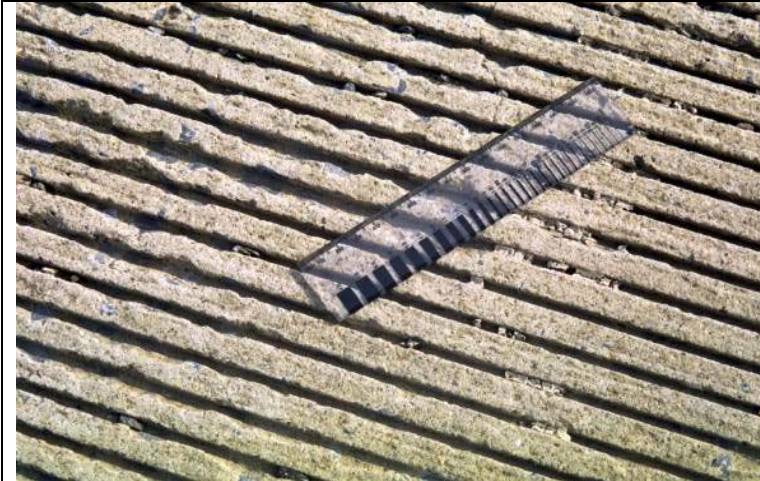
Photo 13: Typical deep-grooving.

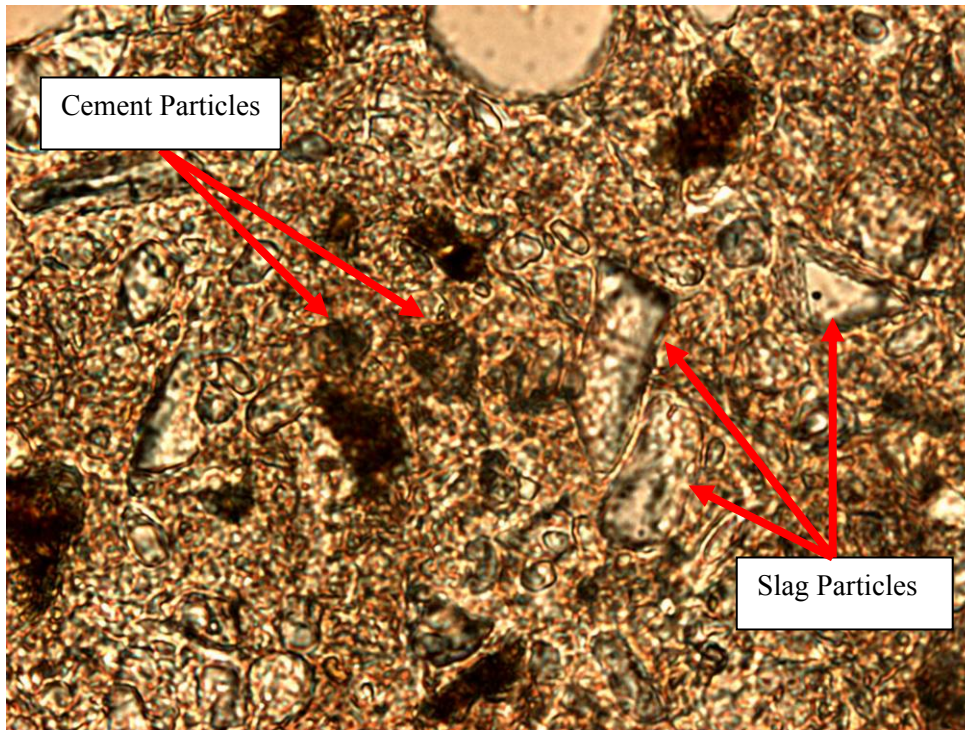
Figure Q1-1. Unhydrated cement and slag particles in paste. Width of field is 0.165 mm. Thin section image.

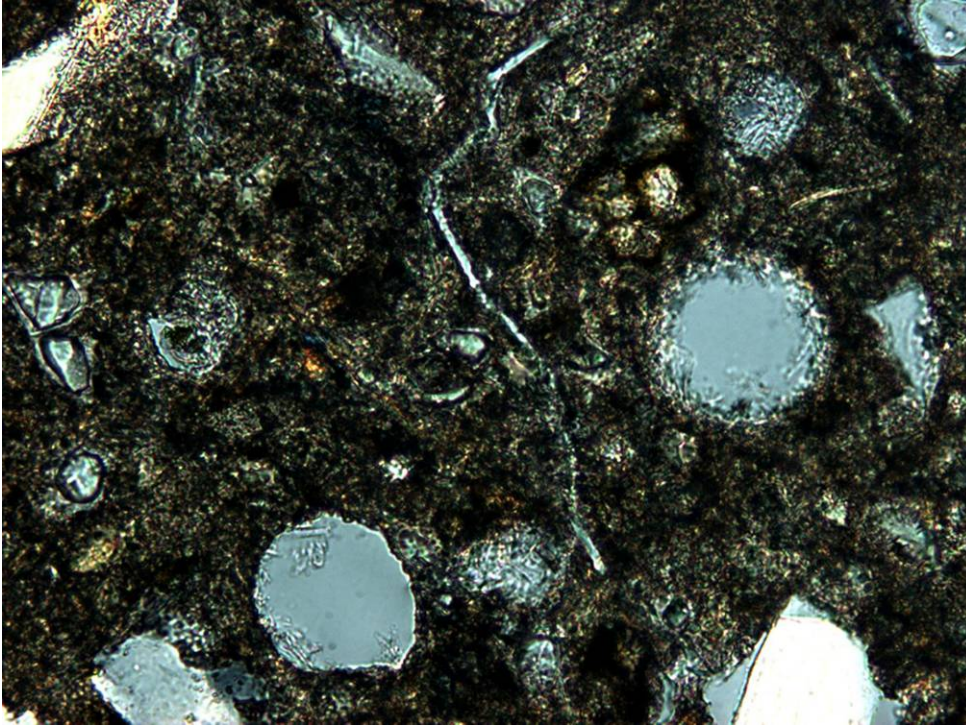
Figure Q1-5. Crack in cement paste. Width of field is 0.33 mm. Thin section image.
