# High Performance Concrete Bridge Deck Investigation

November 2009

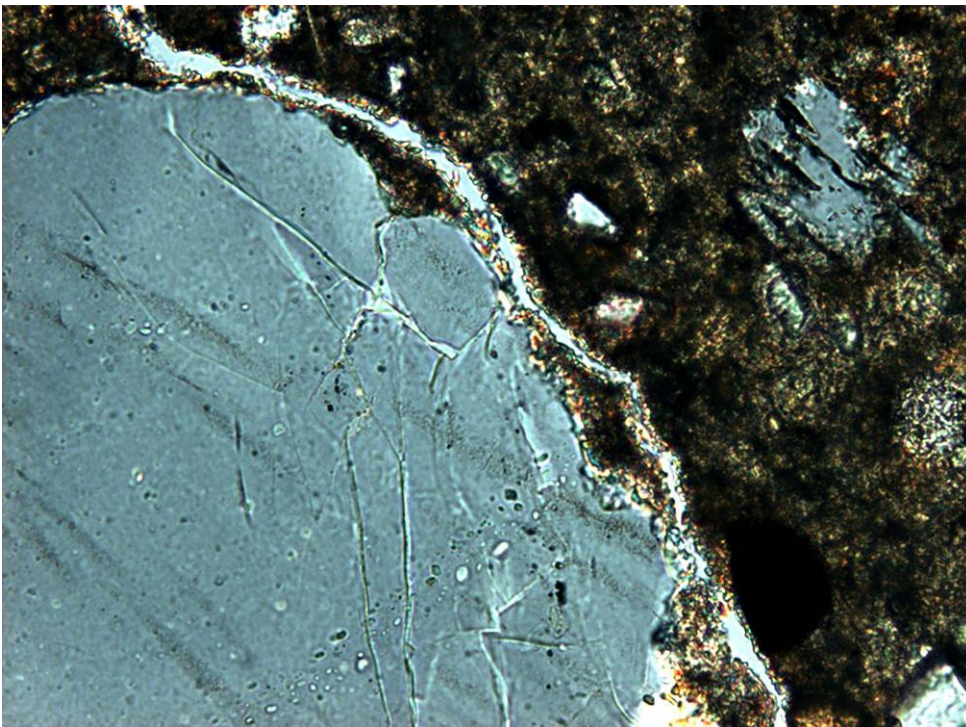
Figure Q1-6. Crack close to the fine aggregate/paste interface. Width of field is 0.33 mm. Thin section image.

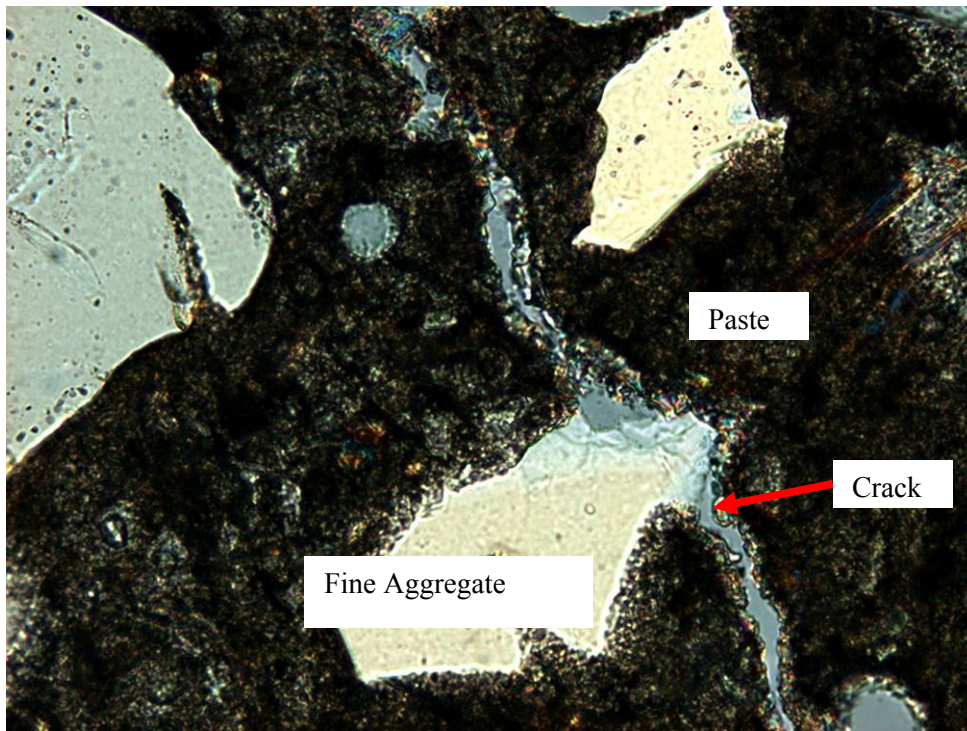
Figure Q1-7. Crack in the cement paste and along the aggregate/paste interface. Width of field is 0.33 mm. Thin section image.

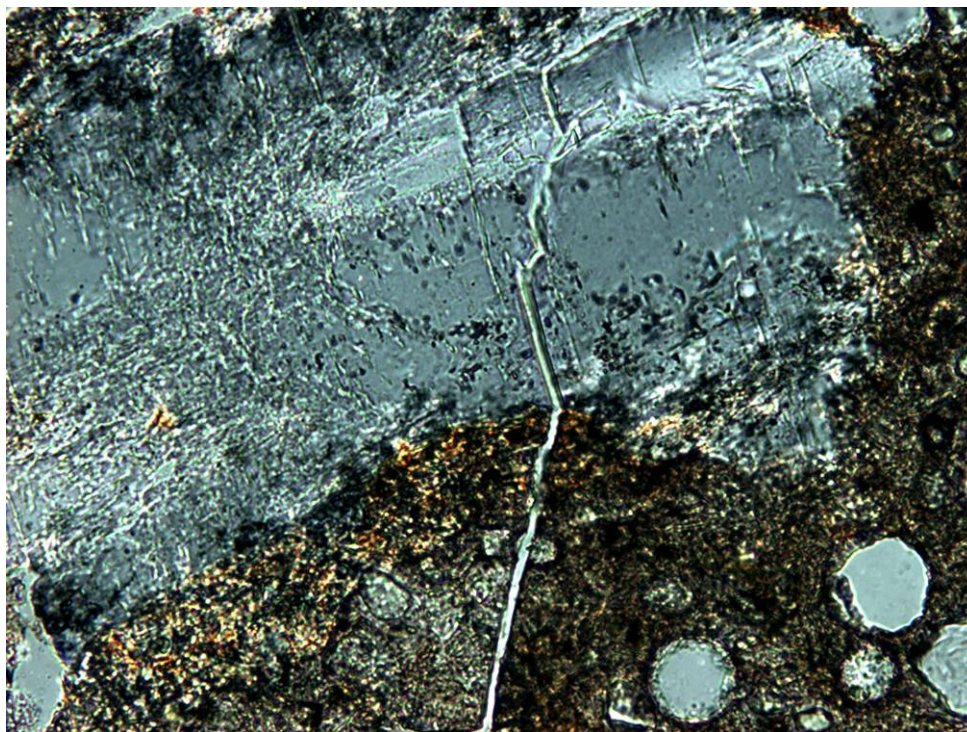
Figure Q1-8. Fracture in fine aggregate. Width of field is 0.33 mm. Thin section image.

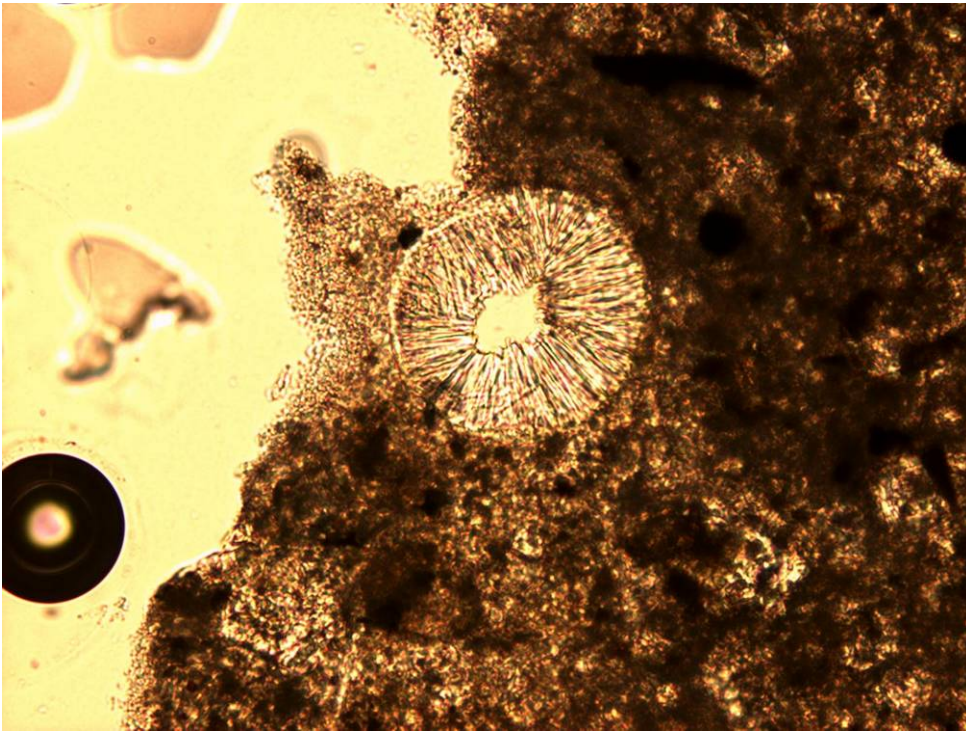
Figure Q1-9. Ettringite in an air void. Width of field is 0.33 mm. Thin section image.

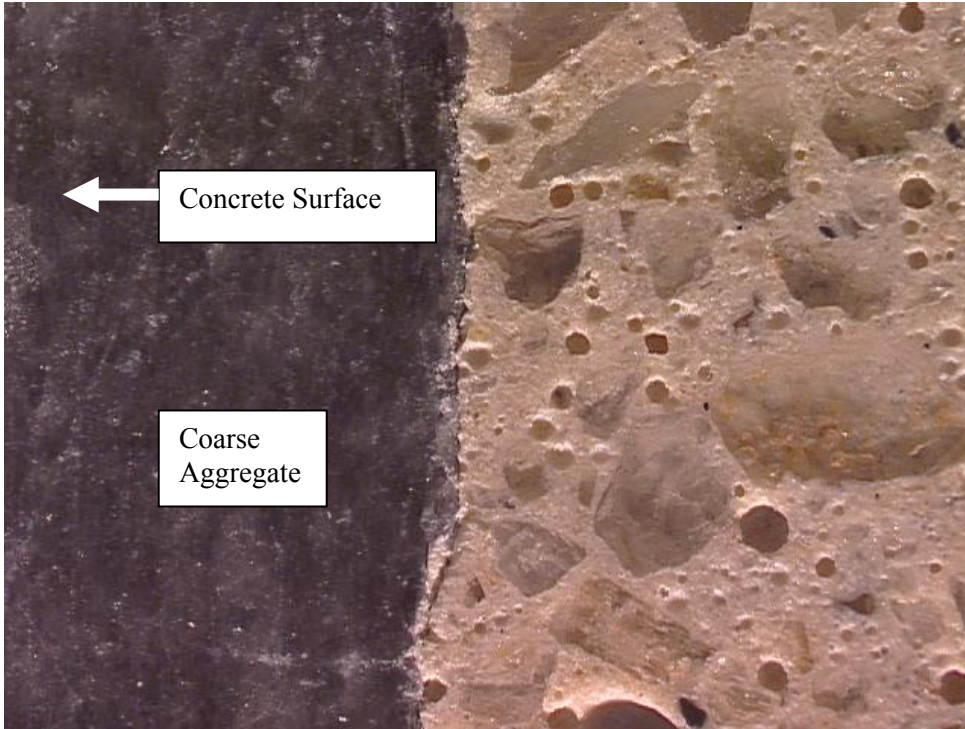
Figure Q1-11. Gap/crack underneath a flaky coarse aggregate. Width of field is 4.0 mm. Polished concrete surface image.

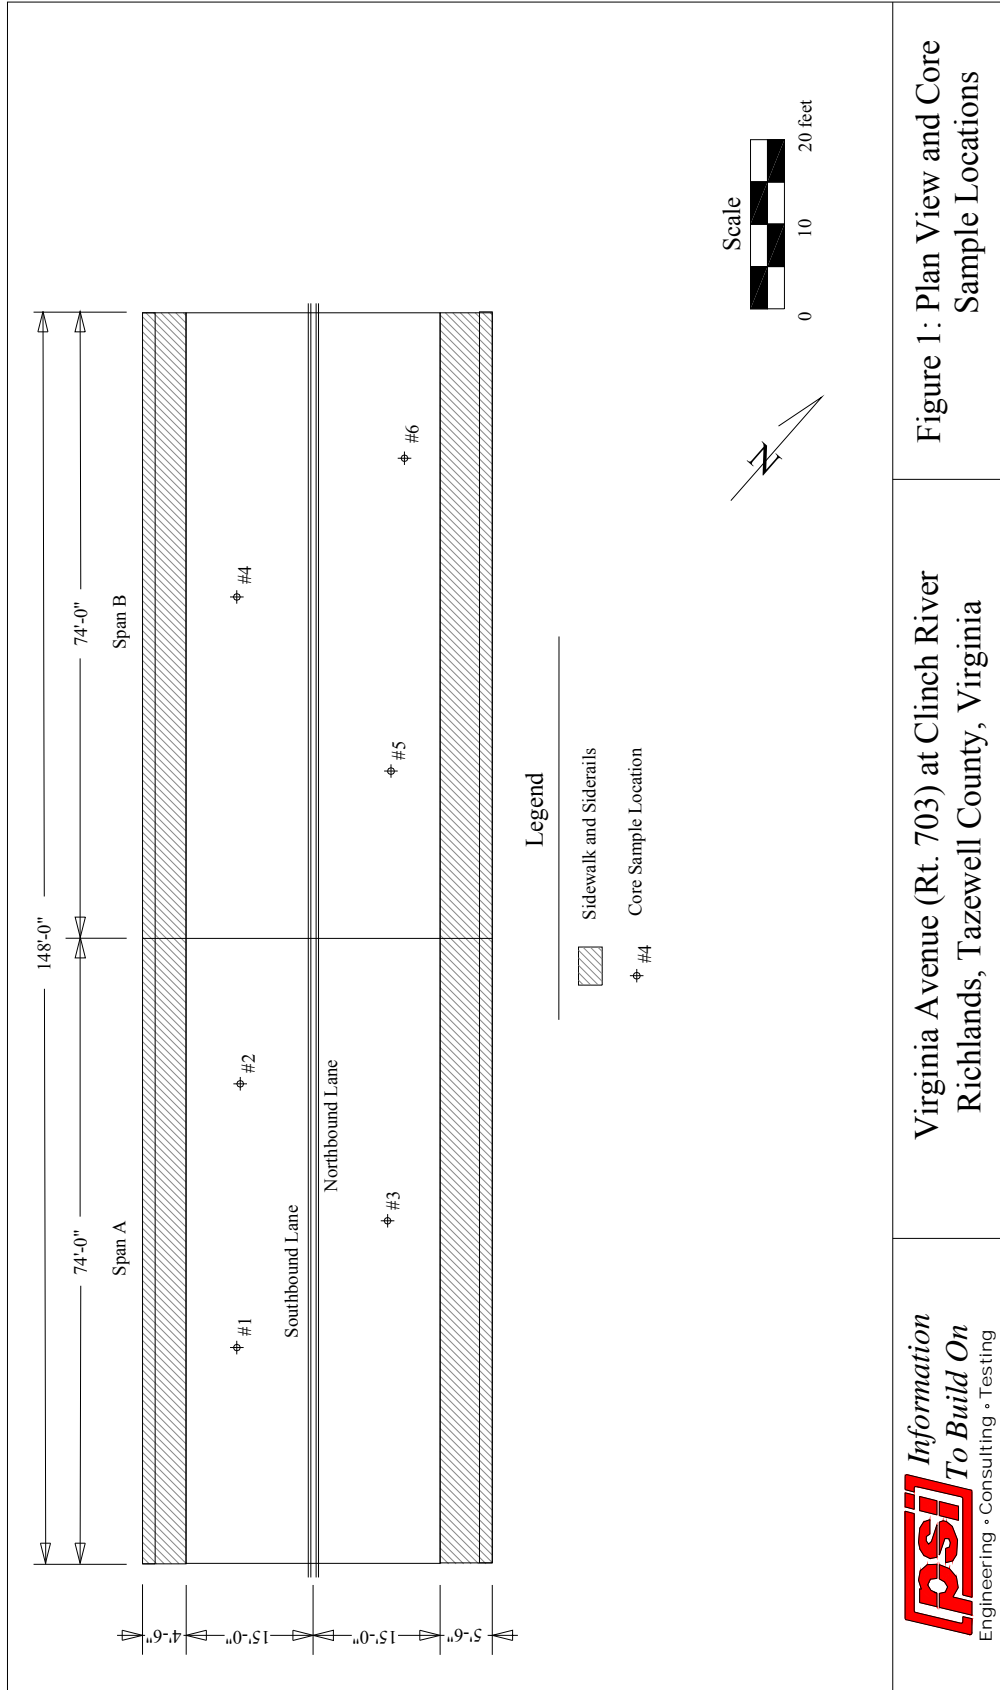
Figure 1: Plan View and Core Sample Locations

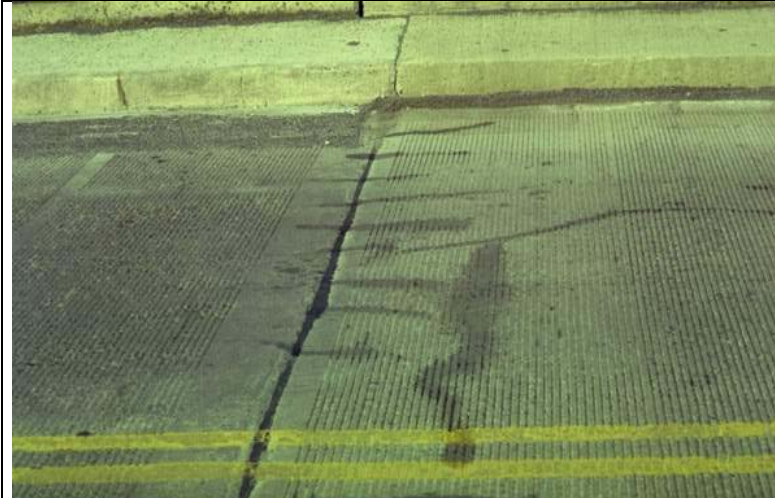
Photo 4: General view of the longitudinal cracks at the south end of the bridge.

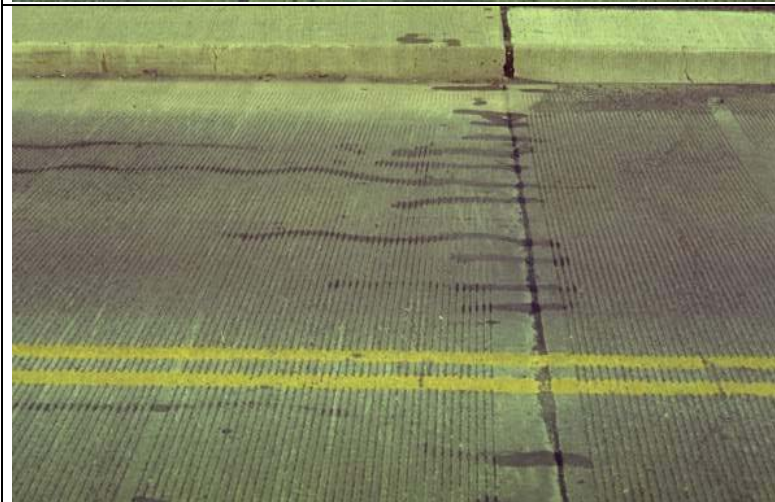
Photo 5: General view of the longitudinal cracks at the north end of the bridge.

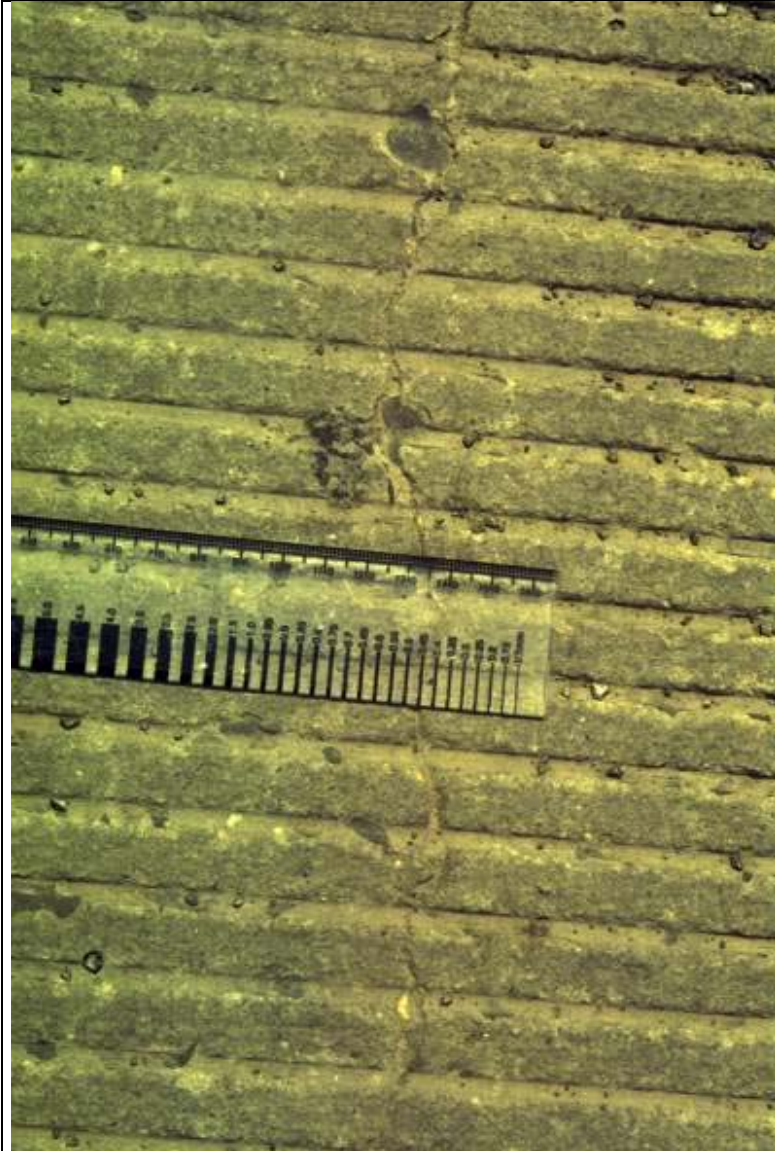
Photo 6: Close-up view of the longitudinal cracks. The width of the crack is 0.016 in.

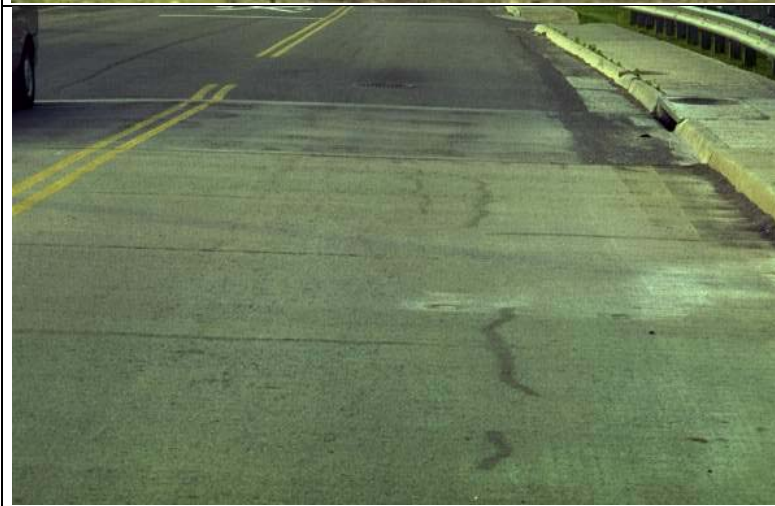
Photo 7: View of the longitudinal cracks on the south bound.

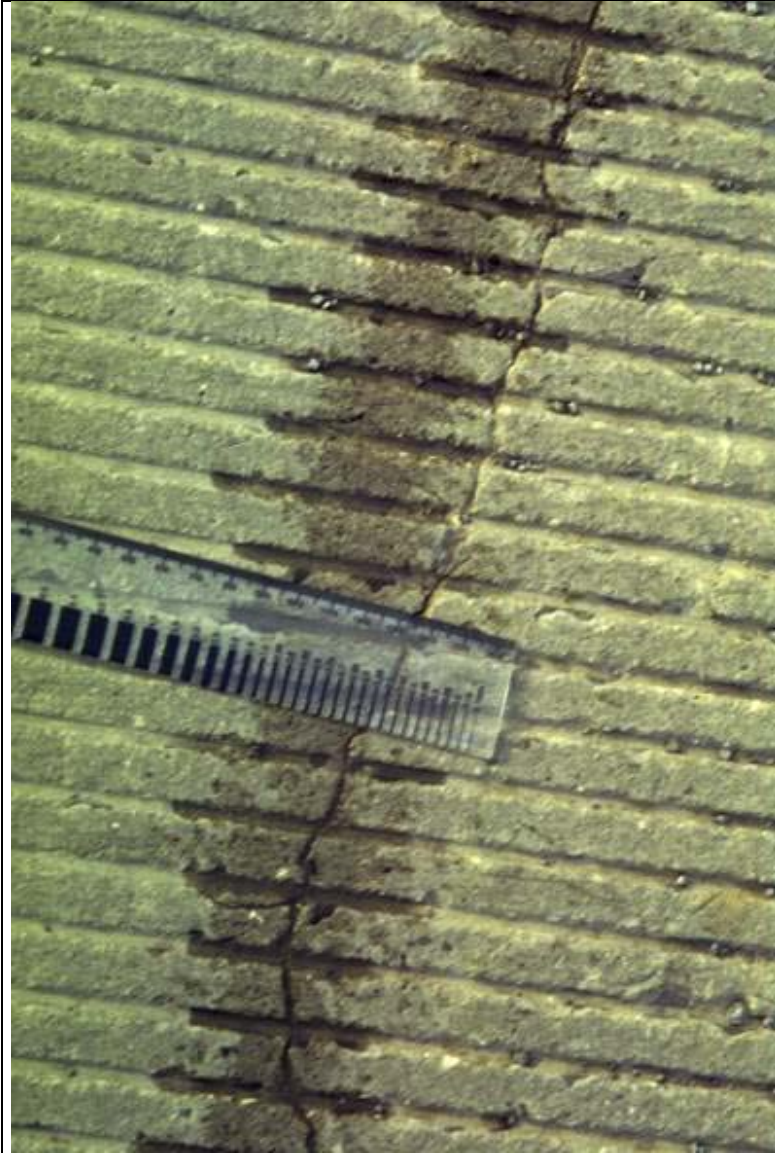
Photo 8: Close-up view of the longitudinal cracks. The width of the crack is 0.022 in.

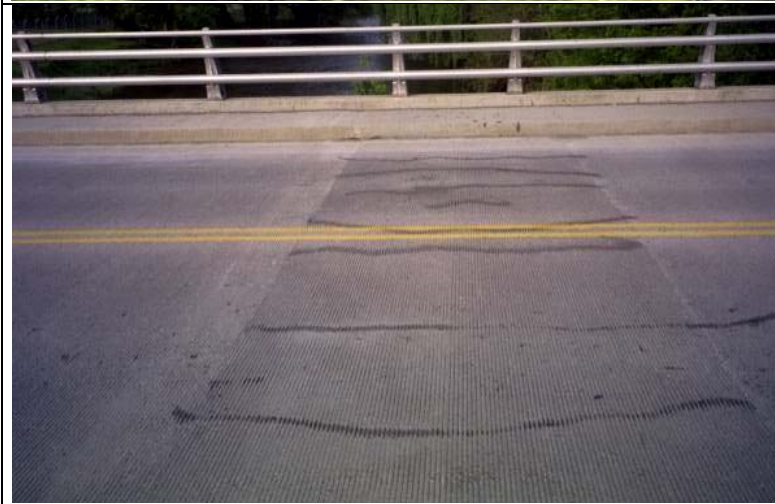
Photo 9: General view of the longitudinal cracks over the pier.

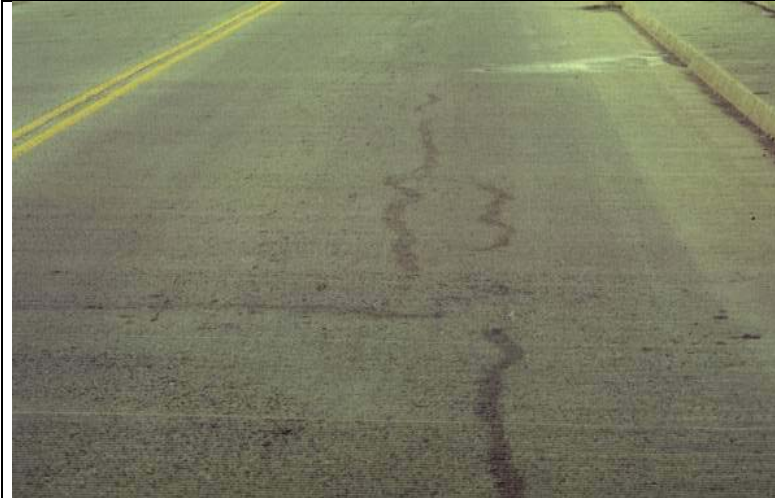
Photo 10: General view of the longitudinal cracks on the north bound.

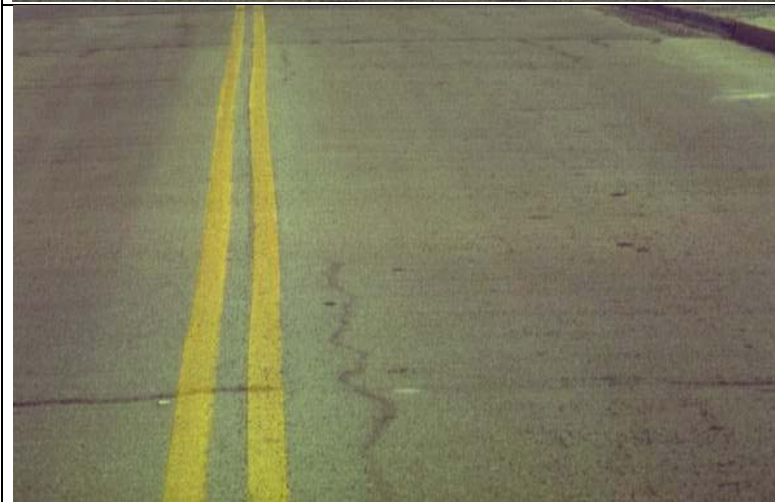
Photo 11: View of transverse cracks.

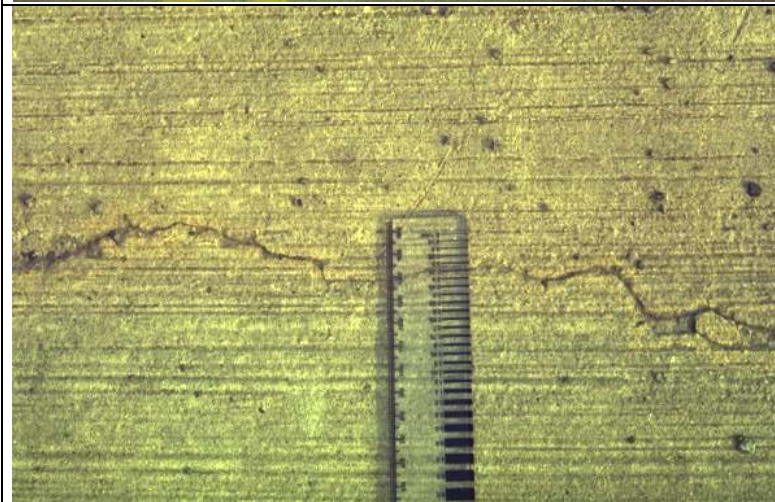
Photo 12: Close-up view of the transverse cracks. The width of the crack is 0.014 in.

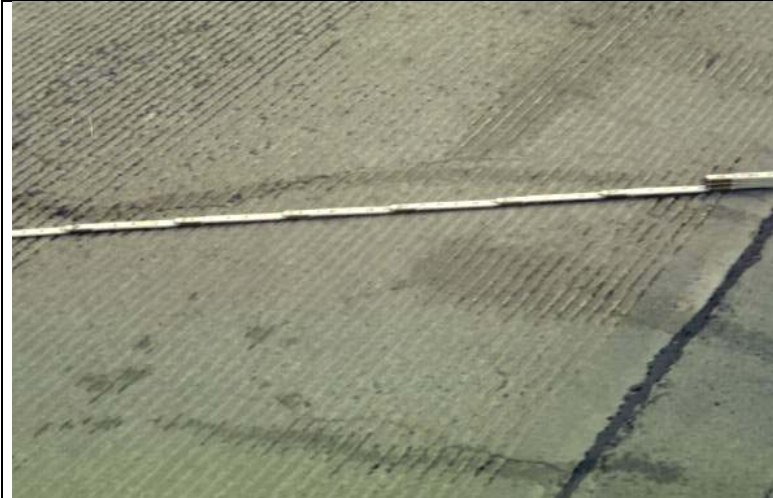
Photo 13: View of the diagonal crack. The width of the crack is 0.010 in.

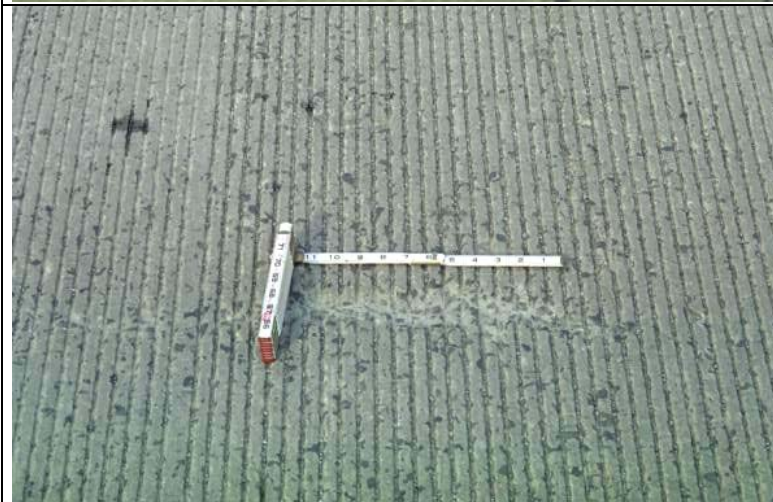
Photo 14: A small gouge with a dimension of 12-in. x 3-in. x 1/2-in.

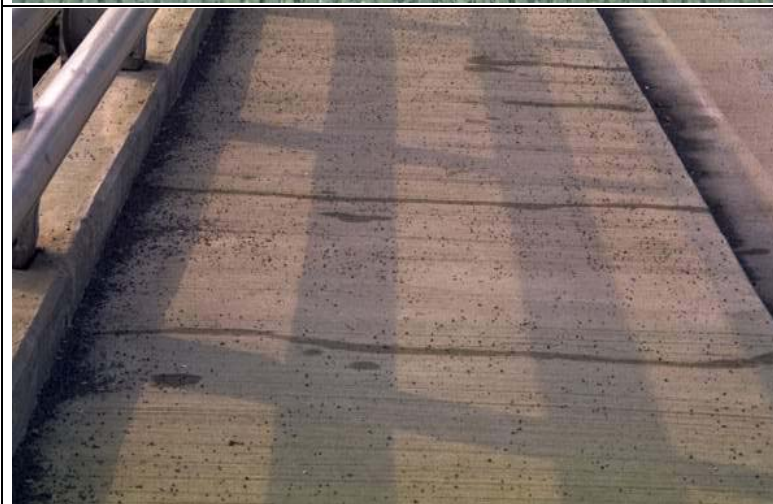
Photo 15: Cracks on the sidewalk.

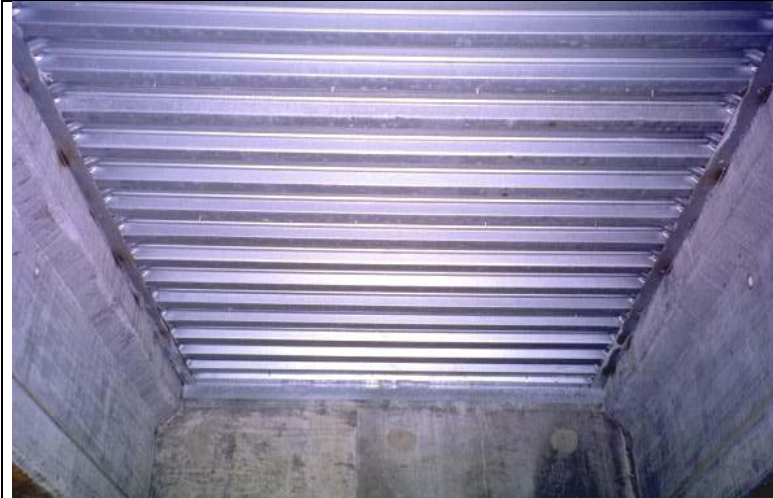
Photo 16: View of the underside of the deck showing the stay-in-place forms.

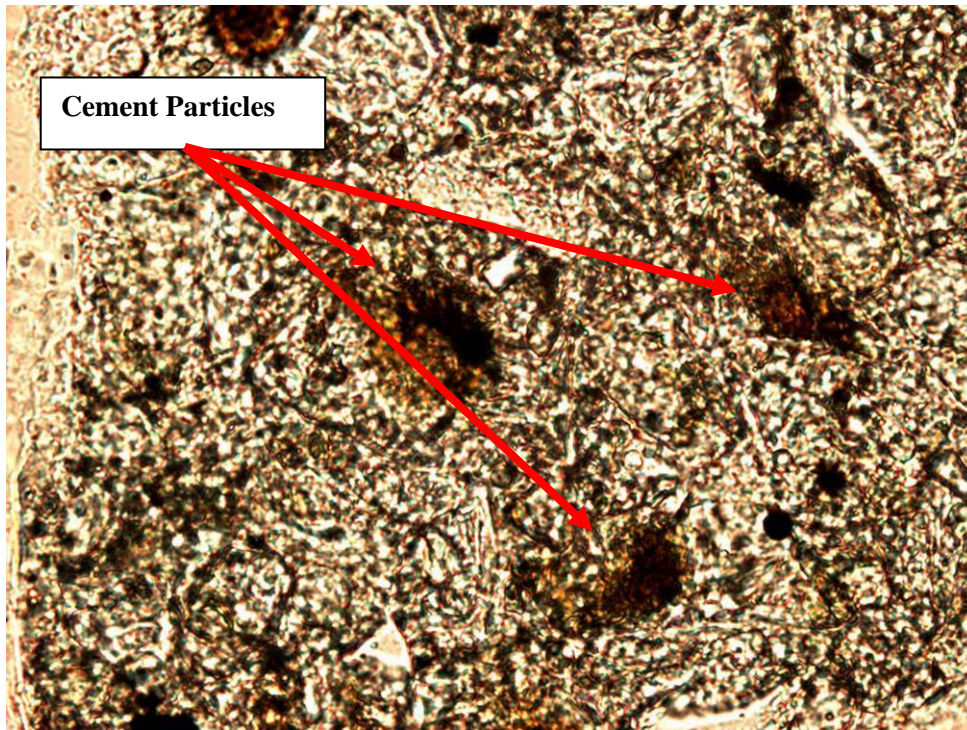
Figure R1-1: Unhydrated cement particles in paste. Width of field is 0.165 mm. Thin section image.

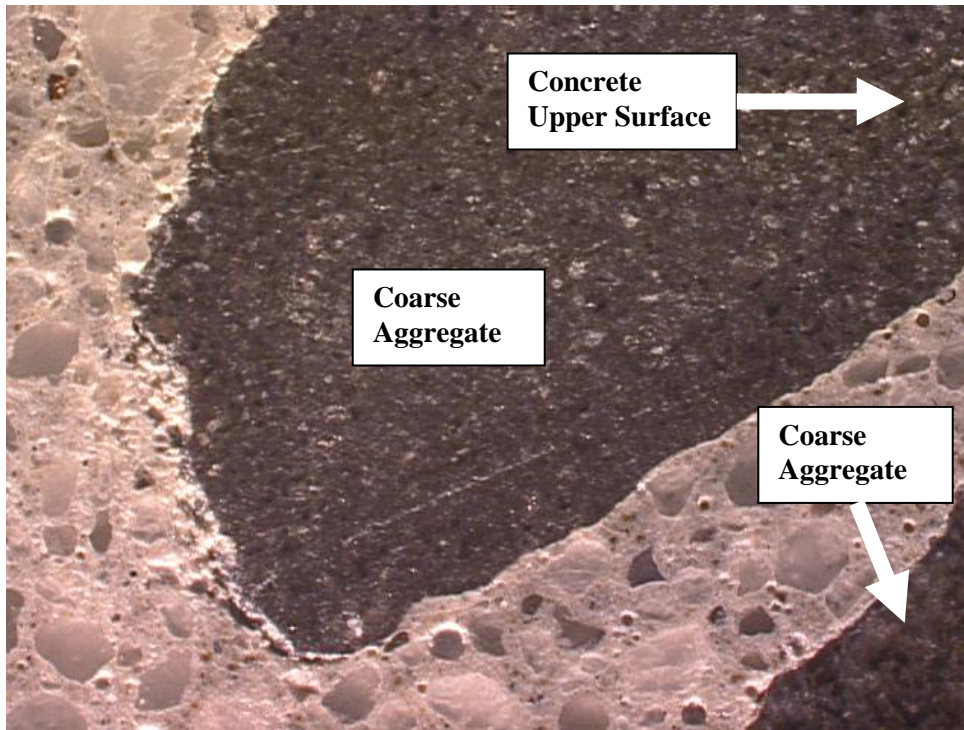
Figure R1-3: Gap and crack, as well as some air voids, line up around the coarse aggregate perimeter. Width of field is 4.0 mm. Polished surface image.

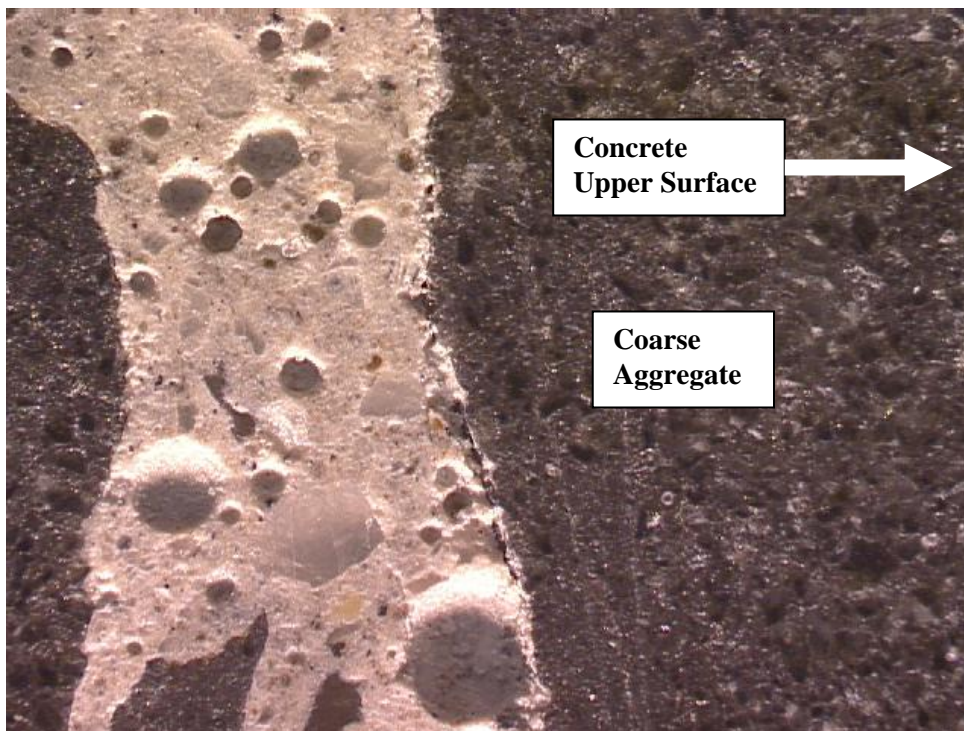
Figure R1-4: Another image of air voids and gap surrounding coarse aggregate. Width of field is 4.0 mm. Polished surface image.

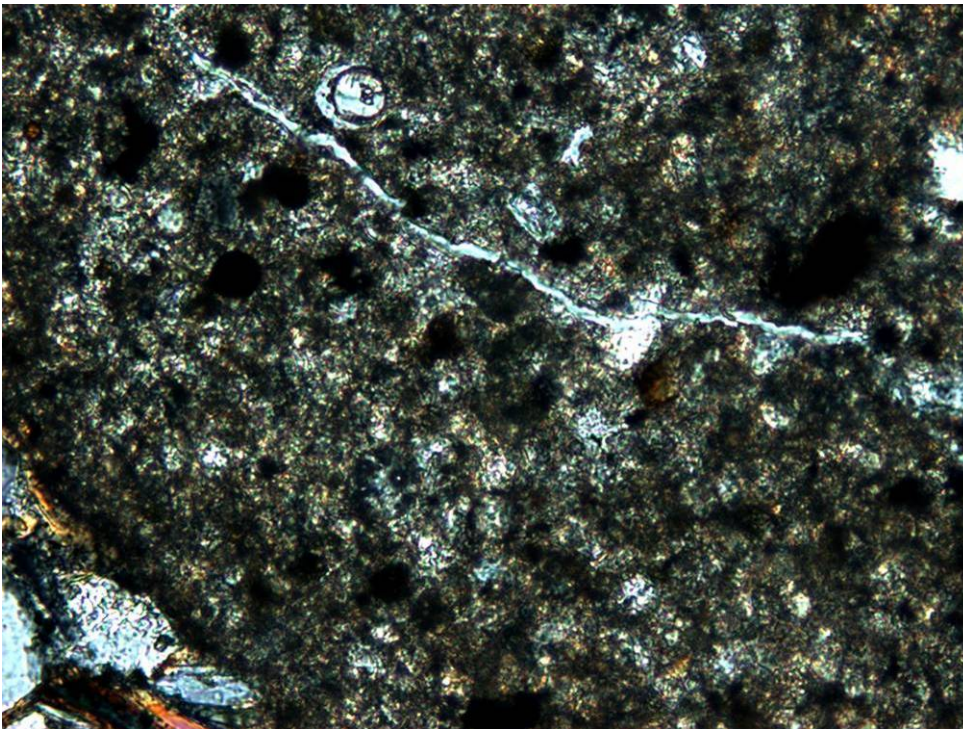
Figure R1-6: Crack in the paste. Width of field is 0.33 mm. Thin section image.

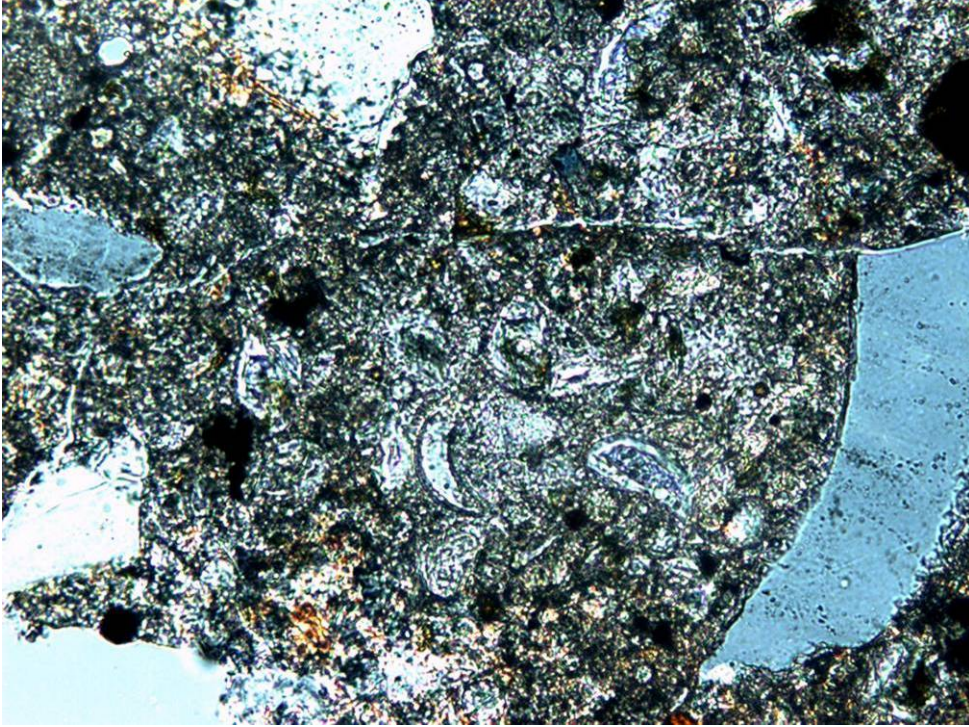
Figure R1-7: A crack connecting two fine aggregate particles. The paste/fine aggregate interface was also cracked. Width of field is 0.33 mm. Thin section image.

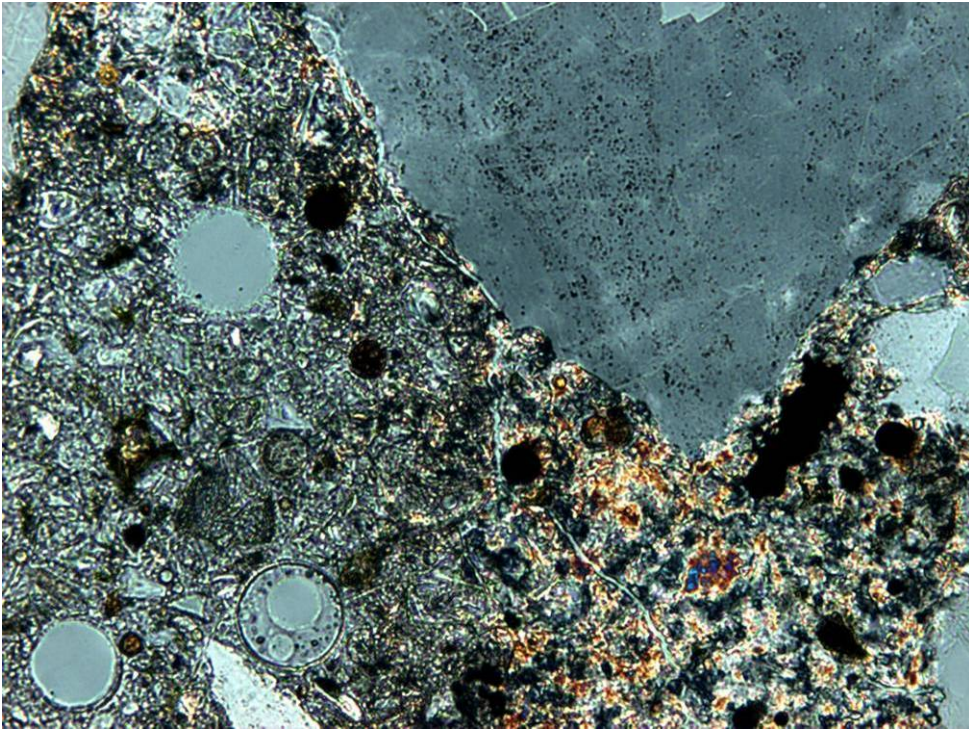
Figure R1-8: Crack in the paste/fine aggregate interfacial region and adjacent paste. Width of field is 0.33 mm. Thin section image.

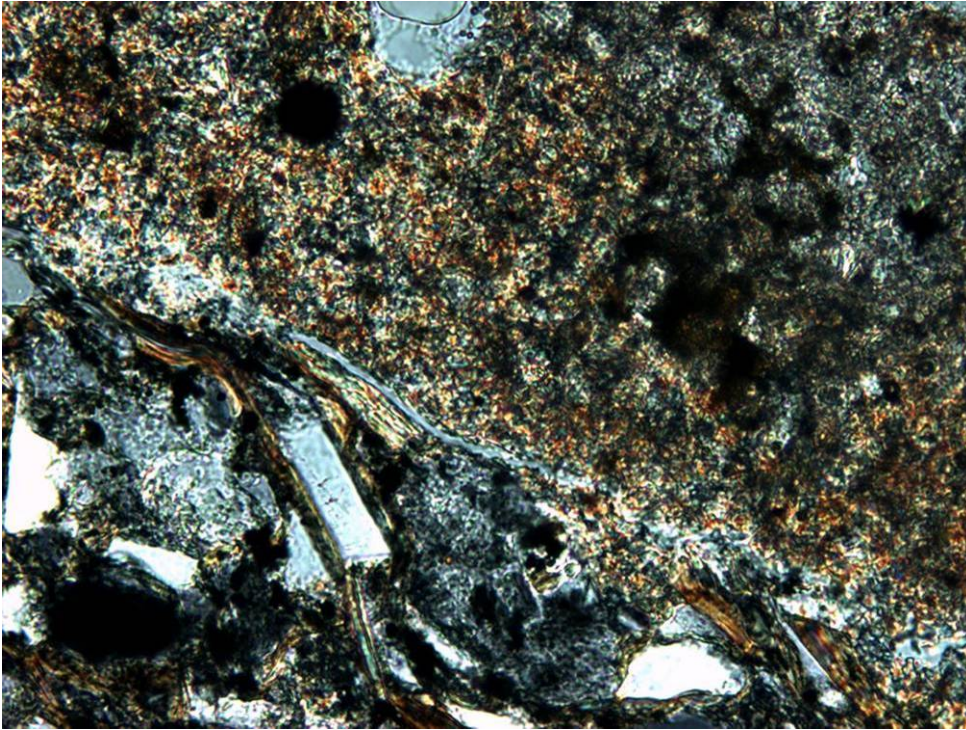
Figure R1-9: Crack in the paste/coarse aggregate interfacial region. Width of field is 0.33 mm. Thin section image.

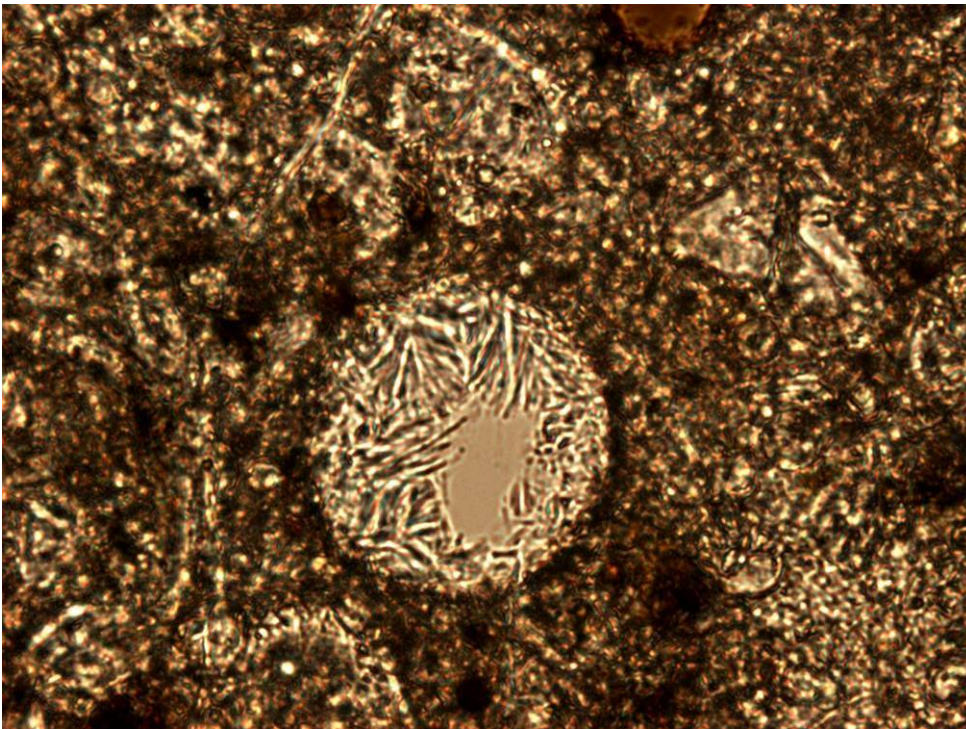
Figure R1-10: Ettringite in an air void. Width of field is 0.165 mm. Thin section image.

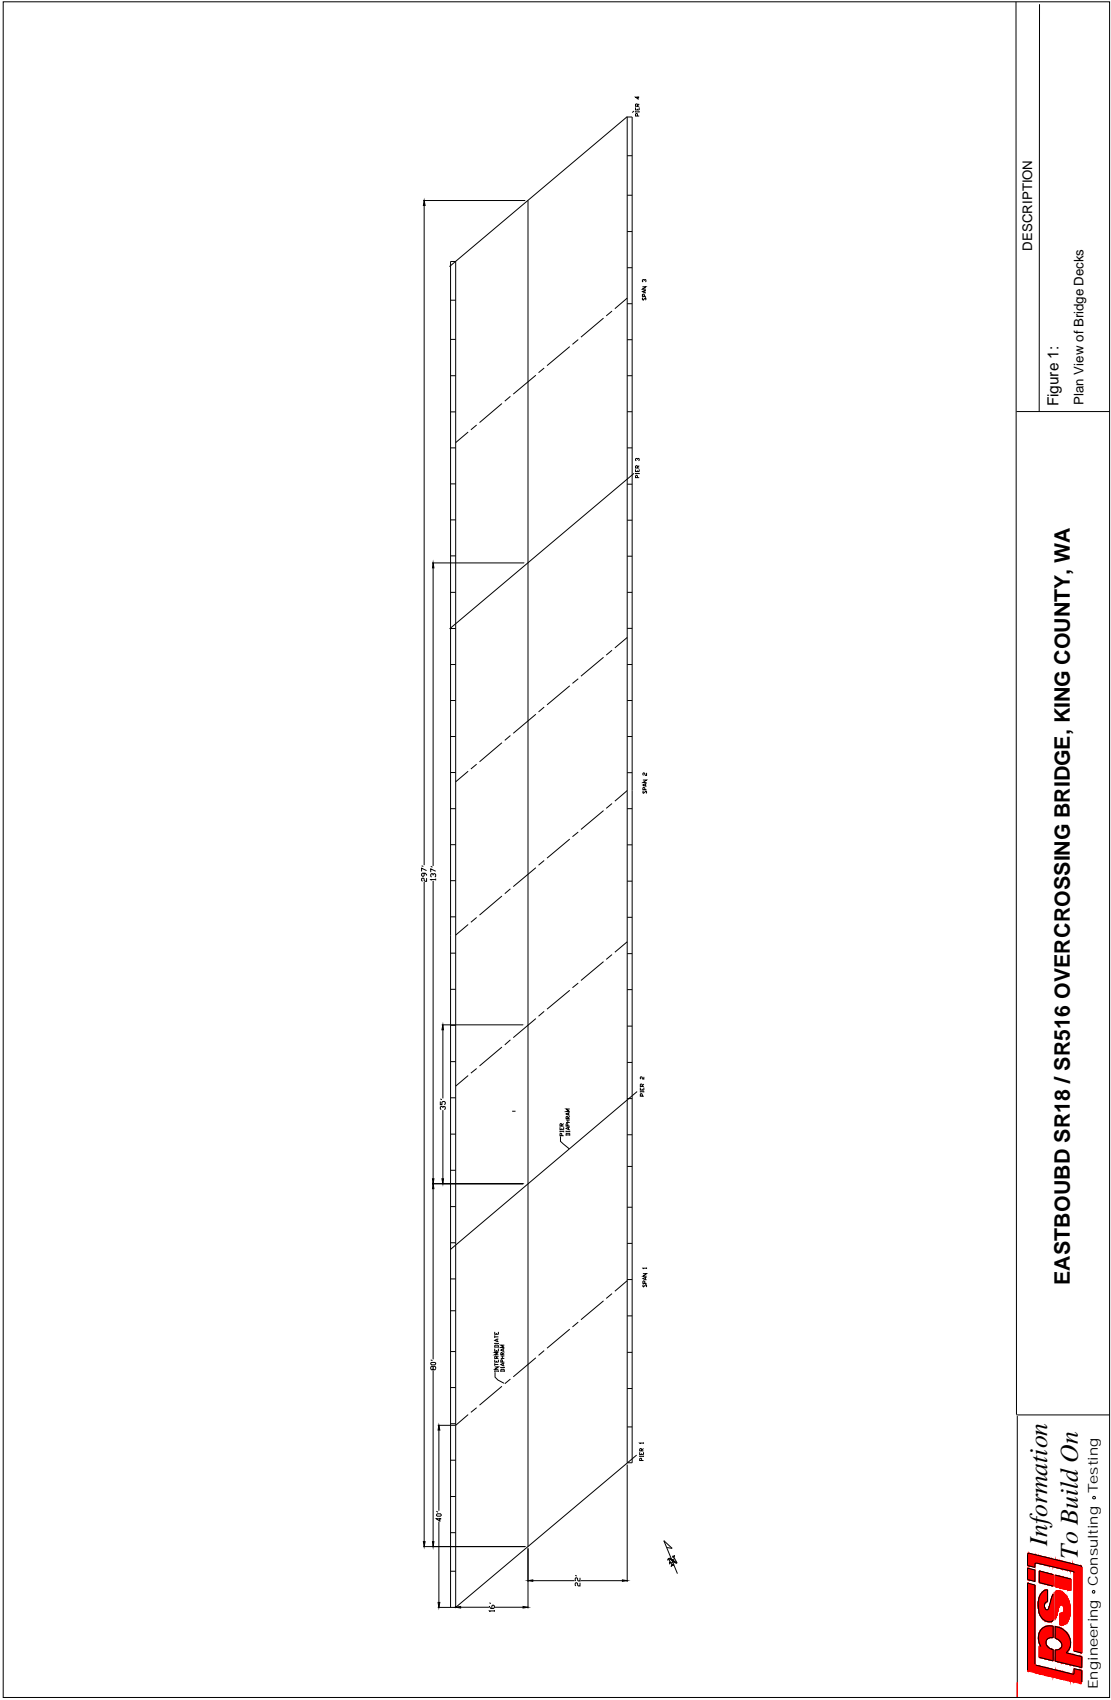
Figure 1:  
Plan View of Bridge Decks

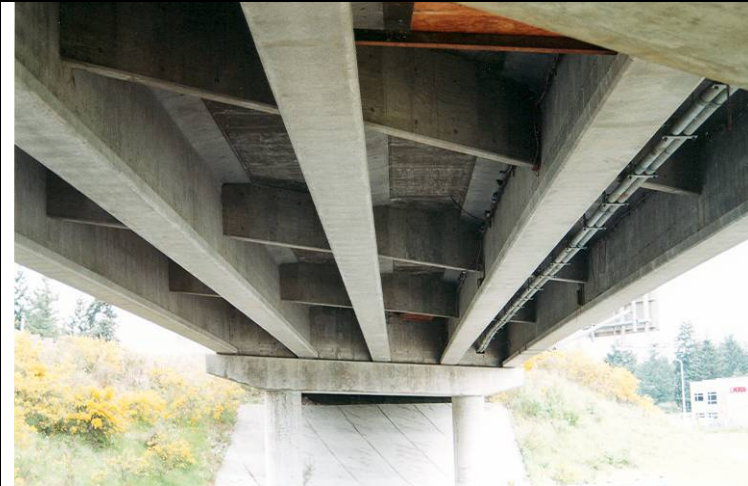
Photo 4: View of the general condition at underside of bridge.

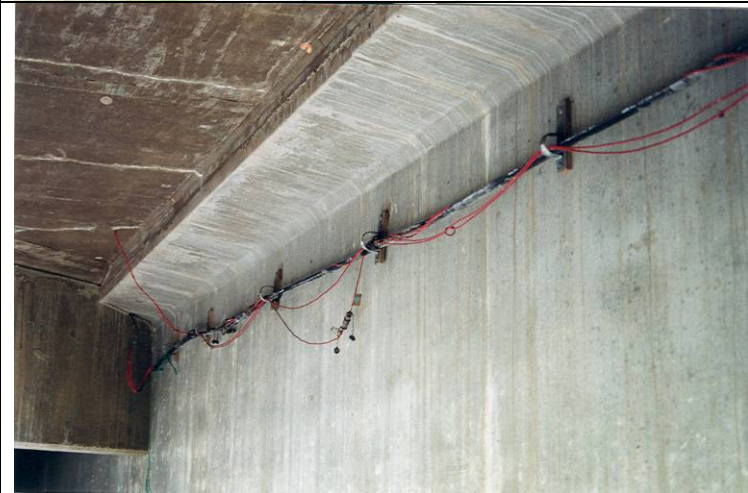
Photo 5: View of the underside of bridge showing cracking and efflorescence.

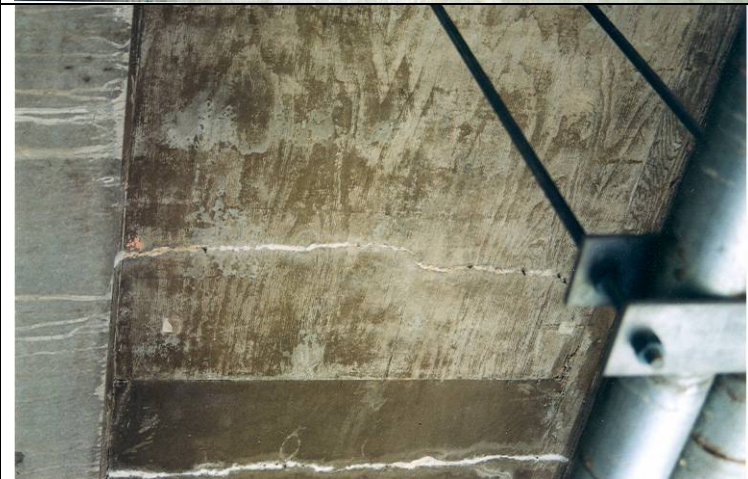
Photo 6: Close up view of the cracking at underside of bridge deck.

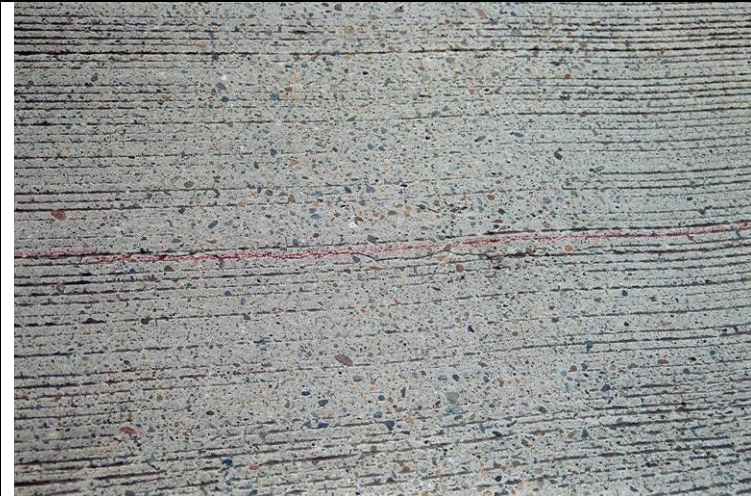
Photo 7: View of the typical transverse cracks.

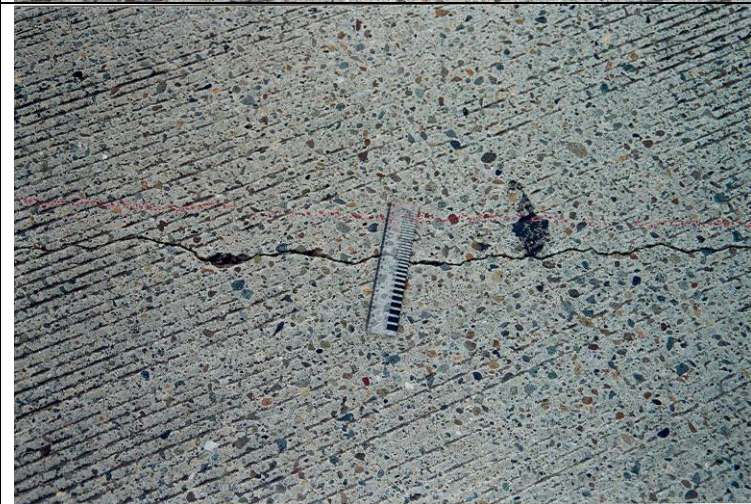
Photo 8: View of the typical diagonal cracks. Crack width is 1mm.

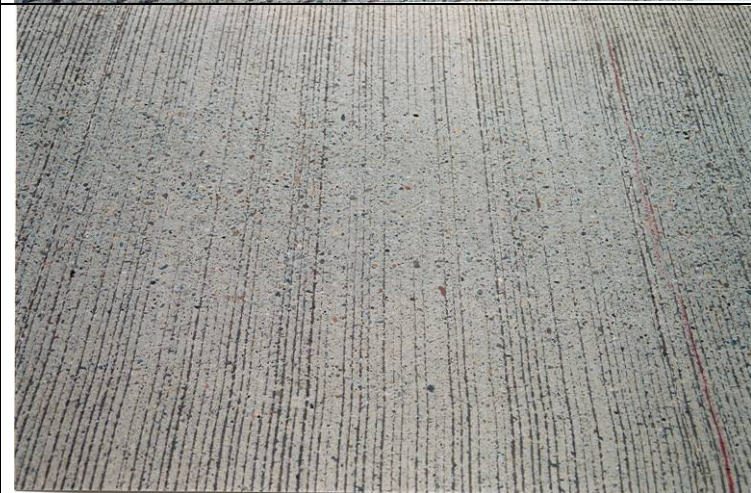
Photo 9: View of the typical polished surface area.

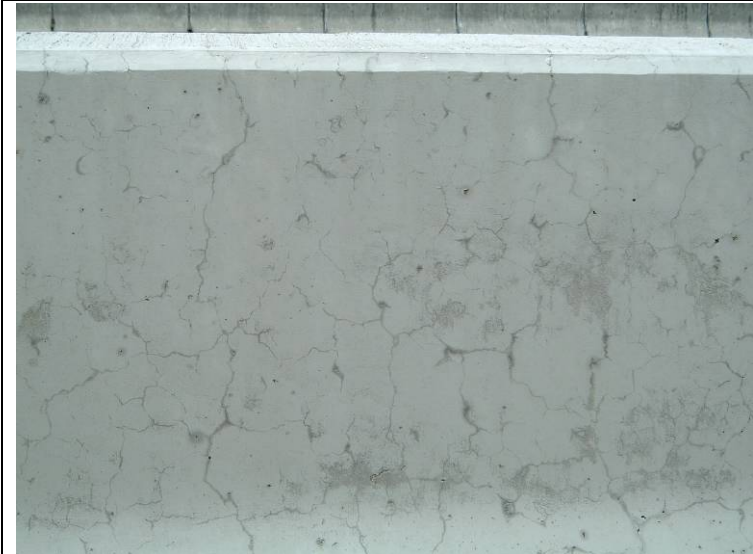
Photo 11: View of the map cracking on concrete barrier wall at eastbound bridge south facing side. Concrete barrier wall showing cracking and efflorescence.

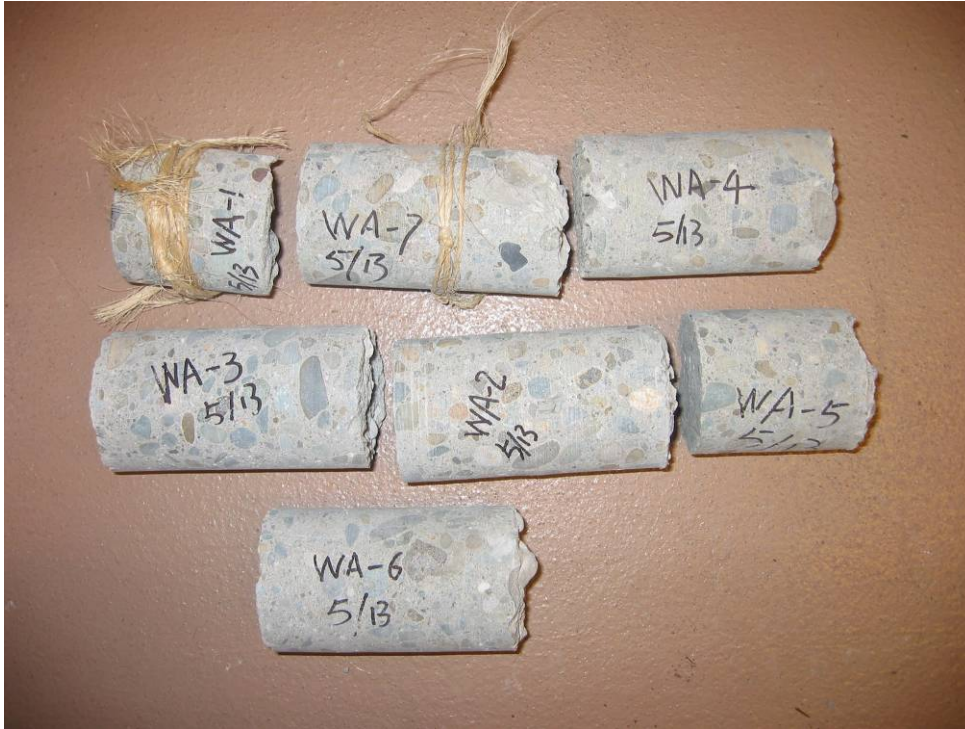
Figure S1-1: Seven concrete cores as received.
