# High Performance Concrete Bridge Deck Investigation

November 2009

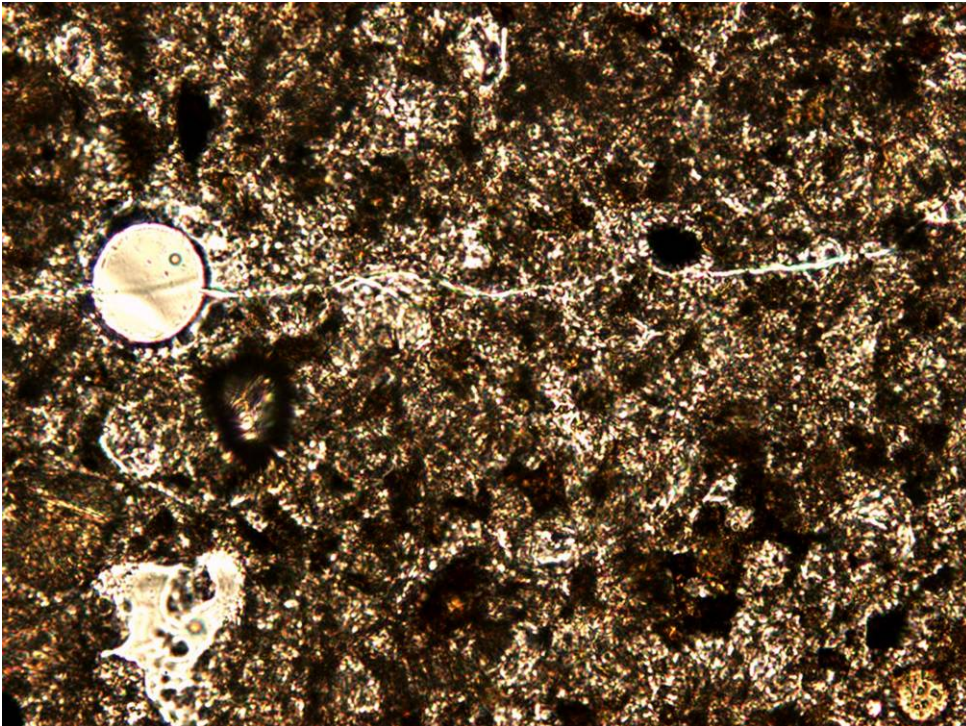
Figure S1-6: A crack in the paste. Width of field is 0.3 mm. Thin section image.

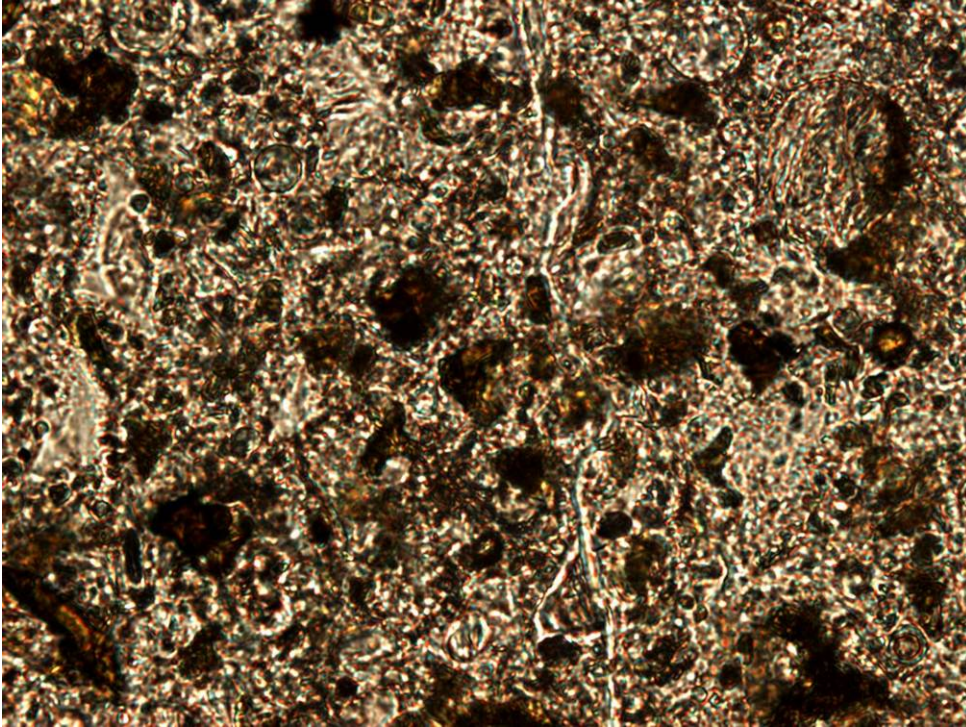
Figure S1-7: Another crack in the paste. Width of field is 0.165 mm. Thin section image.

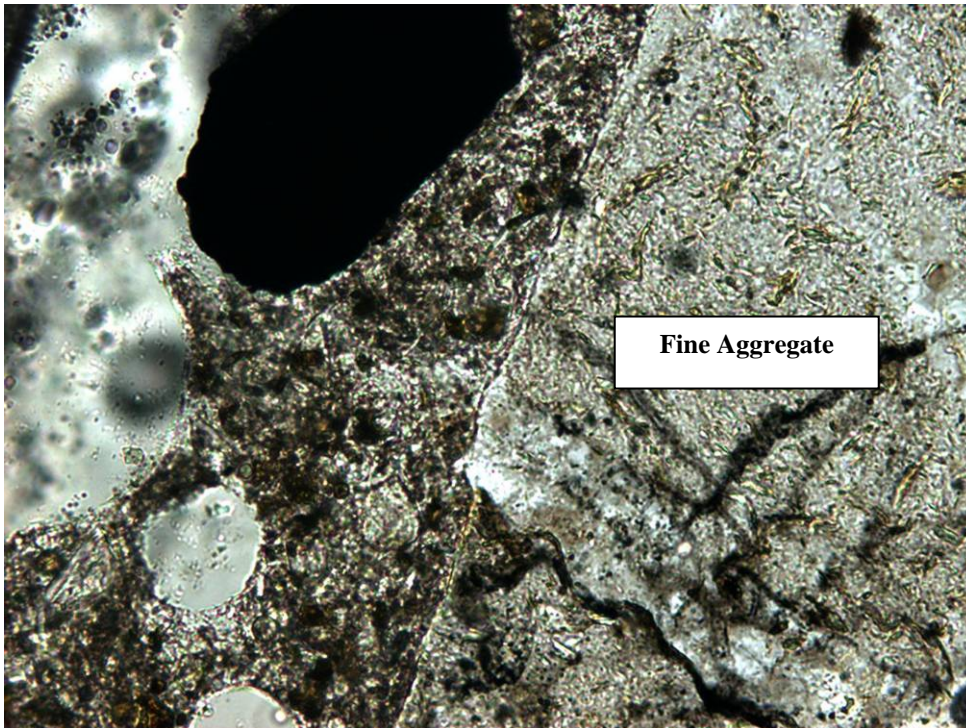
Figure S1-8: A crack at the interfacial region between the fine aggregate and paste. Width of field is 0.33 mm. Thin section image.

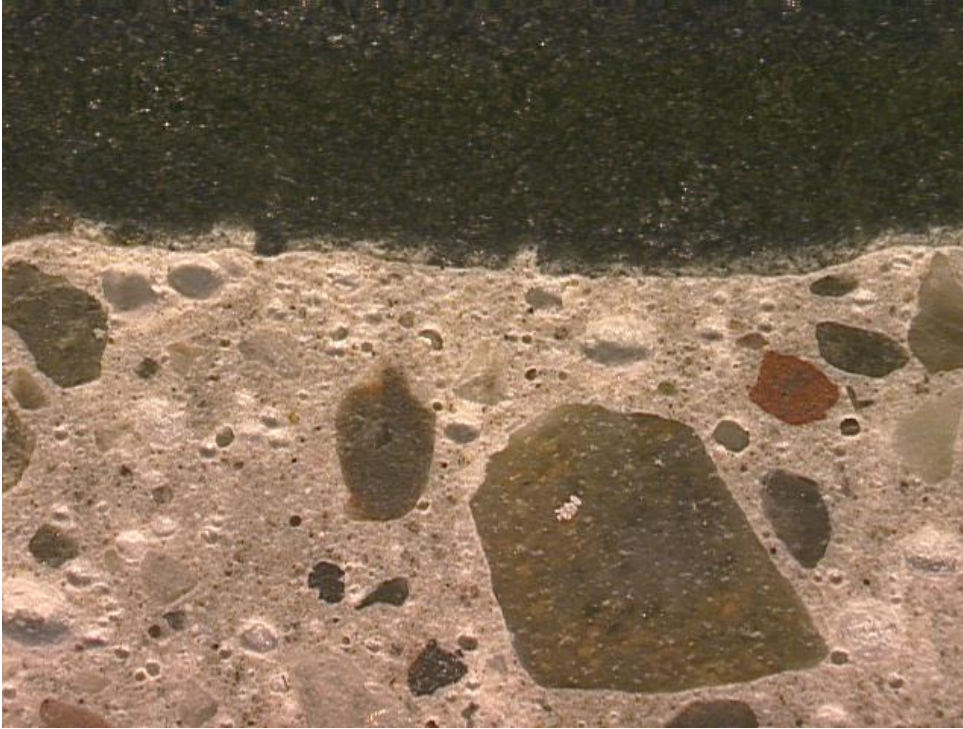
Figure S1-9: Cracking at the interfacial region between the paste and coarse aggregate. Width of field is 4.0 mm. Thin section image.
