**NCHRP REPORT 350 ASSESSMENT OF
EXISTING ROADSIDE SAFETY HARDWARE**

Contract No. DTFH61-97-C-00039
Project No. 404211-F

Sponsored by
**U.S. Department of Transportation
Federal Highway Administration**

**TEXAS TRANSPORTATION INSTITUTE
THE TEXAS A & M UNIVERSITY SYSTEM
COLLEGE STATION, TEXAS 77843**

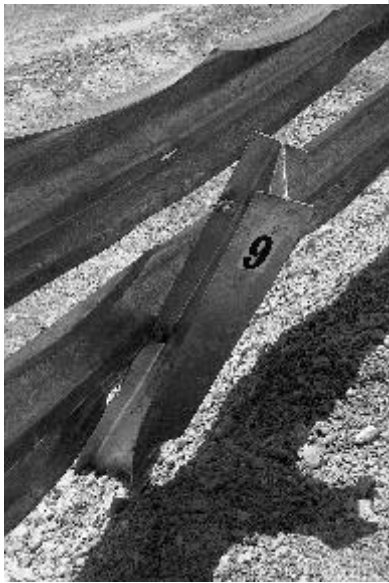
Figure 10. Installation after test 404211-13.

The buried-in-backslope terminal sustained minimal damage as shown in figure 10. Two sections of W-beam rail element and rub rail were deformed and tire marks were on the front face of posts 9 and 10. The blockout at post 9 was detached and resting behind the installation. The tops of the blockouts at posts 10 and 11 were scarred. Length of contact of the vehicle with the installation was 6.7 m. Maximum dynamic deflection during the test was 861 mm and maximum permanent deformation was 445 mm on the rub rail and 695 mm on the upper W-beam rail element.

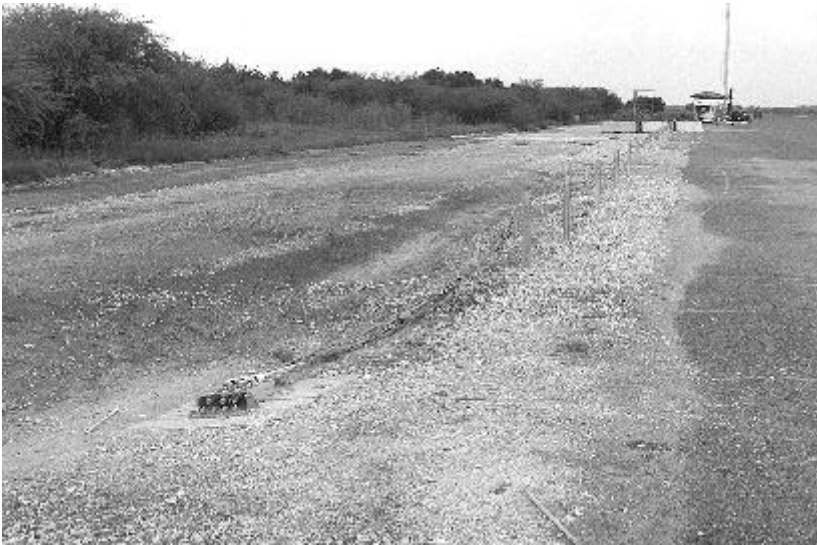
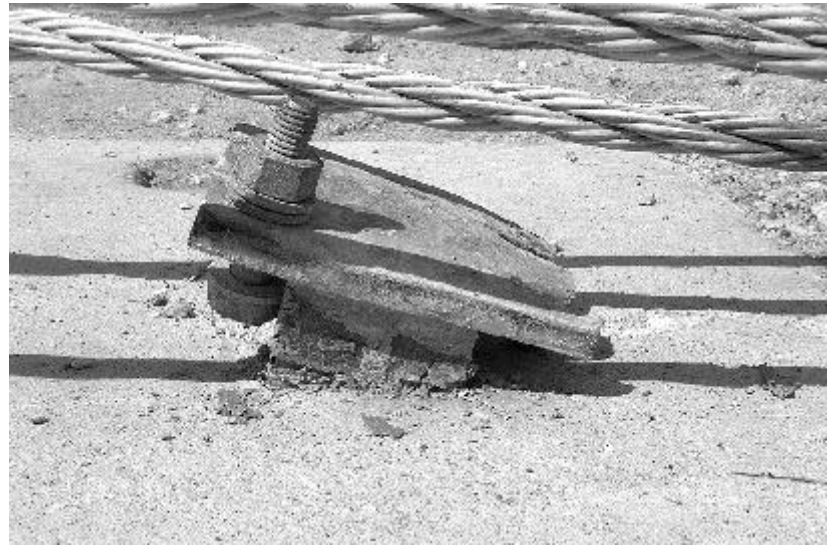
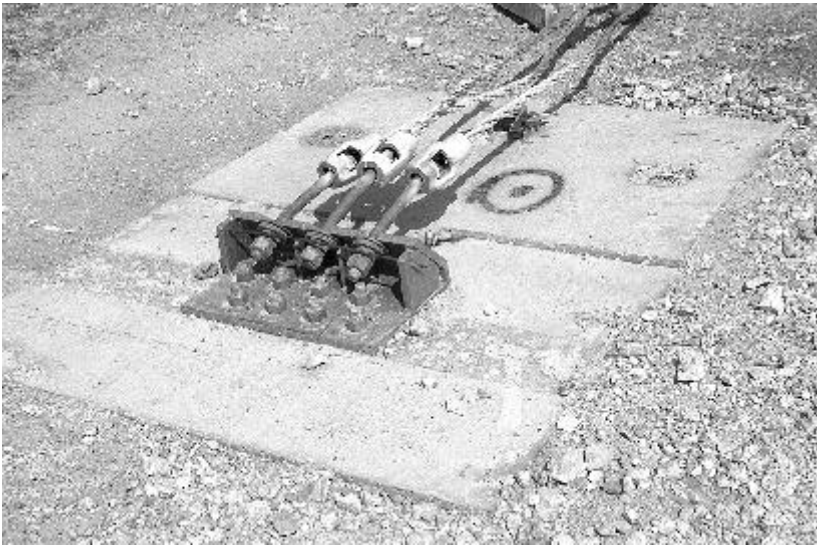
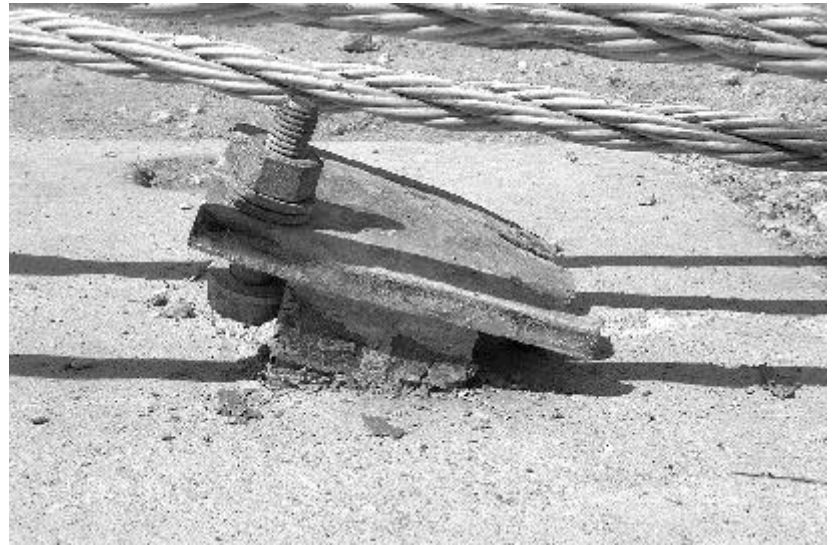
Figure 16. New York cable rail terminal after test 404211-6.

Damage to the 3-cable New York cable rail terminal was minimal as shown in figure 16. The end post broke away at the slip base and was found 480 mm from the base. The rear bolt on the right side remained on the base and the rear bolt from the left side was lying near the base. The two bolts on the front remained with the end post. The turnbuckles near the anchor plate and the cables received scuff marks from the vehicle tires. The cables were slack throughout the length of the installation, but neither anchor moved.

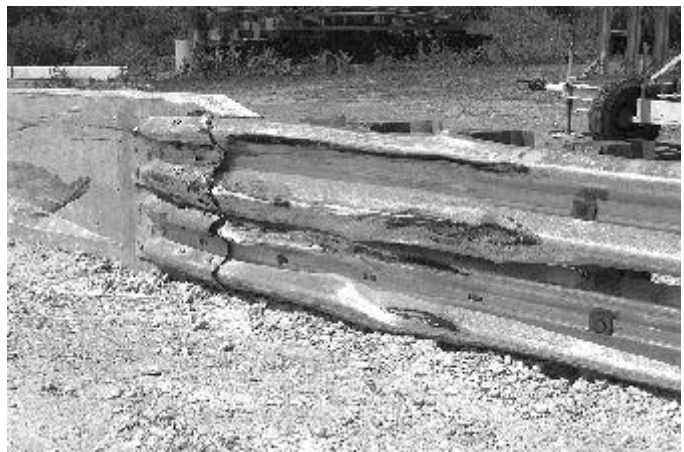
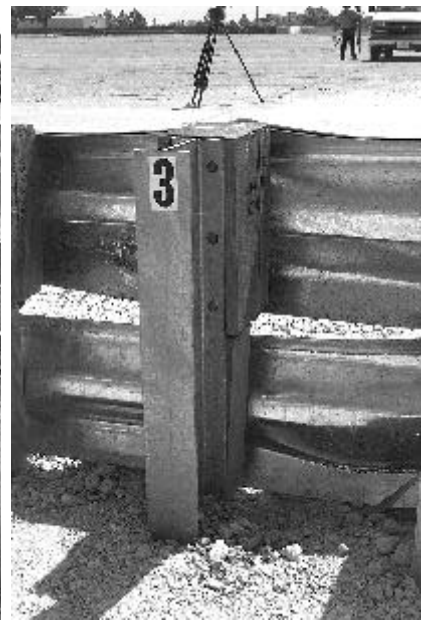
Figure 22. Installation after test 404211-2.

The vertical wall transition received moderate damage as shown in figure 22. The rail was deformed from post 5 through post 1. The blockout on the upper rail element at post 1 was split and separated from the post. The blockout on the rub rail at post 1 was split but remained attached. The blockout on the upper rail element at post 2 was gouged. A piece of metal from the vehicle was caught on the edge of the connection at the end shoe. The top of the CMB was scraped from contact with the vehicle. Total length of contact of the vehicle with the transition and CMB was 4.24 m. Maximum permanent deformation of the rail was 90 mm at post 2.

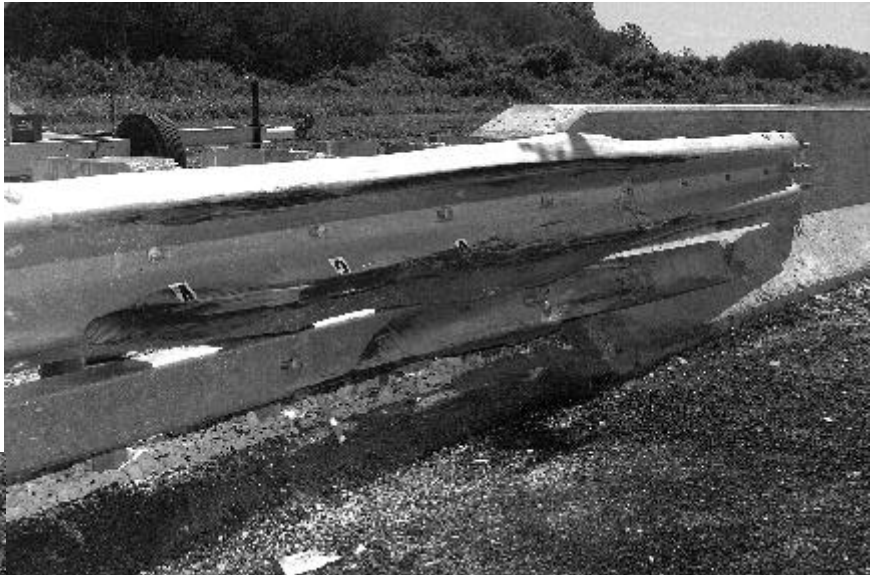
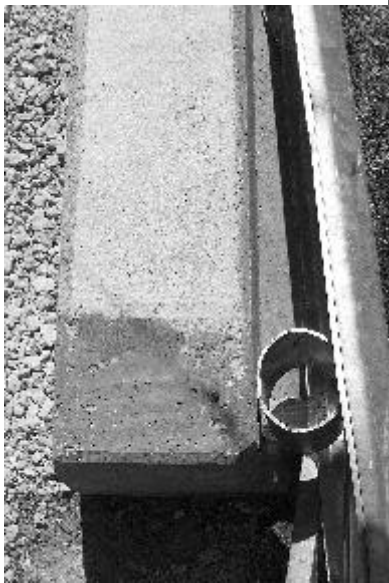
Figure 51. Installation after test 404211-9.

Moderate damage was imparted to the transition as shown in figure 51. Tire marks were on the face of the W-beam rail element and rub rail and both were deformed. The blockouts at posts 2 and 3 were rotated and the blockout at post 4 was fractured on one corner. The pipe insert was crushed 10 mm. The lower bolt on the connection to the parapet was partially pulled out. No movement was noted in the end terminal. Maximum dynamic deflection of the W-beam rail element was 77 mm. Maximum permanent rail deformation of the W-beam rail element was 68 mm at post 2 and the rubrail was deformed 45 mm at post 2. The length of contact with the transition was 2.9 m.
