THREE BEAM TRANSITION CRASH TESTS

January 2005

**U.S. Department of Transportation
Federal Highway Administration**

1. Report No. FHWA-RD-04-115		2. Government Accession No.		3. Recipient's Catalog No.	
4. Title and Subtitle Thrie Beam Transition Crash Tests				5. Report Date January 2005

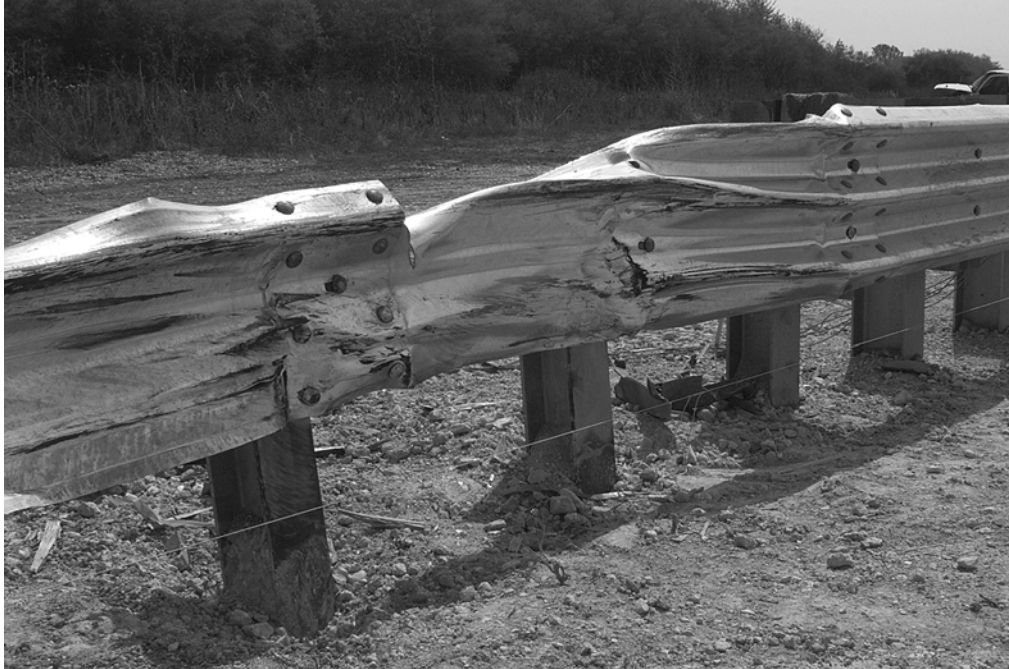
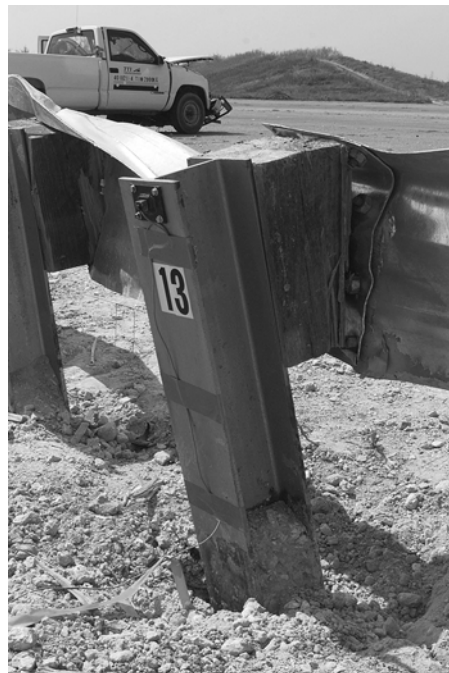
Figure 7. Installation after test 401021-4.

The Ohio transition sustained moderate damage as shown in figures 6 and 7. Tire marks marred post 13 and the rail element was torn at the splice at post 13. The rail element was detached from post 14. Blockouts were chipped at posts 13 and 14. The blockout at post 15 was twisted and chipped. Posts 16 through 14 were pushed rearward 5 mm, 22 mm, and 80 mm, respectively. Posts 13 and 12 moved 170 mm and 53 mm rearward. Posts 11 to the end terminal were disturbed. Length of contact of the vehicle with the transition was 4.6 m. Maximum dynamic deflection of the rail element during the test was 439 mm and maximum permanent deformation was 190 mm to the rail element at post 13.

a) Damage at impact.

b) Damage at post 13.

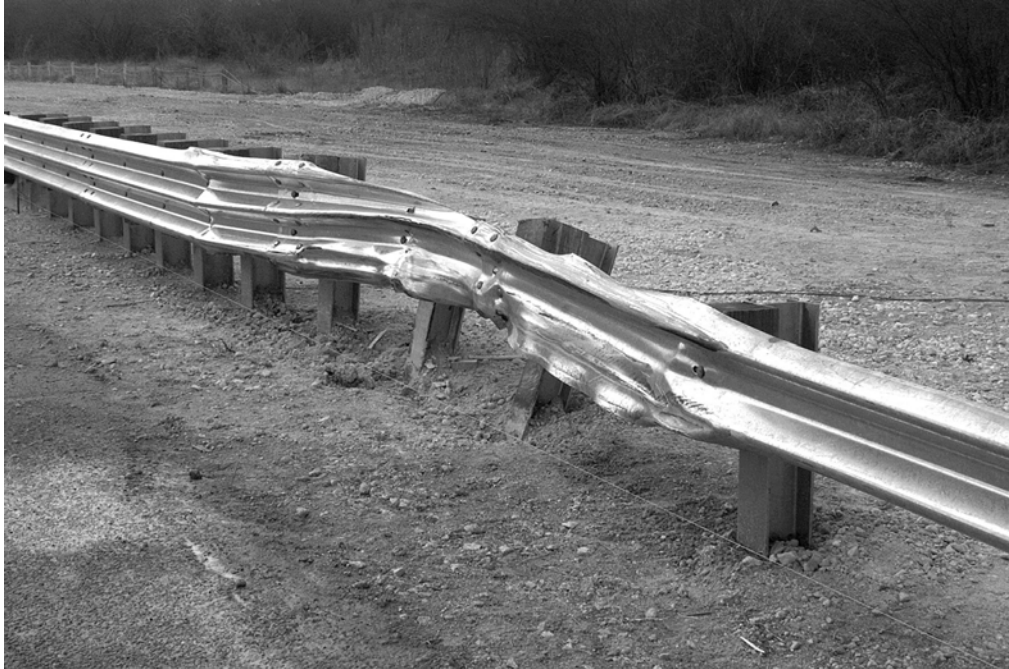
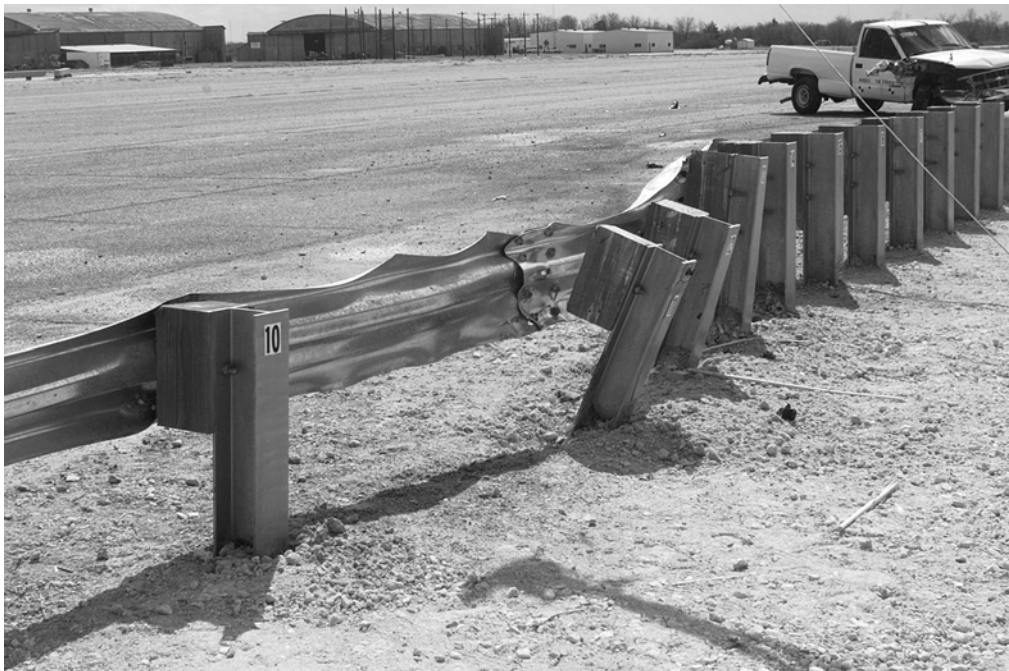
Figure 16. Installation after test 401021-6.

Damage to the transition is shown in figures 15 and 16. Tire marks were on the impact edge of the flange and front faces of posts 11 and 12. The rail element was separated from the blockout at post 11; the rail element was torn around the lower right splice bolt. The upstream terminal was pulled longitudinally 25 mm. Maximum dynamic deflection of the rail during the test was 659 mm; maximum permanent deformation was 554 mm. The vehicle was in contact with the rail element for a distance of 6.67 m.

a) Damage at impact.

b) Damage from field side.

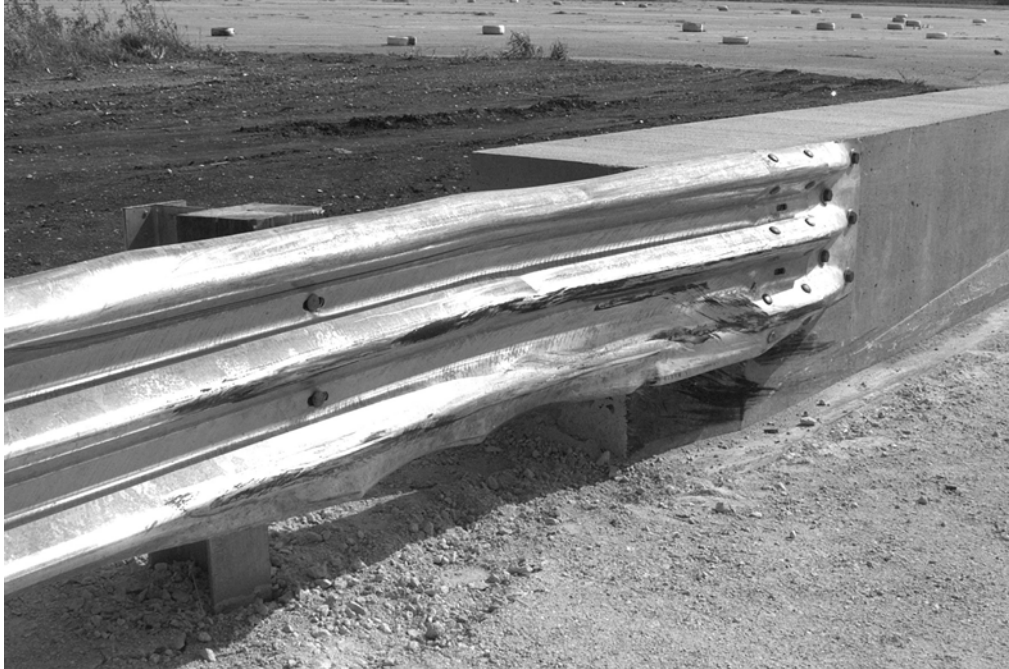
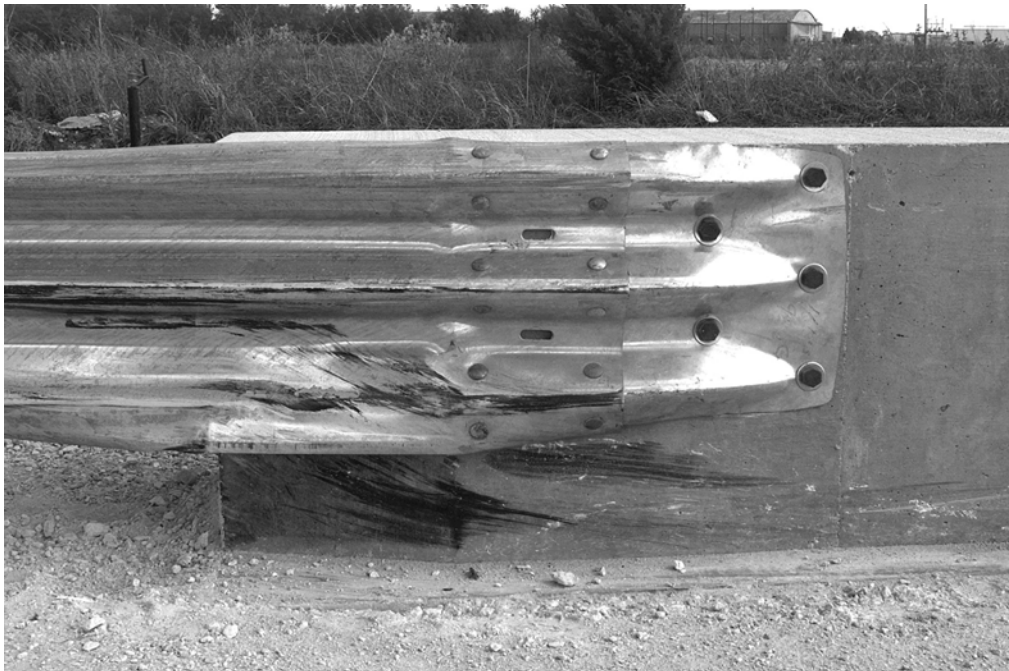
Figure 26. Installation after test 401021-1.

The Ohio Type 1 Thrie Beam Transition to Concrete Parapet sustained minimal damage as shown in figures 25 and 26. Tire marks marred the rail at post 13 and the end of the concrete parapet (which was chipped). The rail element remained attached at all posts. Post 13 moved 60 mm toward the field side and the rail deformed 78 mm. Post 12 moved 28 mm toward the field side and the rail deformed 15 mm. Posts 11 to the end terminal showed no movement. Length of contact of the vehicle with the transition was 3.2 m. Maximum dynamic deflection of the rail element during the test was 163 mm and maximum permanent deformation was 146 mm to the rail element between post 13 and the end of the concrete parapet.

a) Damage at impact.

b) Damage to parapet.

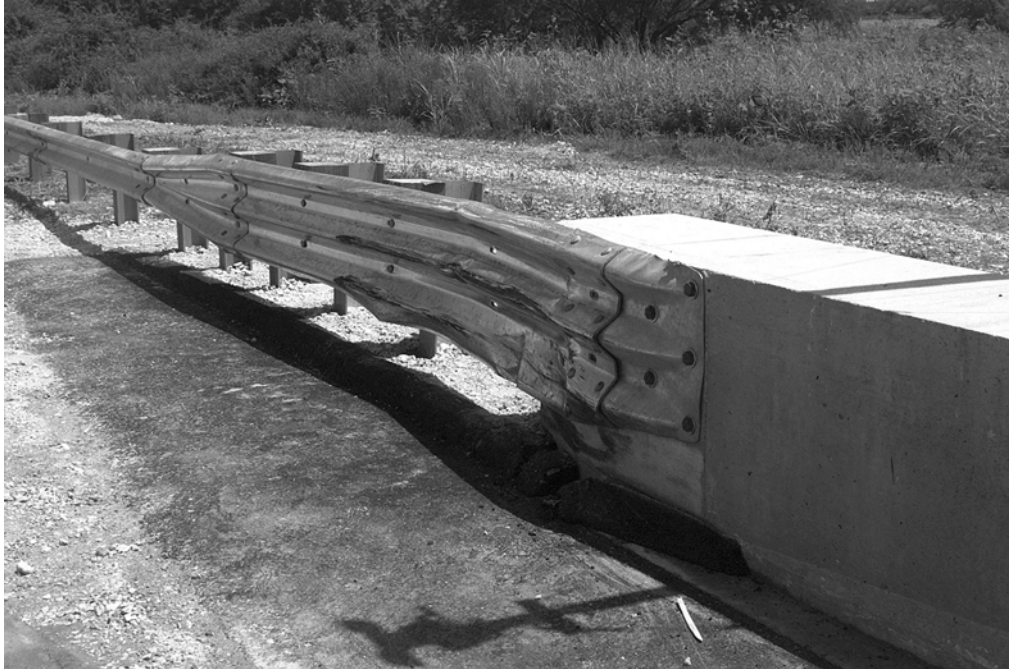
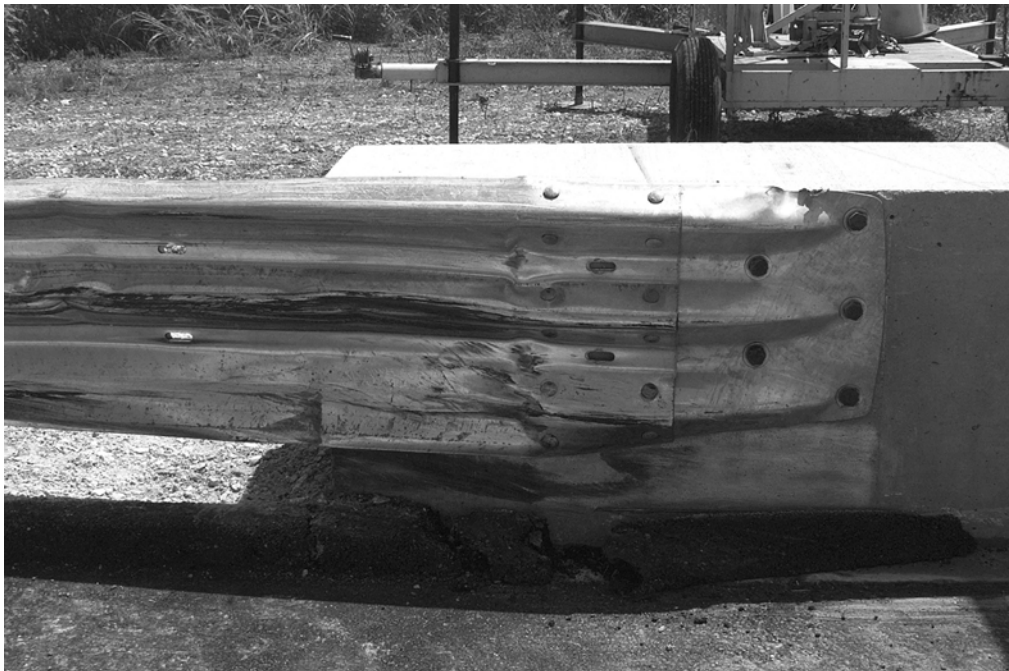
Figure 37. Installation after test 401021-5.

a) Overall view of damage.

b) Damage at transition.

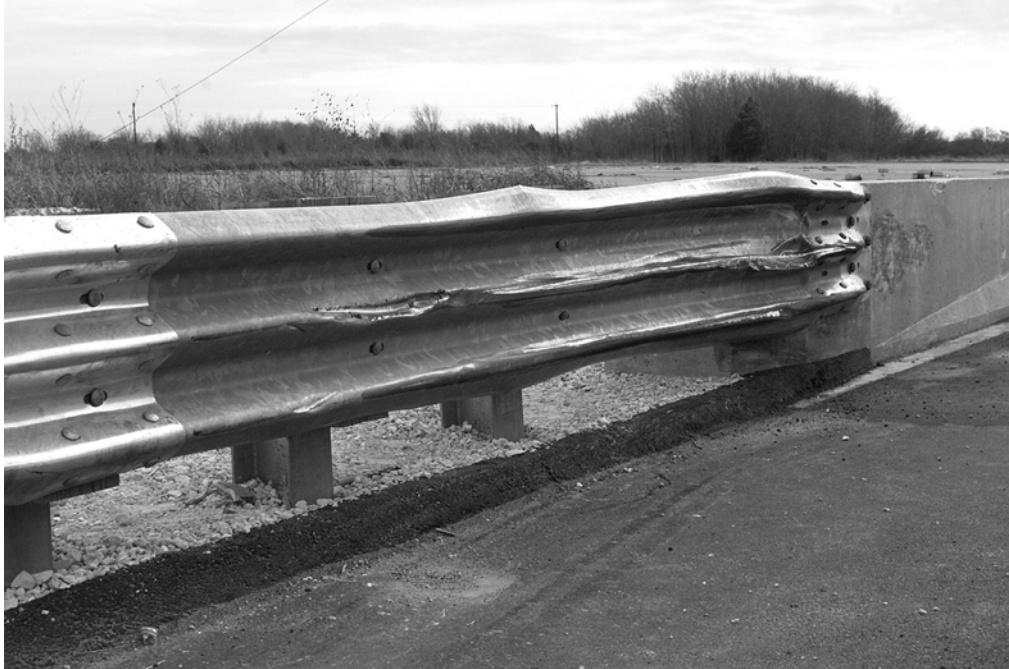
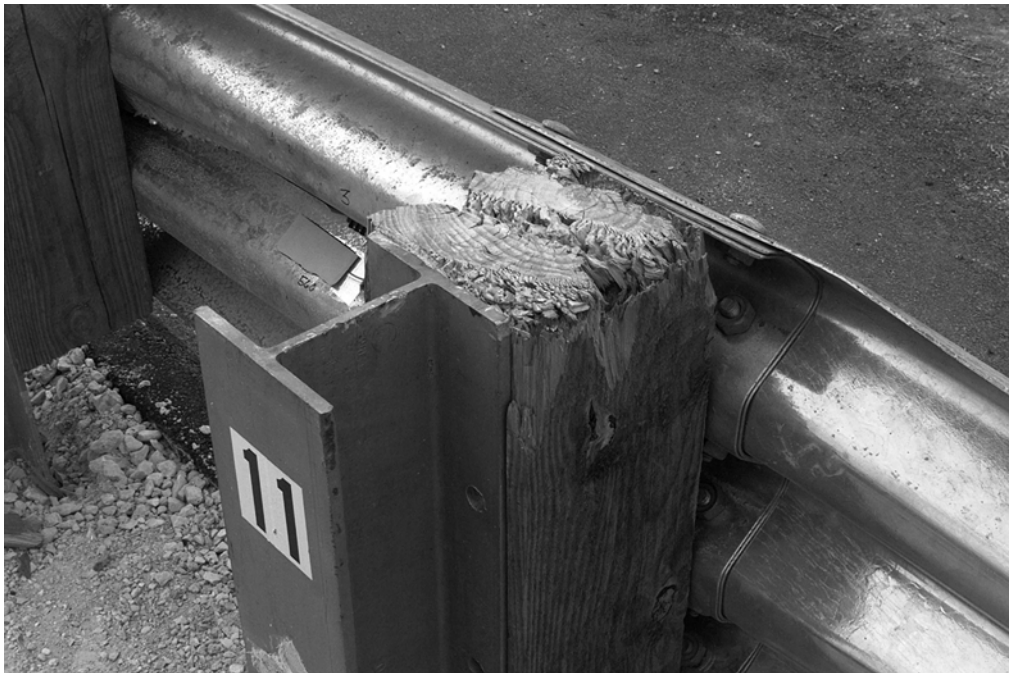
Figure 44. Installation after test 401021-2a.

a) Overall view of damage.

b) Damage at post 11.

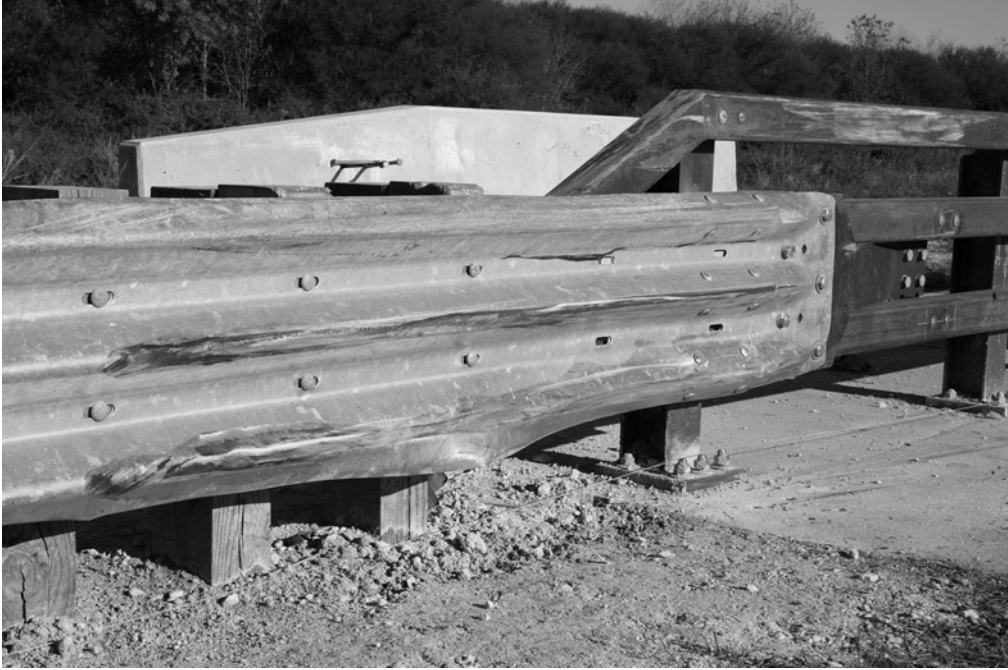
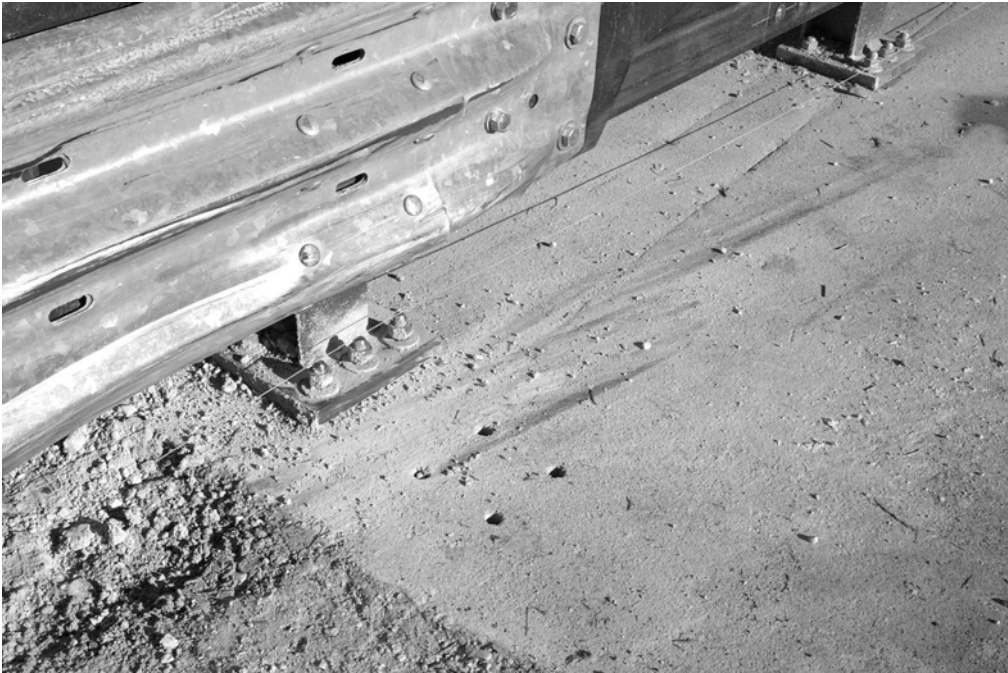
There was minimal damage to the test installation as shown in figures 63 and 64. The top of the blackout at post 18 was gouged, and posts 15 through 18 were pushed toward the field side with a maximum permanent deflection of 45 mm at post 18 at the top thrie beam corrugation. Maximum dynamic deflection during the test was 49 mm. The mechanical anchor bolts were pulled up slightly on post 19 and the concrete deck surface around the front of the post was spalled. Total length of contact of the vehicle with the transition was 3.66 m and the working area was 0.52 m.

a) Damage at impact.

b) Damage at end post.

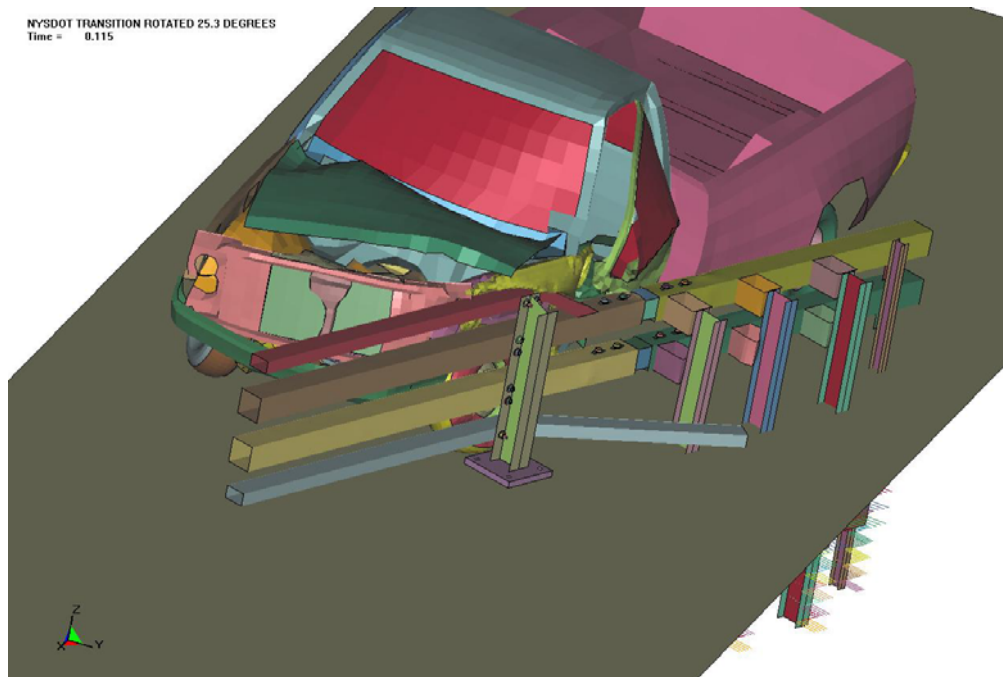
Figure 68. Snagging of door edge on box-beam splice.

A model of a 2000-kg pickup truck developed by the National Crash Analysis Center (NCAC) under FHWA sponsorship was used in the simulation. Several changes were made to the vehicle model to enhance its capability to detect door edge snagging as well as the capability to fail (erode) elements associated with the door hinges. The revised vehicle model was used to simulate an impact with the original NYSDOT box-beam transition using the speed, angle, and impact location from the actual crash test. The model successfully captured the snagging of the door edge on the box-beam splice (see figure 68). As shown in figure 69, the resulting deformation of the door was excessive.

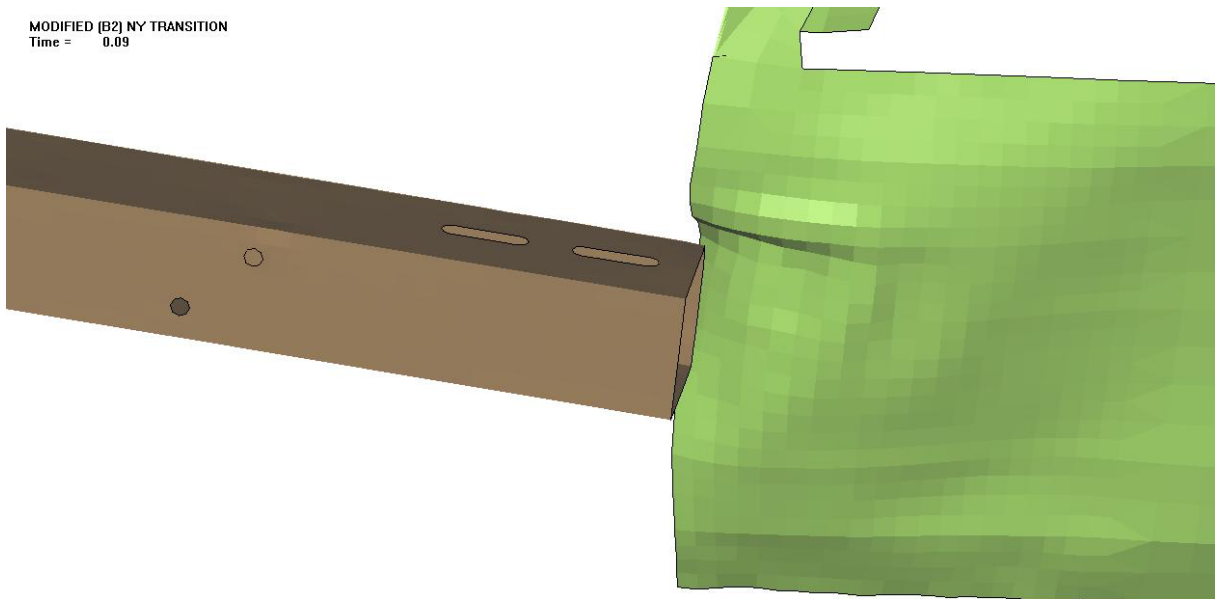
Figure 71. Door edge contact with the rail splice.

In the pickup truck simulation, the vehicle impacted the system the same distance upstream of the expansion joint as that used in the failed crash test of the original New York box-beam transition to four-tube bridge rail and the simulation studies conducted under Task B1. As expected in a transition impact of this severity, the front left corner of the vehicle experienced substantial damage. Some snagging contact occurred between the door and the downstream edge of the expansion splice. However, the resulting damage to the door was not as severe as that observed in the original system. Figure 71 shows the door edge contact as it reaches the downstream edge of the splice.

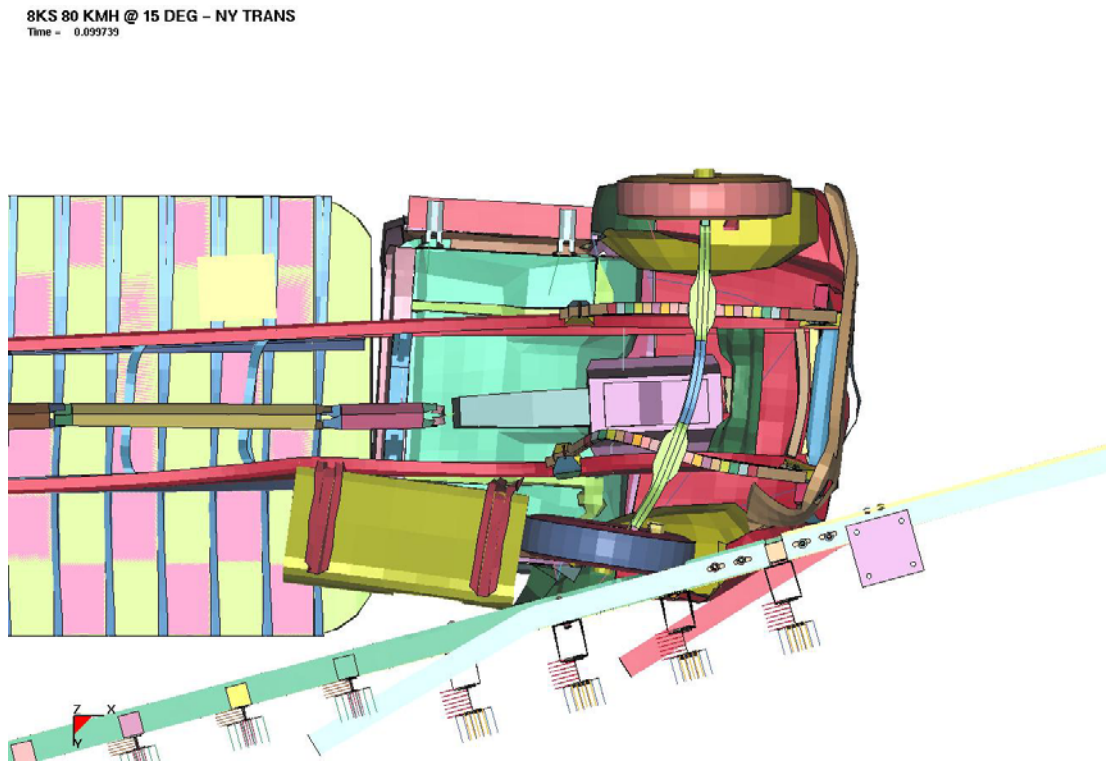
Figure 75. Single-unit truck simulation without suspension failure.

As shown in figure 75, the F800 model experienced significant structural deformation to the suspension, frame rails, and cab. The researchers felt this level of deformation was unrealistic for a redirection impact of this type and is at least partially attributable to the absence of failure in the model (e.g., axle-to-suspension connection). It is very common in redirection tests with single-unit trucks to have the front axle detach from the suspension during impact. If this failure mechanism is not accounted for in the model, the axle cannot release at the proper load level, and more force is transmitted into the suspension, frame rails, etc., resulting in excessive deformation.

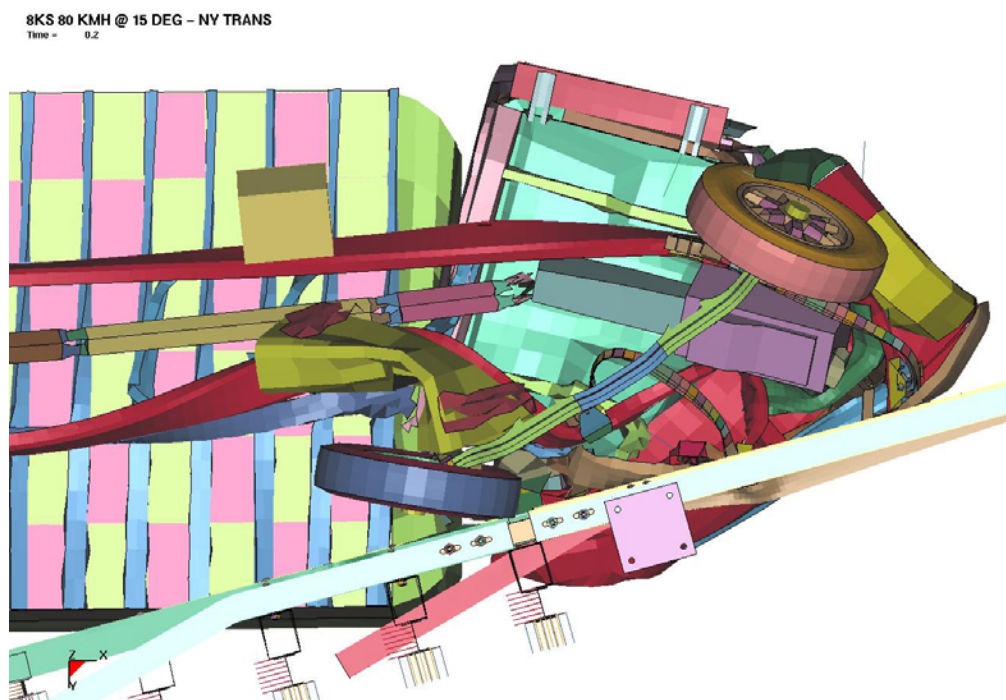
Figure 76. Unrealistic deformation of single-unit truck after axle separation.

In the opinion of the researchers, the current F800 model was not providing realistic response, and any simulation results associated with its use in evaluating the New York box-beam transition were, therefore, highly suspect. The researchers and the COTR agreed that no further simulations with the F800 truck model should be conducted until revisions to the model can be completed by FHWA or others.

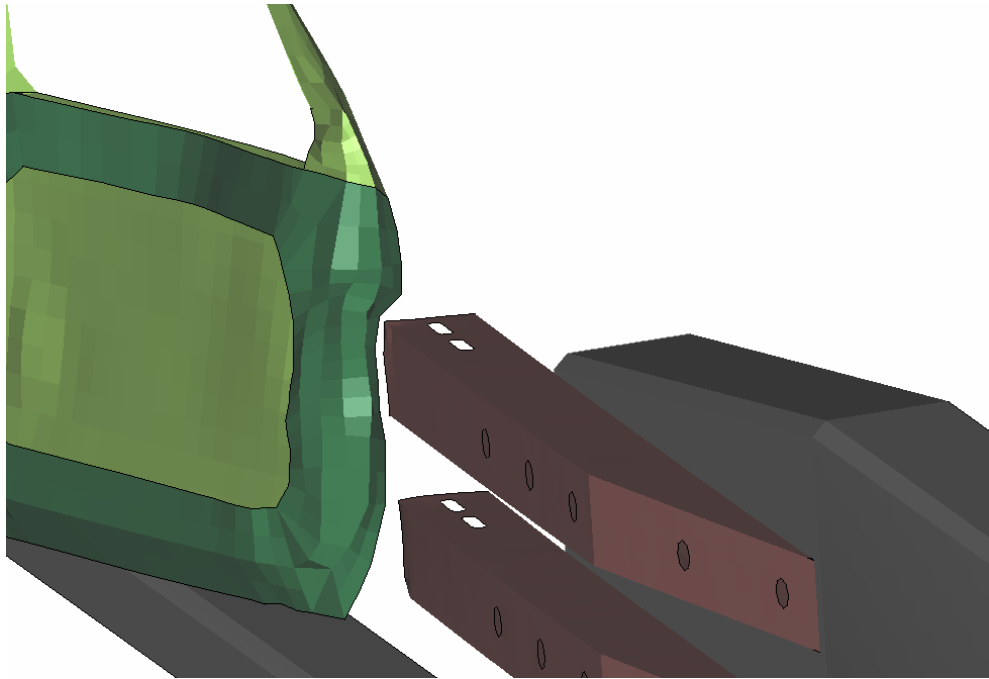
Figure 78. Door edge at downstream end of expansion splice.

In the first analysis, the vehicle impacted the system at the same distance upstream of the expansion joint as was used in the failed crash test of the original New York box-beam transition to four-tube bridge rail and the simulation studies conducted under Tasks B1 and B2. As expected in a transition impact of this severity, the front left corner of the vehicle experienced substantial damage. Although some contact occurred between the door and the expansion splice, the door edge on the impact side did not exhibit severe snagging nor indicate a propensity to otherwise disengage from the vehicle cabin. Figure 78 shows the door edge (with other vehicle components removed for clarity) as it reaches the downstream edge of the splice. An image of the vehicle as it is exiting the transition system is shown in figure 79. The vehicle damage resulting from the impact is shown in figure 80.

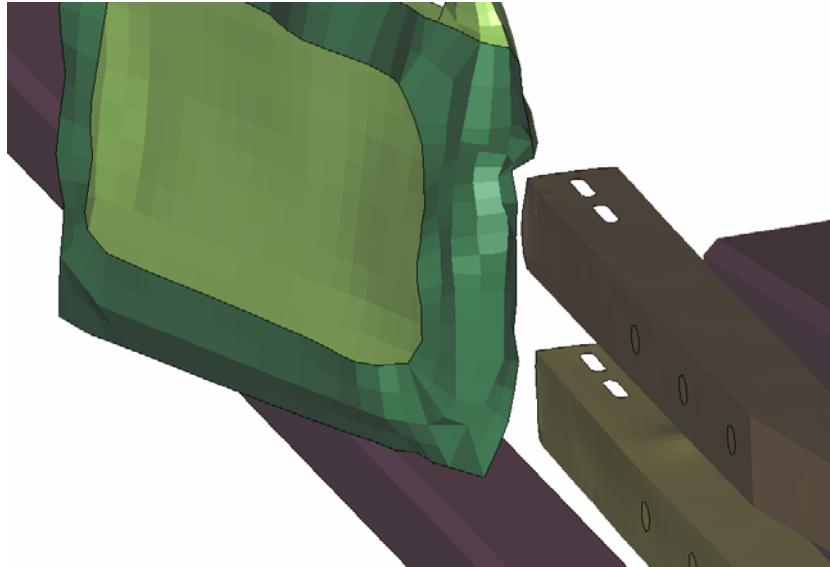
Figure 82. Door edge at downstream edge of expansion splice for alternate impact location.

In the second simulation, the damage to the door was more pronounced. The edge of the box beam engaged some “wrinkled” sheet metal on the door just past the door edge (see figure 82). However, the contact with the splice did not force the front door edge to separate from the cabin. The damage to the vehicle after impact is shown in figure 83.

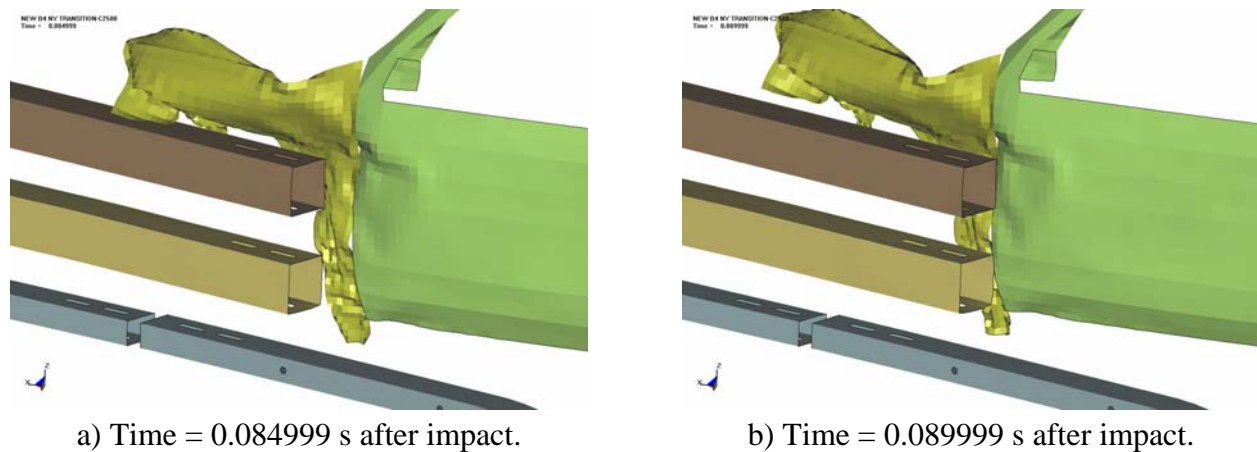
Figure 86. Interaction of door edge with box-beam expansion splice.

As expected in a transition impact of this severity, the front left corner of the vehicle experienced substantial damage. The deformed front fender of the pickup truck protected/shielded the door edge from the box beam, thereby allowing the door to avoid significant snagging with the expansion splice. The resulting damage to the door was, therefore, not as severe as observed in the original transition system. Figure 86 shows the door edge contact as it reaches the downstream edge of the splice.

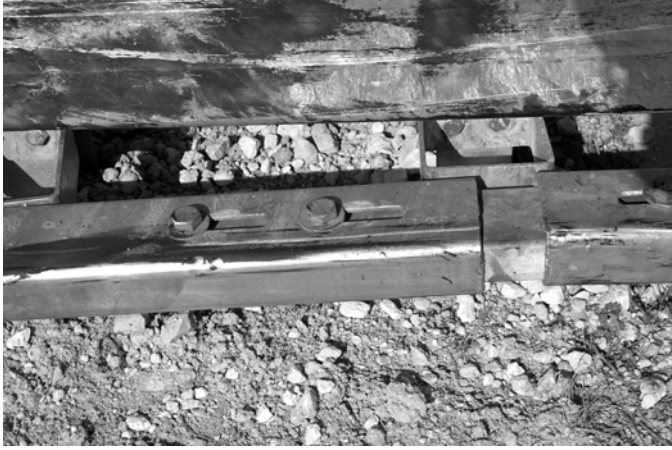
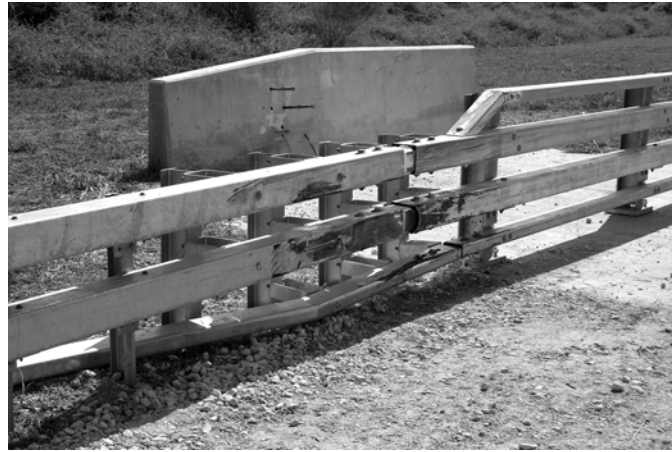
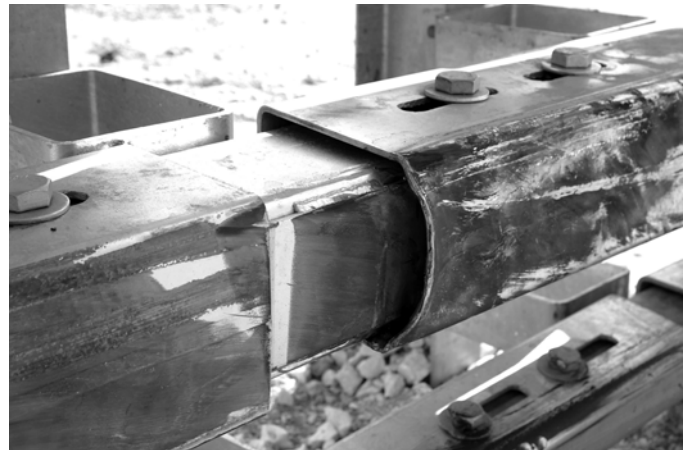
a) Damage at lower splice.

b) Overall view of damage.

c) Damage at upper splice.
