Structural Behavior of a Prototype Ultra-High Performance Concrete Pi-Girder

November 2009

FHWA Publication No. FHWA-HRT-10-027

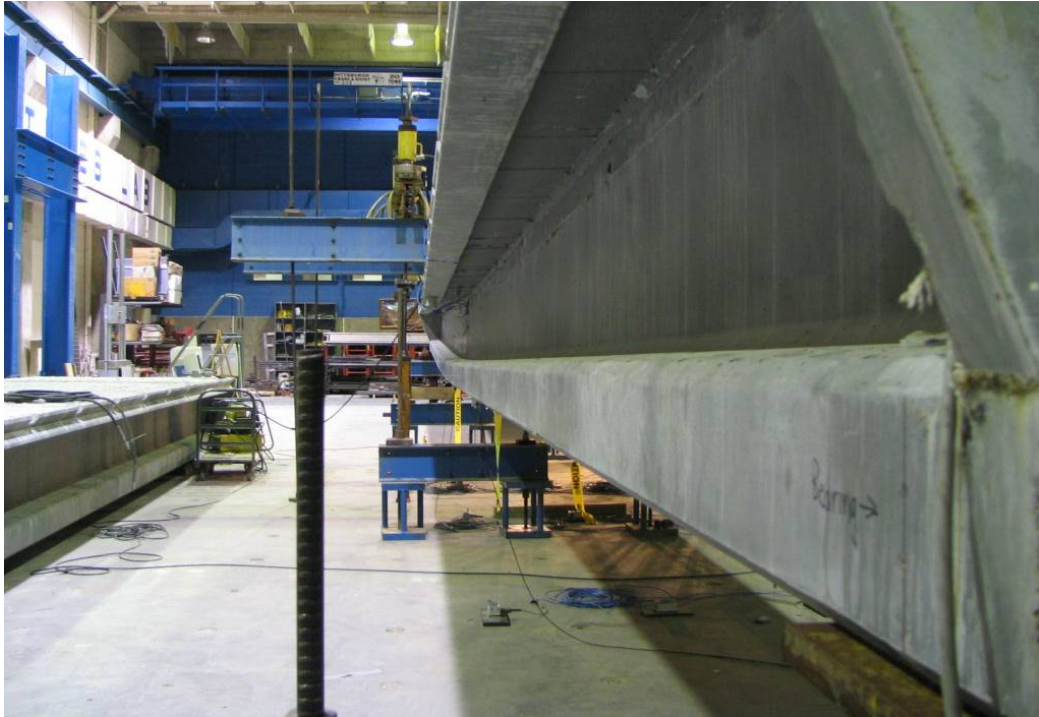
This girder exhibited a significant deflection capacity prior to failure. Figure 78 shows the girder carrying a load of 716 kN (161 kips) with a resulting midspan deflection of 230 mm (9 inches). Soon thereafter, the girder reached its maximum applied load of 738 kN (166 kips) which corresponds to an applied moment of 3540 kN-m (31,350 kip-inches). The maximum combined dead and live load moment was 4250 kN-m (37,600 kip-inches).

Figure 78. Photo. North face of Girder P2-70F after 230 mm (9 inches) of deflection.

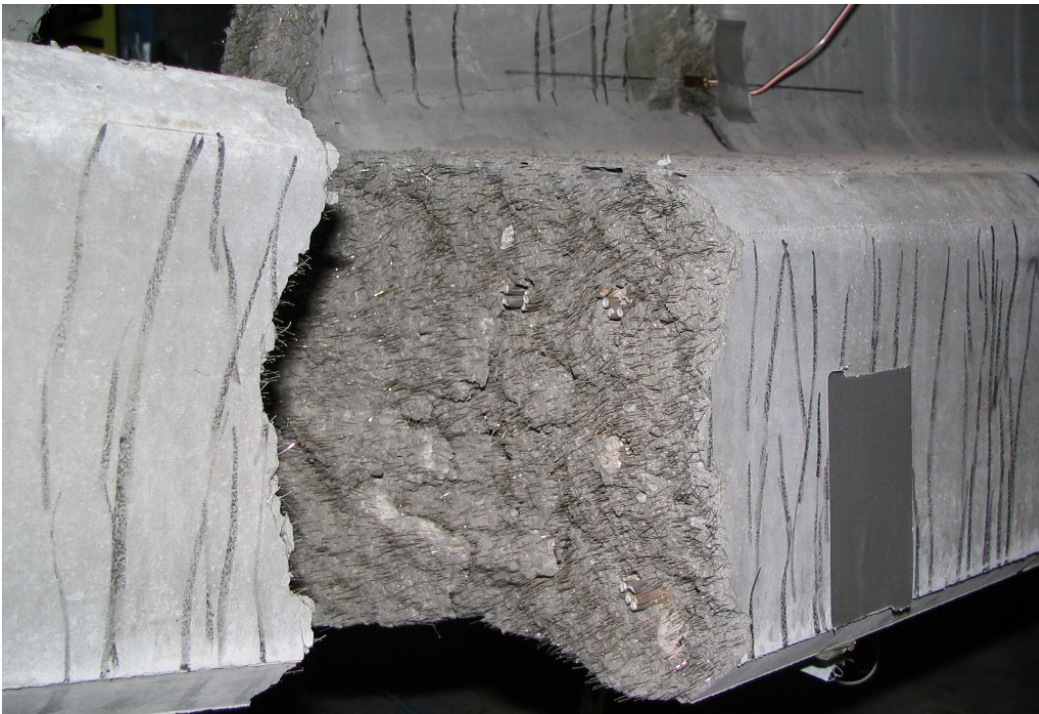
Flexural failure of the girder occurred immediately after the fiber reinforcement bridging an individual flexural crack pulled out of the matrix thus shedding the tensile load it had been carrying into the prestressing strands. The failure crack was located at midspan in the south bulb. All eleven prestressing strands in this bulb ruptured and the crack ran up the web and into the deck. The loss of resistance on the south side of the girder allowed the hydraulic jacks to sufficiently reduce their applied load that the north bulb of the girder did not rupture. (The north side of the girder was later taken to flexural failure so as to disconnect the girder pieces and allow for the completion of future tests.)

Figure 79 shows the west face of the south bulb failure surface after the girder had been broken into two pieces. Note the pulled out fiber reinforcement and the ruptured strands. Figure 80 shows the north face of the south leg immediately after the south leg failed. Note the red instrumentation cable which is visible inside of the crack. This cable was attached to vibrating wire strain gage which was cast into the girder during fabrication. The wire ran from the middle of the deck, across the deck, and down the web into the bulb at midspan. Given that the girder failed at this location, it is likely that the ultimate flexural capacity of the girder was impacted by the presence of this cable within the web. Visual inspection of the failure surface in the vicinity of the cable indicated that the cable impeded the proper dispersion of fiber reinforcement during casting and thus precluded fibers from bridging the eventual failure crack for approximately 12 mm (0.5 inches) of width over the height of the web.

Figure 79. Photo. West face of Girder P2-70F south bulb failure surface.

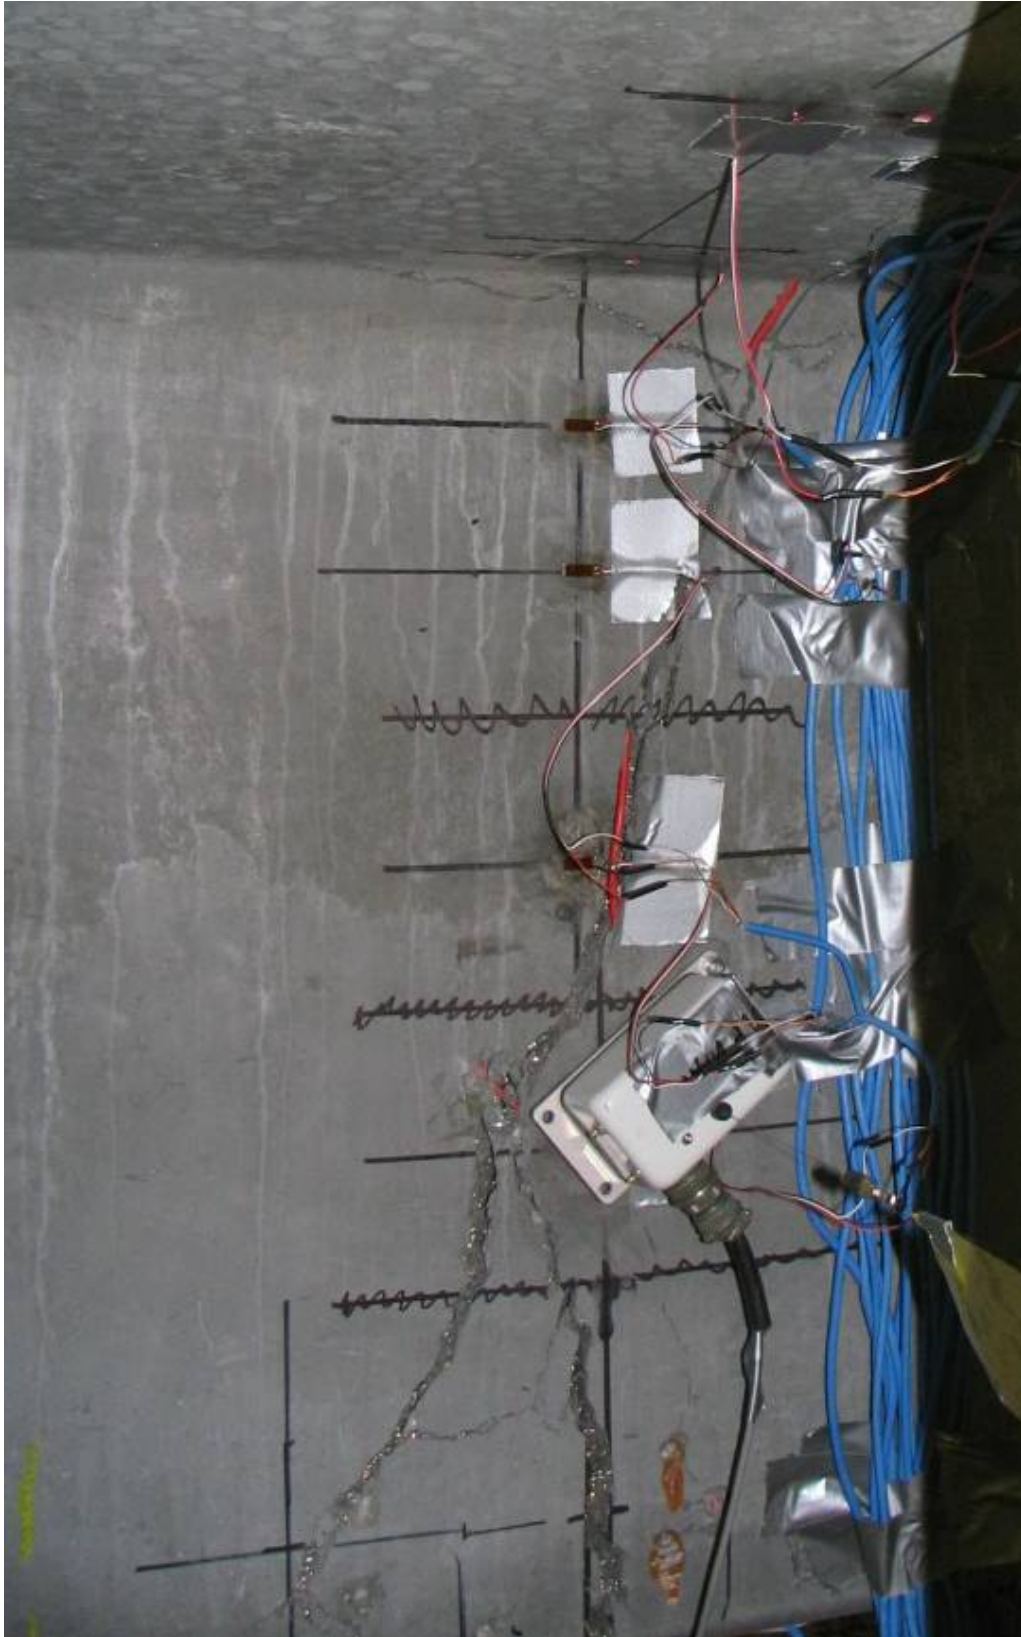
Figure 80. Photo. North face of Girder P2-70F south web immediately after failure.

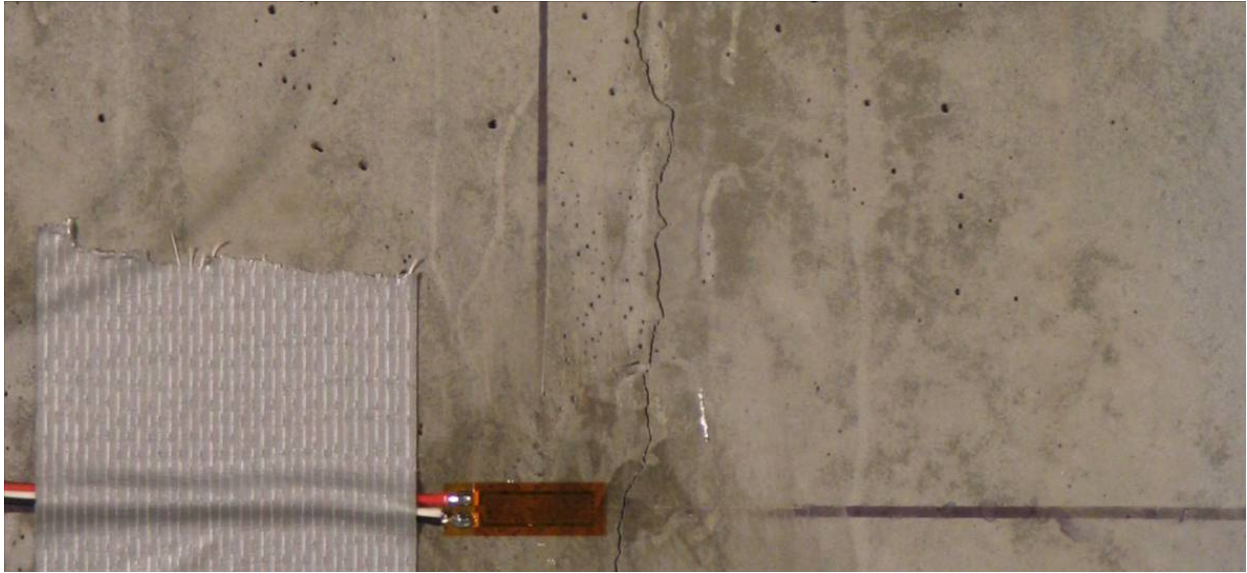
Significant audible cracking began at an applied load of approximately 645 kN (145 kips) and continued during loading steps throughout the remainder of the test. A quantitative assessment of flexural cracks was not completed for this test. In contrast to Test P2-70F, a clearly visible flexure crack was observed on the south face of the south leg at an applied load of 1070 kN (240 kips). This crack was located within 25 mm (1 inch) of midspan, was visible over most of the height of the web, and had a maximum width of approximately 0.25 mm (0.01 inches). By an applied load of 1200 kN (270 kips), this crack had extended higher in the web and had a maximum width of approximately 0.38 mm (0.015 inches). Figure 88 shows a photo of this crack. For reference, a 51 mm (0.5 inch) gage length strain gage is also shown in the picture. Figure 89 shows a photo of this crack just before failure of the girder.

Figure 88. Photo. Crack on south face of Girder P4-45F at 1070 kN (240 kips).

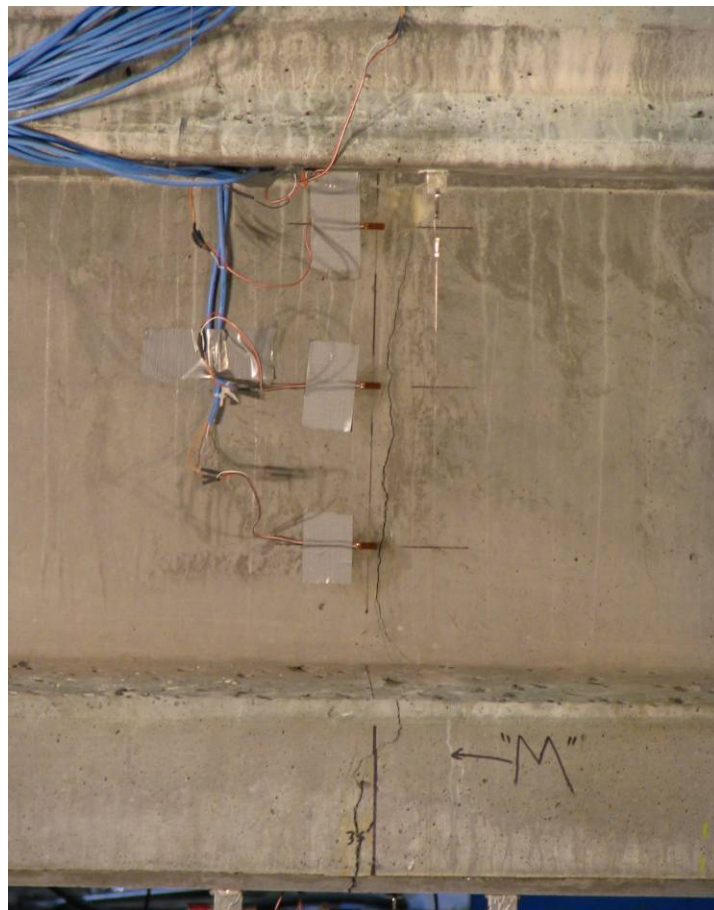
Figure 89. Photo. Crack on south face of Girder P4-45F just before failure.

Flexural failure of the girder occurred when fiber pullout and strand rupture occurred across the crack discussed previously and shown in Figure 89. The south leg of the girder failed while the north leg remained intact. All eleven prestressing strands in the south bulb ruptured and the crack ran up the web and into the deck. (The north side of the girder was later taken to flexural failure so as to disconnect the girder pieces.)

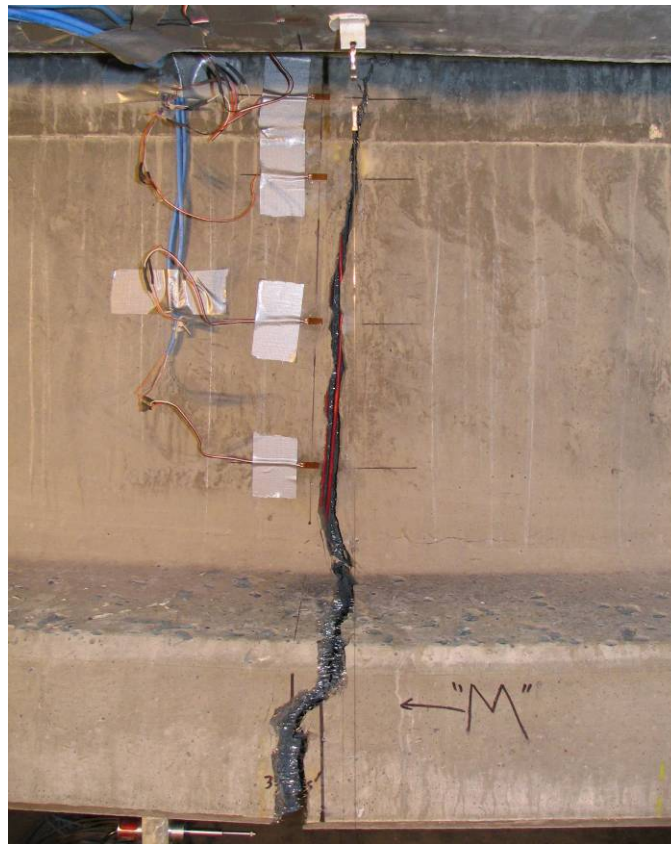
Figure 90 shows the south face of the girder immediately after flexural failure of the south leg. Note the red instrumentation cables which are visible inside of the crack in the web. Figure 91 shows a close-up view of the west face of the south leg flexural failure surface. As in Girder P2, the instrumentation cables were attached to vibrating wire strain gage which were cast into the girder during fabrication. Given that the girder failed at this location, it is likely that the ultimate flexural capacity of the girder was impacted by the presence of this cable within the web. Visual inspection of the failure surface in the vicinity of the cable indicated that the cables impeded the proper dispersion of fiber reinforcement during casting and thus precluded fibers from bridging the eventual failure crack for approximately 19 mm (0.75 inches) of width over the height of the web.

Figure 90. Photo. Crack on south face of Girder P4-45F just after failure.

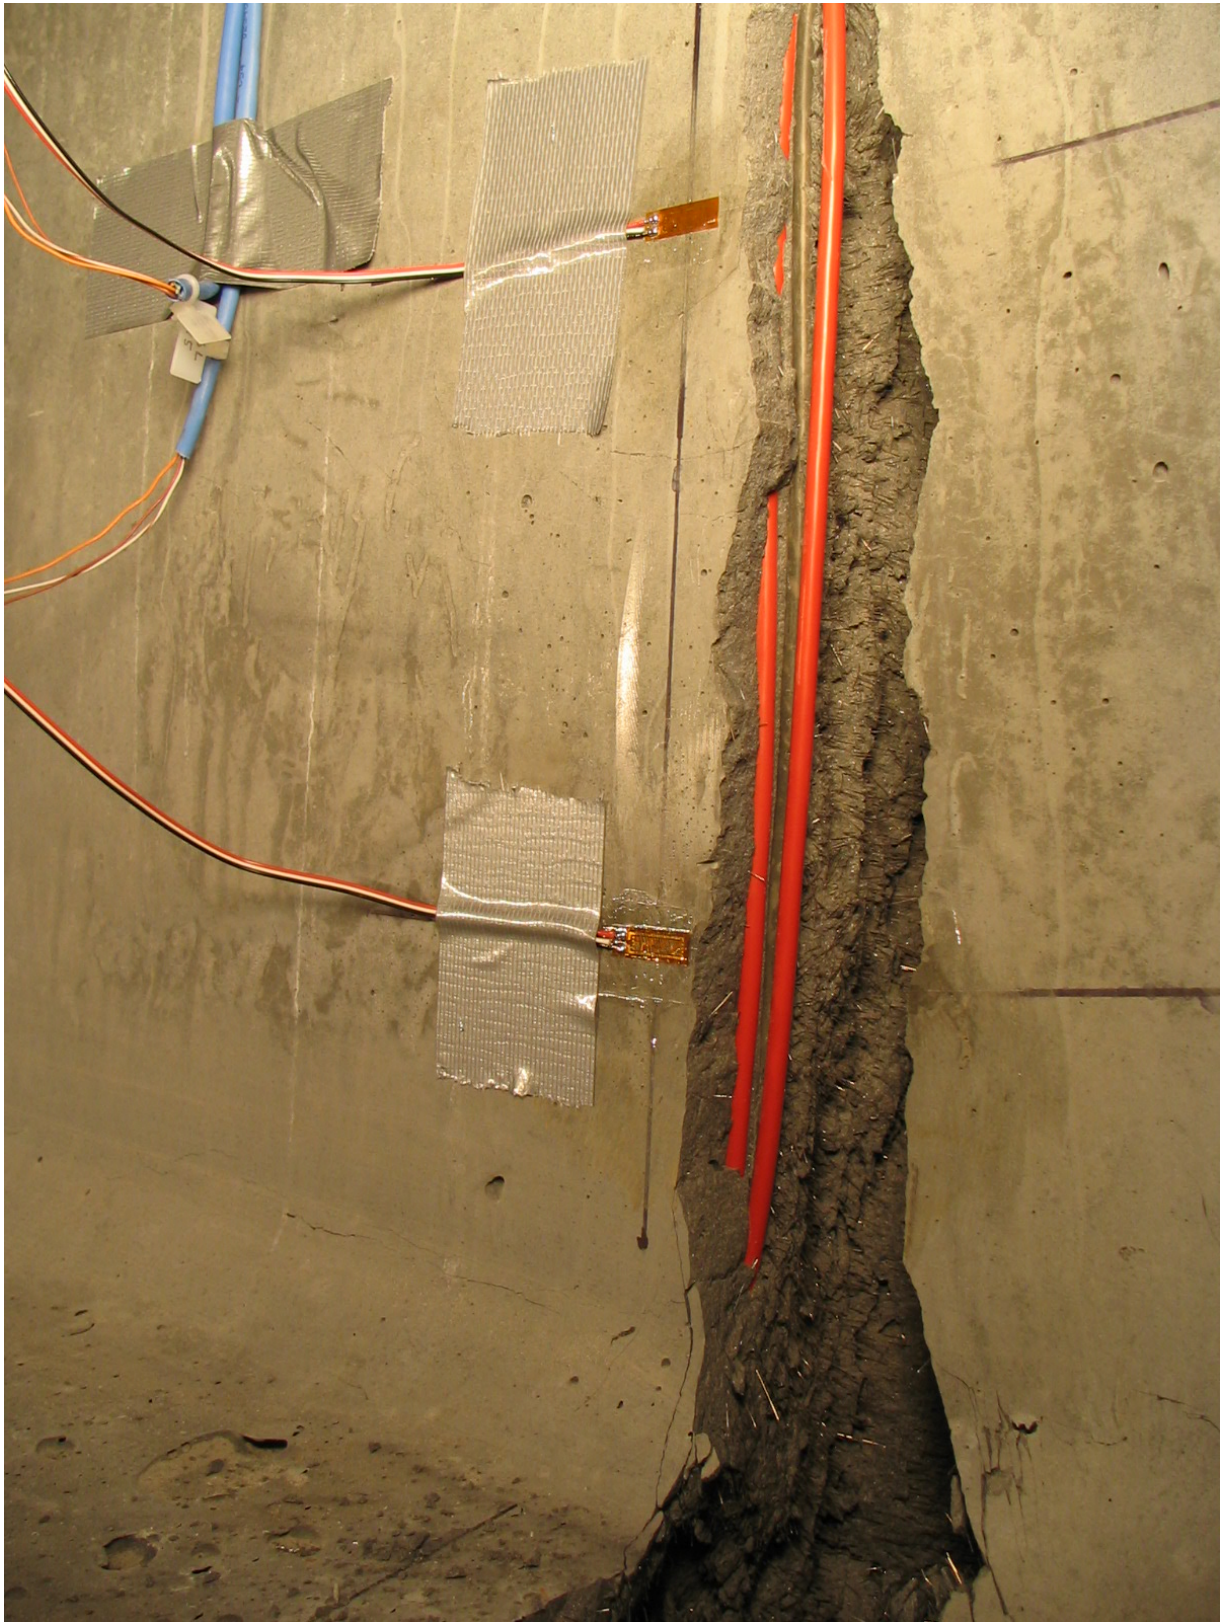
Figure 91. Photo. West failure surface of Girder P4-45F south web.

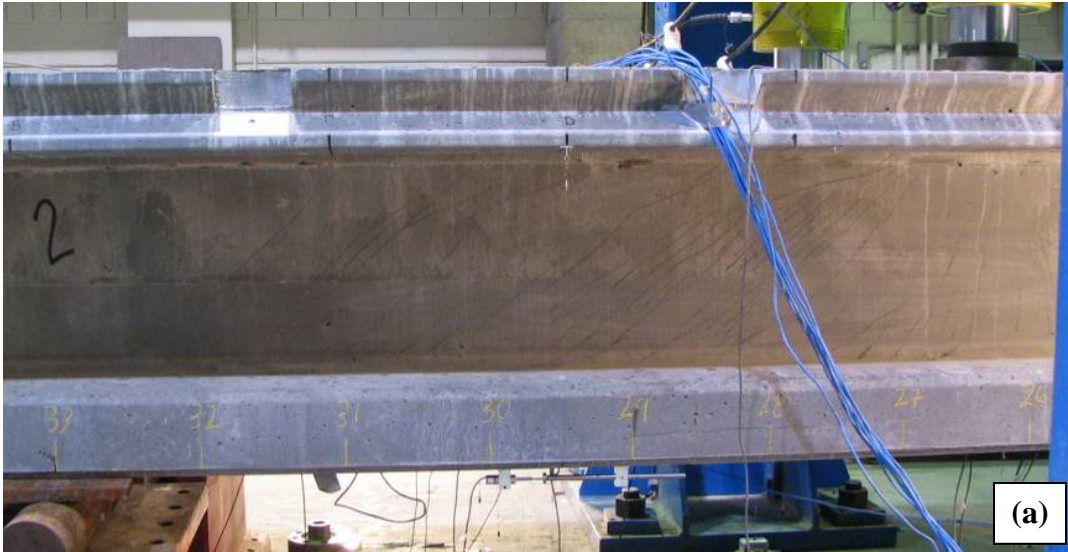
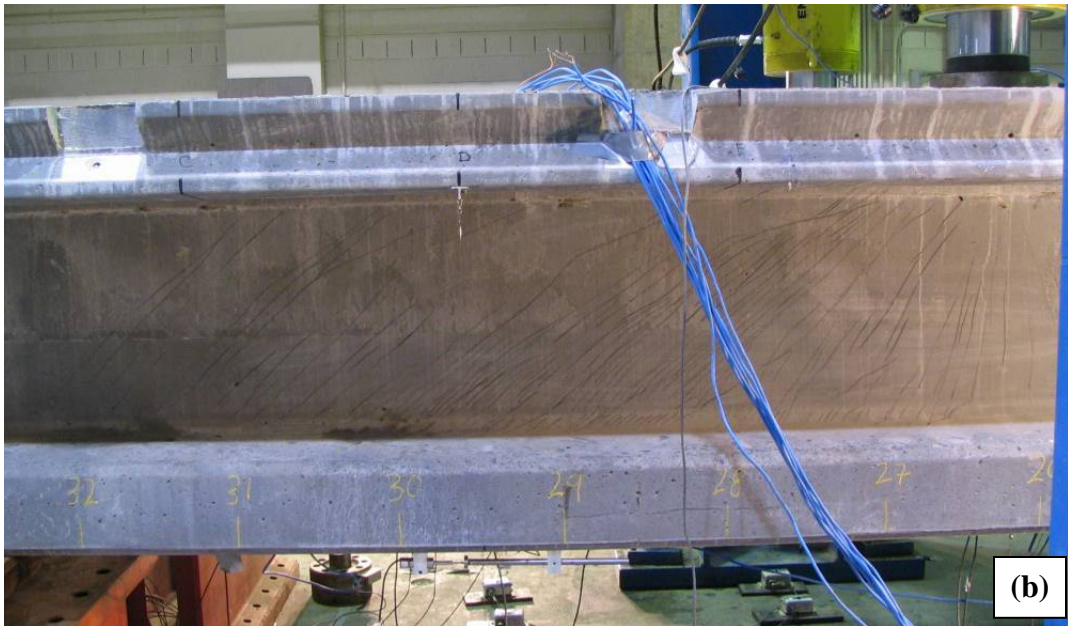
Cracking of the concrete was observed audibly and visually beginning at an applied load of 1,180 kN (265 kips), with the first crack occurring in the north web within the shear span. Additional cracking was observed on loading steps through the remainder of the test. Both shear cracking in the webs as well as primary flexure cracking in the bulbs was observed. Cracks were mapped in the webs periodically in order to capture the progression of damage accumulation. The photos in Figure 106 show the progression of cracking in the north web of the shear span between the loads of 2,000 kN (450 kips) and 2,220 kN (500 kips). Note that the cracks were marked on the surface of the girder with wax crayon as they are not visible to the naked eye.

Figure 106. Photo. Web crack map for Girder P2-21S at (a) 2,000 kN and (b) 2,220 kN.

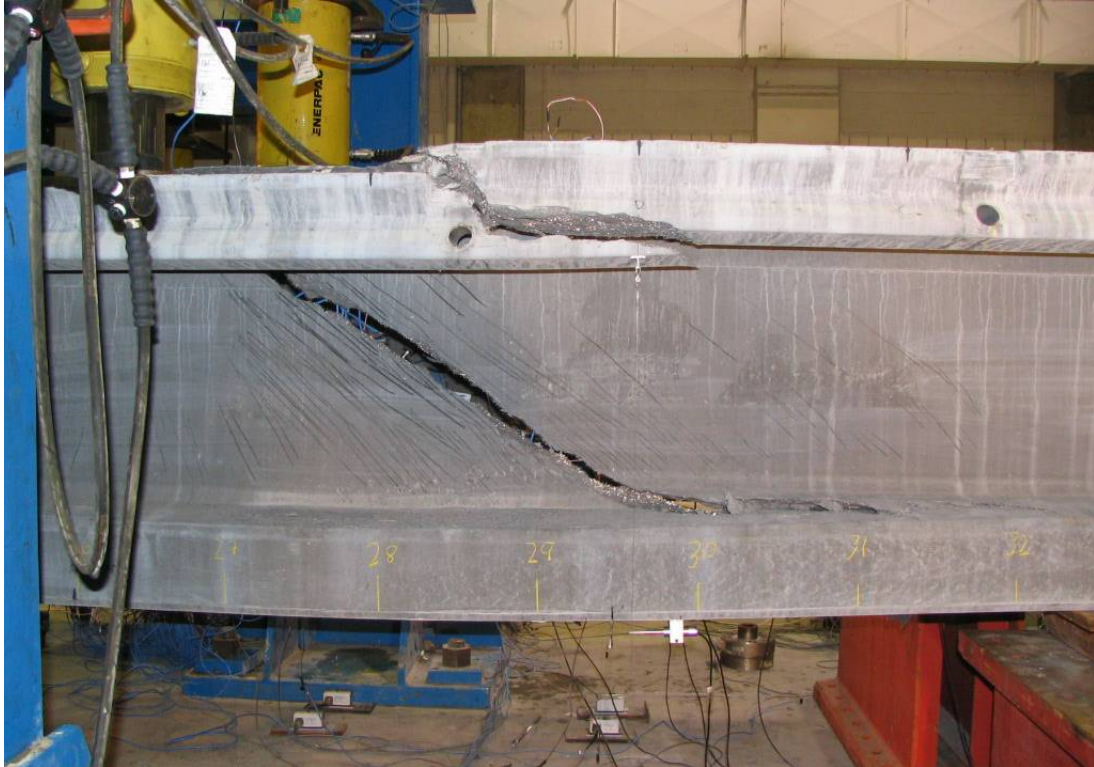
surfaces in both the north and south webs ran parallel to the cracks existing prior to failure, but did not follow an individual crack over the entire length. The orientation of the cracks comprising the failure surfaces was approximately 35 degrees clockwise from the horizontal as viewed from the south.

Figure 107. Photo. South face of Girder P2-21S after shear failure.

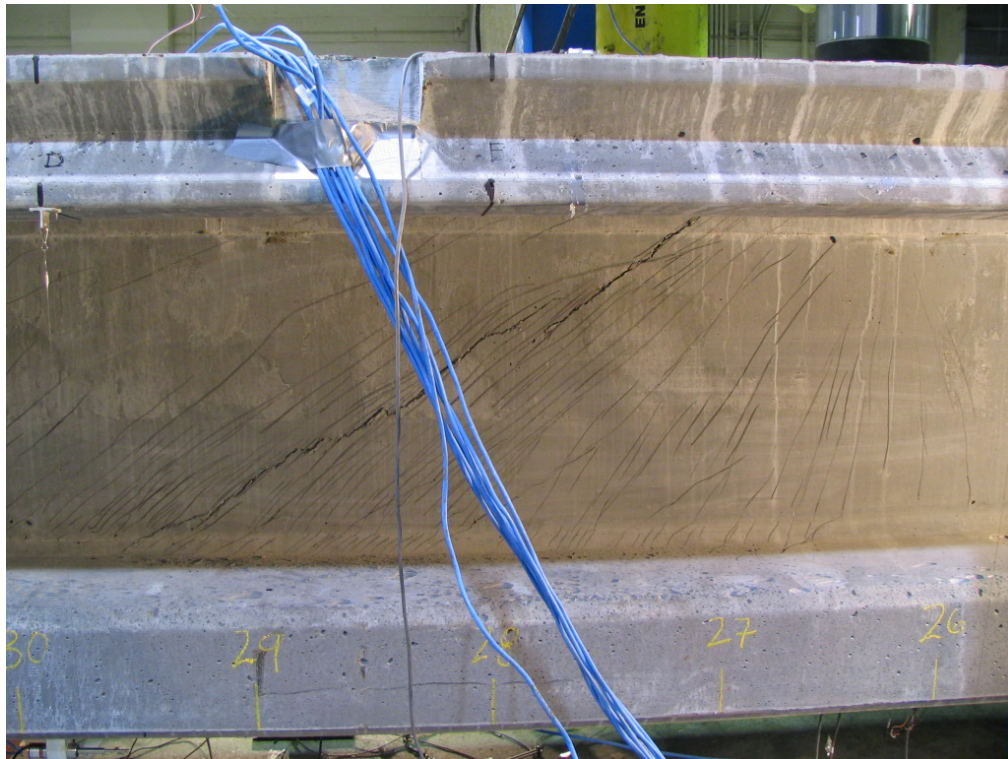
Figure 108. Photo. North face of Girder P2-21S after shear failure.

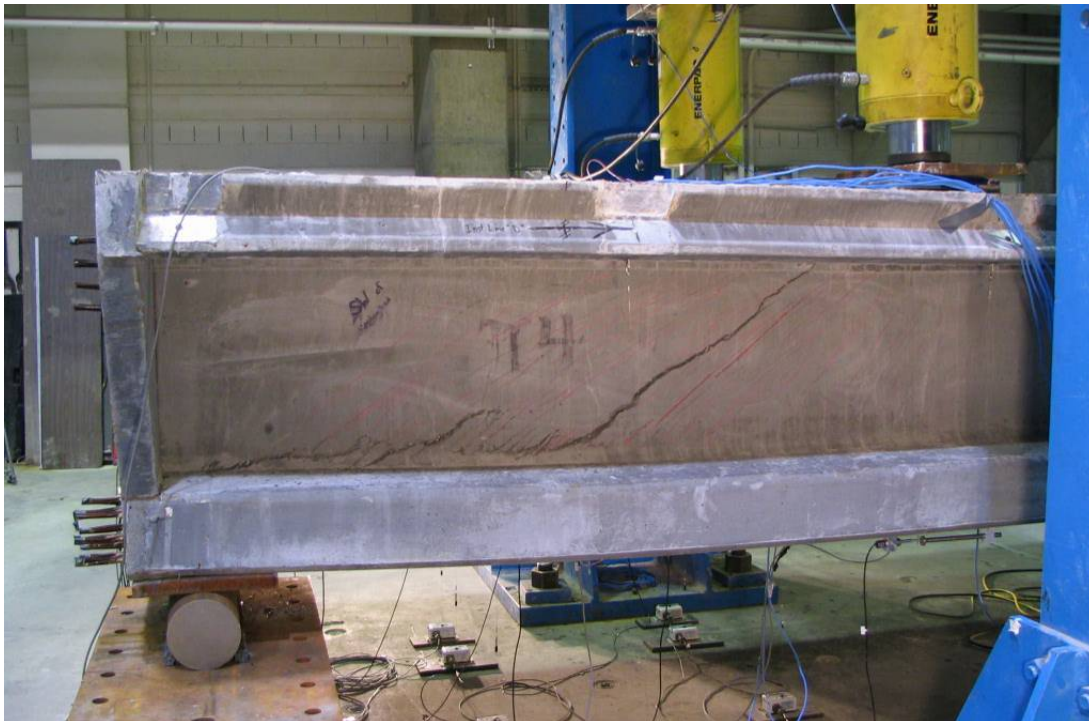
Figure 119. Photo. North face of P2-57Sh after failure.

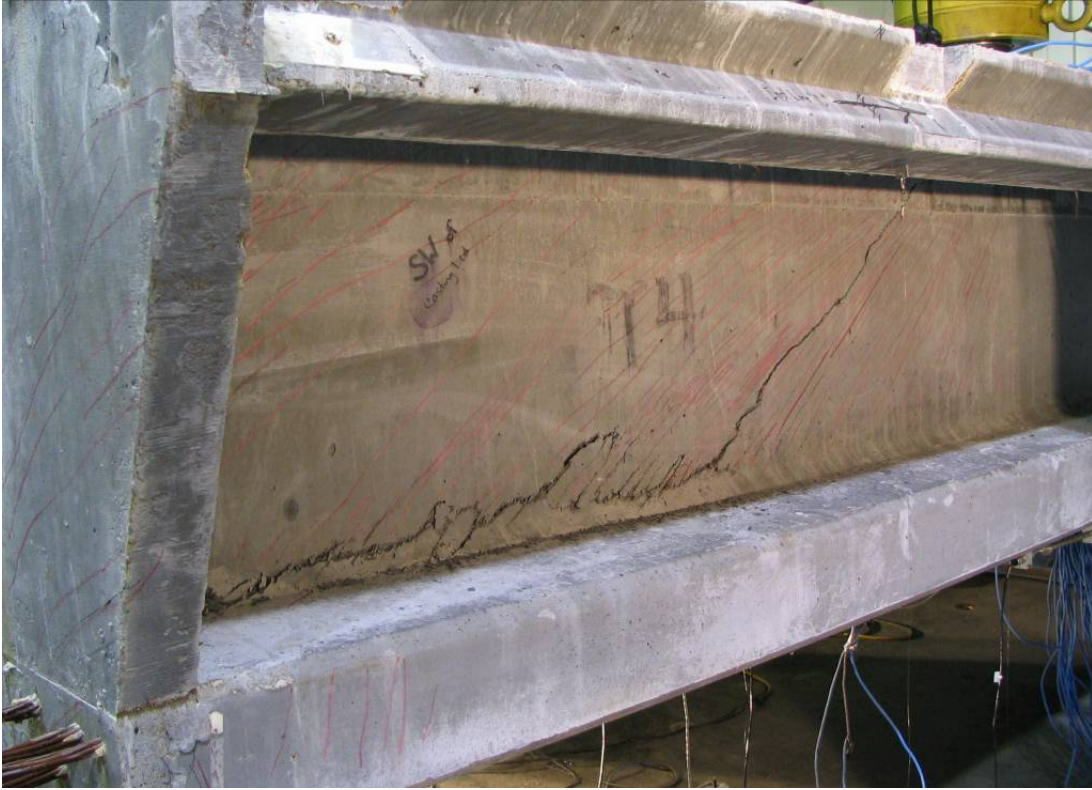
Figure 120. Photo. Northeast end of P4-57Sh after failure.

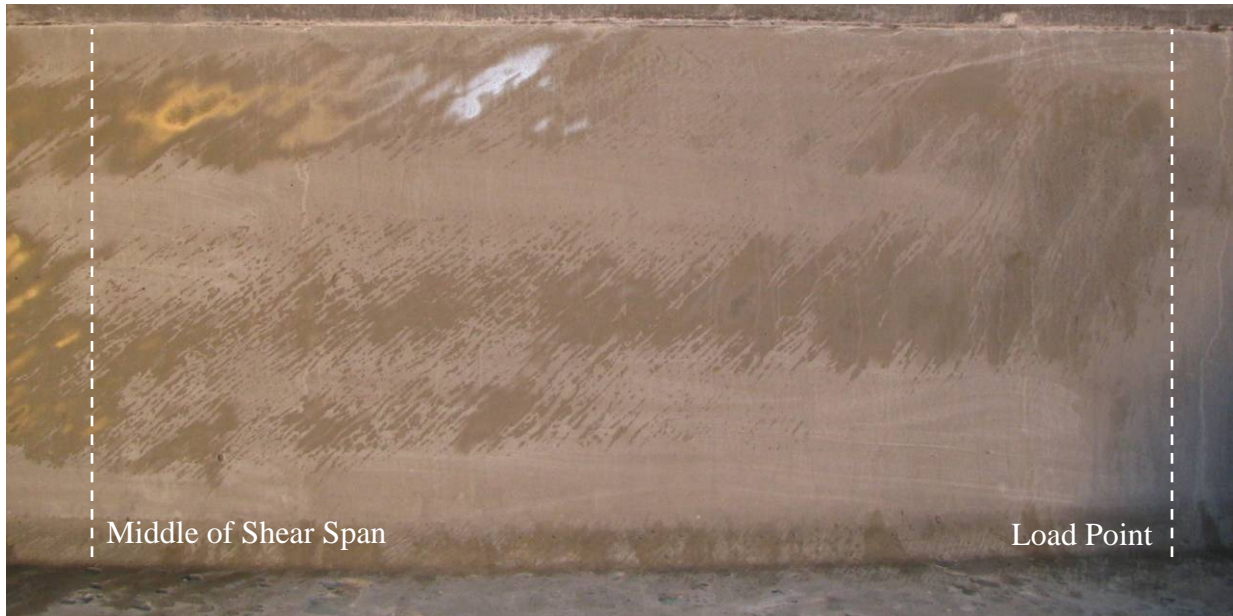
Figure 134. Photo. Cracking on south face of P4-57Ss web at 2,000 kN applied load.

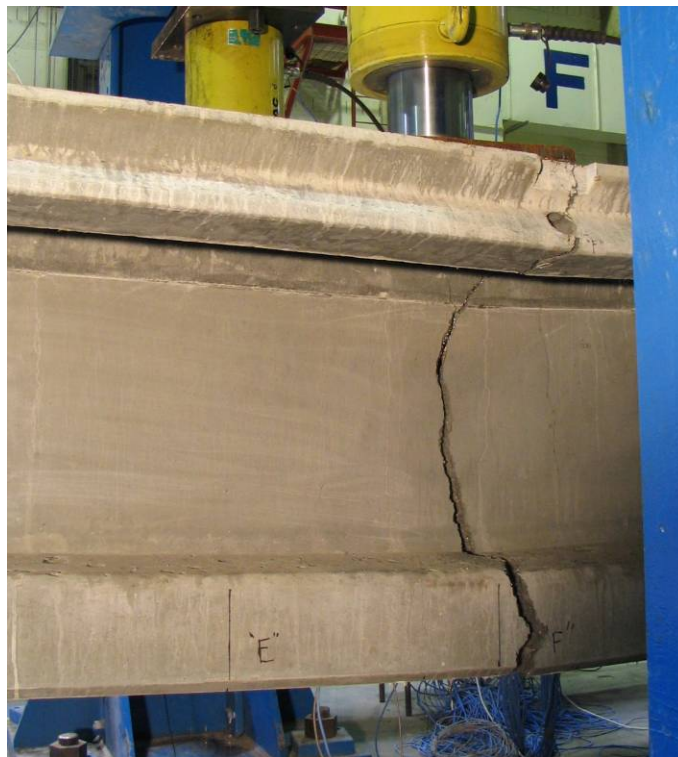
Figure 135. Photo. Flexural failure of P4-57Ss south leg.

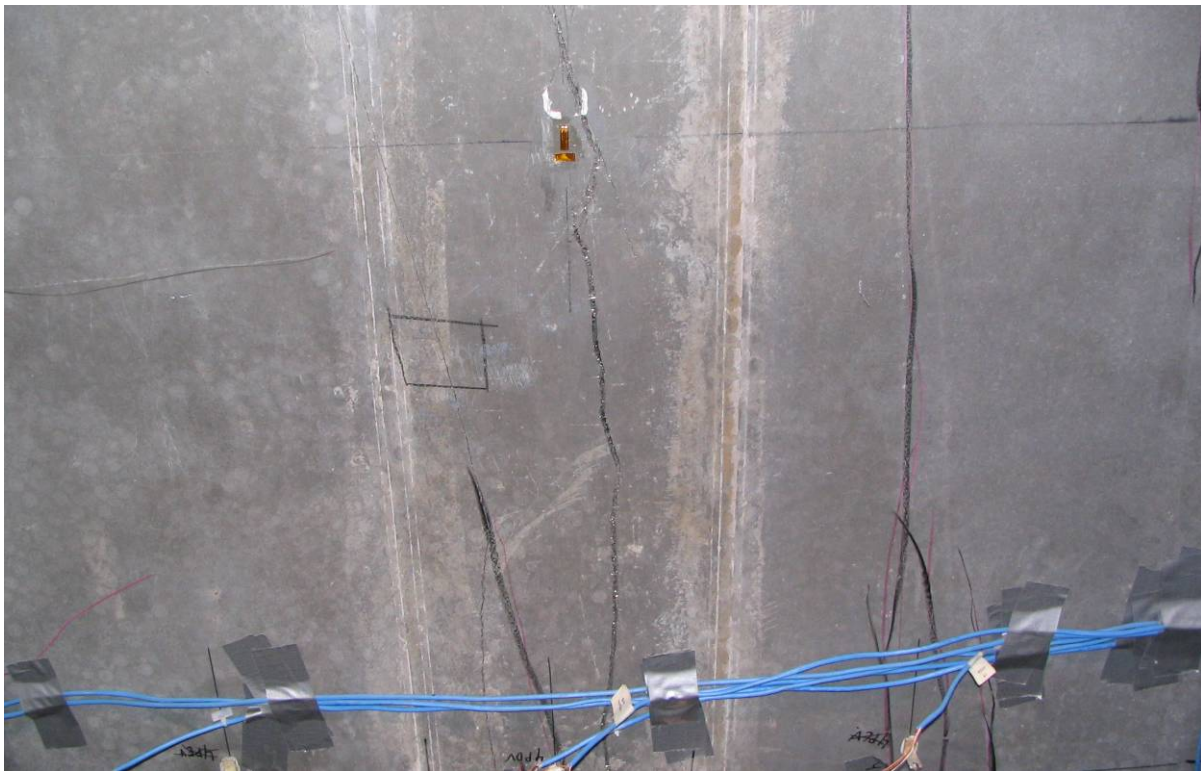
Figure 146. Photo. Longitudinal mid-deck crack on P4-24T after conclusion of test.

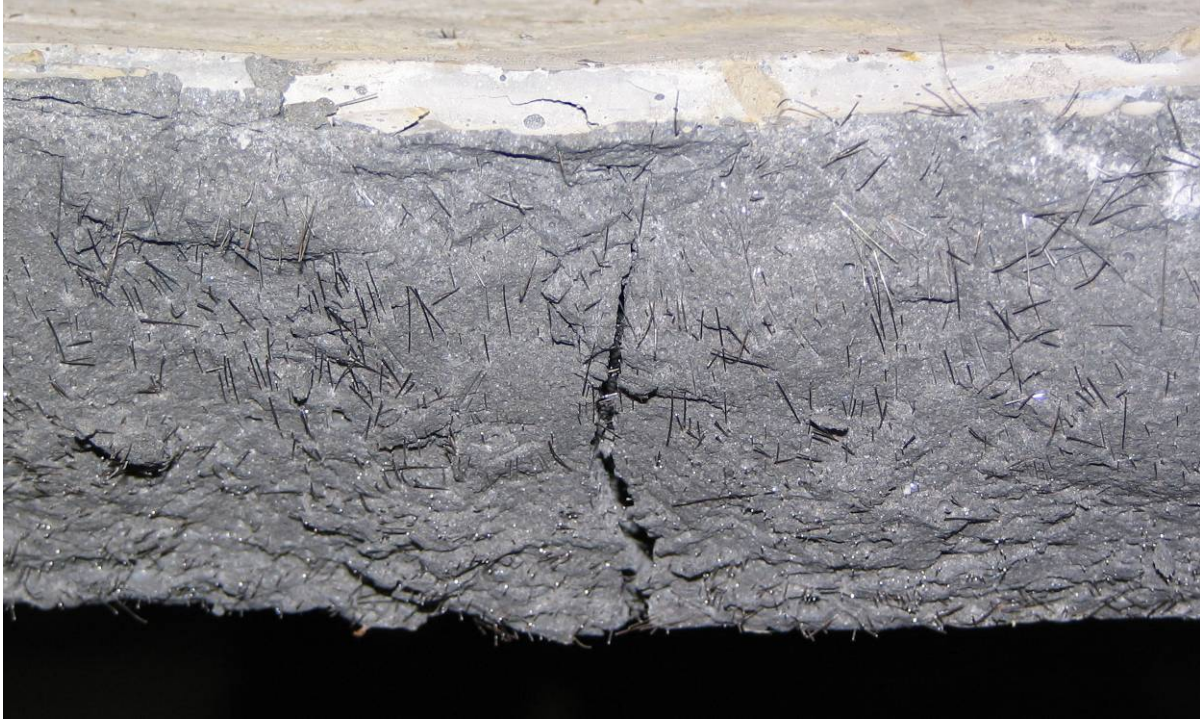
Figure 147. Photo. Failure crack in P4-24T as observed after conclusion of test.

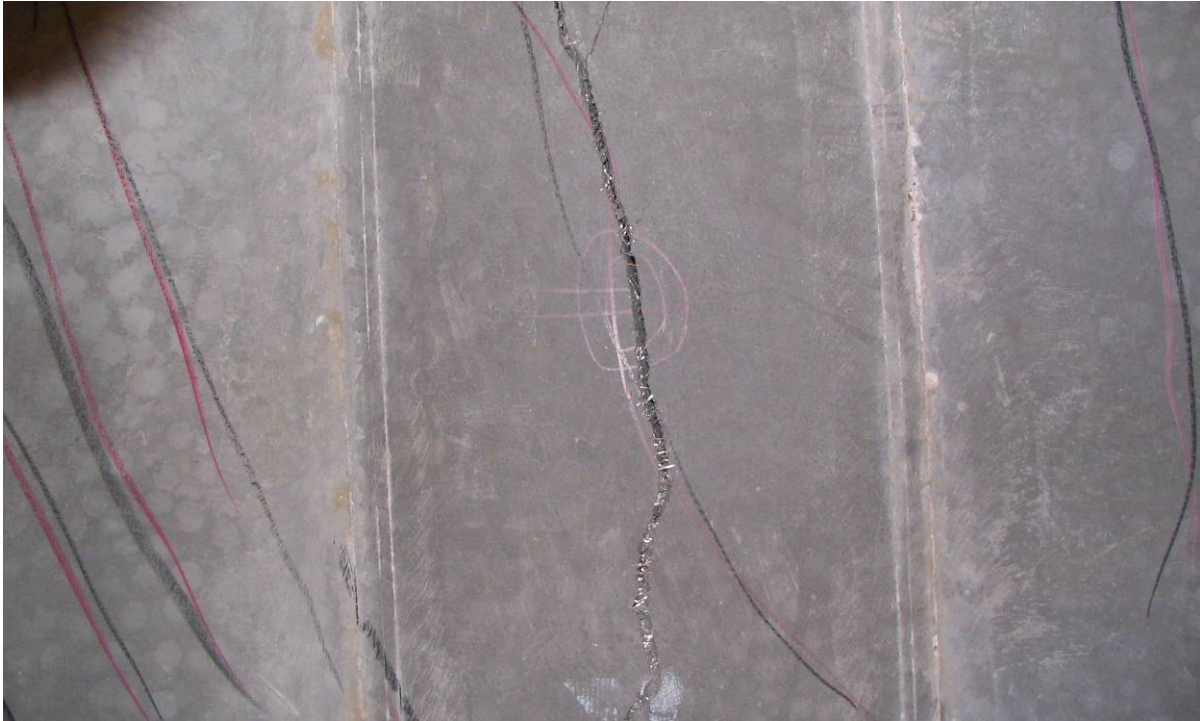
Figure 156. Photo. Longitudinal mid-deck crack on P4-24D after conclusion of test.

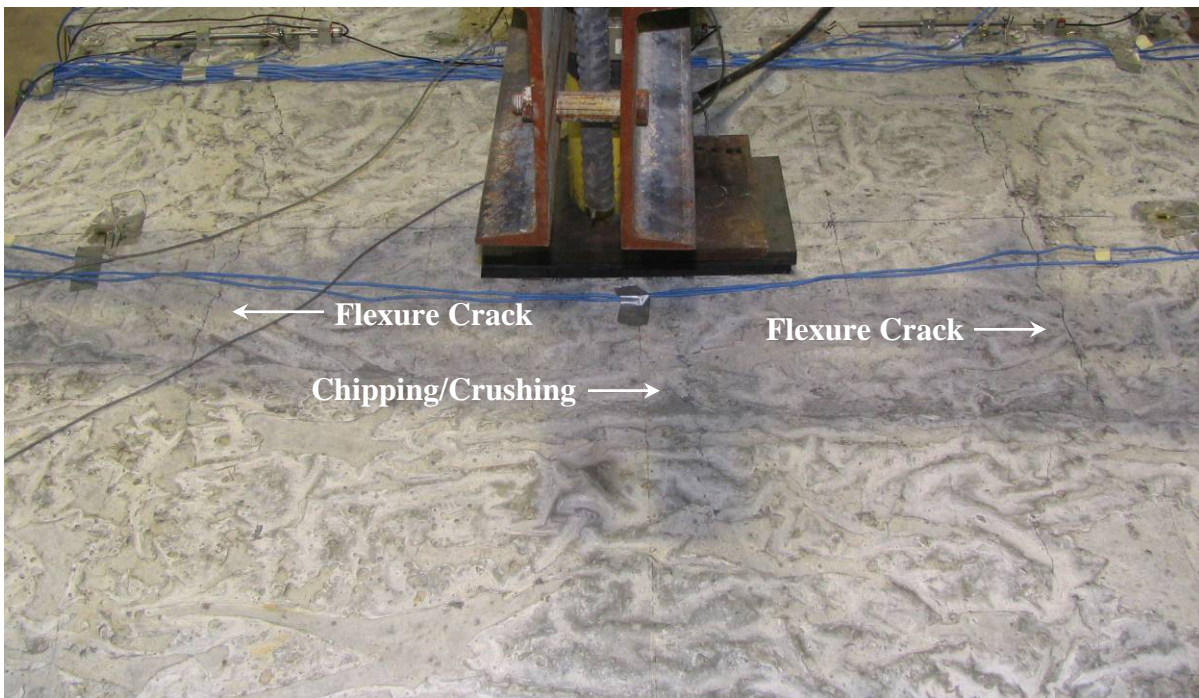
Figure 157. Photo. Damage on top of P4-24D deck after conclusion of test.

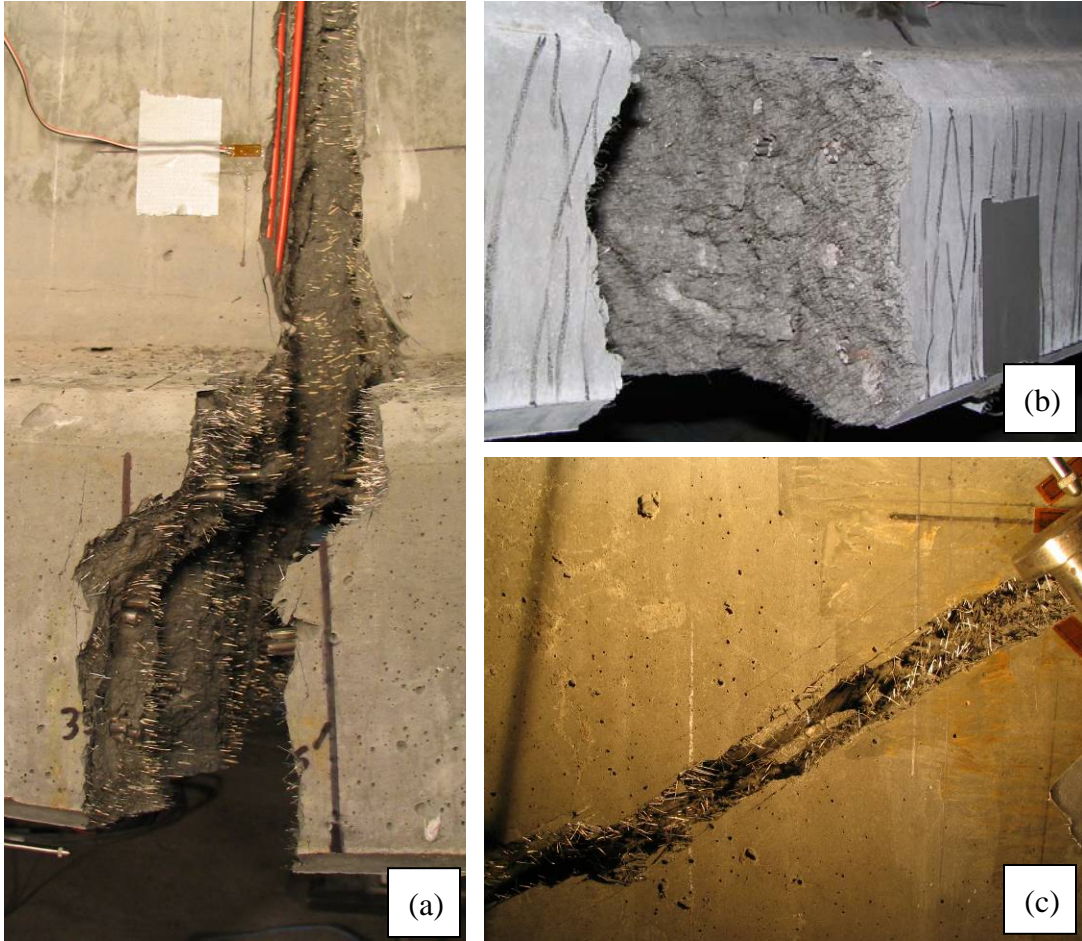
Figure 162. Photo. Failure surfaces including (a) bulb of P4-45F, (b) bulb of P2-70F, and (c) web of P2-21S.
