Destructive Testing of IDOT Bridge Structure Number 020-3087

Research Report No. FHWA-ICT-20-008

Destructive Testing of IDOT Structure Number 020-3087

August 2020

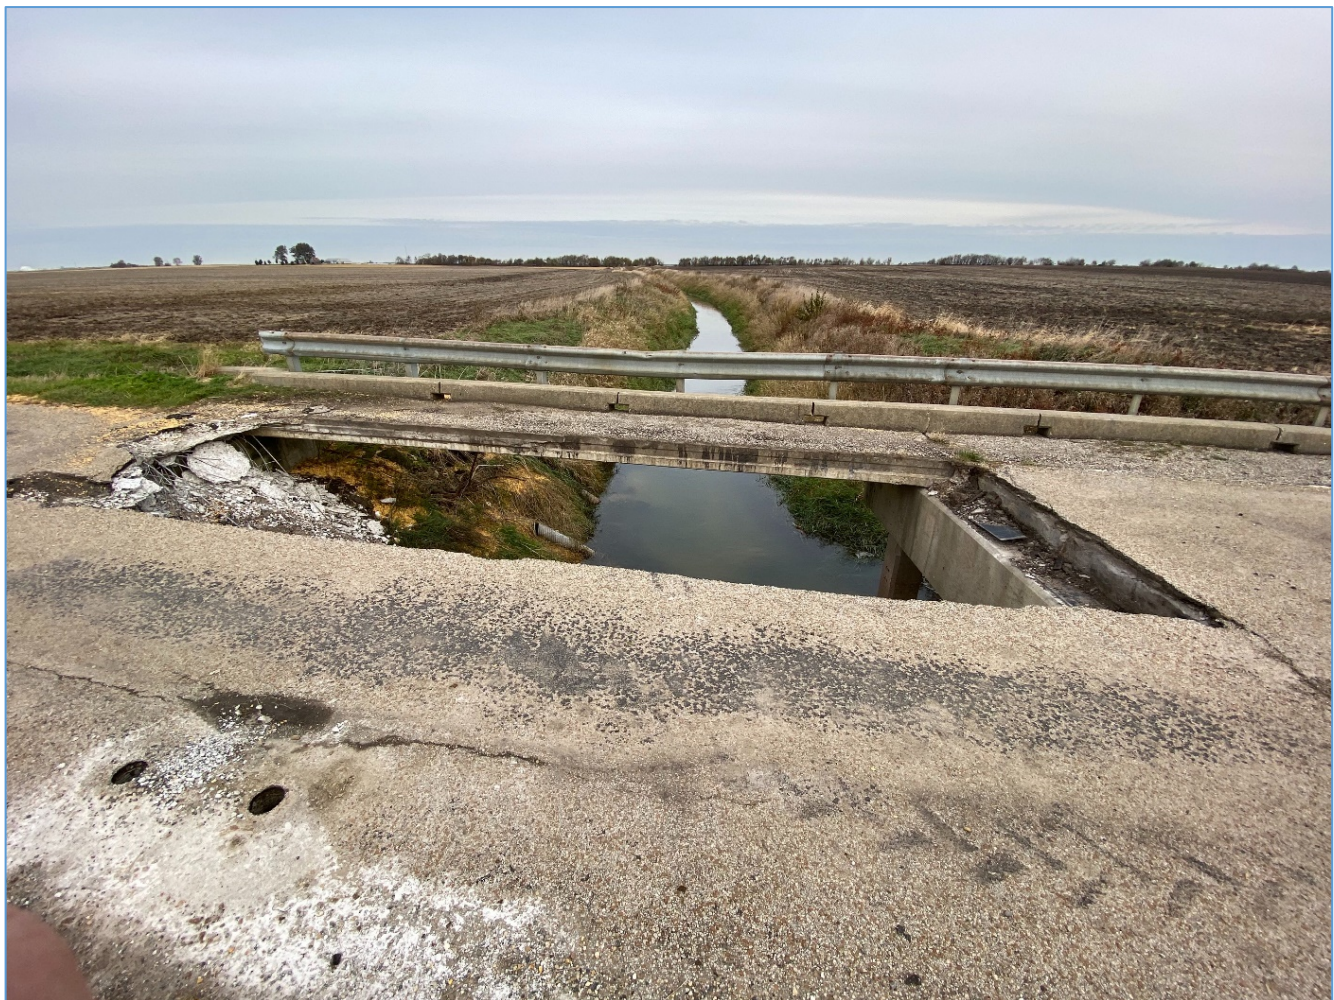
Figure 3. Photo. A picture of structure number 020-3087 after the failure of two beams, taken in November 2019 by the authors.

On October 1, 2019, the bridge was damaged by a tractor pulling a loaded single-axle grain wagon crossing the span. The load caused the collapse of two interior beams on the north side of the western span. The southern beams on the west and east spans were undamaged. The weight of the grain wagon is not known.

After deciding to replace rather than repair the bridge, IDOT chose to utilize one of the undamaged beams for a destructive load test to determine its flexural capacity. This test would allow for a comparison of the actual strength with the current methods for strength prediction. The method for estimating the flexural capacity of PPC deck beam bridges is described in the IDOT Bureau of Bridges and Structures Division of Highways Structural Services Manual Section 4.3.4.2.4 and Appendix A-10: Guidelines for Estimating Strand Loss in PPC Deck Beam Bridges (IDOT, 2017). This method is based on visual observations of cracking or staining on the underside of the beam and discounting any strands in these areas.

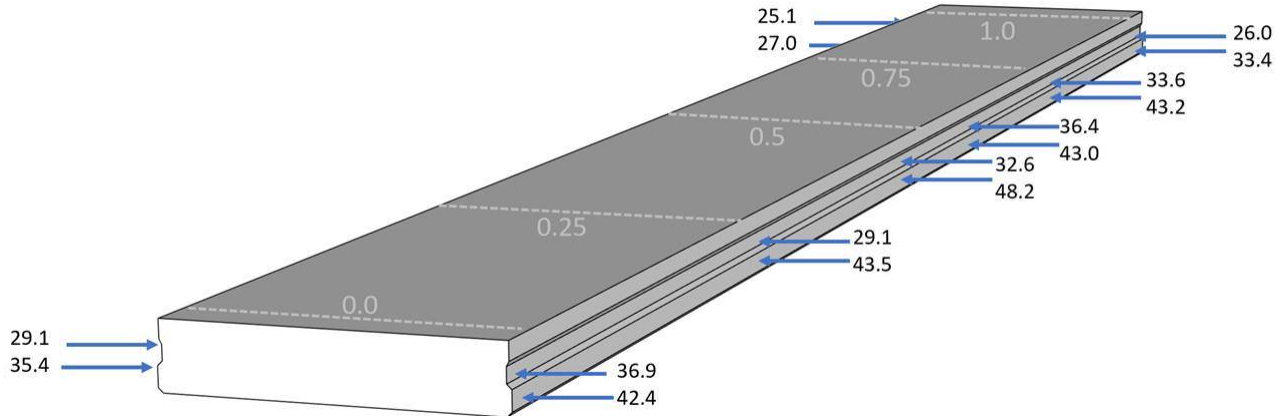
Figure 5. Photo. Schematic of a PPC bridge beam showing average rebound numbers at various locations.

The rebound hammer test results were used to determine that the concrete quality was not significantly different at the beam ends, compared to the midspan location. This result justified the decision to support the beam near its ends.

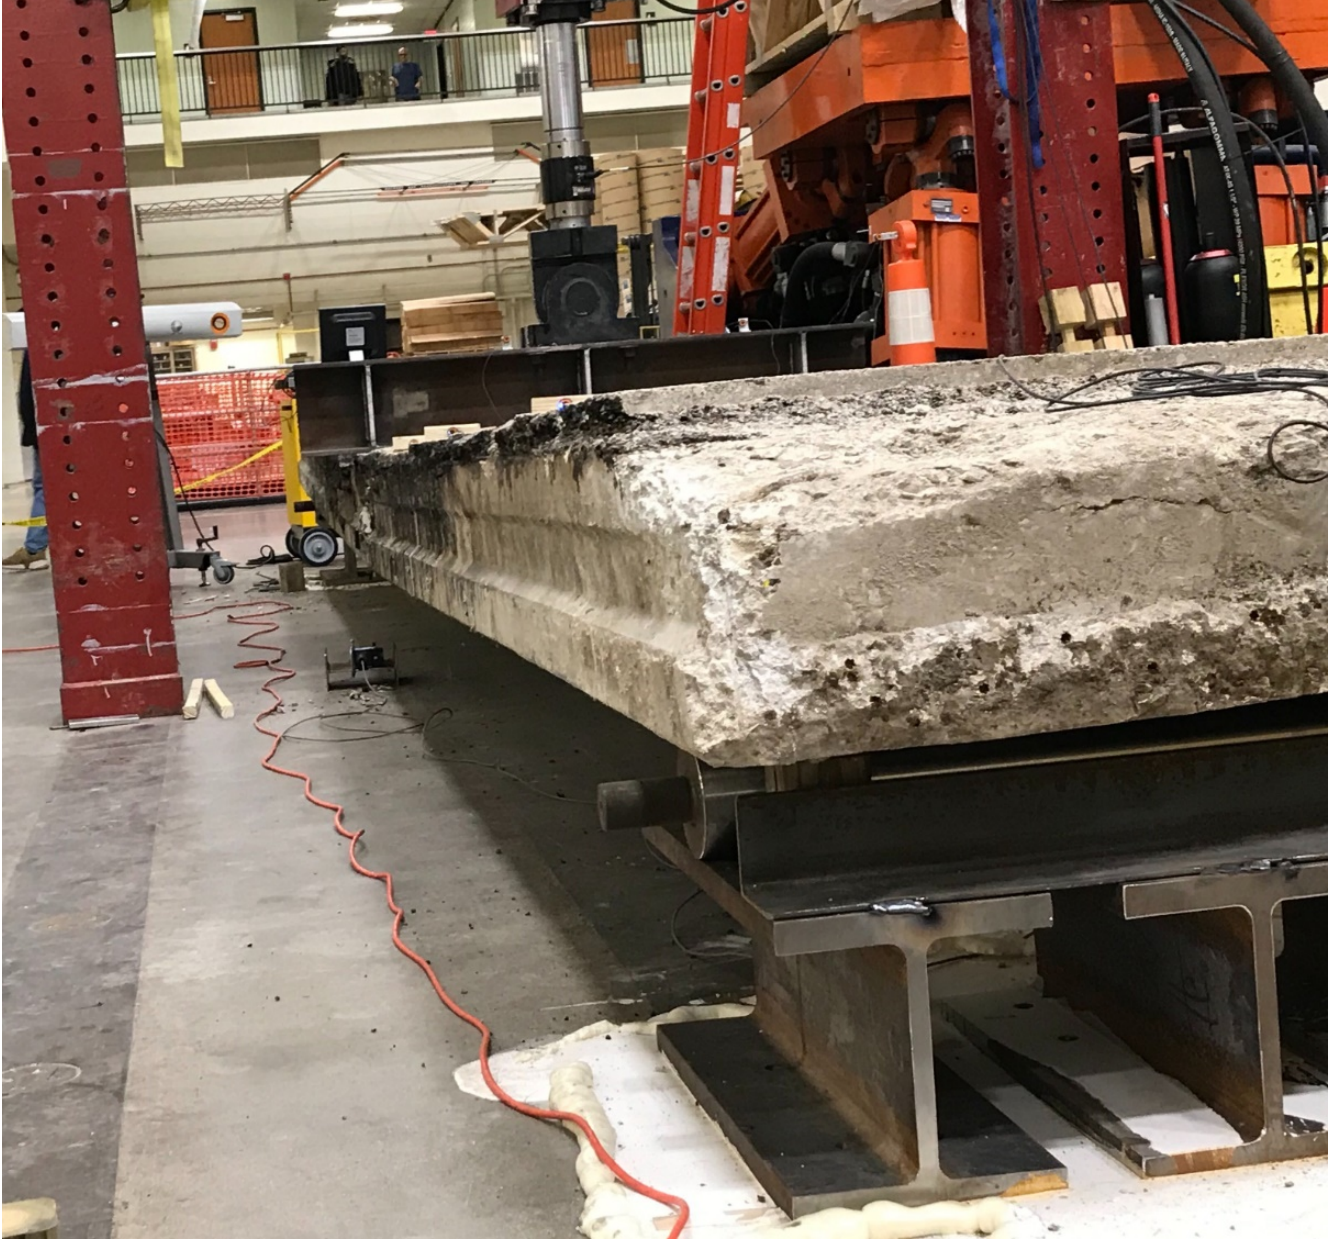
Figure 9. Photo. Test specimen during the three-point bending test.

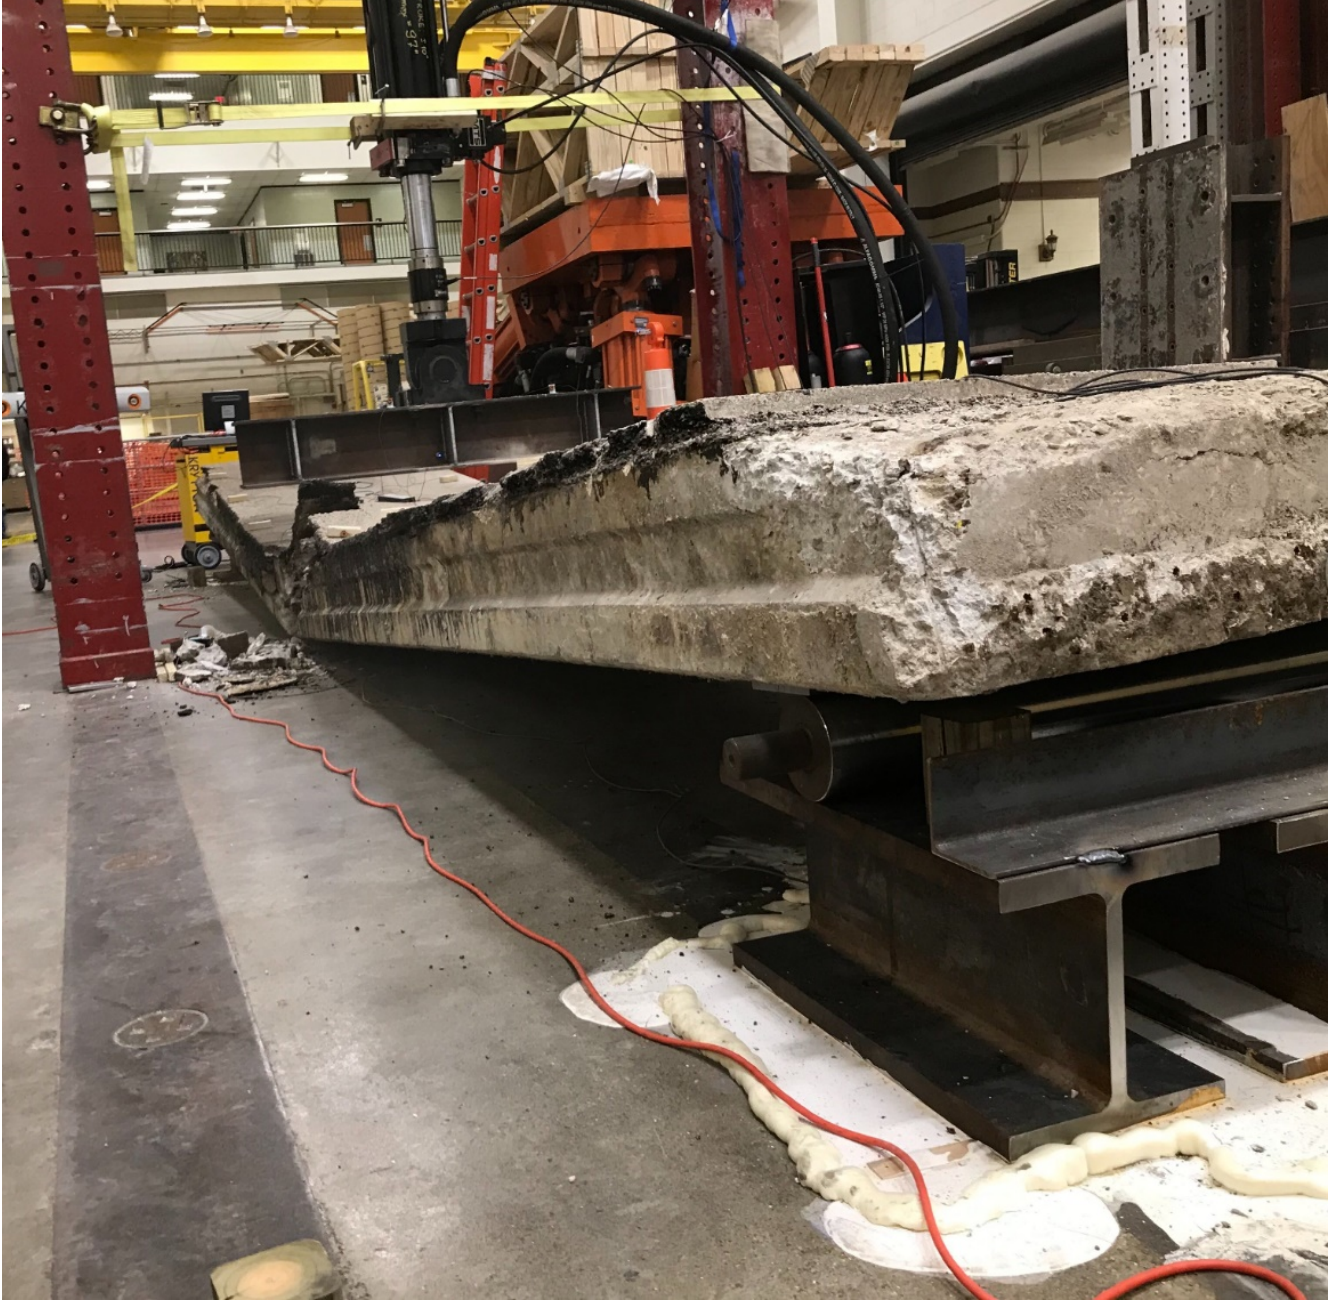
Figure 10. Photo. Test specimen after completion of the test.

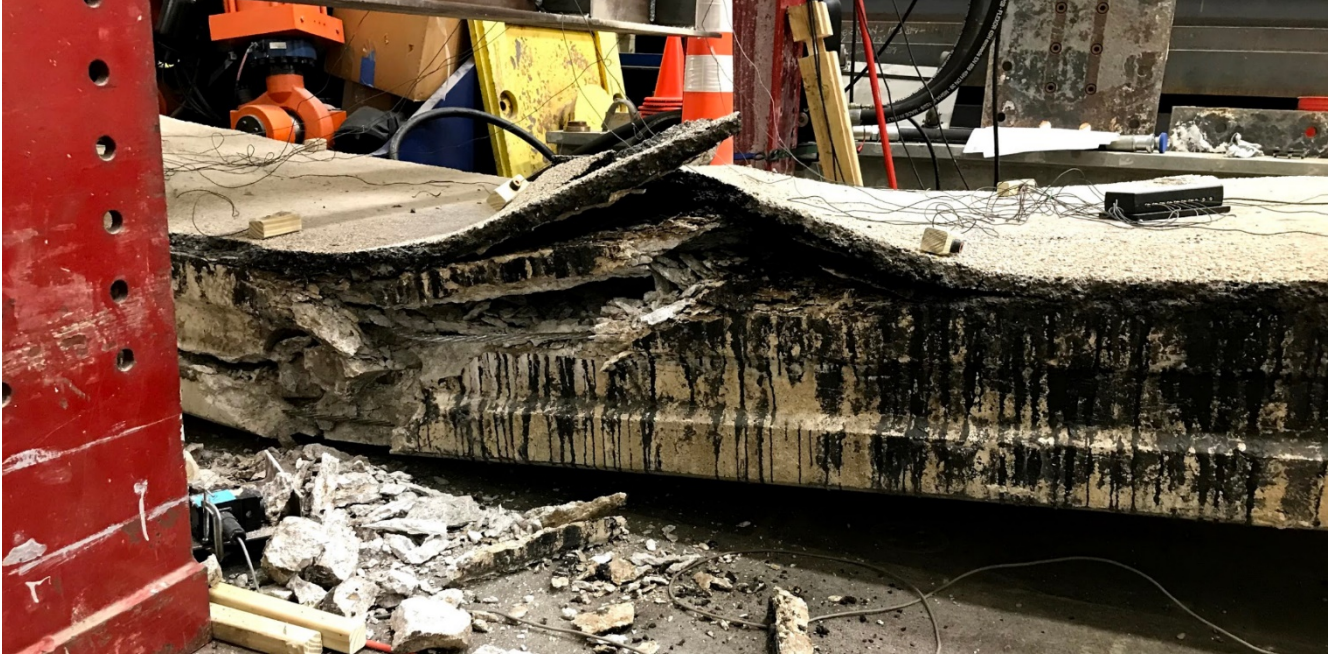
Figure 11. Photo. A picture of the flexural failure at midspan.

The three-point bending test successfully loaded the member to a flexural failure that consisted of concrete crushing at the top surface. The load-displacement behavior of the three-point bending test resulted in an ultimate strength well below a moment capacity computed using nominal material strengths. When the laboratory reopens following the COVID-19–related closures, concrete core samples will be taken from the undamaged portion of the deck and tested to determine the actual concrete strength of the beam.

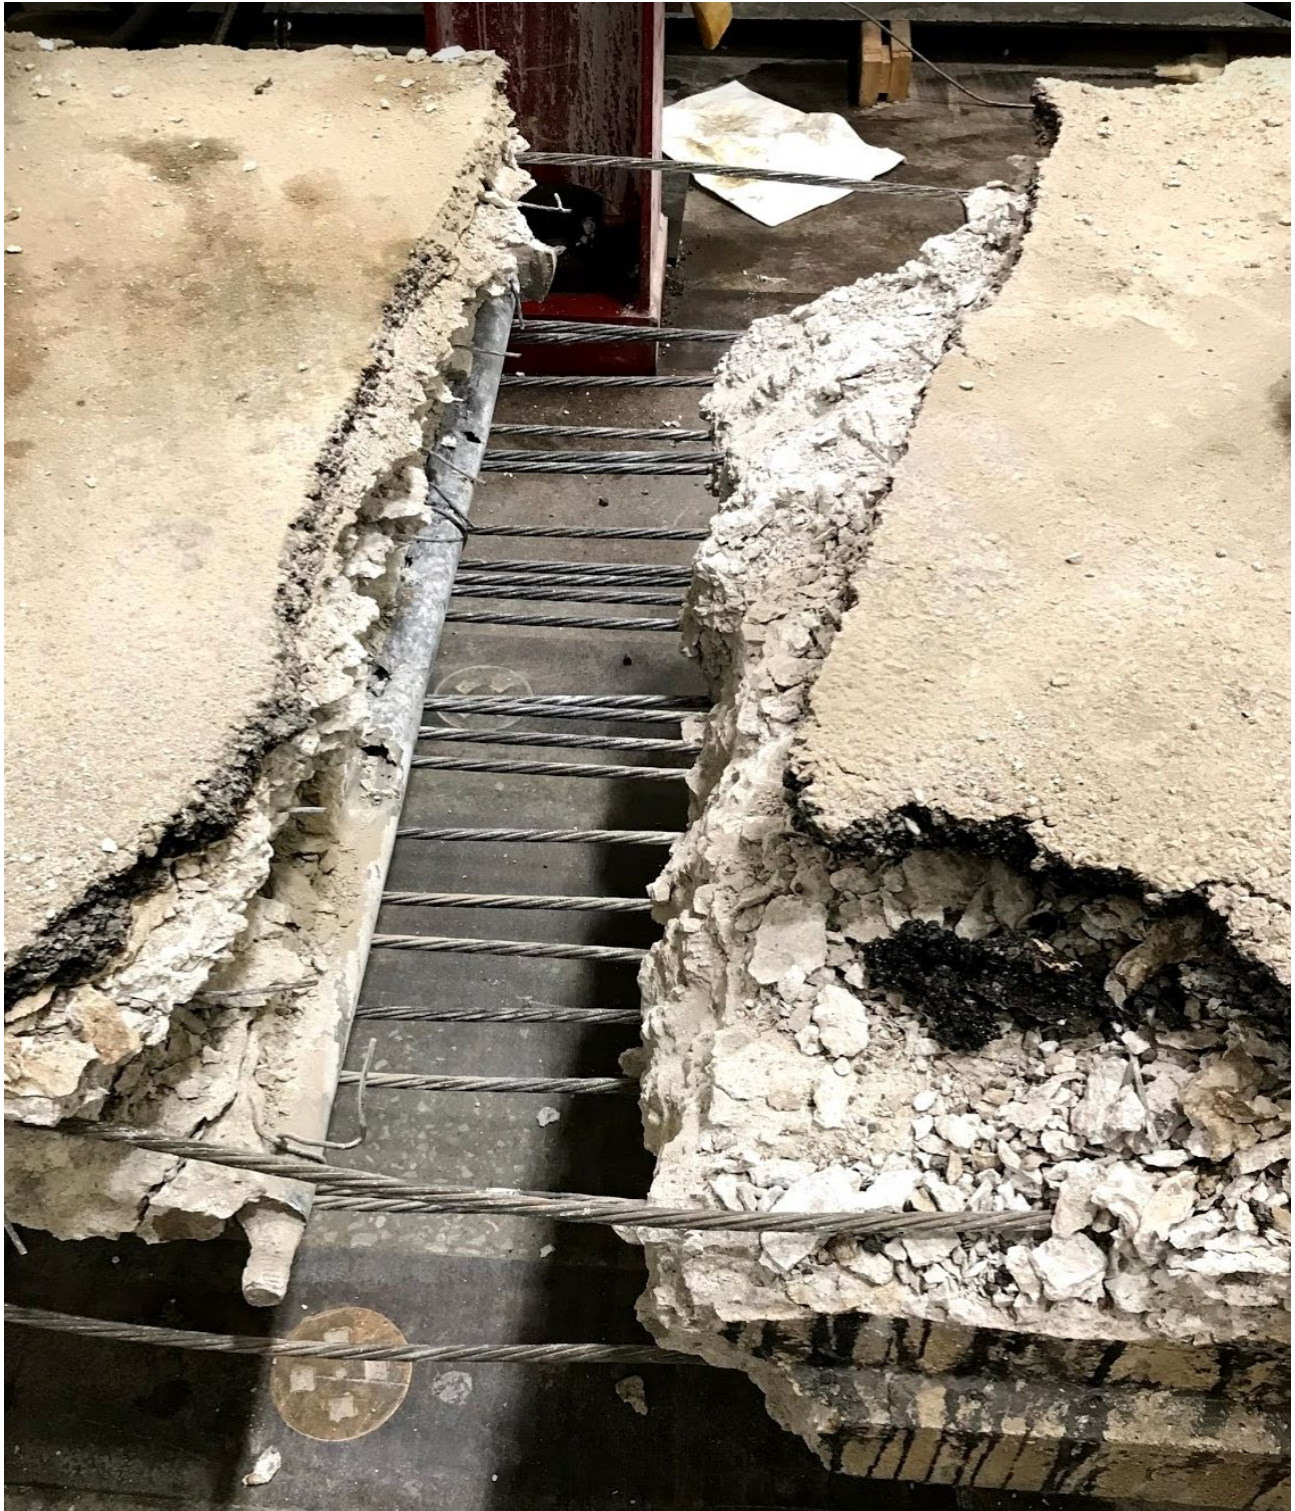
Following the three-point bending test, the damaged concrete near midspan was removed to expose the prestressing strands, as shown in Figures 14 and 15. Note that all strands are in very good condition, with no corrosion or deterioration visible on any strands.

Figure 14. Photo. Exposed prestressing strands near midspan of the test specimen.

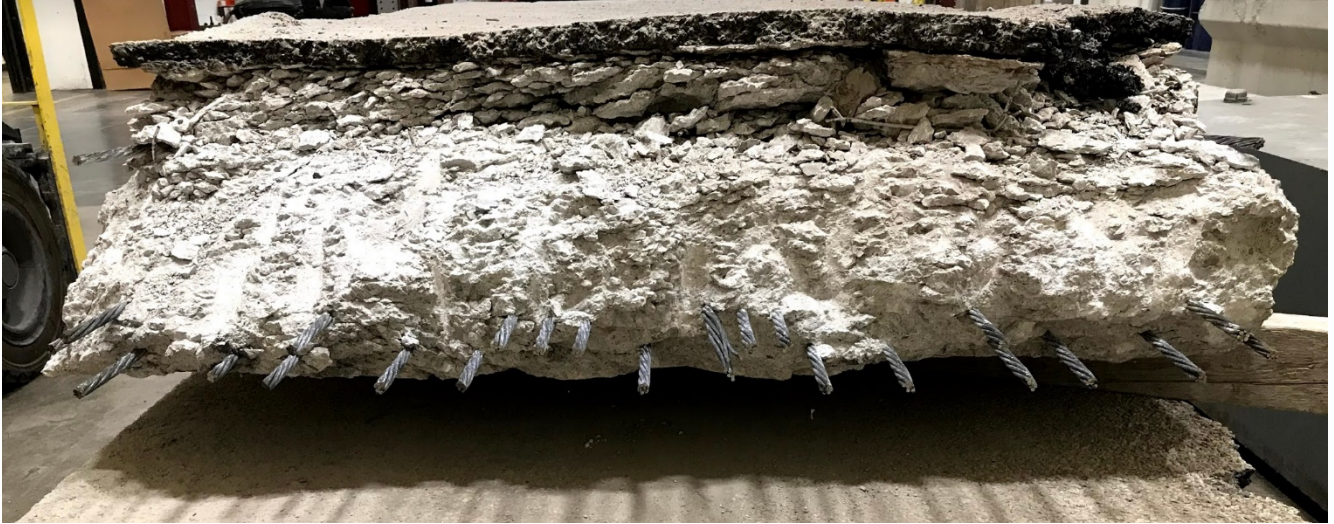
**Figure 15. Photo. Cross-section of the beam specimen after cutting prestressing strands.
Note that the configuration of the strands is different than shown in Figure 4.**
