Alaska Department of Transportation & Public Facilities  
**Research & Technology Transfer**

# High Friction Surface Treatment Experimental Feature Final Report and 3<sup>rd</sup> Year Monitoring Results

Alaska Department of Transportation and Public Facilities,  
Central Region Materials and Statewide Asset Management & Research

**Publication Number:** FHWA-AK-RD-000S(882)

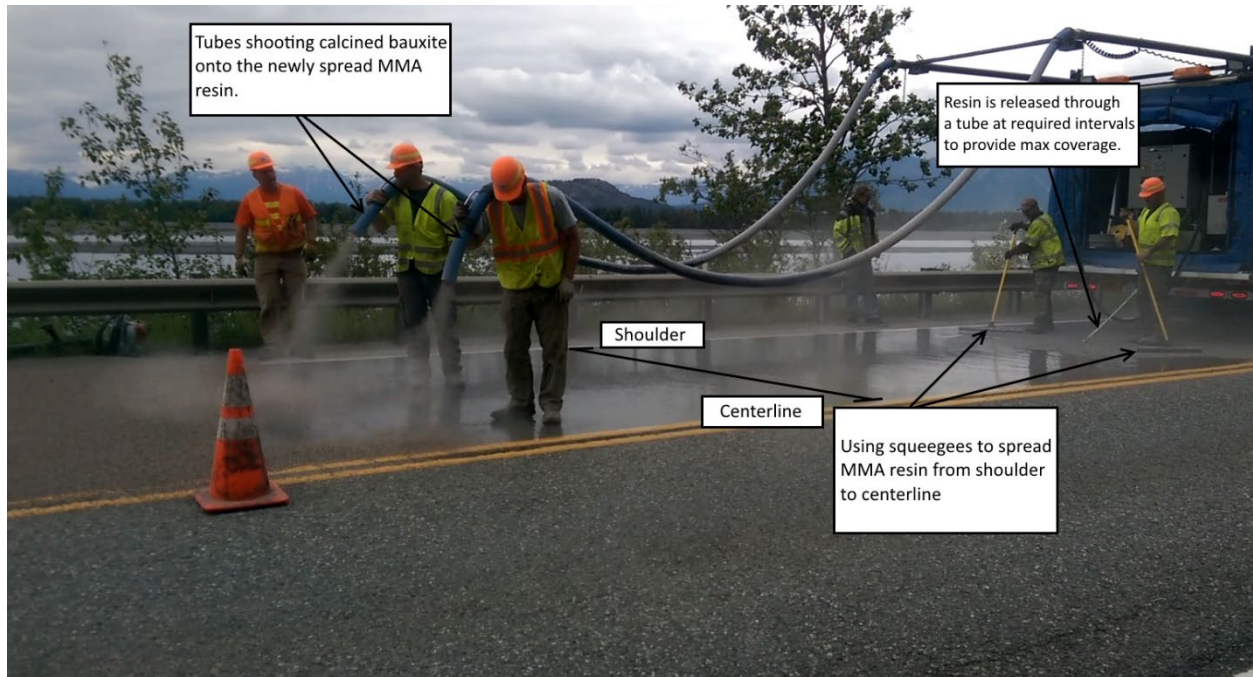
Photo 1: 2016 Application using Method 2 on Old Glenn Highway

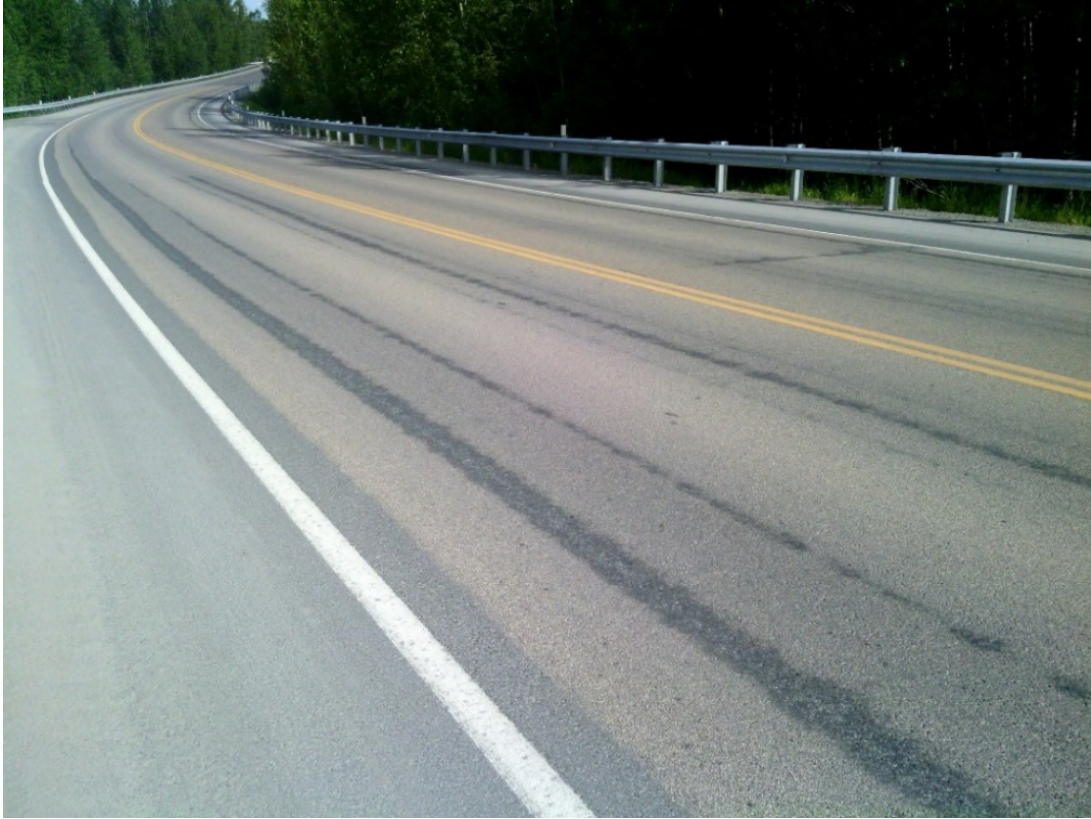
Site 30 (Eagle River Road Mile Point 0-5.3 Pavement Preservation) revealed there may have been an error with the resin application which resulted in strips of bare pavement a consistent distance from the fog line prior to the first winter (See Photo 2). This result, however, was noticeable in other areas as well with Method 2 though it has a distinctly different wear pattern (see Photo 3).

Photo 2: June 2016, Eagle River Road one year after Method 1 application.

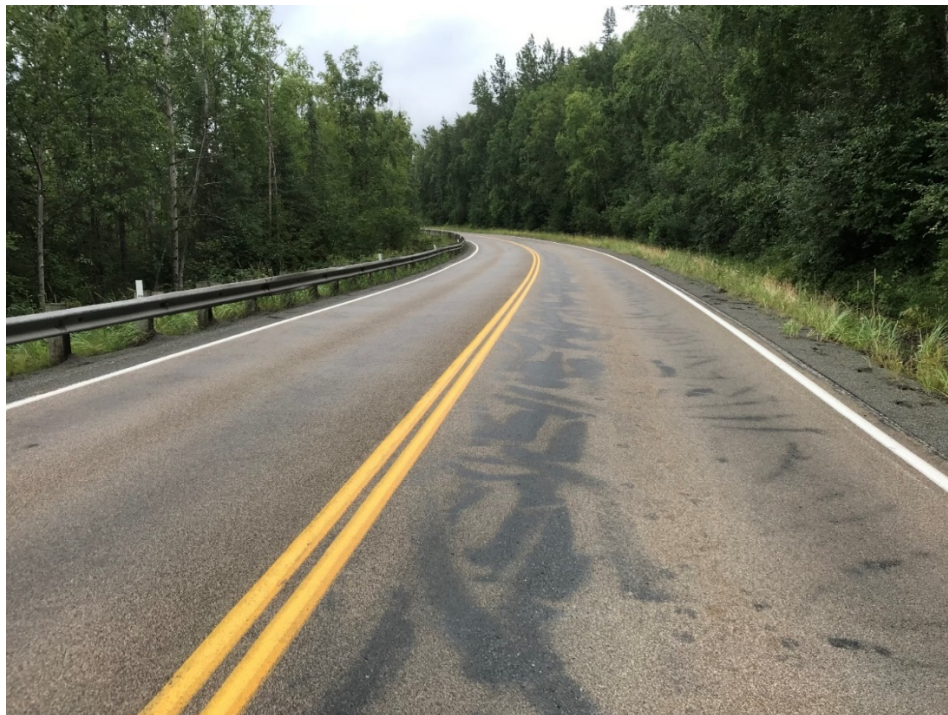
In Anchorage, roads with higher AADT had higher friction loss than those with lower AADT, but all sites have lost a significant amount of friction in the wheel paths. The application process may be contributing to friction loss as well due to the hoses used for application of aggregate dragging through applied material prior to hardening. Photo 6, on page 13, has a unique pattern of material loss in the right lane wheel paths that may have been caused by this.

**Unique Pattern of Material Loss In Wheelpaths**

Photo 6: Old Glenn Highway at Milepost 2 – Site 17 (2018)

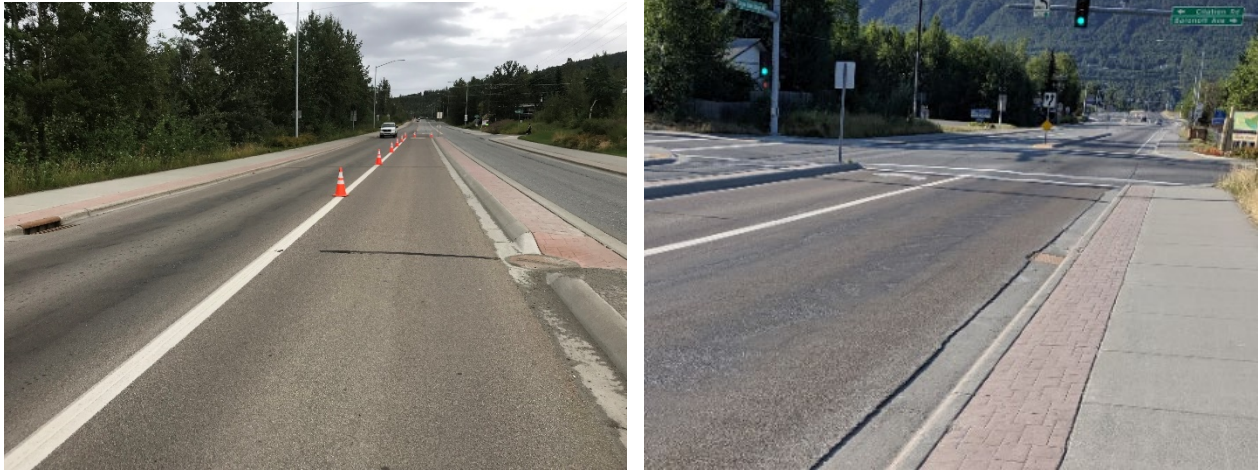
Photo 7 (Left) 2018 & 8 (Right) 2019: Eagle River Loop Road – Site 16

In these images, you can see the turn pocket (right side of Photo 7) has significantly less obvious wear than the high AADT through lane. In 2018 (Photo 7) significant wear is evident on the through lane while minimal in the turn pocket, and in 2019 (Photo 8) a significant amount of pavement is visible in the wheelpaths of the through lane.

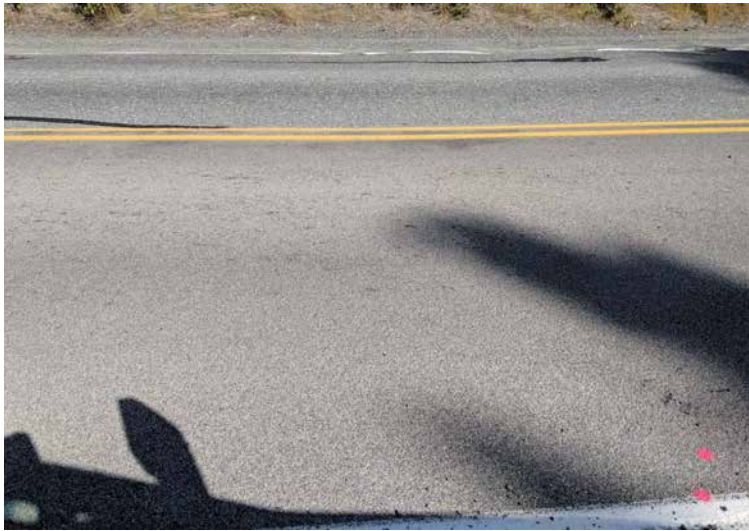
**Site 3 – Photo Log**

Funny River Road has lost moderate friction, but did not lose a large amount between testing in 2018 and 2019. None of the four tests in 2019 were less than typical pavement value of 0.48, with an average value of 0.67. The first picture below from 2019 does show visible wear in the wheelpaths into and out of curves. Areas in straightaways seemed to show less signs of visible wear, as shown in the second picture taken in 2019.

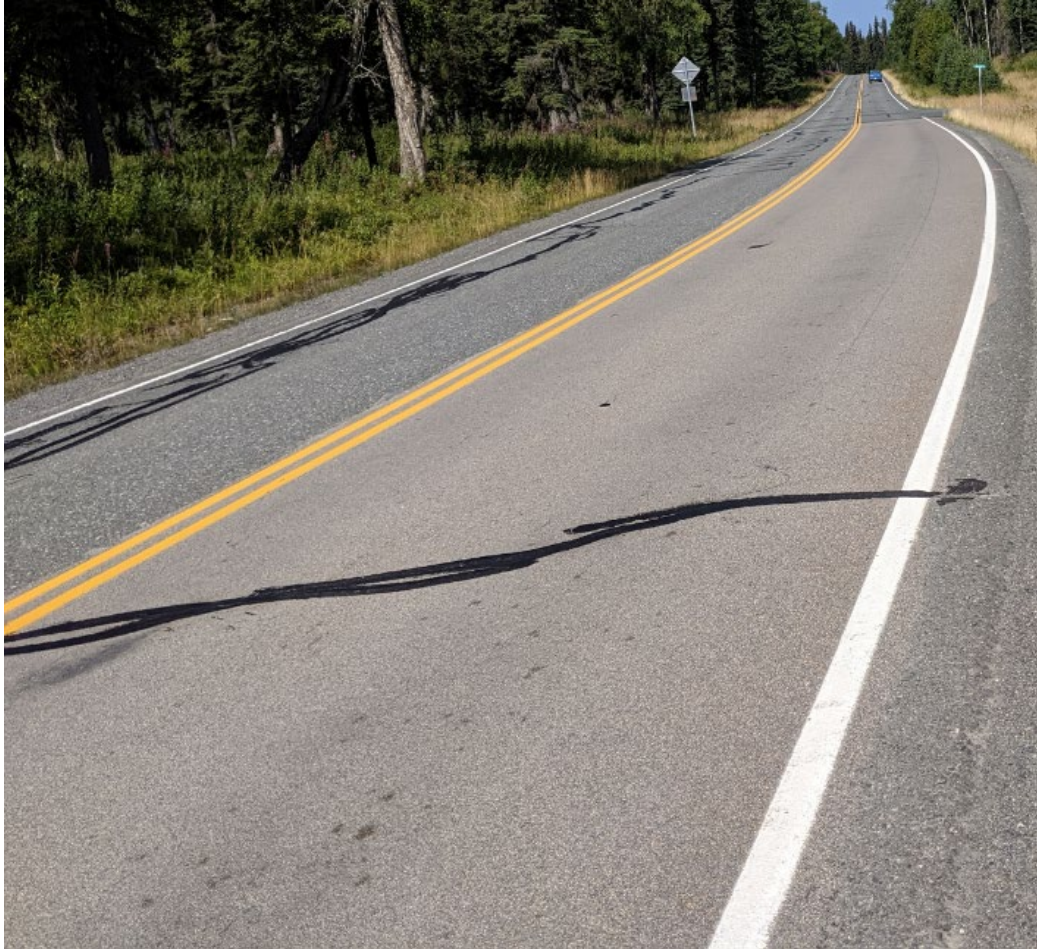
## Site 4 – Photo Log

Funny River Road has lost moderate friction, but did not lose a large amount between testing in 2016 and 2019. None of the four tests in 2019 were less than typical pavement value of 0.48, with an average value of 0.61. The picture below shows slight wear in the wheelpaths, and as at Site 3 on Funny River more wear was evident into and out of curves.

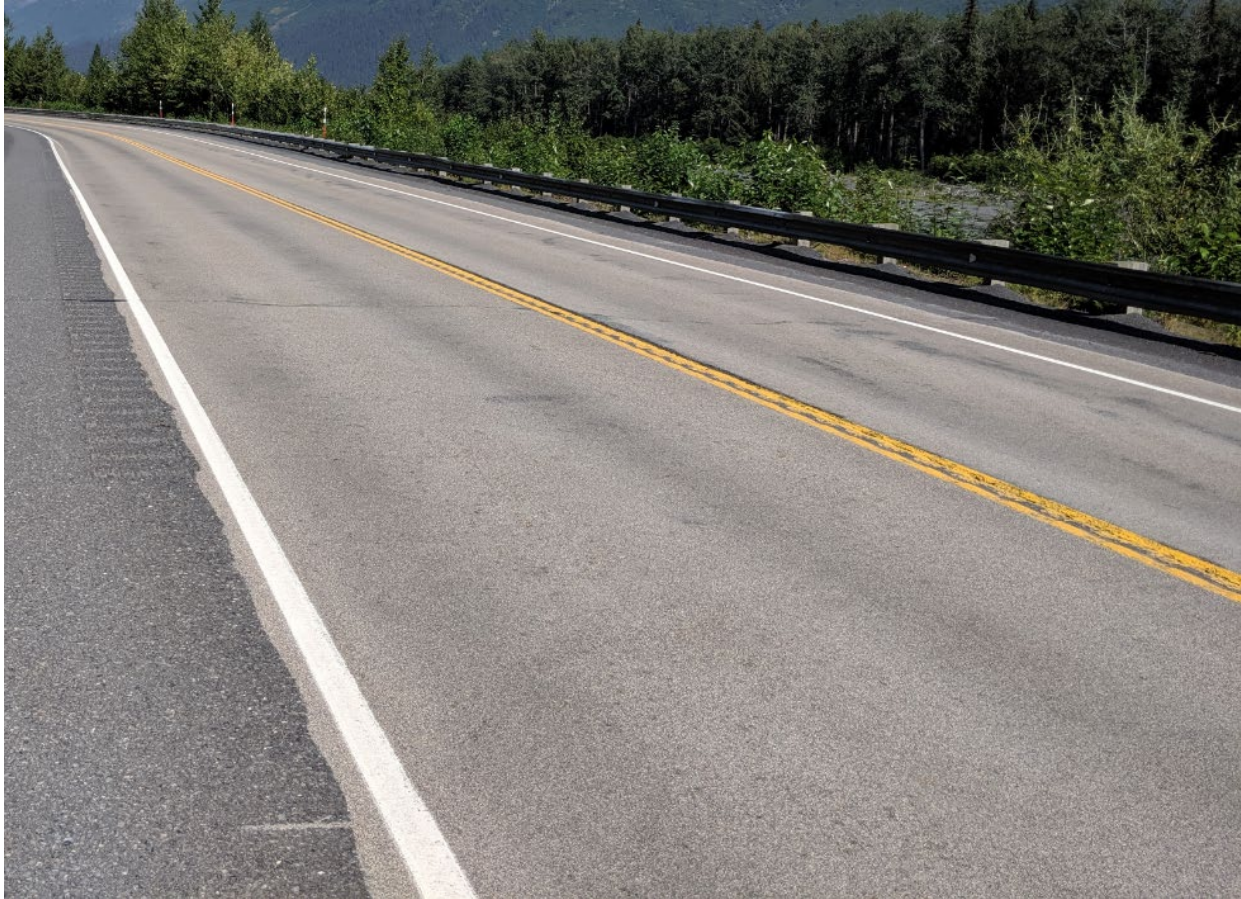
**Site 5 – Photo Log**

Seward Highway at milepost 15 has lost moderate friction overall, but significant friction at specific locations. Three of the six tests in 2019 were less than typical pavement value of 0.48, with an average value of 0.50. The picture from 2019 below shows wear in the wheelpaths going into and out of a curve.

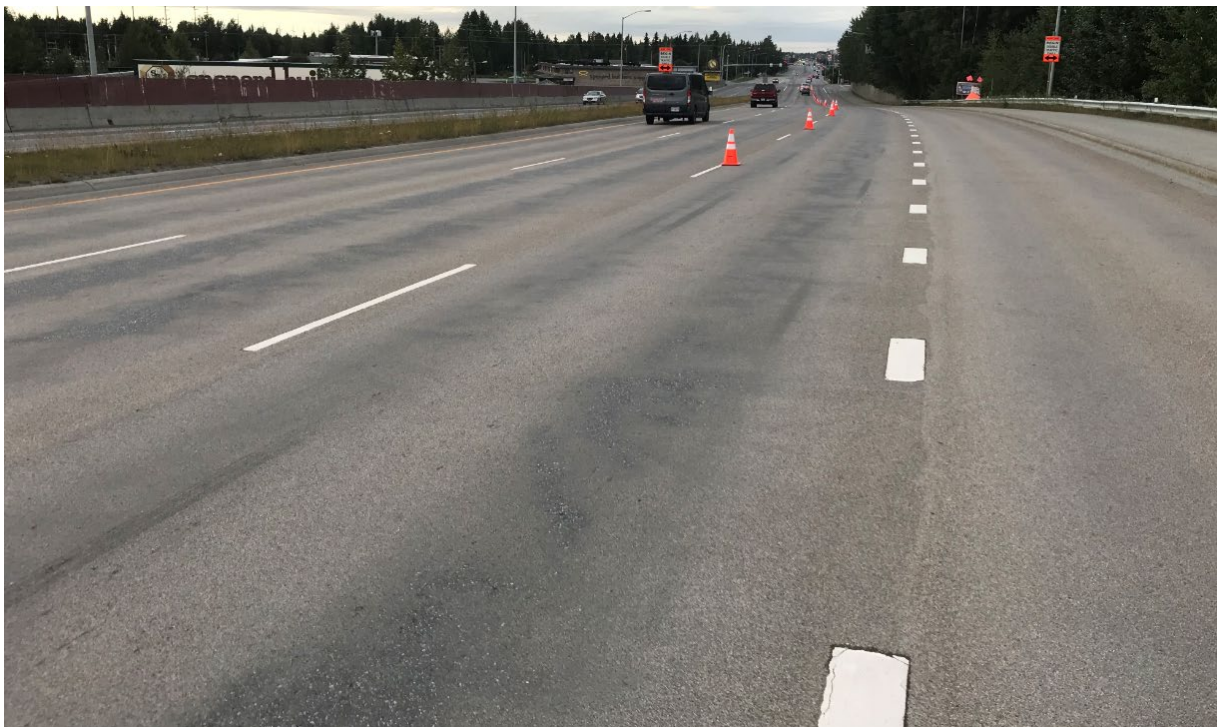
## Site 8 – Photo Log

Minnesota Drive at Tudor lost significant friction. The friction drop between 2017 and 2018 was major and all four tests in 2018 were less than typical pavement value of 0.60, with an average value of 0.30. As can be seen in the 2018 photo, below, all wheelpaths show wear and show large amounts of bare pavement.

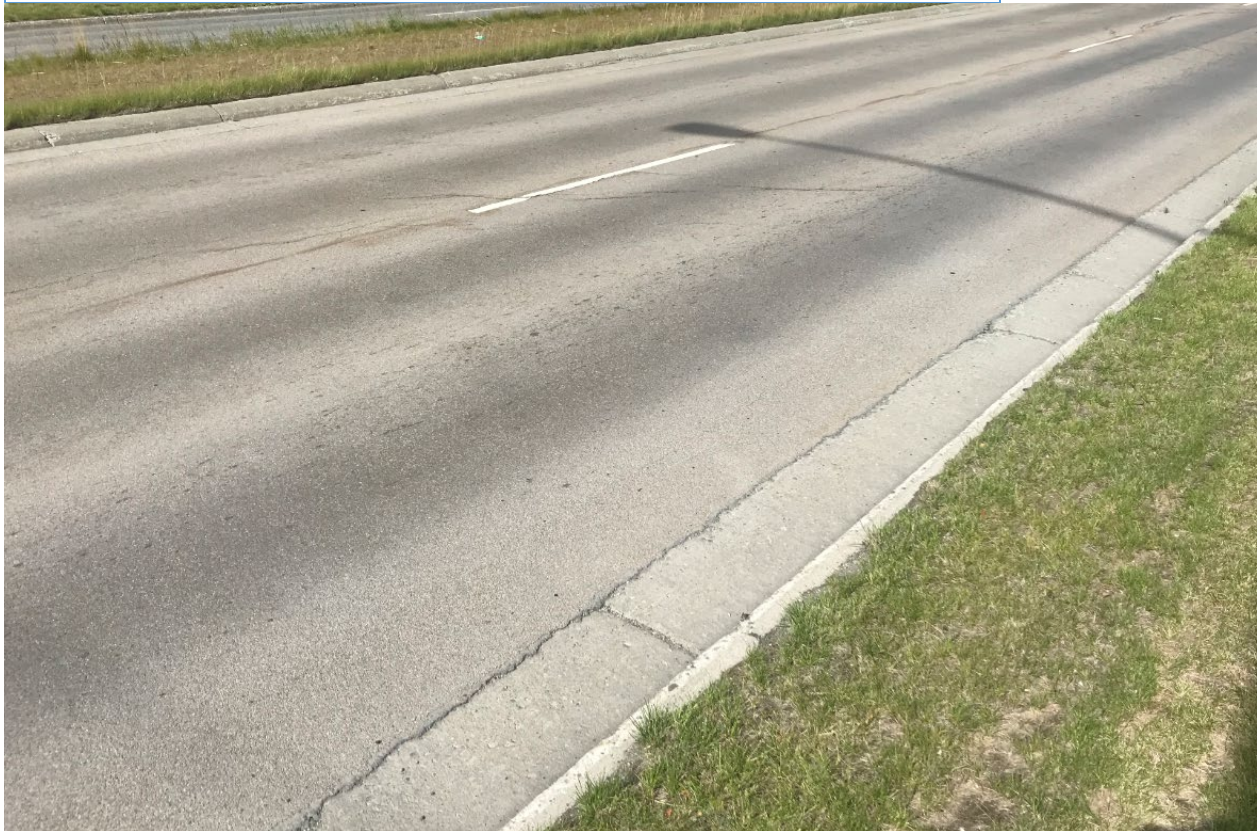
**Site 9 – Photo Log**

Lake Otis at Waldron lost significant friction. The friction drop between 2017 and 2018 was major and the two tests in the through lanes in 2018 were less than typical pavement value of 0.56, with an average value of 0.34. As can be seen in the 2018 photo, below, all wheelpaths show significant wear. The third test performed in 2018 was in the turn pocket, and that data can be seen at the end of the appendix summarized with other turn pocket data.

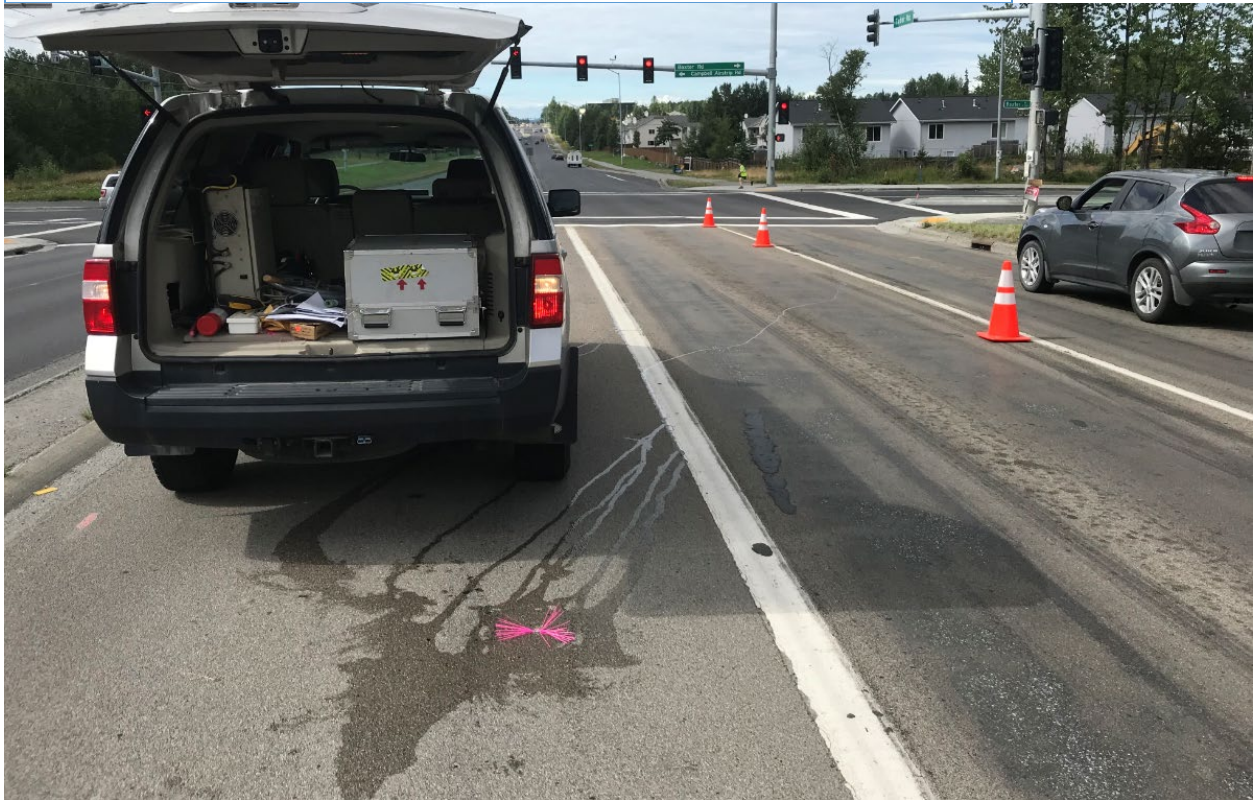
**Site 11 – Photo Log**

Tudor Road showed major friction loss in all tests. The friction drop between 2017 and 2018 was significant and both tests were less than typical pavement value of 0.58, with an average value of 0.31. As can be seen in the 2018 photo, below, the turn pocket shows minimal wear while the wheelpaths in the the through lanes show visible pavement and substantial wear. The third test performed in 2018 was in the turn pocket, and that data can be seen at the end of the appendix summarized with other turn pocket data.

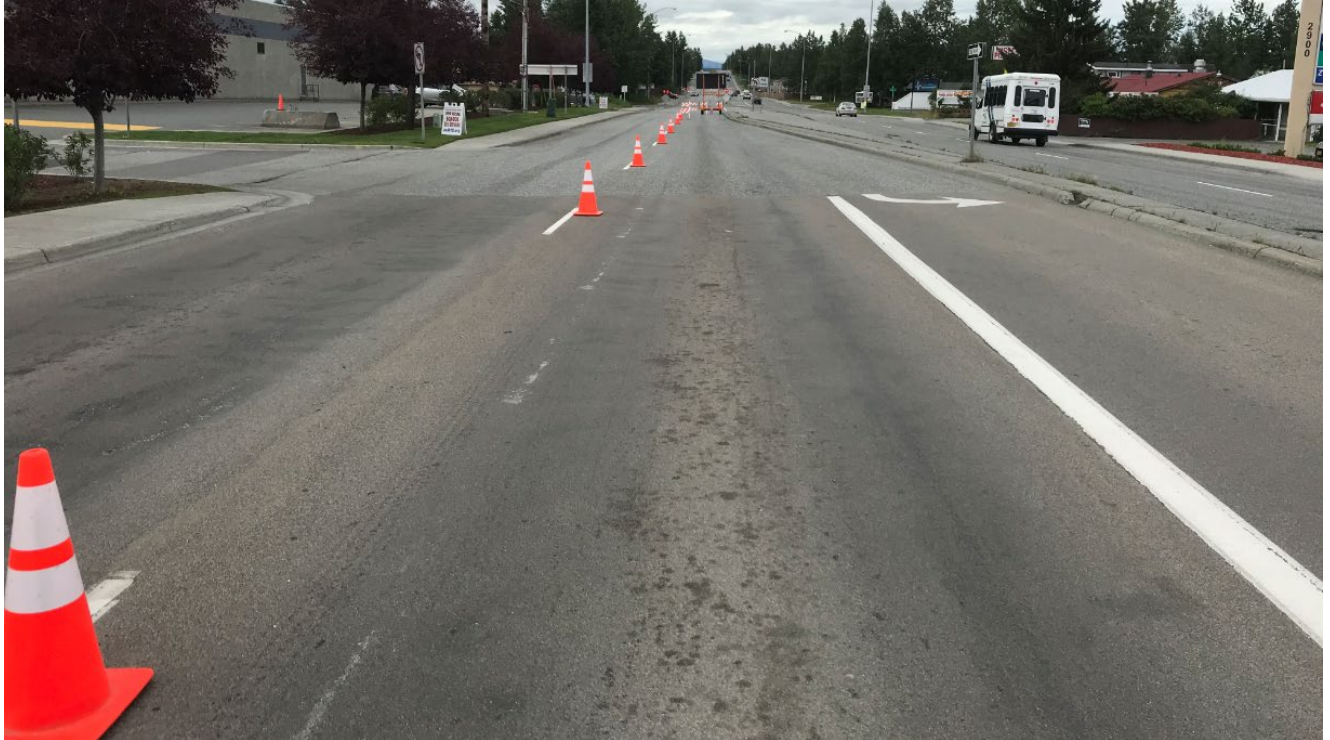
**Site 12 – Photo Log**

Boniface and Northern Lights showed major friction loss in all tests. The friction drop between 2017 and 2018 was significant and all six tests were less than typical pavement value of 0.60, with an average value of 0.38. Through lanes showed wear with visible pavement in areas. Turn pocket testing can be found at the end of the appendix summarized with other turn pocket data.

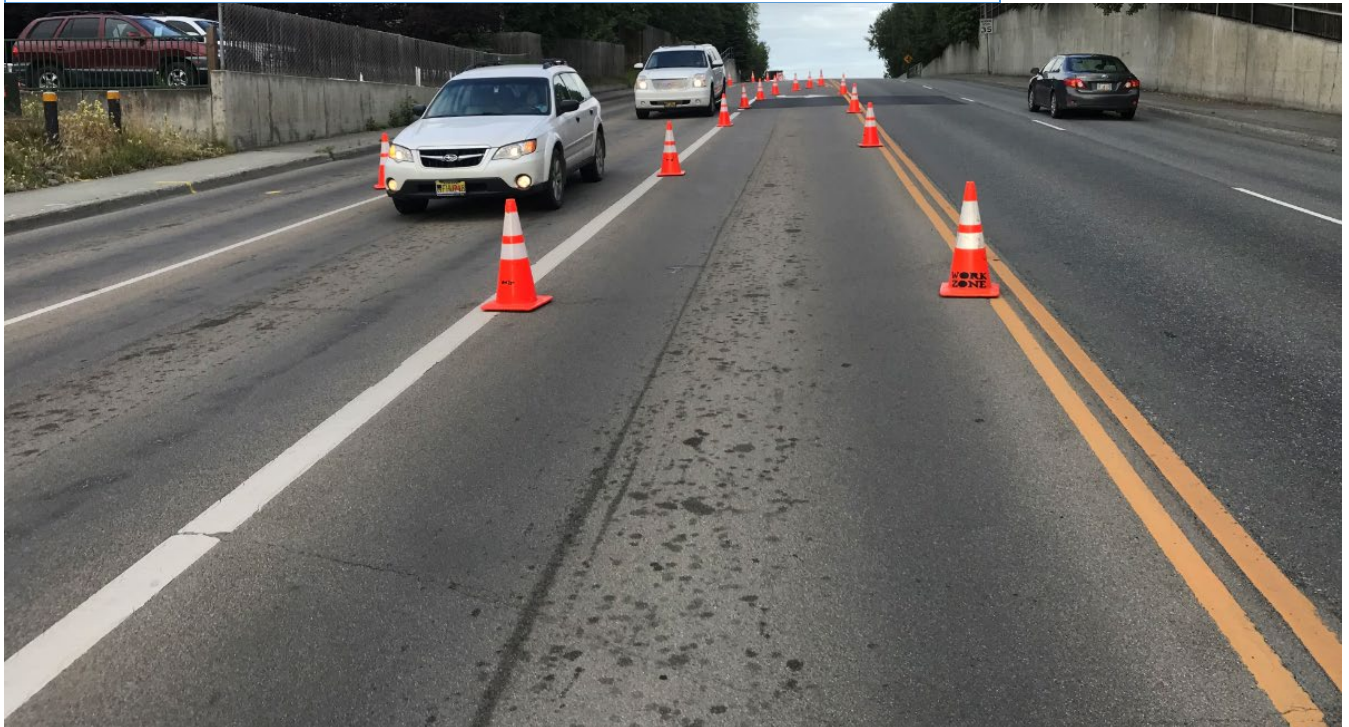
**Site 13 – Photo Log**

36<sup>th</sup> at Lake Otis showed major friction loss in all tests. The friction drop between 2017 and 2018 was significant and both tests in through lanes were less than the pavement control value of 0.57, with an average value of 0.35. Through lanes showed wear with visible pavement in areas. While the turn pocket showed major wear no pavement was visible. Turn pocket testing can be found at the end of the appendix summarized with other turn pocket data.

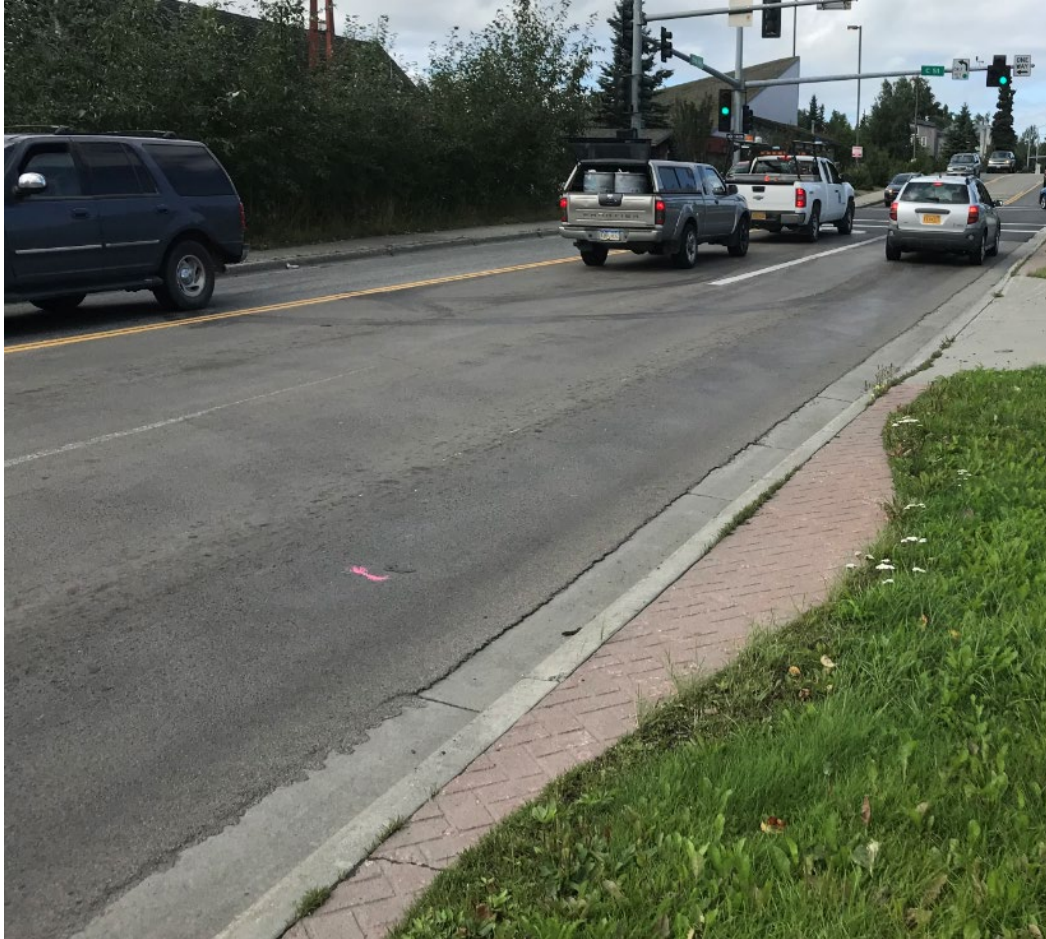
**Section 15 – Photo Log**

C Street at 15<sup>th</sup> showed major friction loss in all tests. The friction drop between 2017 and 2018 was significant and both tests in through lanes had less friction than the pavement control value of 0.57, with an average value of 0.35. Through lanes showed bare pavement as can be seen in the 2018 photo, below. Turn pocket testing can be found at the end of the appendix.

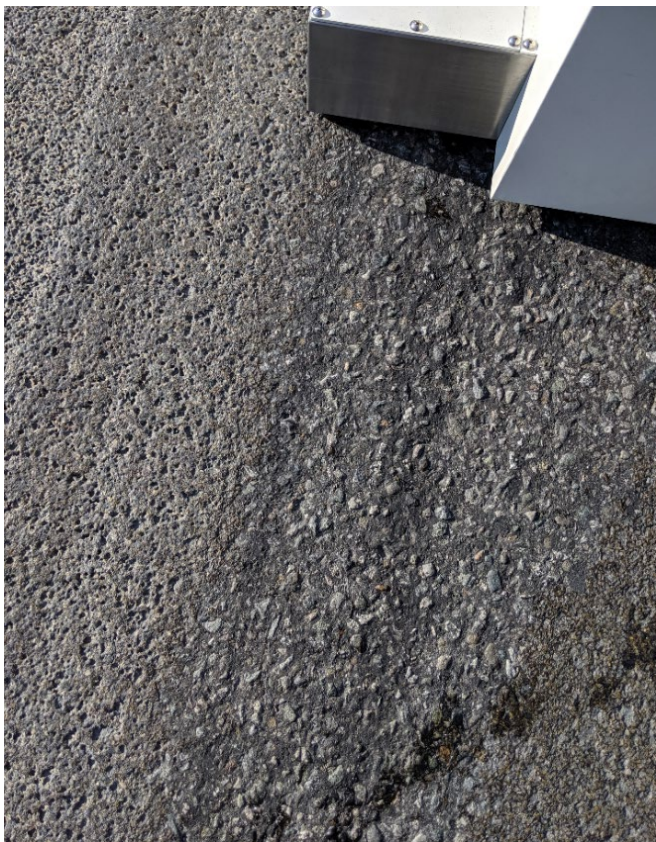
**Site 16 – Photo Log**

Eagle River Loop Road showed significant friction loss. A third test was performed in through lanes in 2019 with a value of 0.73. This value remained higher than the other two performed in the through lanes closer to the intersection with 2019 values of 0.31 and 0.20. This higher value raised the average value in 2019. Major polishing of the HFST and bare pavement can be seen in the 2019 photo, below. Turn pocket testing can be found at the end of the appendix.

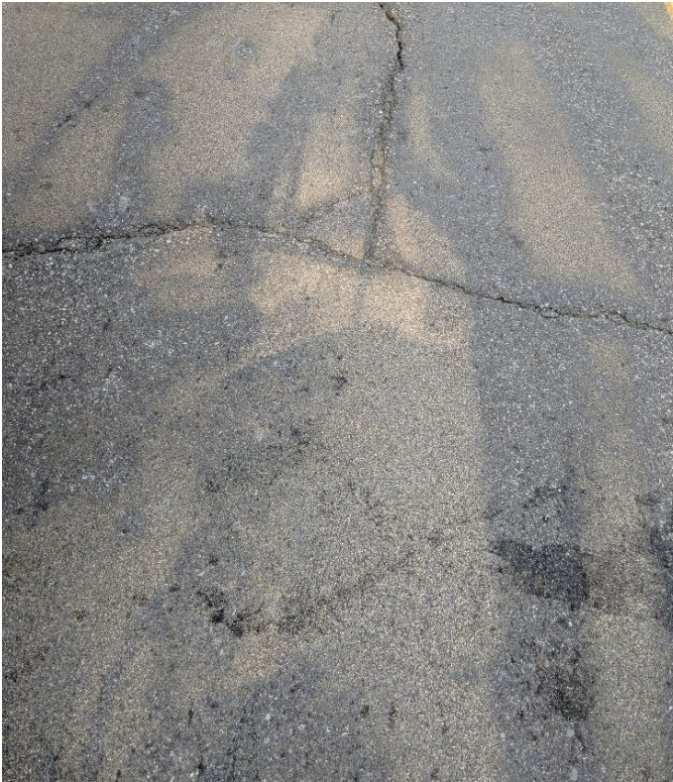
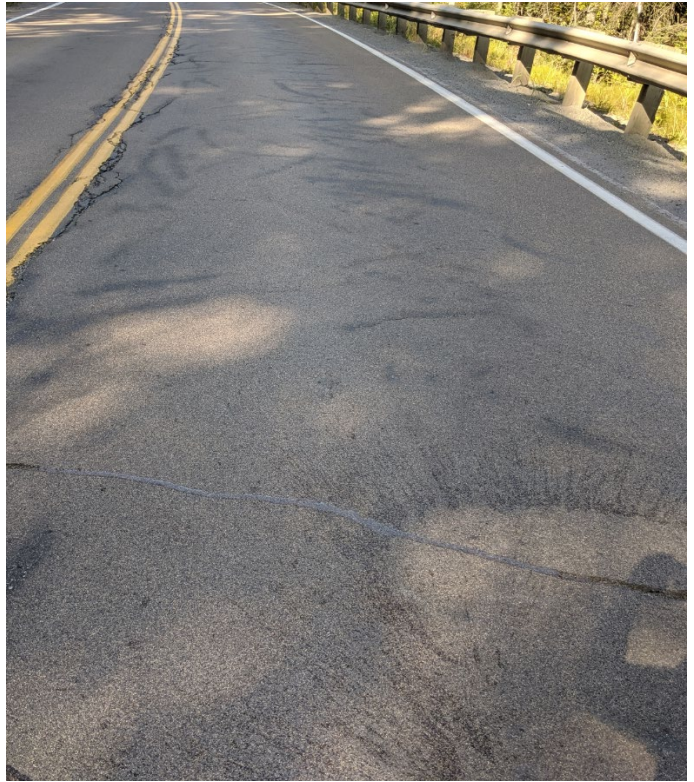
**Site 17 – Photo Log**

Old Glenn at MP 2 showed moderate friction loss, although not a major loss on average between 2018 and 2019. Two of the four tests had less friction than the original pavement control of 0.57, with an average of 0.54. Areas of bare pavement were visible from both studded tire wear in wheelpaths and areas where the pavement heaved in the winter and the HFST was bladed through, as can be seen in the 2019 photos, below.

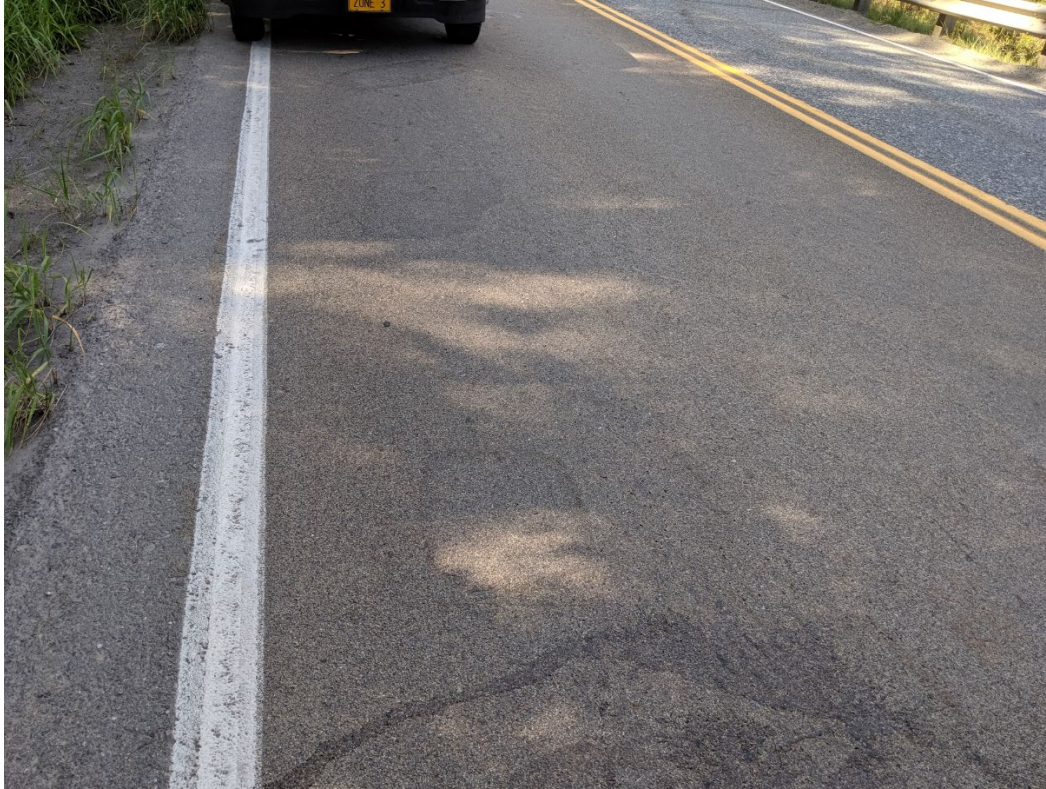
## Site 20 – Photo Log

Old Glenn at at milepost 5 showed moderate friction loss. None of the three tests had less friction than the original pavement control of 0.54, with an average of 0.68. The PK nails could not be located in 2019 so the testing was performed as close as the crew could manage to the original loations. This is likely the cause of the discrepancy of friction values between 2018 and 2019.

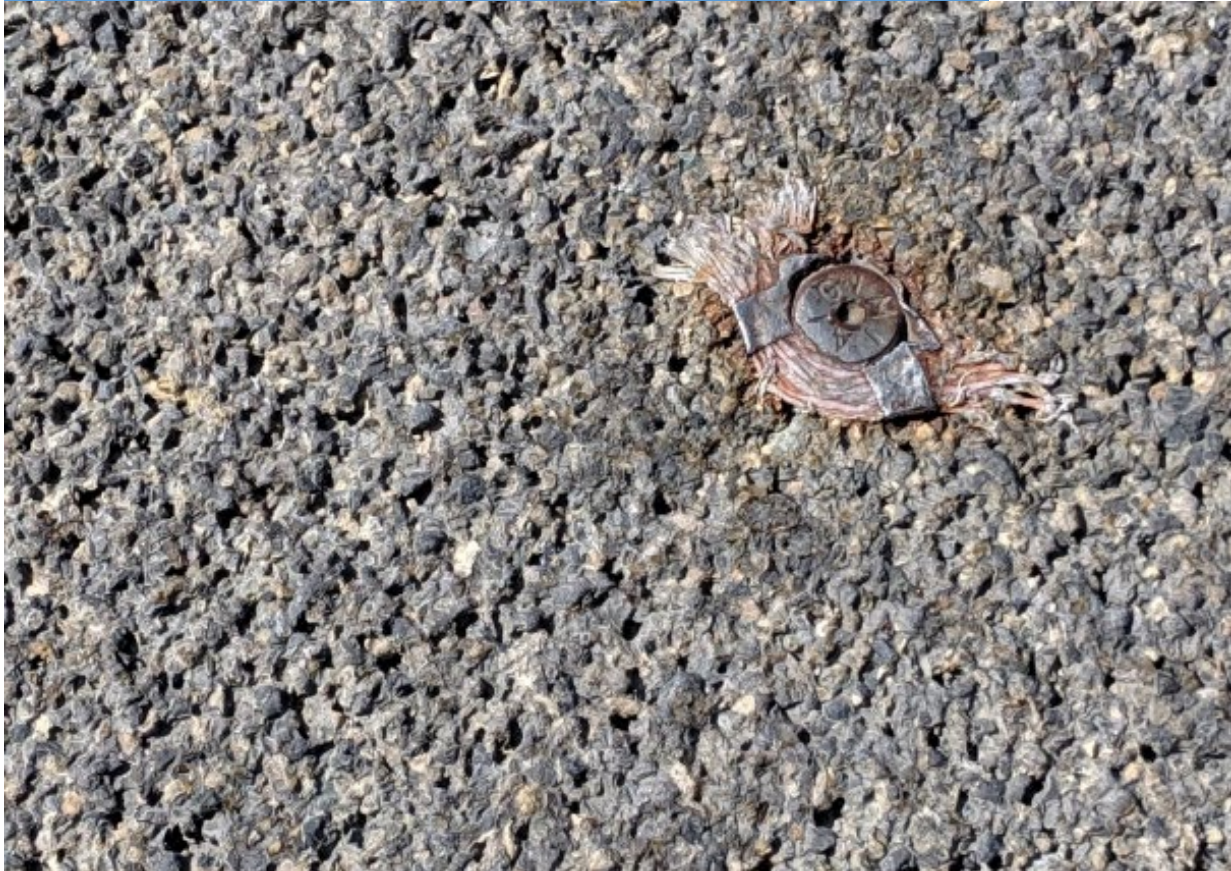
**Site 21 – Photo Log**

Old Glenn at at milepost 6 showed moderate friction loss, although no loss on average between 2018 and 2019. None of the three tests had less friction than the original pavement control of 0.54, with an average of 0.63. Small amounts of bare pavement was visible under the HFST, although this did not affect testing at this location. Typical wear of the HFST can be seen in the second 2019 picture adjacent to the PK nail, below.

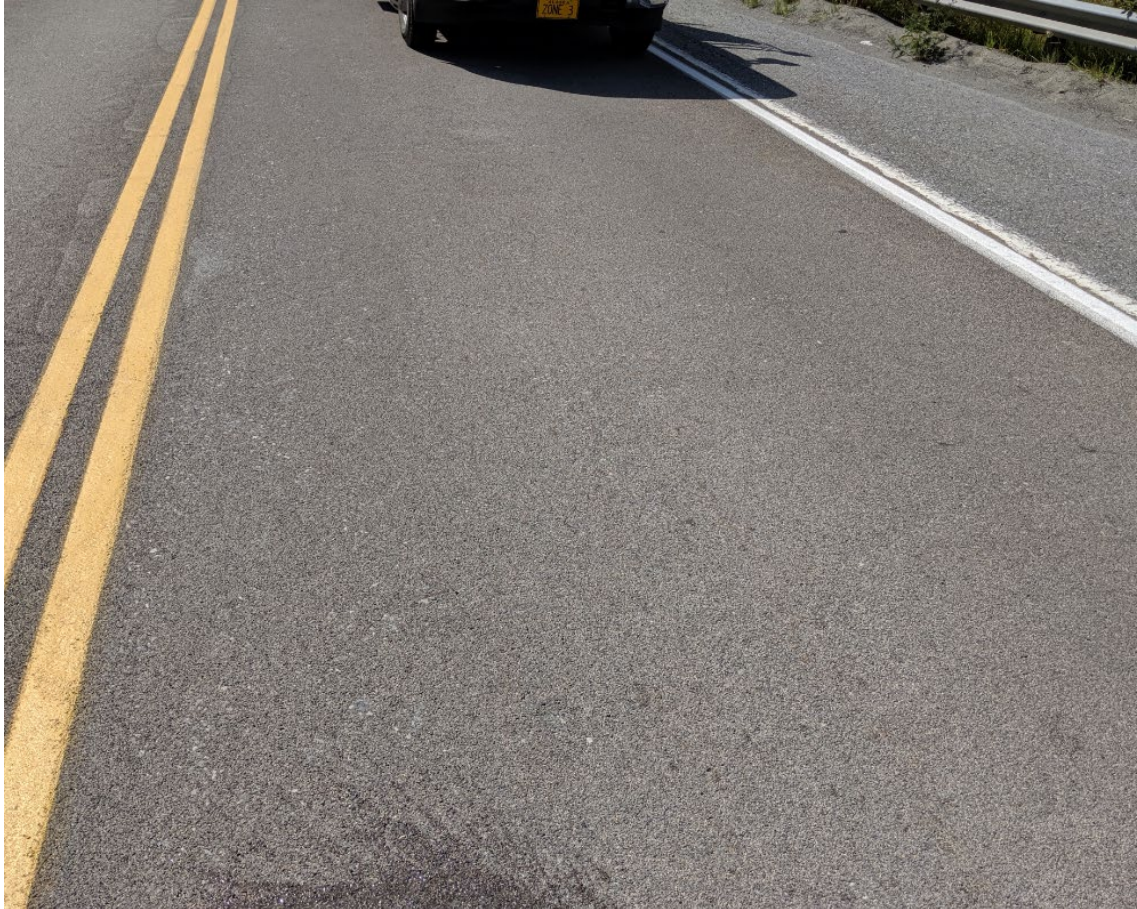
**Site 22 – Photo Log**

Old Glenn at at milepost 7 showed moderate friction loss. One of the five tests had less friction than the original pavement control of 0.49, while the average was 0.55. Small amounts of bare pavement was visible under the HFST, likely due to snowplowing as there typically wasn't major wear evident in the wheelpaths. See the 2019 picture, below.

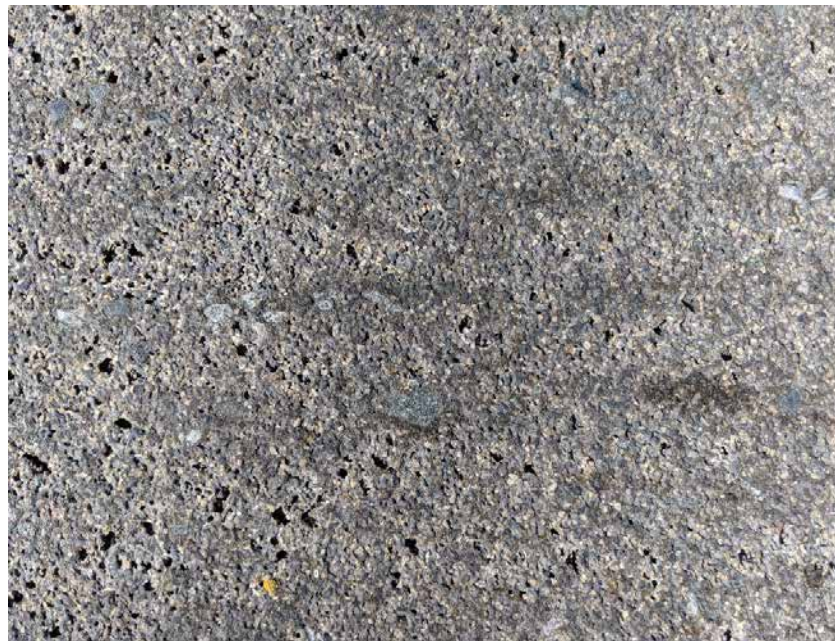
**2018**

Old Glenn at milepost 8 showed moderate friction loss, although minimal loss on average between 2018 and 2019. One of the five tests had less friction than the original pavement control of 0.49, while the average was 0.61. Small amounts of bare pavement was visible under the HFST, likely due to snowplowing and studded tire wear. See the 2019 picture, below and on the next page.

**2019 – Bare Pavement and Significant Wear**

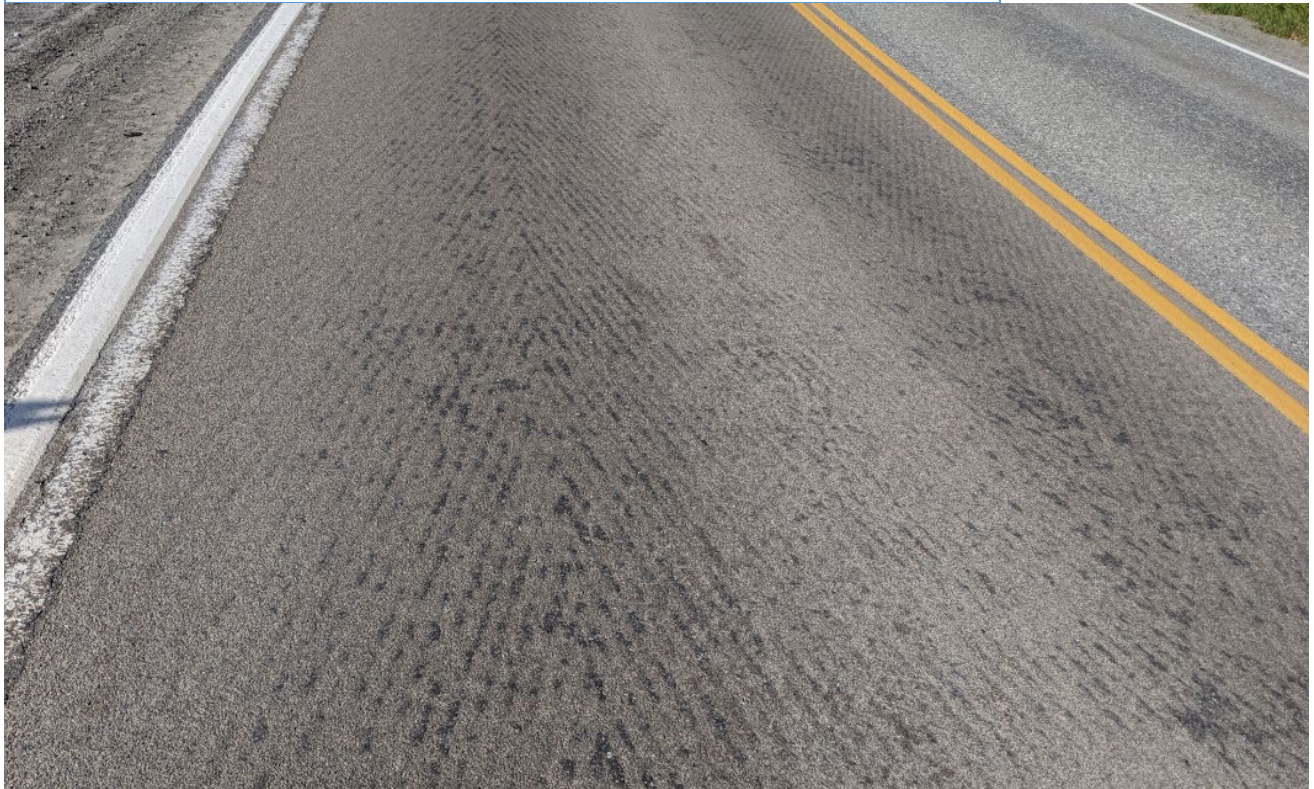
**Site 24 – Photo Log**

Old Glenn at Our Road showed moderate friction loss, although minimal loss on average between 2018 and 2019. One of the three tests had less friction than the original pavement control of 0.55, while the average was 0.59. Small amounts of bare pavement was visible under the HFST, likely due to snowplowing as some of the observed pavement is outside of wheelpaths. The surface texture observed in the 2019 photo, below, is due to the HFST application being located in the floodplain and the surface required milling to maintain elevation.

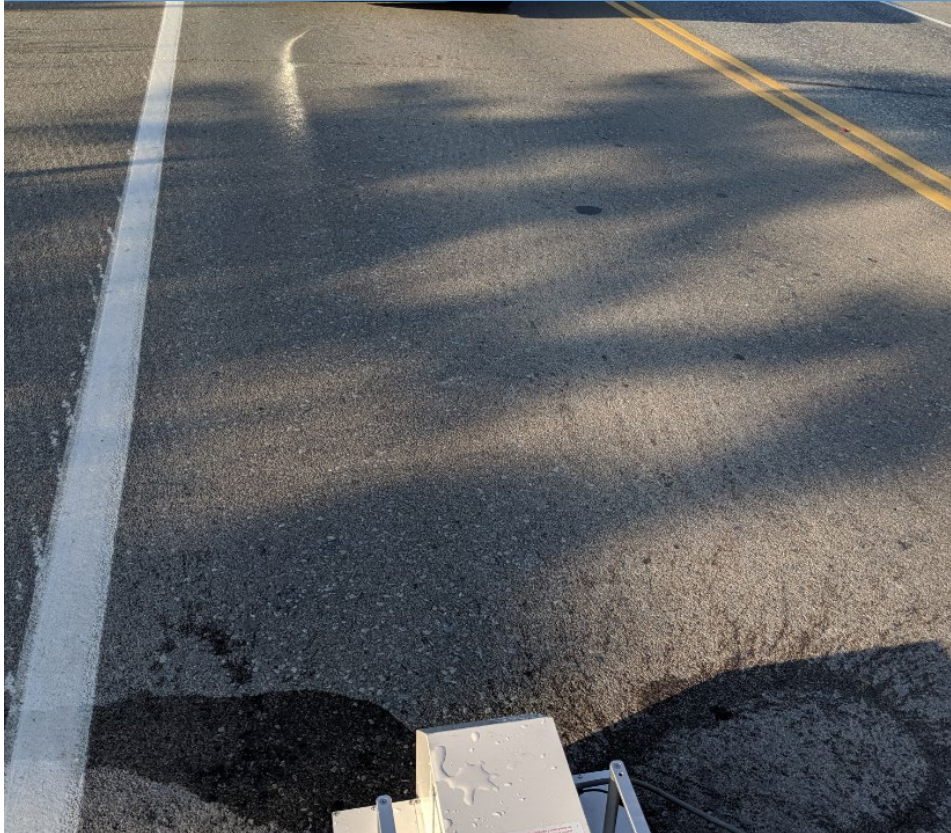
**Site 25 – Photo Log**

Old Glenn at milepost 12 lost significant friction. All three of the tests had less friction than the pavement control of 0.56. The average 2019 friction value was 0.37. Bare pavement was common at this site and in the 2019 photo, below, bare pavement can be observed in the wheelpath where the friction test is being performed. This site is closer to Palmer and contains higher traffic volumes than the rest of the sites on the Old Glenn Highway which is contributing to the wear compared to other Old Glenn Highway sites.

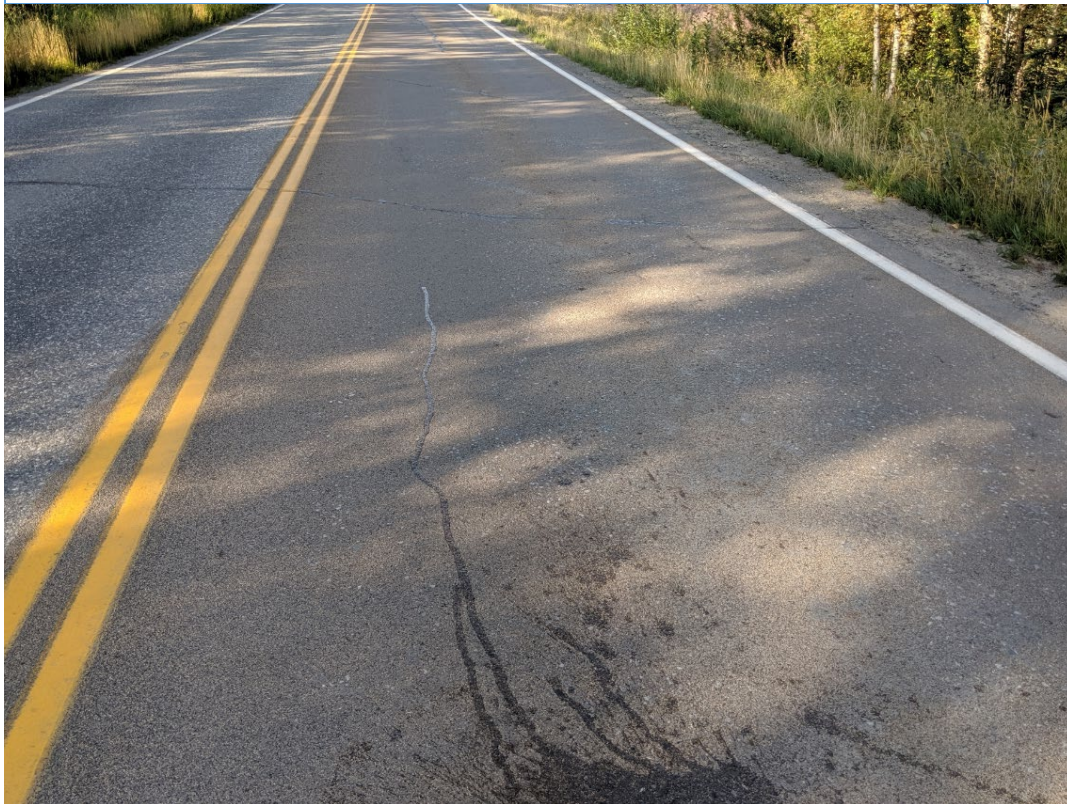
**Site 26 – Photo Log**

Site 26 lost significant friction. All four of the tests performed had less friction than the pavement control of 0.57. The average 2019 friction value was 0.34. Bare pavement was common at this site and in the 2019 photo, below, bare pavement can be observed in both wheelpaths, although primarily in the right. This site is close to East Seldon and Bogard and has the highest traffic volume on Wasilla/Fishhook at almost 5,000 AADT.

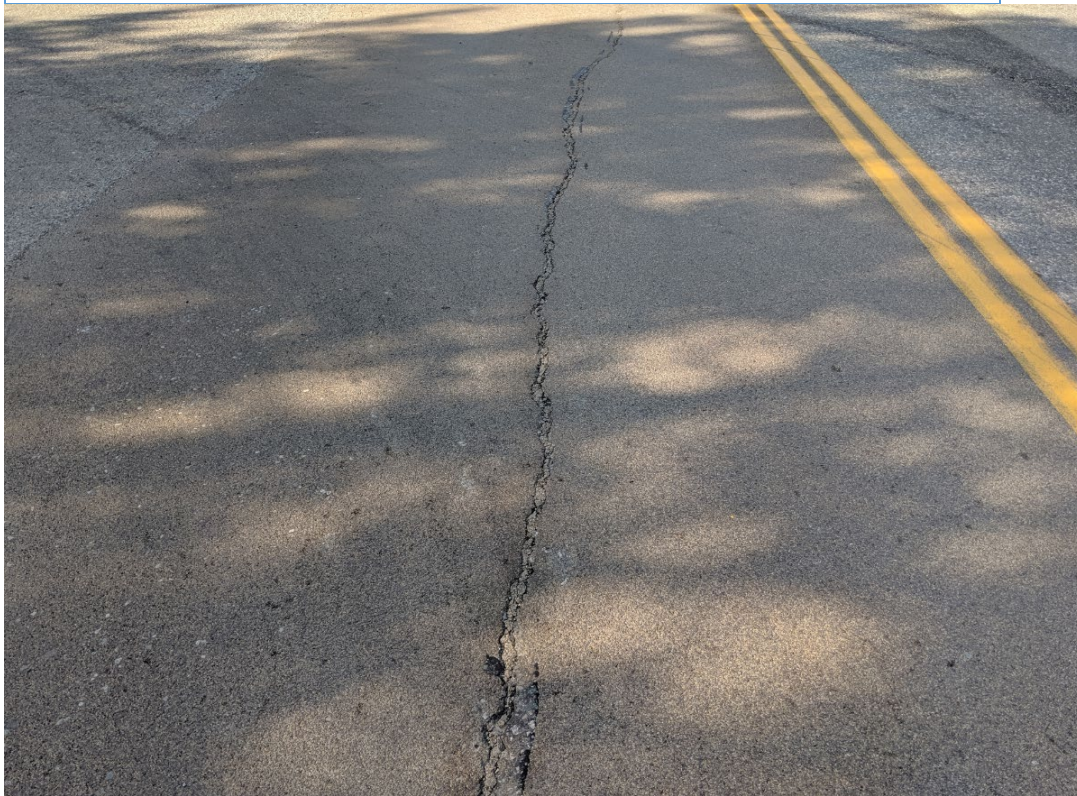
**Site 27 – Photo Log**

Site 27 lost significant friction, although the average drop in friction between 2018 and 2019 was minimal. Three of the five tests performed had less friction than the pavement control of 0.57. The average 2019 friction value was 0.47. Bare pavement was visible at this site and in the 2019 photo, below, bare pavement can be observed in the left wheelpath. As with site 26 this location has a relatively high AADT at over 4,000, or twice that of the Old Glenn sites.
