Alaska Department of Transportation & Public Facilities  
**Research & Technology Transfer**

# High Friction Surface Treatment Experimental Feature Final Report and 3<sup>rd</sup> Year Monitoring Results

Alaska Department of Transportation and Public Facilities,  
Central Region Materials and Statewide Asset Management & Research

**Publication Number:** FHWA-AK-RD-000S(882)

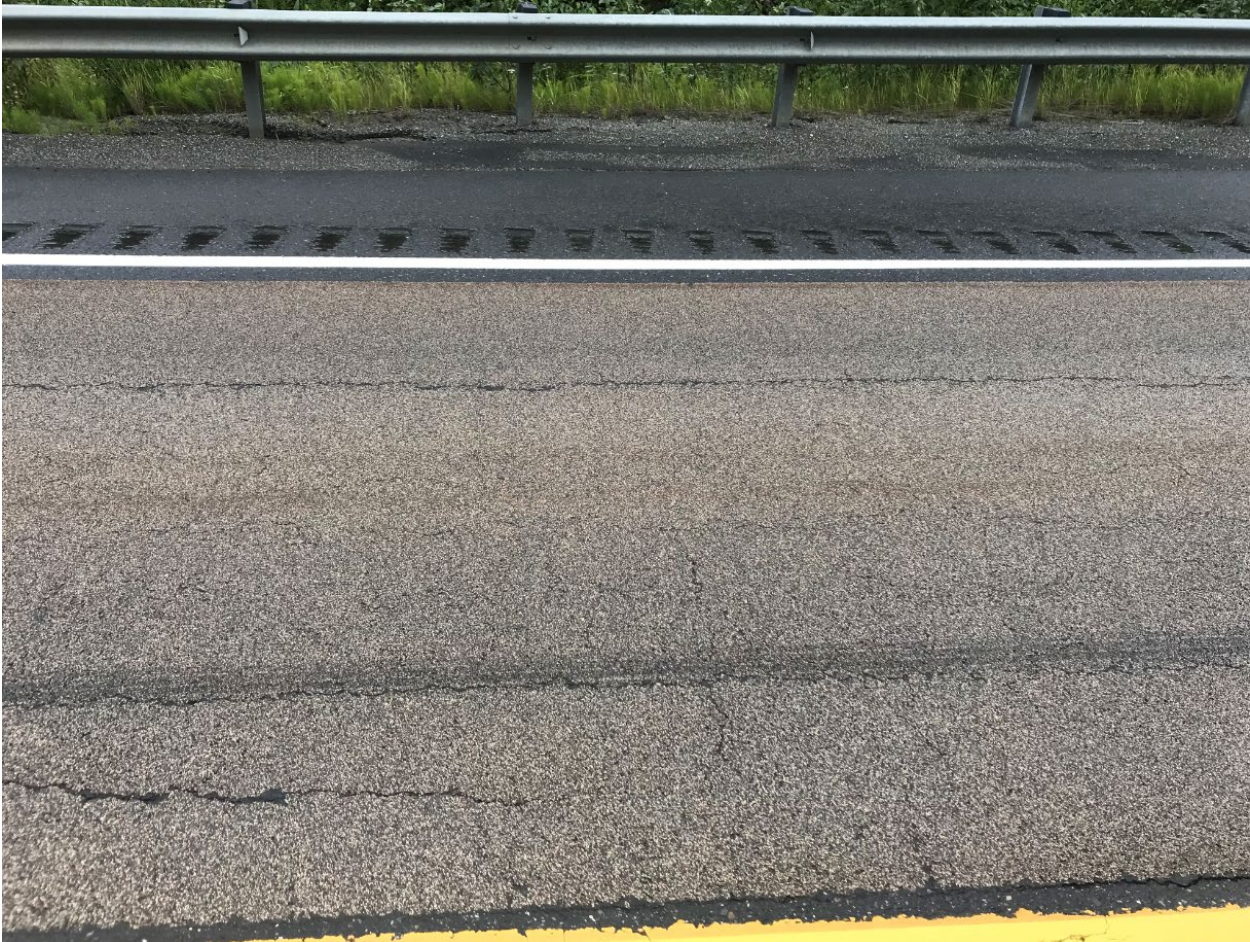
While the Parks Highway at Chutlina lost moderate friction, it still retains higher friction than most other locations. All tests retain the friction of pavement or higher after 4 winters. The average 2019 friction value was 0.66. This was the only location tested that used fully automated application and used epoxy resin. A cracking pattern can be seen in the 2019 photo, below, that may be due to the contraction of the epoxy during the winter seasons.

2018 Photo – observed cracking pattern

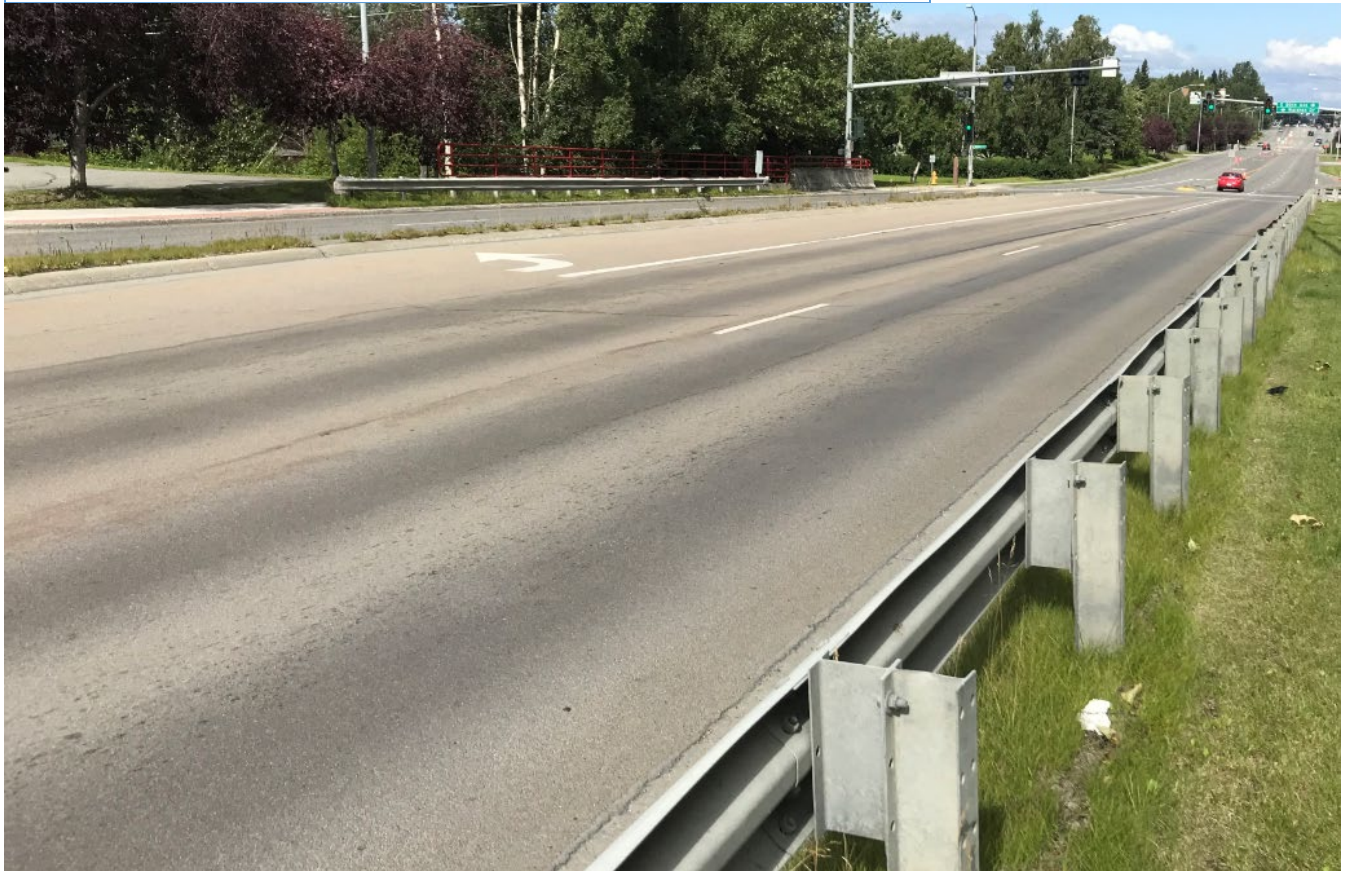
In the picture on the previous page, taken in 2018 just south of the intersection of Waldron and Lake Otis, extensive wheelpath wear is apparent in the through lanes while the turn pocket looks to have minimal wear. At this site the turn pocket retained a friction value of 0.70, while the two tests in the through lanes had values of 0.30 and 0.37.

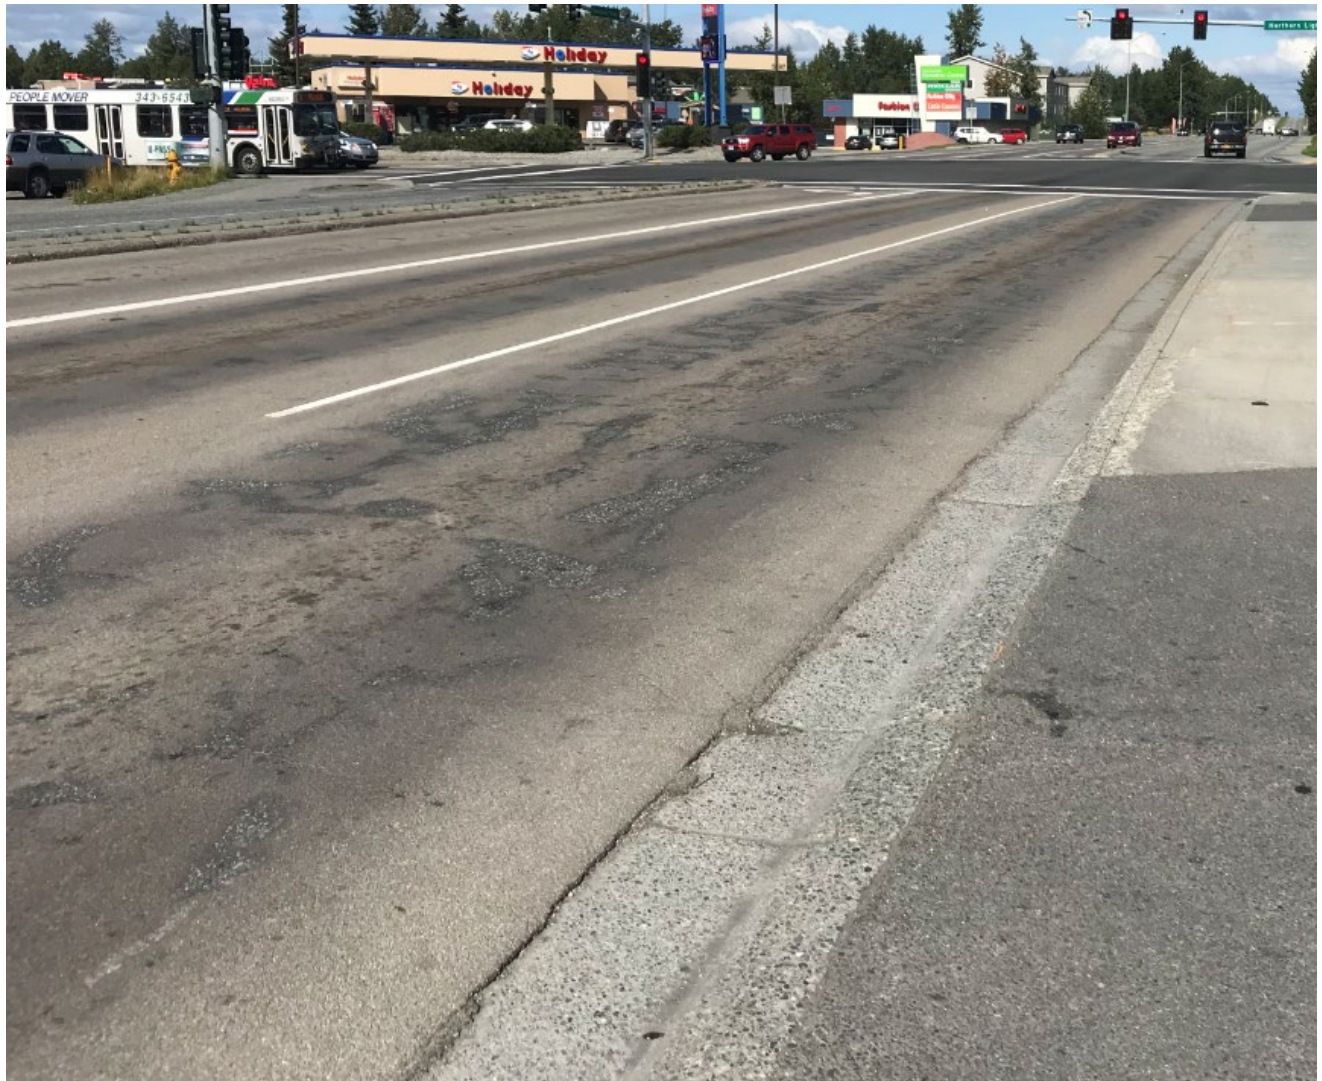
The wear across the lanes can be observed at the 2018 photo taken at the intersection of Boniface and Northern Lights. The most wear is on the outside lane (right) while the turn pocket has noticeable wear, but not nearly to the extent the right hand lane does.
