Test Report No. 608331-01-1A-2-3  
Test Report Date: April 2019

## **MASH TL-4 EVALUATION OF 2019 MASH 2-TUBE BRIDGE RAIL**

Contract No.: 1602767  
Test No.: 608331-01-1A / 2 / 3  
Test Date: 2018-12-10 / 12-12 / 12-14

Sponsored by  
State of Alaska Department of Transportation and Public  
Facilities and North Dakota Department of Transportation

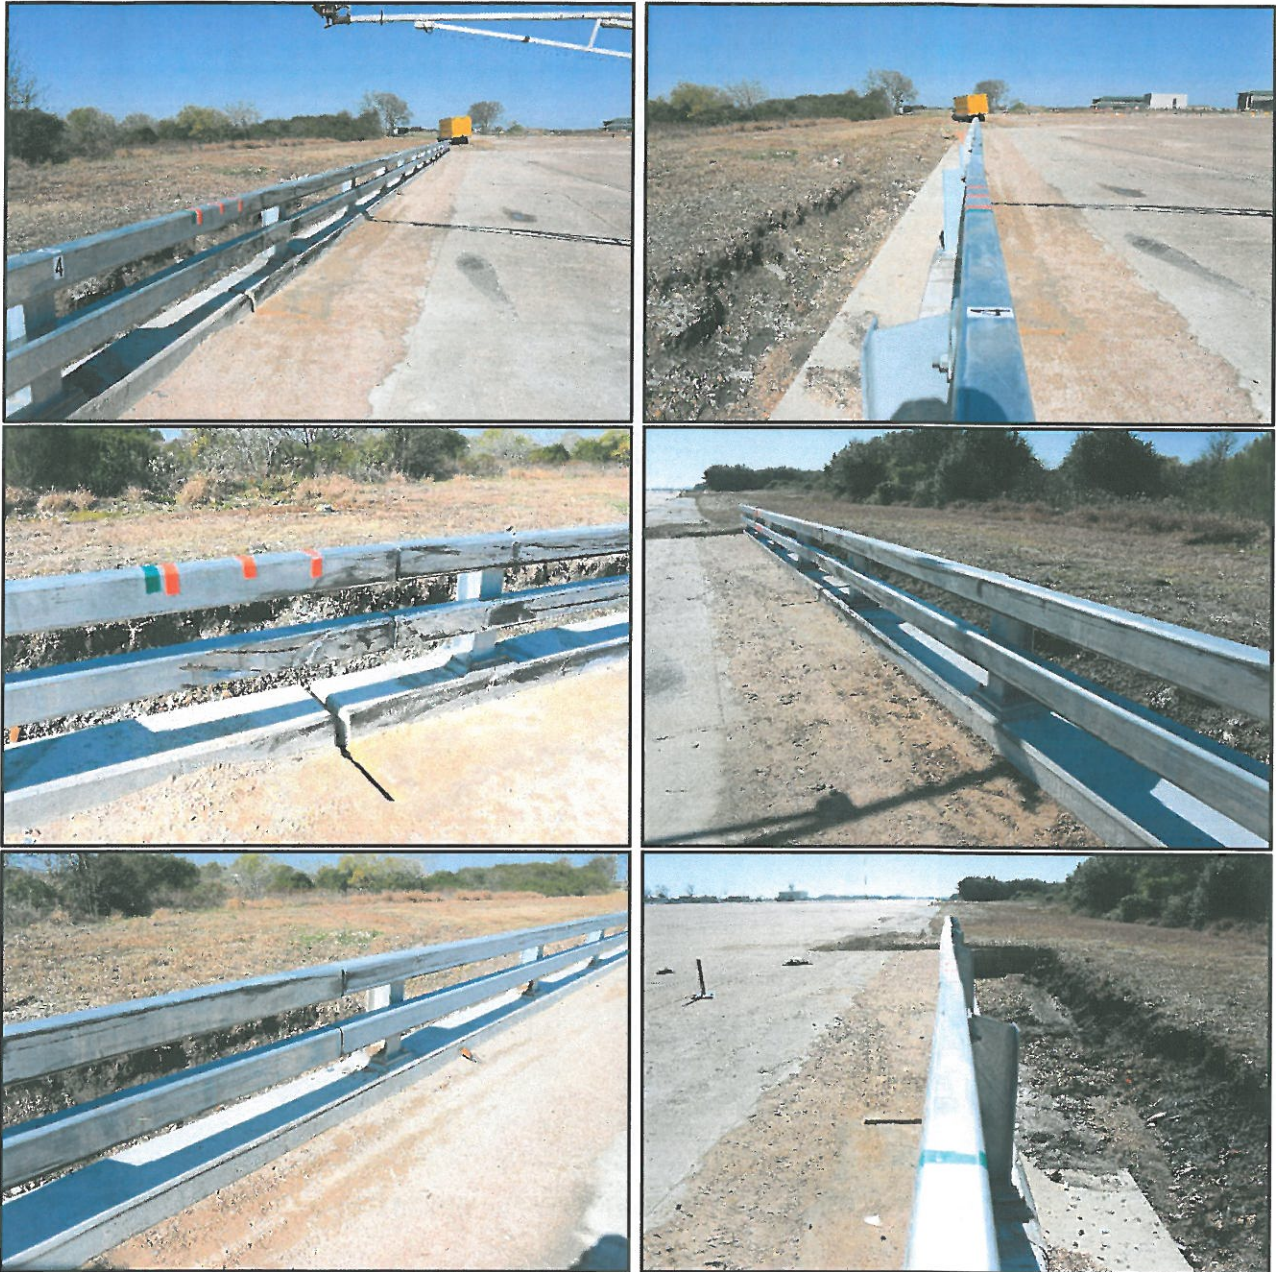
**Figure 5.3. Overall Damage to Alaska Bridge Rail after Test No. 608331-01-1A.**

Figures 5.3 and 5.4 show the damage to the 2019 MASH 2-Tube Bridge Rail. The traffic face of the bridge rail was scuffed with tire marks, and the lower rail element was gouged in the impact area. The curb was cracked on the downstream side of post 5 and just upstream of post 5 (see Figure 5.4). Working width was 56.7 inches at a height of 136.8 inches. Maximum

dynamic deflection during the test was 3.0 inches, and maximum permanent deformation was 2.0 inches.

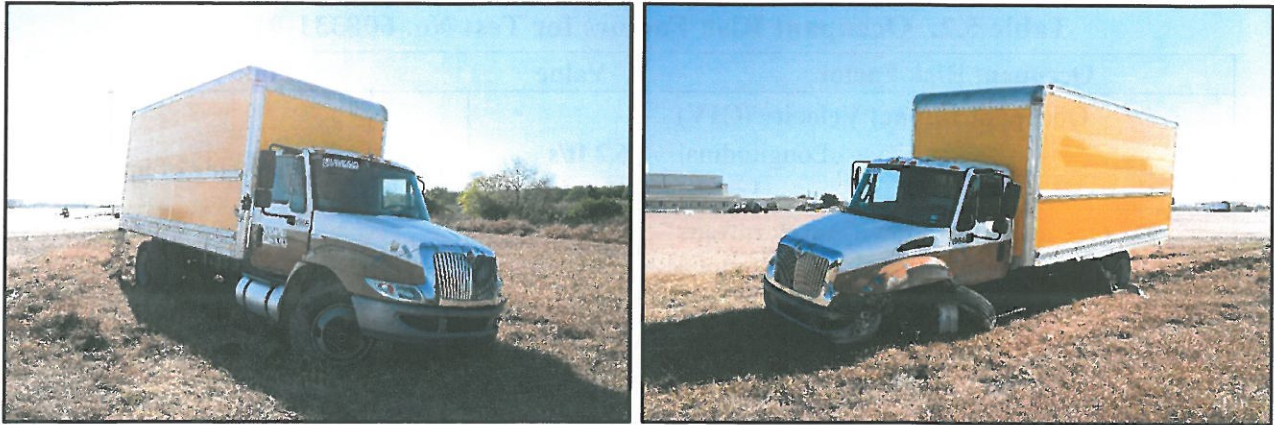
**Figure 5.5. Test Vehicle after Test No. 608331-01-1A.**

Figure 5.5 shows the damage sustained by the vehicle. The front bumper, hood, left front tire and rim, left front U-bolts, left battery box, left side steps, left door, left rear cab corner, lower edge of box, and left rear outer tire and rim were damaged. Maximum exterior crush to the vehicle was 12.0 inches in the front plane at the left front corner at bumper height. Maximum occupant compartment deformation was 5.5 inches in the left front corner of the floor pan. Figure 5.6 shows the interior of the vehicle.

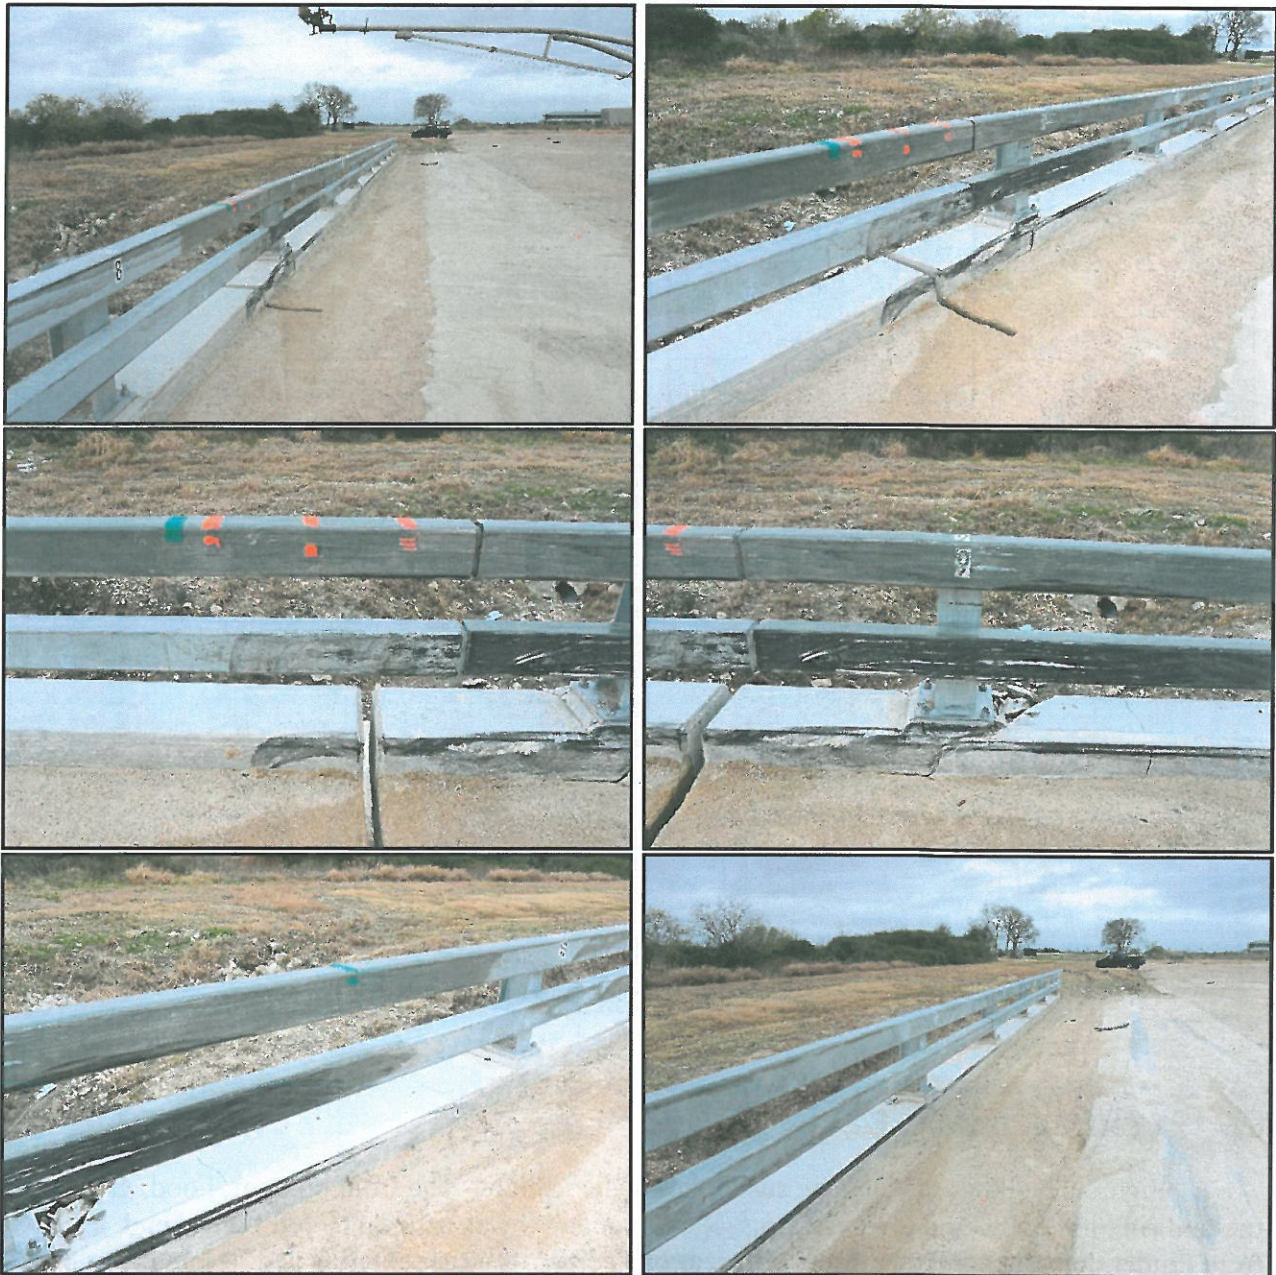
Figure 6.3. 2019 MASH 2-Tube Bridge Rail after Test No. 608331-01-2.

Figures 6.3 and 6.4 show the damage to the 2019 MASH 2-Tube Bridge Rail. The metal rail elements were scuffed with tire marks and cosmetic damage. The concrete around the curb at post 8 was cracked. The concrete around post 9 was cracked and spalled off, revealing the rebar on the field side of the curb and on the underside of the deck. Working width was 20.2 inches at the top of post 9. Maximum dynamic deflection during the test was 7.1 inches, and maximum permanent deformation was 2.0 inches.

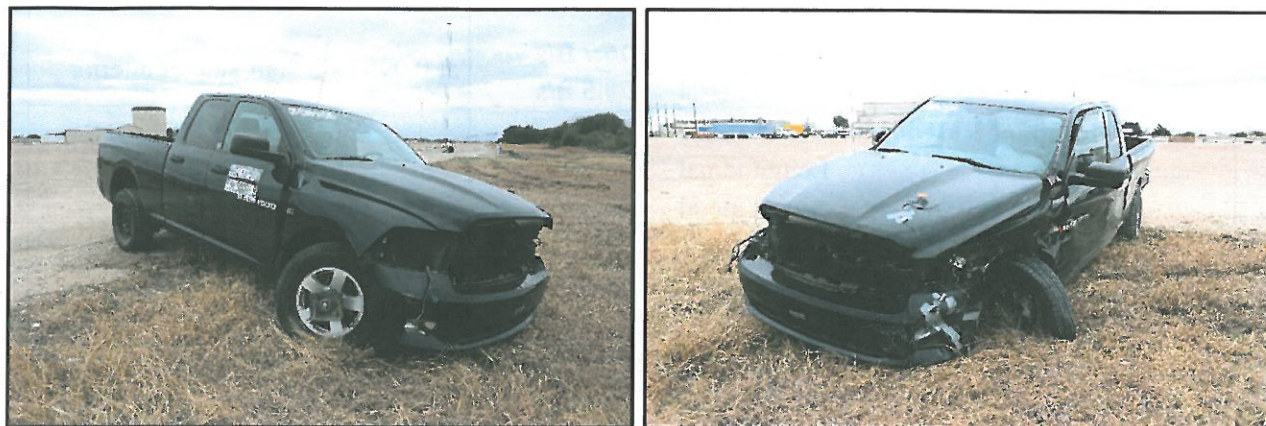
**Figure 6.5. Test Vehicle after Test No. 608331-01-2.**

Figure 6.5 shows the damage sustained by the vehicle. The front bumper, hood, grill, left tire and rim, left upper and lower A-arms, left upper and lower ball joints, left tie rod end, left front fender, left front and rear doors, left rear cab corner, left rear exterior bed, left rear rim, rear bumper, and tailgate were damaged. The windshield sustained stress cracks radiating up and out from the left lower corner. Maximum exterior crush to the vehicle was 11.0 inches in the side plane at the left front corner at bumper height. Maximum occupant compartment deformation

was 0.5 inch in the left front firewall area. Figure 6.6 shows the interior of the vehicle. Tables D.3 and D.4 in Appendix D1 provide exterior crush and occupant compartment measurements.

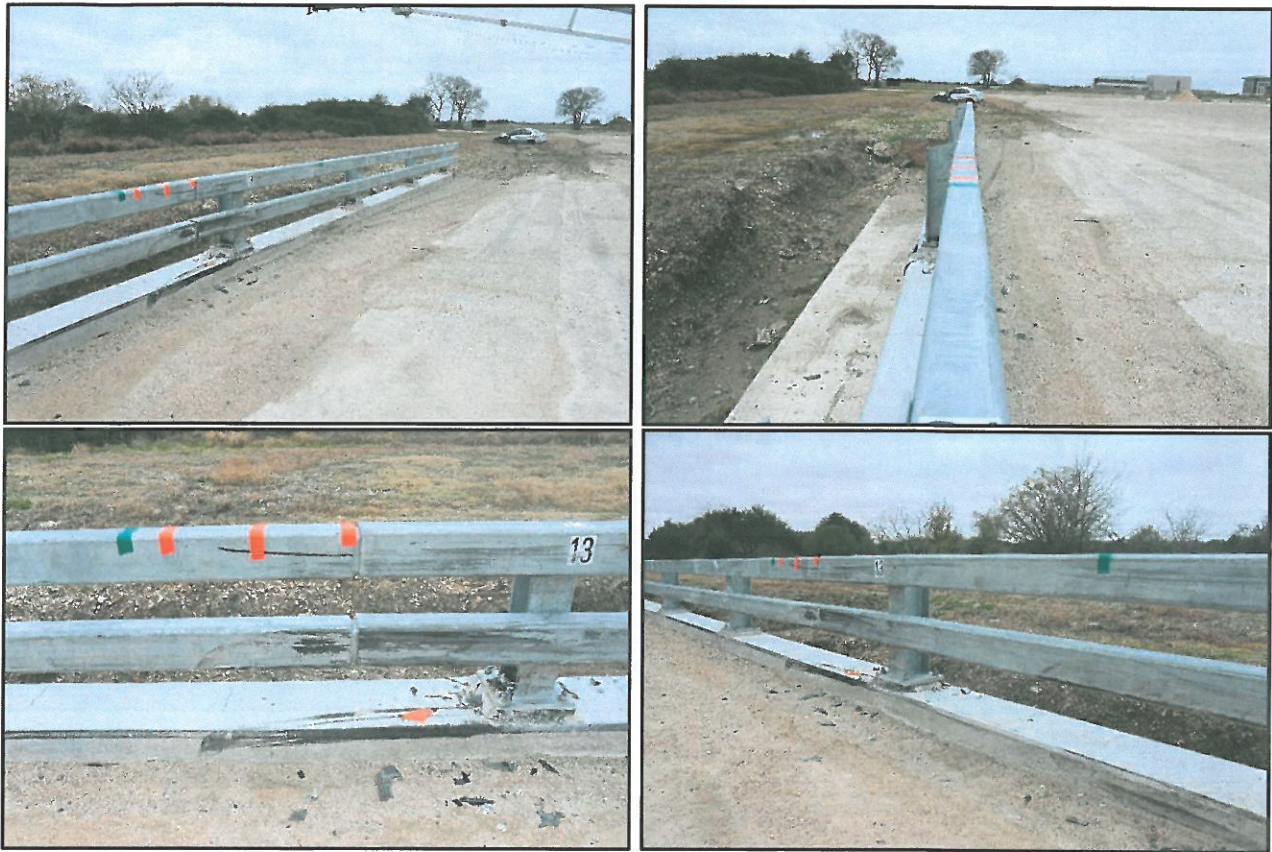
**Figure 7.3. 2019 MASH 2-Tube Bridge Rail after Test No. 608331-01-3.**

Figure 7.3 and 7.4 show the damage to the 2019 MASH 2-Tube Bridge Rail. The metal rail elements were scuffed with tire marks and cosmetic damage. The concrete around the base

of post 13 was broken through the curb on both sides of the post and extended to the bottom of the deck. Working width was 8.5 inches at a height of 44.3 inches. Maximum dynamic deflection during the test was 2.8 inches, and maximum permanent deformation was 1.0 inch.

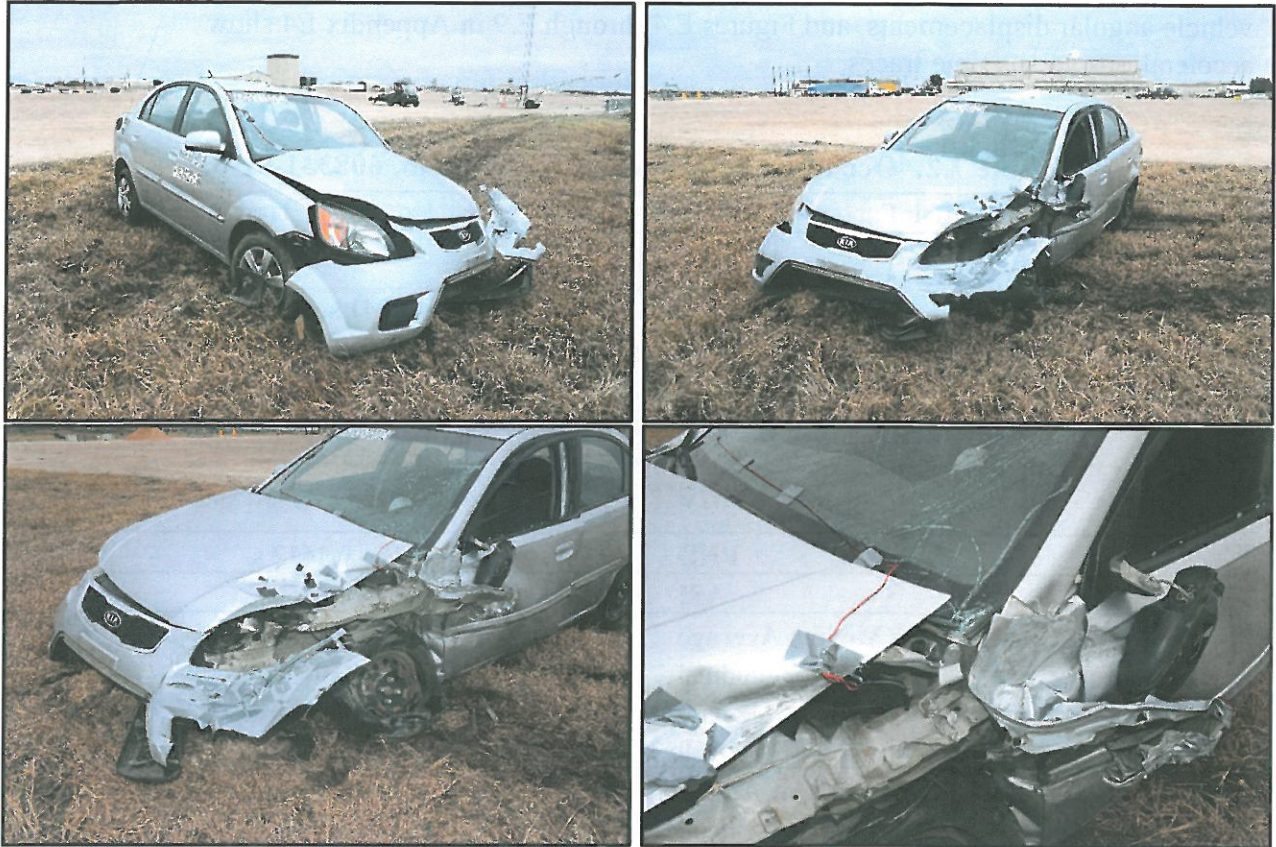
**Figure 7.5. Test Vehicle after Test No. 608331-01-3.**

Figure 7.5 shows the damage sustained by the vehicle. The front bumper, hood, radiator and support, left front fender, left front tire and rim, left front strut and tower, left A-post, roof, left front door and window glass, left rear door, left rear quarter panel, and rear bumper were damaged. The windshield sustained stress cracks radiating upward and outward from the left lower corner. Maximum exterior crush to the vehicle was 11.0 inches in the side plane at the left front corner at bumper height. Maximum occupant compartment deformation was 4.0 inches in the left front firewall area. Figure 7.6 shows the interior of the vehicle. Tables E.2 and E.3 in Appendix E1 provide exterior crush and occupant compartment measurements.
