Underwater Inspection of Bridge Substructures Using Imaging Technology

June 14, 2018

Sponsored by
Federal Highway Administration
Office of Infrastructure
FHWA-HIF-18-049

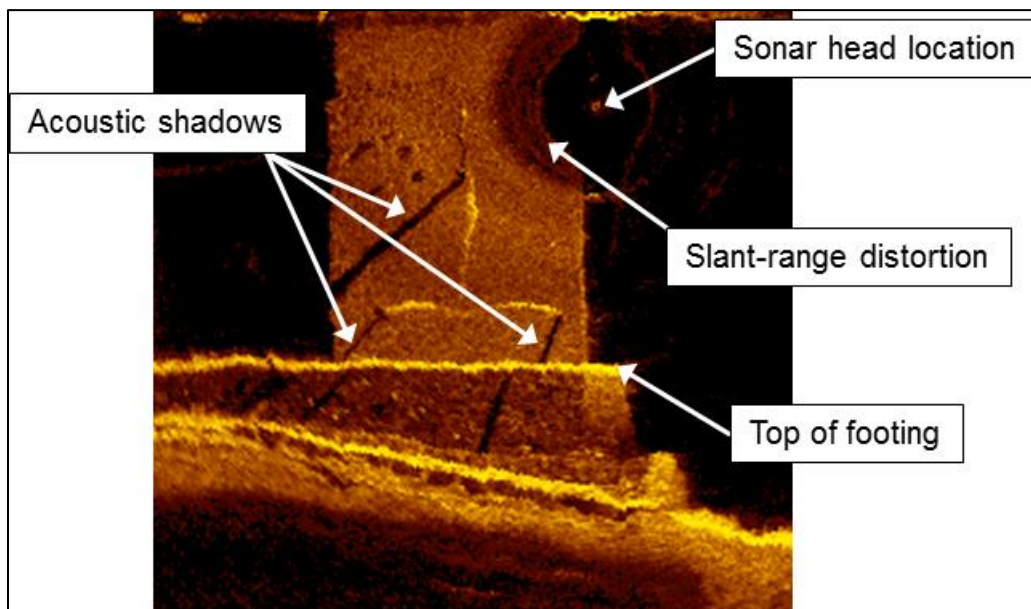
Shadows can easily be misinterpreted as defects in a bridge substructure. For example, an inverted T-shape is apparent on the face of the concrete pier in figure 18. An inspector unfamiliar with sonar may misinterpret this image as concrete deterioration or cracking. However, as shown in the bridge plans for this location in figure 19, the shape is actually a steel frame designed to mount a fixed scour monitoring device to the pier. The acoustic shadow connects to the target that formed it at the location where the steel frame is connected to the pier face.

Figure 18. Image. Sector-scanning sonar image with shadows on the face of a concrete pier.

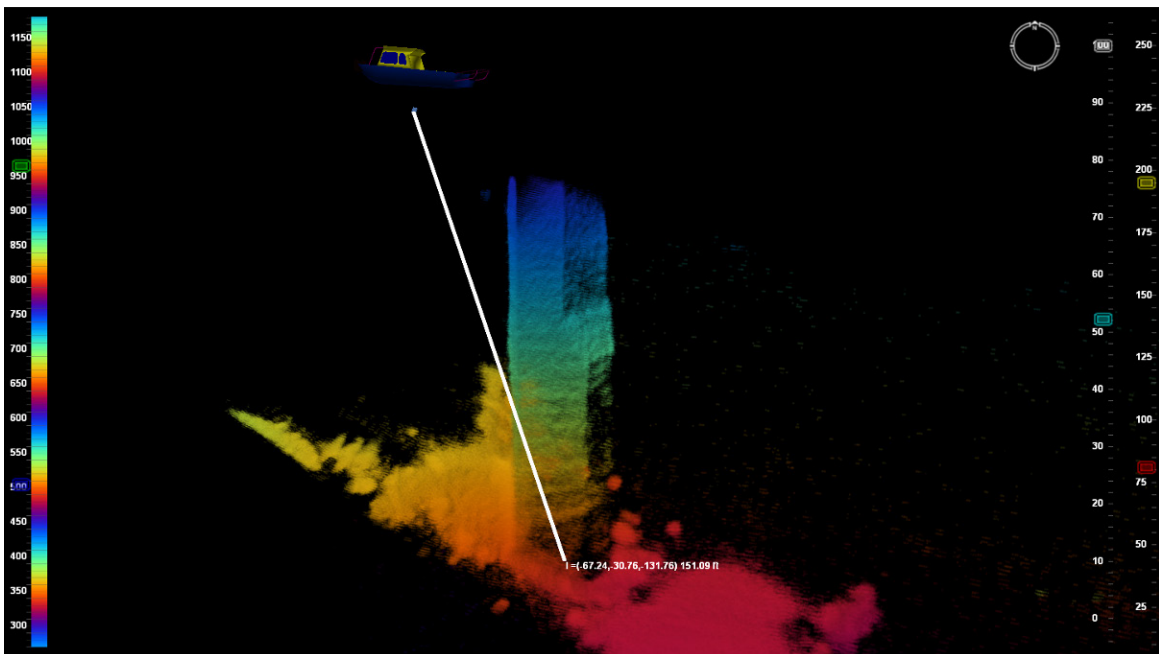
Figure 40 shows the image of bent 4 captured by the sonar. A symbol representing the data collection boat is also shown to illustrate the range required of the sonar at this site. Figure 41 is a data mosaic showing bents 4 and 5 as viewed from the west side of the bridge. The annotations on the figure demonstrate how structure dimensions can be obtained from the image. Close analysis of the images may reveal reportable observations. For example, a closer view of the base of bent 4 shown in figure 42 provides an indication of scour at the base of the bent.

Figure 40. Image. Bent 4 with boat location showing sonar range.

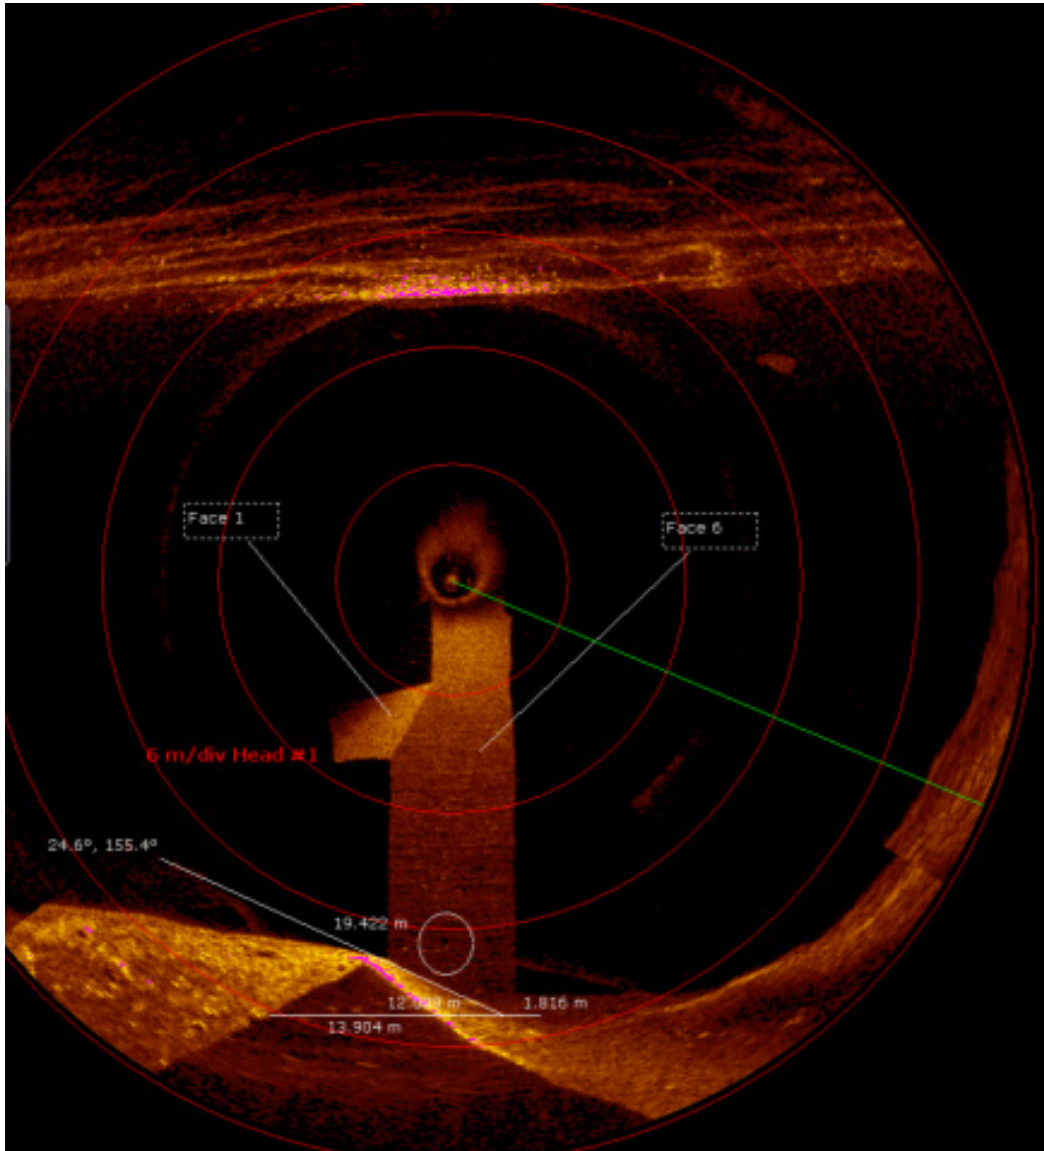
After completing the bottom scans the head was fitted into a drop frame and lowered along each face of the pier. As an example, figure 47 displays the image for face 6. It appears in good condition with the lakebed slope at the mud line at 24.6 degrees. The circled 'target' is 7.2 ft (2.2 m) above the mud line and may be a small void in the concrete face. Various anomalies were reported on other faces.

Figure 47. Image. Face 6 of the James E. Roberts Bridge.

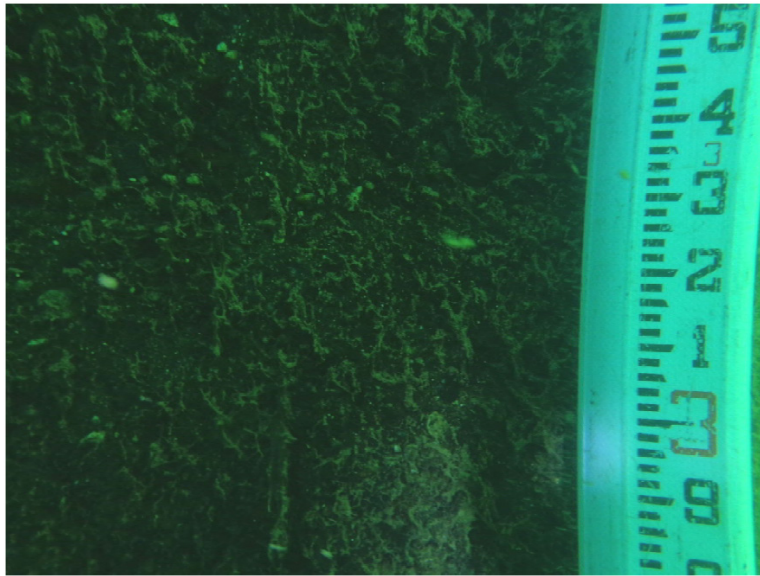
Figure 48. Photo. Marine growth on concrete 15 ft (4.6 m) below the waterline.

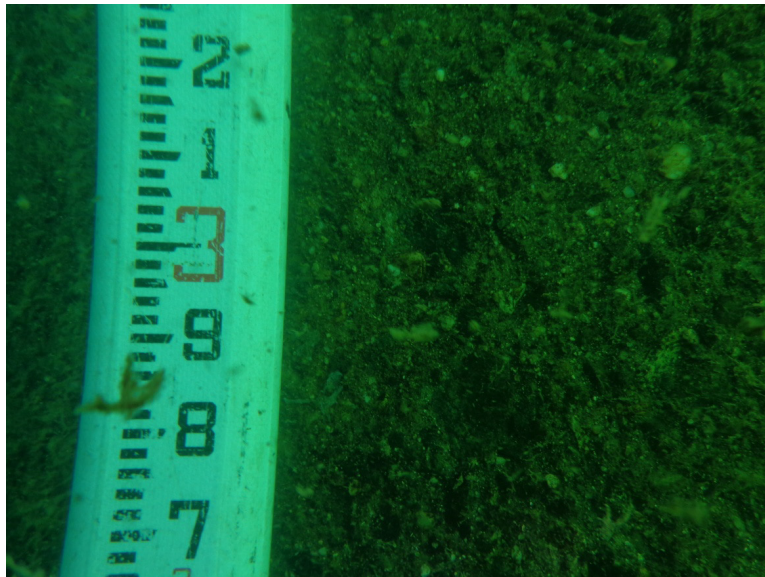
Figure 49. Photo. Typical concrete condition with level II cleaning (15 ft (4.6 m) below the waterline).

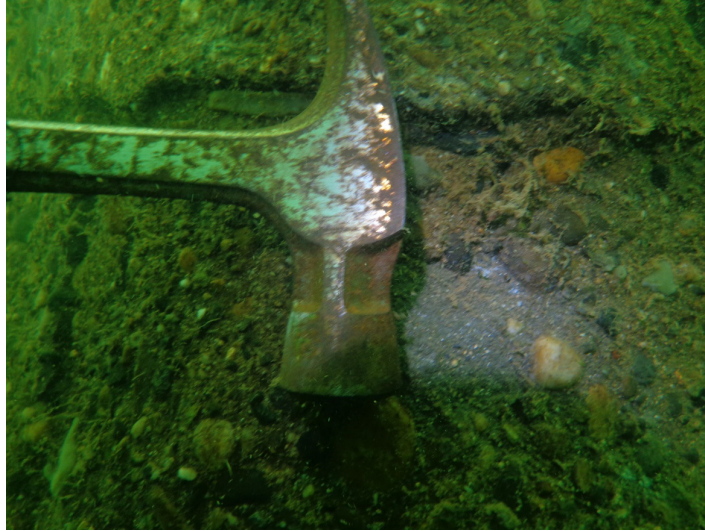
Figure 50. Photo. Typical cold joint after cleaning.
