FEDERAL AVIATION AGENCY

# Airworthiness Directives

Effective January 1, 1963

Part 507 of Regulations of the Administrator

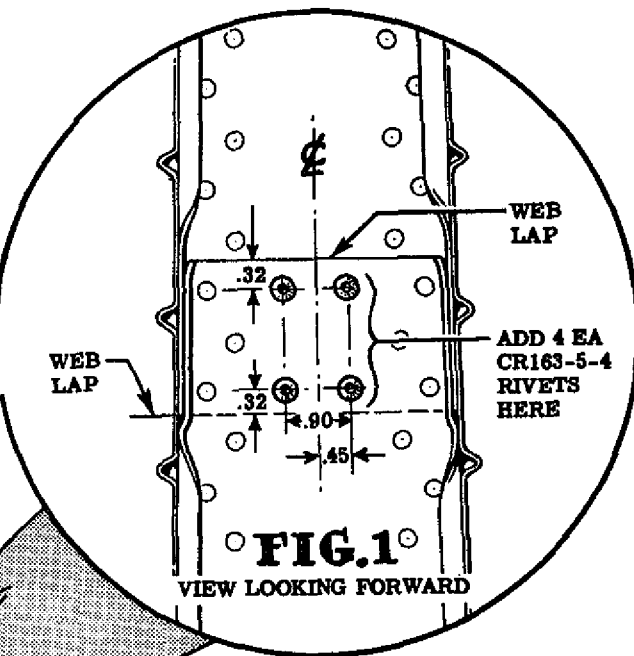
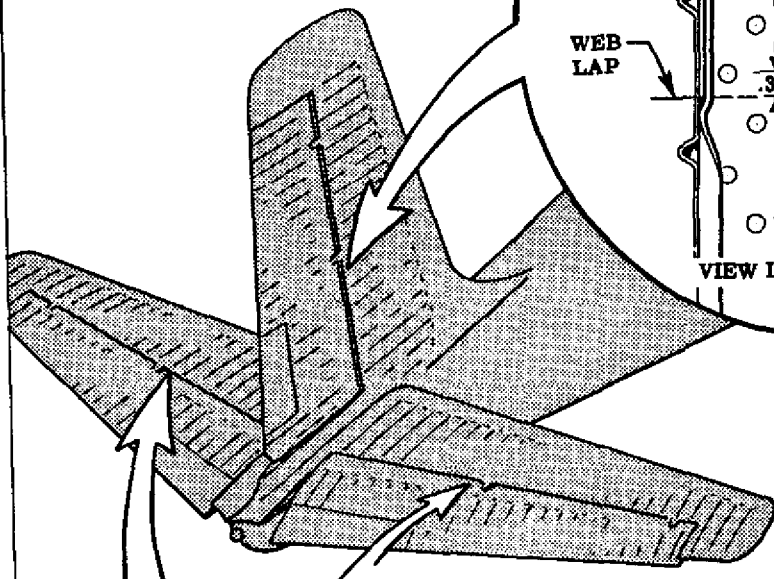
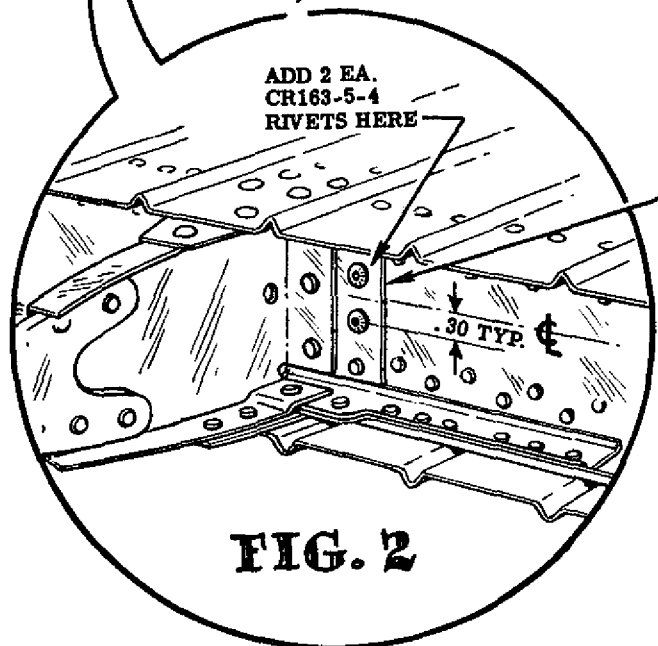
Service Bulletin No. 50

Within the next five hours of flight unless previously accomplished, inspect each elevator front spar in the area of the outboard hinge brackets for cracks. The elevator outboard hinge brackets must be removed for this inspection. If no cracks are found, the horizontal stabilizer must be modified as outlined in Item II. If any cracks are found in the elevator front spar, the spar must be reworked as outlined in Item III and the horizontal stabilizer must be modified as outlined in Item II.

SEE REPAIR DATA PARAGRAPH FOR SPECIAL INSTRUCTIONS WHERE WEB LAP EXTENDS LESS THAN 1/2 INCH INBOARD OF FORWARD FLANGE ON CENTER HINGE BRACKET.

If cracks are present, contact the Service Department, Aero Design and Engineering Company, Post Office Box 118, Bethany, Oklahoma, for rework of the elevator front spars.

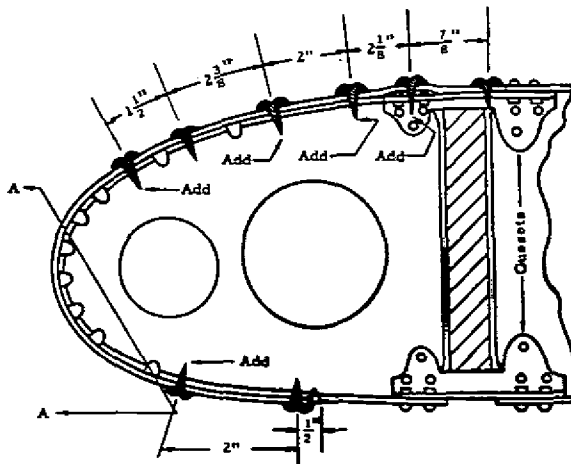
FIGURE 1

Inspect the wing leading edge for buckled nose ribs or loose PK screws by pressing leading edge skin with hand to nose ribs. If the skin can be depressed beyond the normal wing contour, other than the extreme nose radius, indicated by section A-A in Figure 1, the fabric should be cut open on the bottom surface

occurred or not, whereas item No. 2 pertains only to damaged ribs found in the above inspection. Repair need not be made if buckling is confined to area forward of section A-A of Figure 1.

1. To help prevent further failures of the nose ribs five additional No. 4 x 1/4 PK screws or, as an alternate, Cherry CR163-4-2 rivets or equivalent are to be installed in all nose ribs. Four PK screws or rivets are to be installed on the top surface and one PK screw or rivet is to be installed in the bottom as shown in Figure 1. Apply dope liberally under the PK screw head before tightening. It is not necessary to remove the fabric to accomplish this modification.

2. Damaged ribs should be cut away at the top and bottom of spar. The new nose ribs are installed by means of two gussets on the side of the ribs as shown in Figure 1. Factory kits, Aeronca P/N 5-185-2 and 5-190-2, are to be used.
